Strategy Guideline: Quality Management in Existing Homes

Cantilever Floor Example

J. Taggart, J. Sikora, J. Wiehagen, and
A. Wood
NAHB Research Center

December 2011

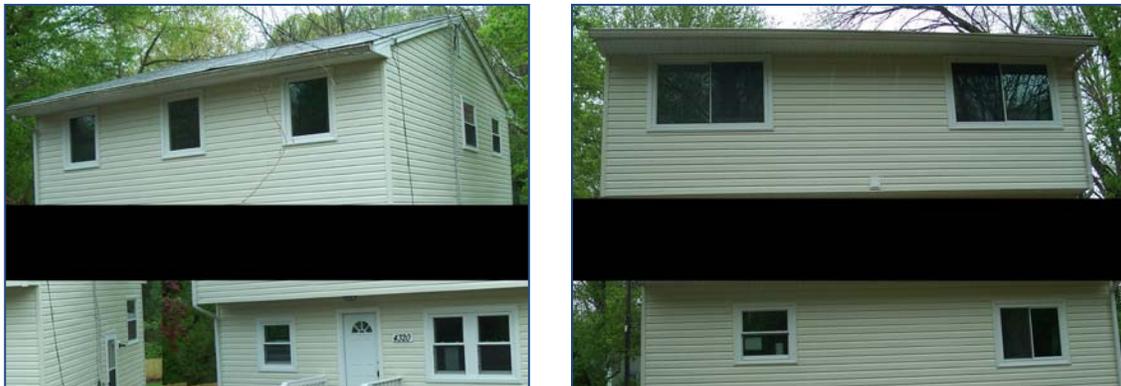
Figure 2. House with cantilever front and rear following remodel

As outlined above, this document uses the example of a cantilever floor remodel as the basis for detailing a quality assurance approach. A cantilevered floor system that projects beyond the supporting wall as shown in Figure 2 is a common architectural element in U.S. homes. This system is common in split-level, ranch, and two-story homes as an affordable way to expand above-grade living area without increasing excavation costs. In this case, a homeowner in the mixed-humid climate of the suburbs of Washington, D.C., was experiencing cold floors and as a result wanted to remodel the cantilever area to improve interior comfort. The reason for the cold floors in this situation is due to poor air sealing and insulation in the cantilever area.

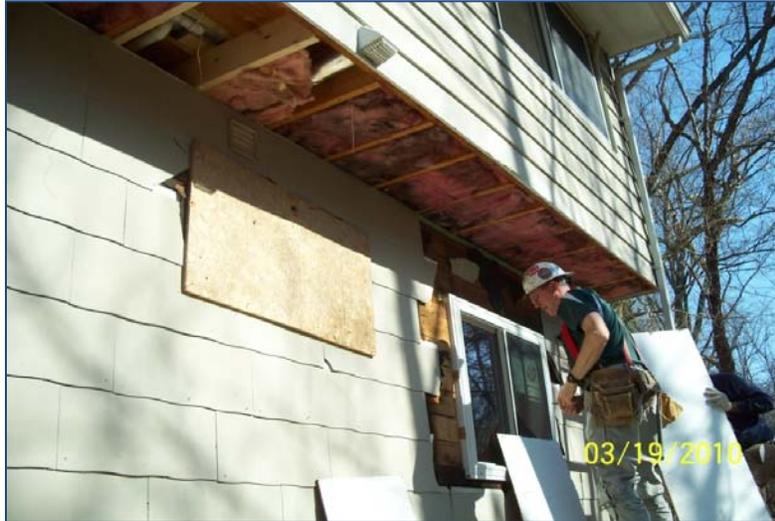
Figure 3. Typical cantilevered floor area depicting issues leading to performance problems

The cantilevered floor area was insulated with fiberglass batts and covered on the underside with soffit material that is perforated and permeable—therefore, not airtight. In addition, the existing design lacks an external air barrier (e.g., sheathing) and permits the relatively free flow of air into the cantilevered space and ultimately directly into the house. There is a direct path for air to infiltrate the home through the vented soffit over the interior wall as shown in Figure 3. The air leakage path through the cantilevered floor area is clearly evident by the dirty spots seen throughout the insulation in Figure 3. The air leakage through a typical cantilevered floor also leads to uneven room temperatures, increased energy bills, and potential condensation issues that can lead to deterioration within the cantilevered space.

Holes cut in the subfloor to accommodate plumbing drains also permit the flow of air between the cantilevered area and the interior, increasing air infiltration to the interior and creating cold floors that can lead to condensation as shown in Figure 3. In addition, an exhaust vent runs through the space nearly adjacent to the exterior and, therefore, is barely insulated. During cold weather, the warm moist air running through this exhaust vent condenses in the vent duct, causing deterioration of the vent duct and, possibly, wetting of the insulation and water leakage through the soffit material. Further, if mechanical systems are run through the exposed floor systems, there is potential for excessive energy loss, condensation, and/or pipe freezing.

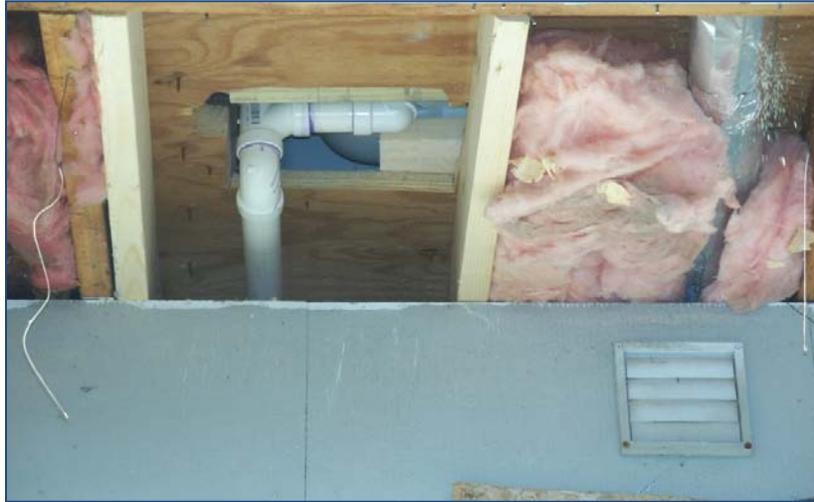
Figure 4. Existing conditions of cantilever floor area per visual inspection

The results of the visual inspection are shown Figure 4. There is batt insulation installed, however, it is not installed in every cavity of the cantilever floor. In addition, the insulation is dirty indicating that there is significant air flow through the insulation. There is not currently an air barrier or blocking installed and there is minimal air sealing of penetrations and duct sealing measures currently installed.

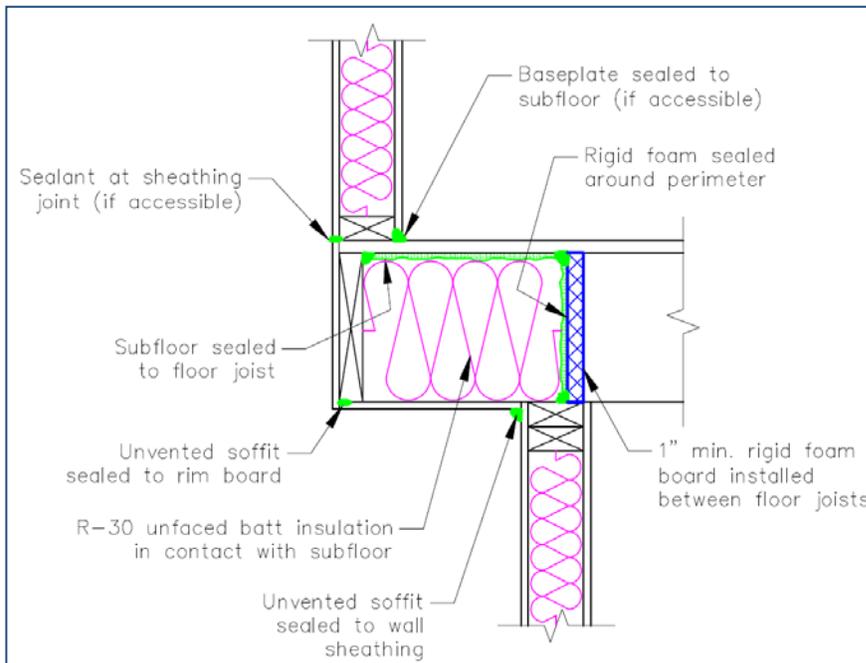
Figure 7. Cantilevered floor blocking, air sealing, and insulation detail

As part of developing the scope of work, it is important to have available and include the construction detail. In this example, the detail for the cantilever floor upgrade is shown in Figure 7. This is also referenced in the Scopes of Work text outlined by trade following the figure.

Install rigid foam blocking between the floor joists over the supporting wall below per Figure 7.

It is also important to outline the approved materials for the project. For a QA approach to energy remodeling of a cantilevered floor, the material specifications as depicted in Figure 7 and Figure 8 include:

- a. Unvented soffit: Exterior painted plywood sheathing
- b. Blocking:
 - i. 1" thick nonstructural sheathing board (R-6.5) between floor joists
 - ii. *Alternate acceptable products are 1" XPS or polyisocyanurate rigid foam sheathing*
- c. Air Sealing:
 - i. Normal expansion polyurethane spray foam insulating sealant
 - ii. Construction adhesive or caulk
- d. Insulation: R-30 un-faced insulation in joist cavities

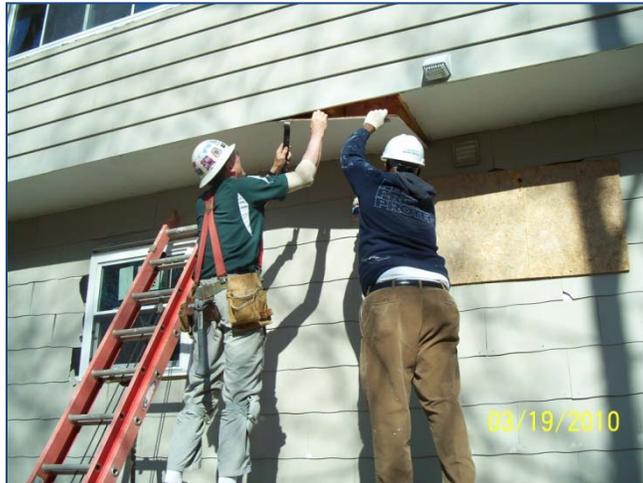
Figure 8. Cantilevered floor blocking, air sealing, and insulation

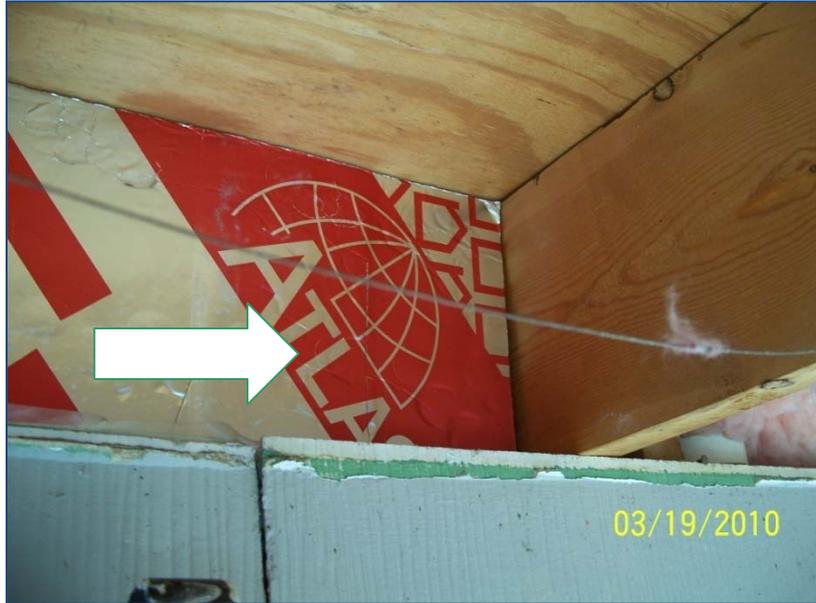
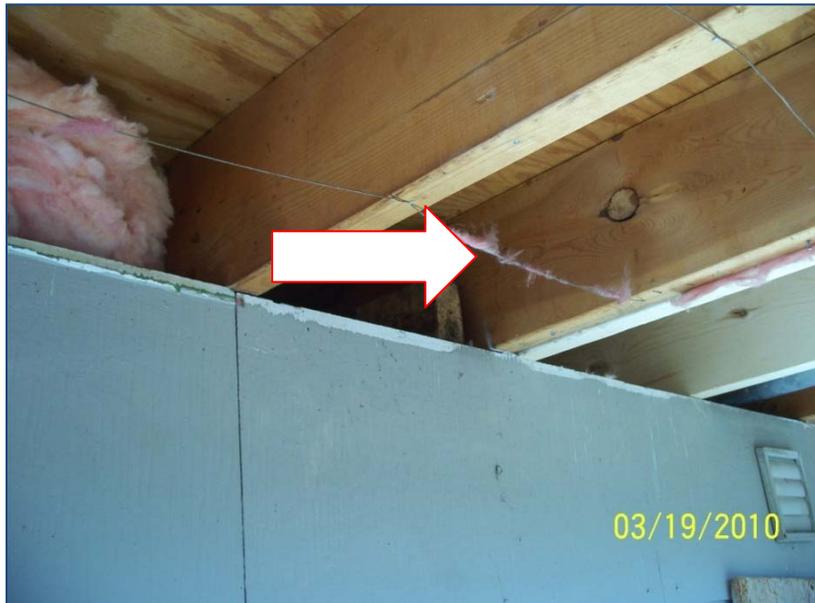
Instalar blocking en los pisos cuando sobresalen espacios no condicionados

Right / Bueno

Wrong / Malo

Figure 9. Cantilevered floor blocking training sheet

1. Review remodeling plans to highlight key specifications and installation steps for training.
For this example, the two training items include blocking cantilevered floors and air sealing after blocking.
2. Add each training item to the inspection process and inspection form as a specific, stand-alone item.
For this example, each of the two items will be addressed individually.
3. Develop a training format (i.e. training sheet, video etc.) to address each item.
For this example, two training sheets were developed, one to address each item (see Figure 9 and Figure 10).
4. Implement the training to all workers and inform them that there will be inspecting for and tracking of the success of each item on every single job. This can be done in the field or in a pre-construction meeting.

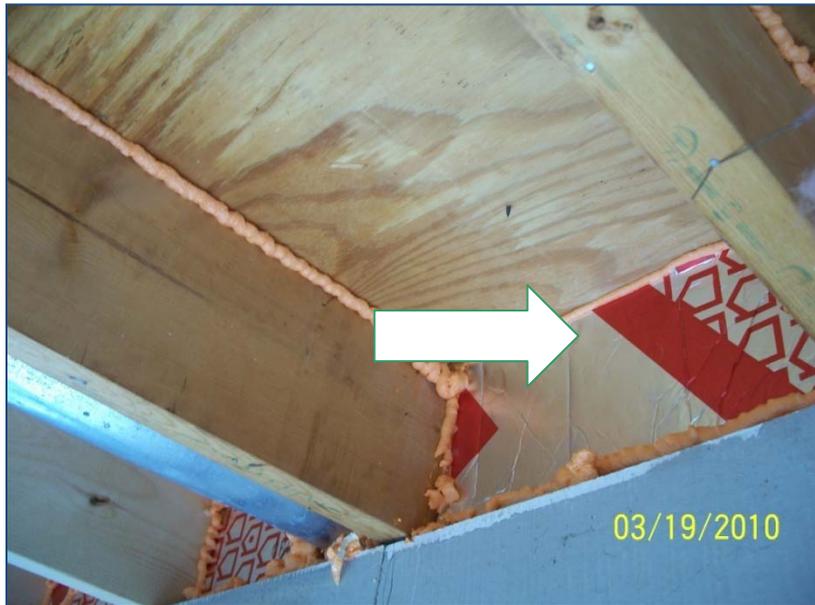
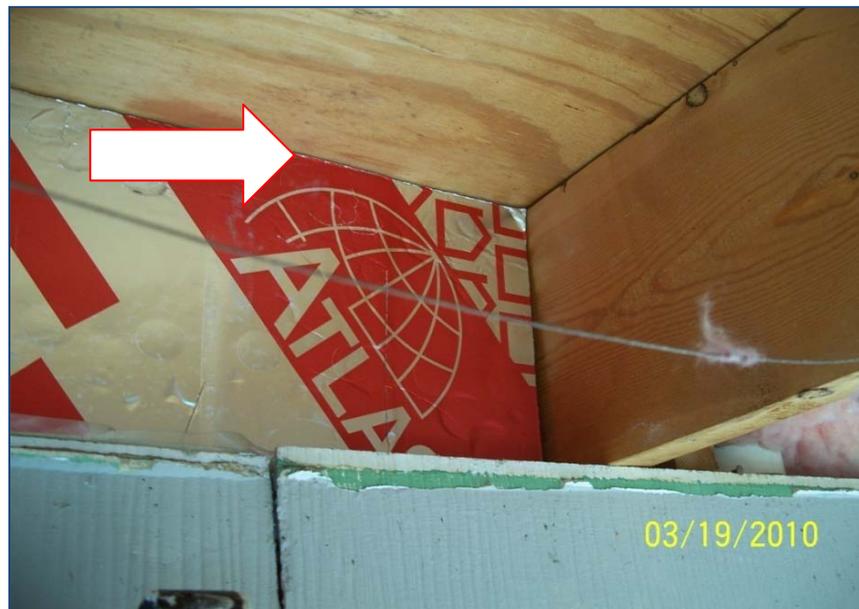
Training Sheet: Sealing cantilevered floors after blocking

No deje un espacio en el blocking más grande que ¼” y selle bien con un sellador

Right / Bueno

Wrong / Malo

Figure 10. Cantilevered floor air sealing training sheet
