# **Performing Onboard Diagnostic System Checks as Part of a Vehicle Inspection and Maintenance Program**

David Sosnowski

U.S. Environmental Protection Agency

June 2001

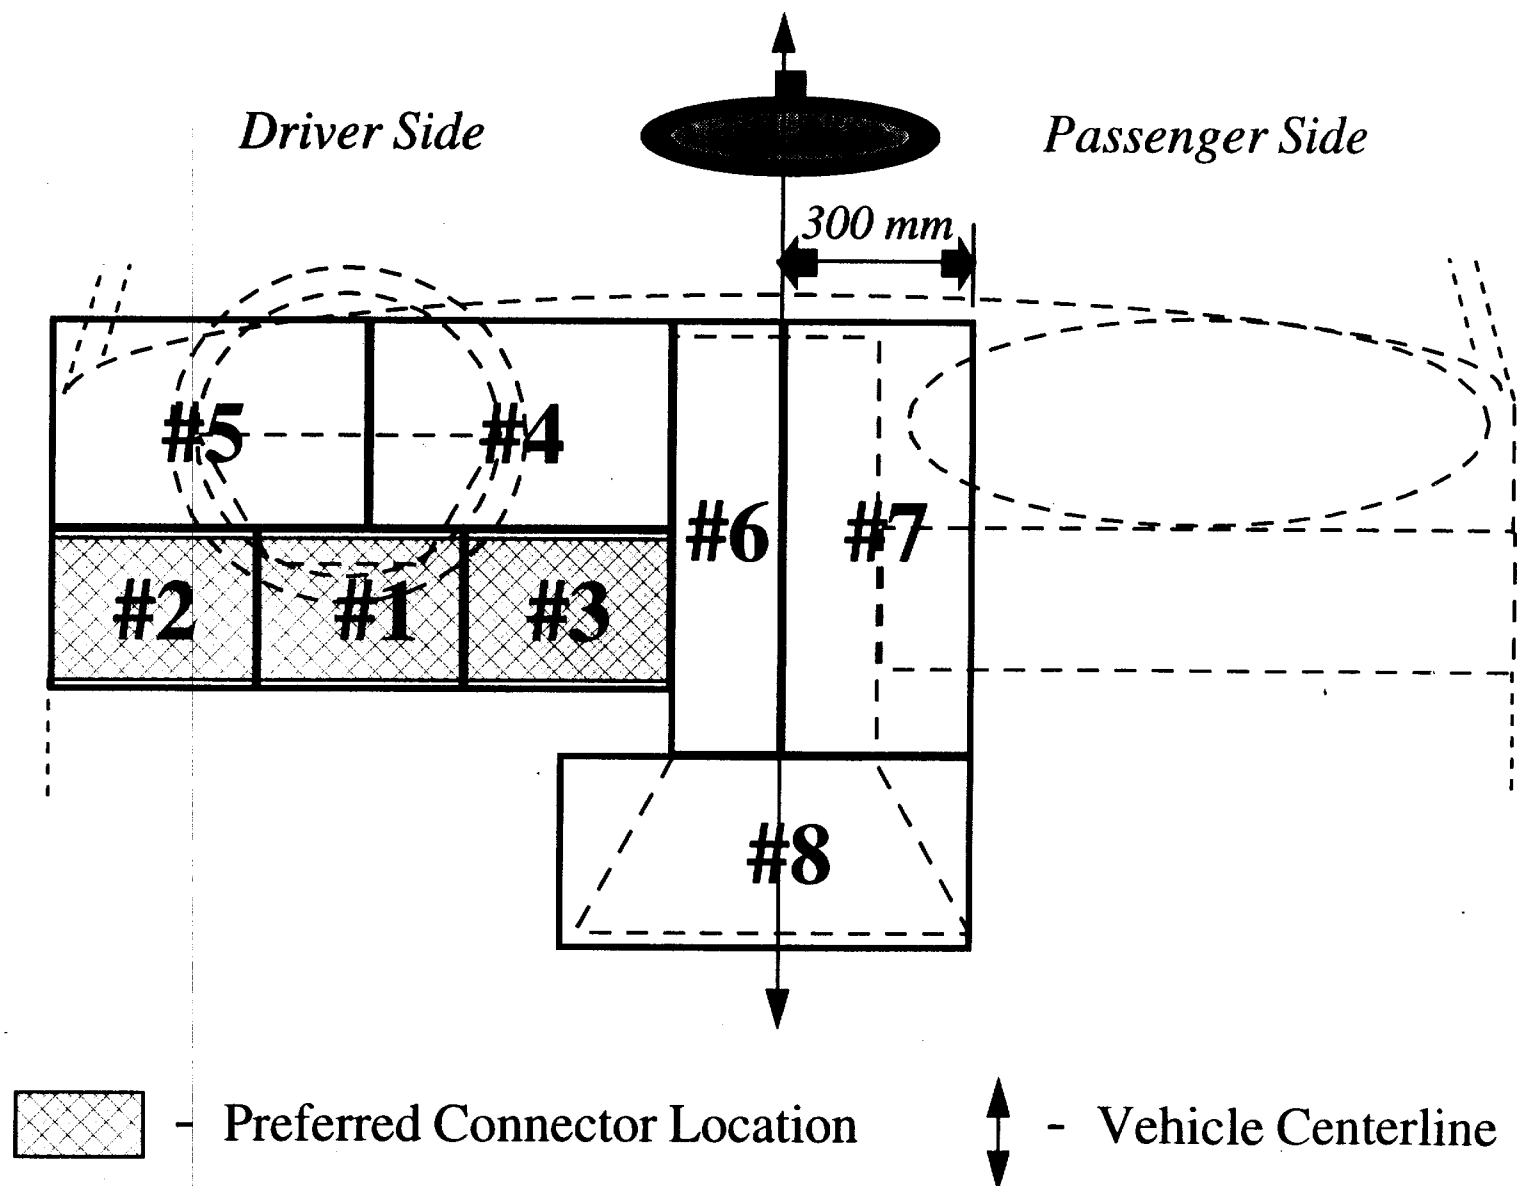
# Diagnostic Link Connector Mapping Diagram

### **Data Link Connector Mapping Diagram**

## **Diagnostic Link Connector (DLC) Mapping Diagram Explanation**

The mapping diagram of DLC locations contains a divided instrument panel (IP) with numbered areas. Each numbered area represents specific sections of the IP where manufacturers may have located DLCs. This document briefly clarifies the numbered locations on the mapping diagram. Areas 1-3 fall within the preferred DLC location while the remaining areas, 4-8, fall into the allowable DLC location according to EPA requirements. Areas 4-8 require that manufacturers label the vehicle in the preferred location to notify parties of the alternate connector location.

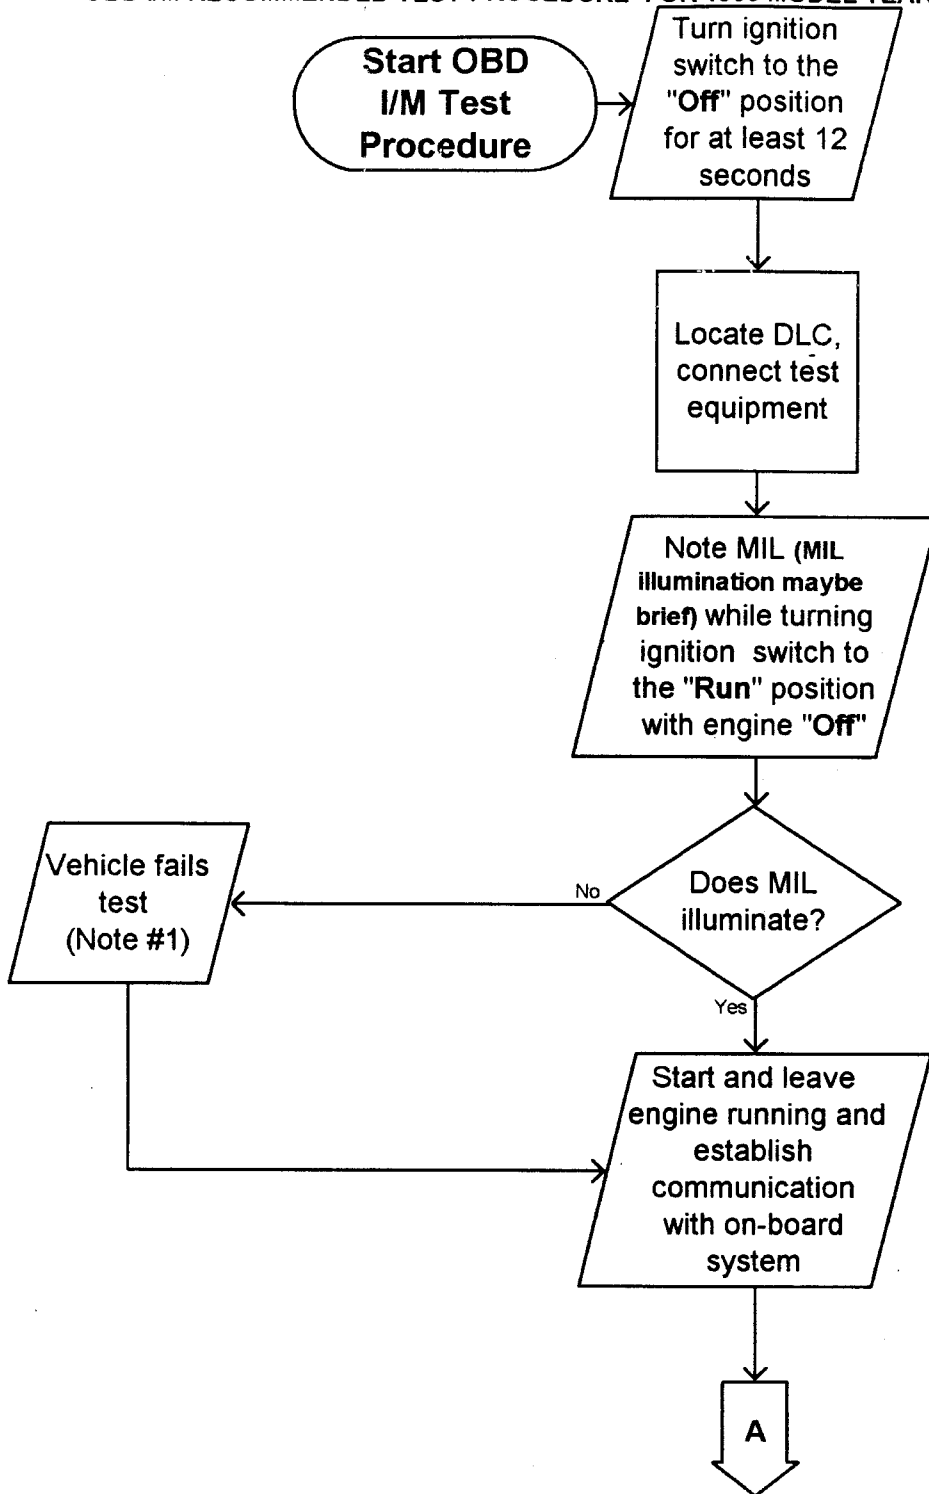
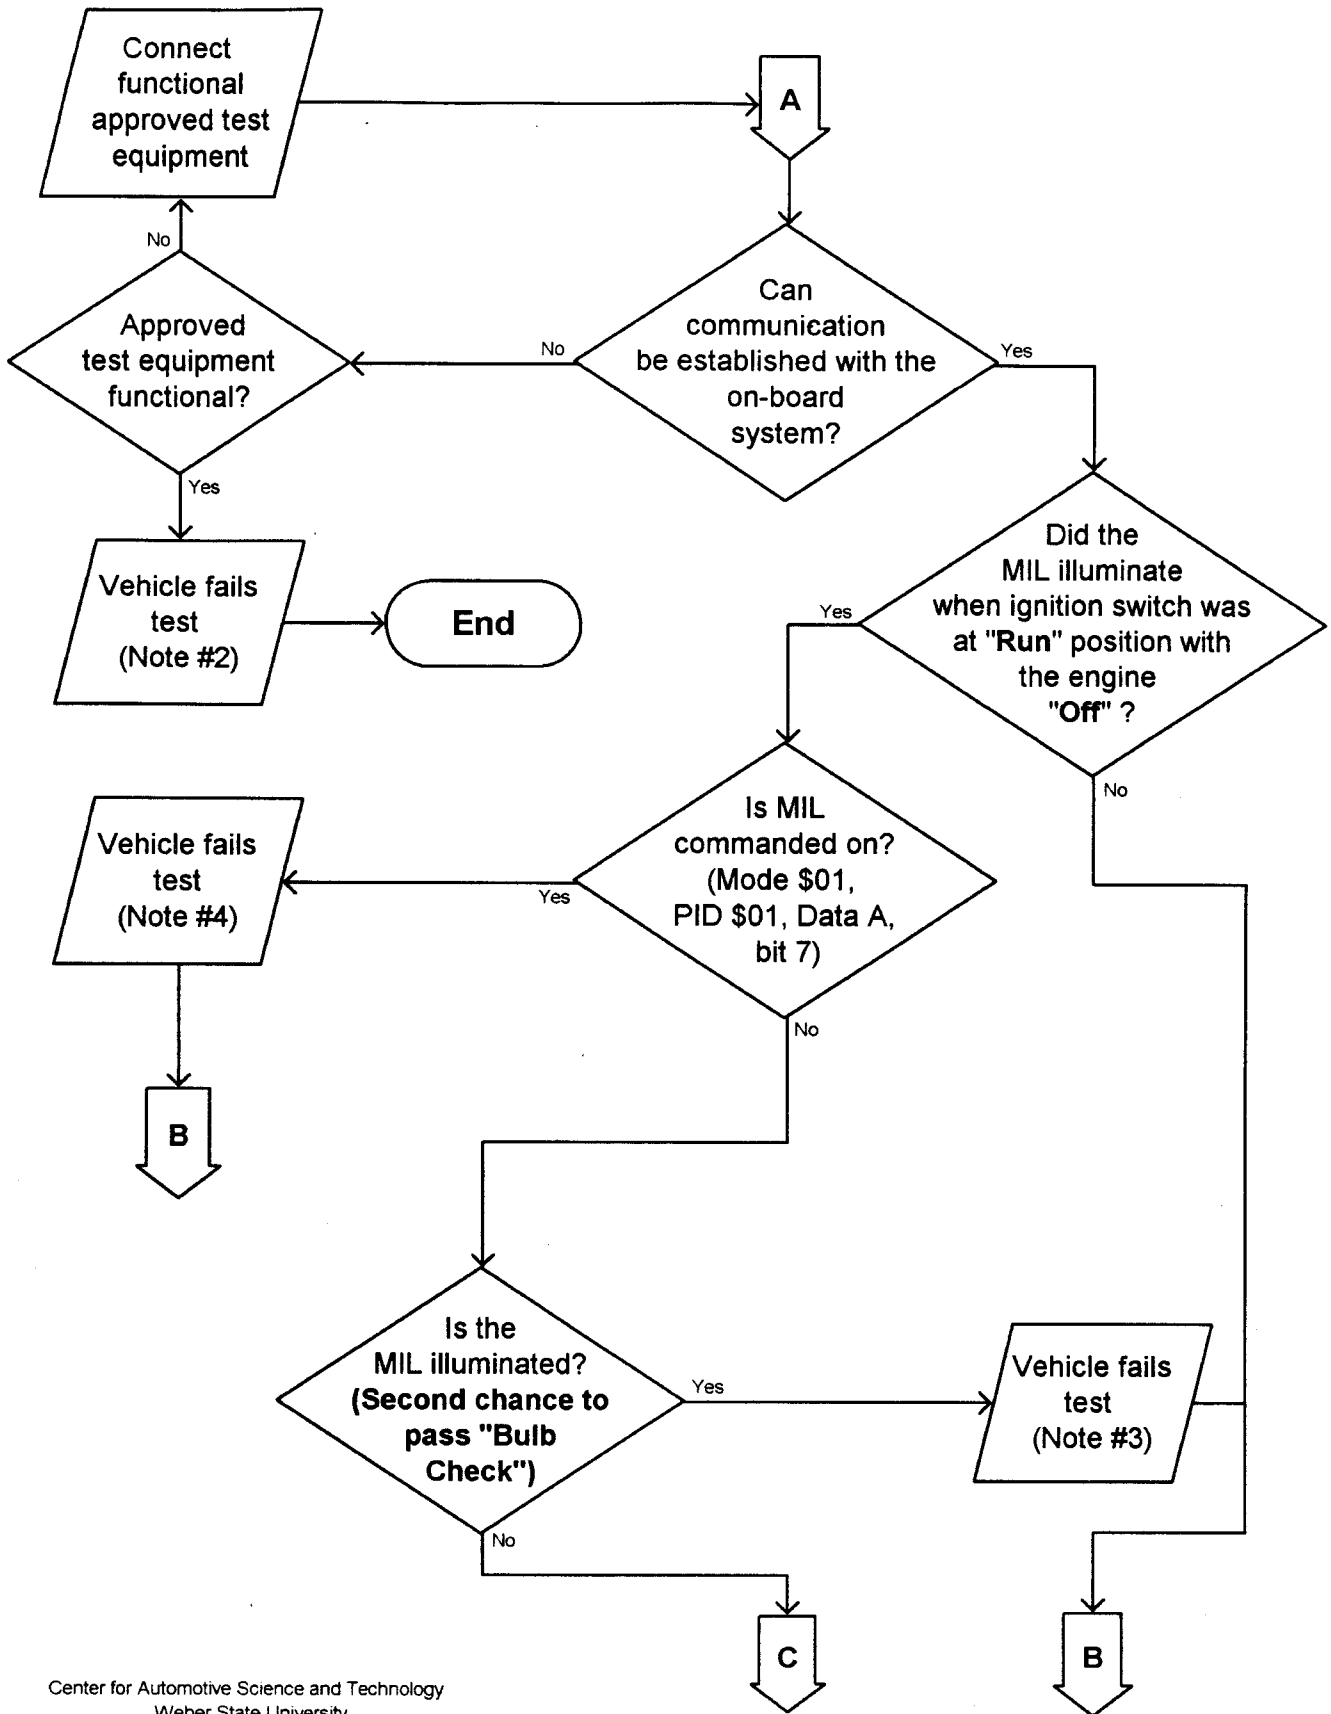
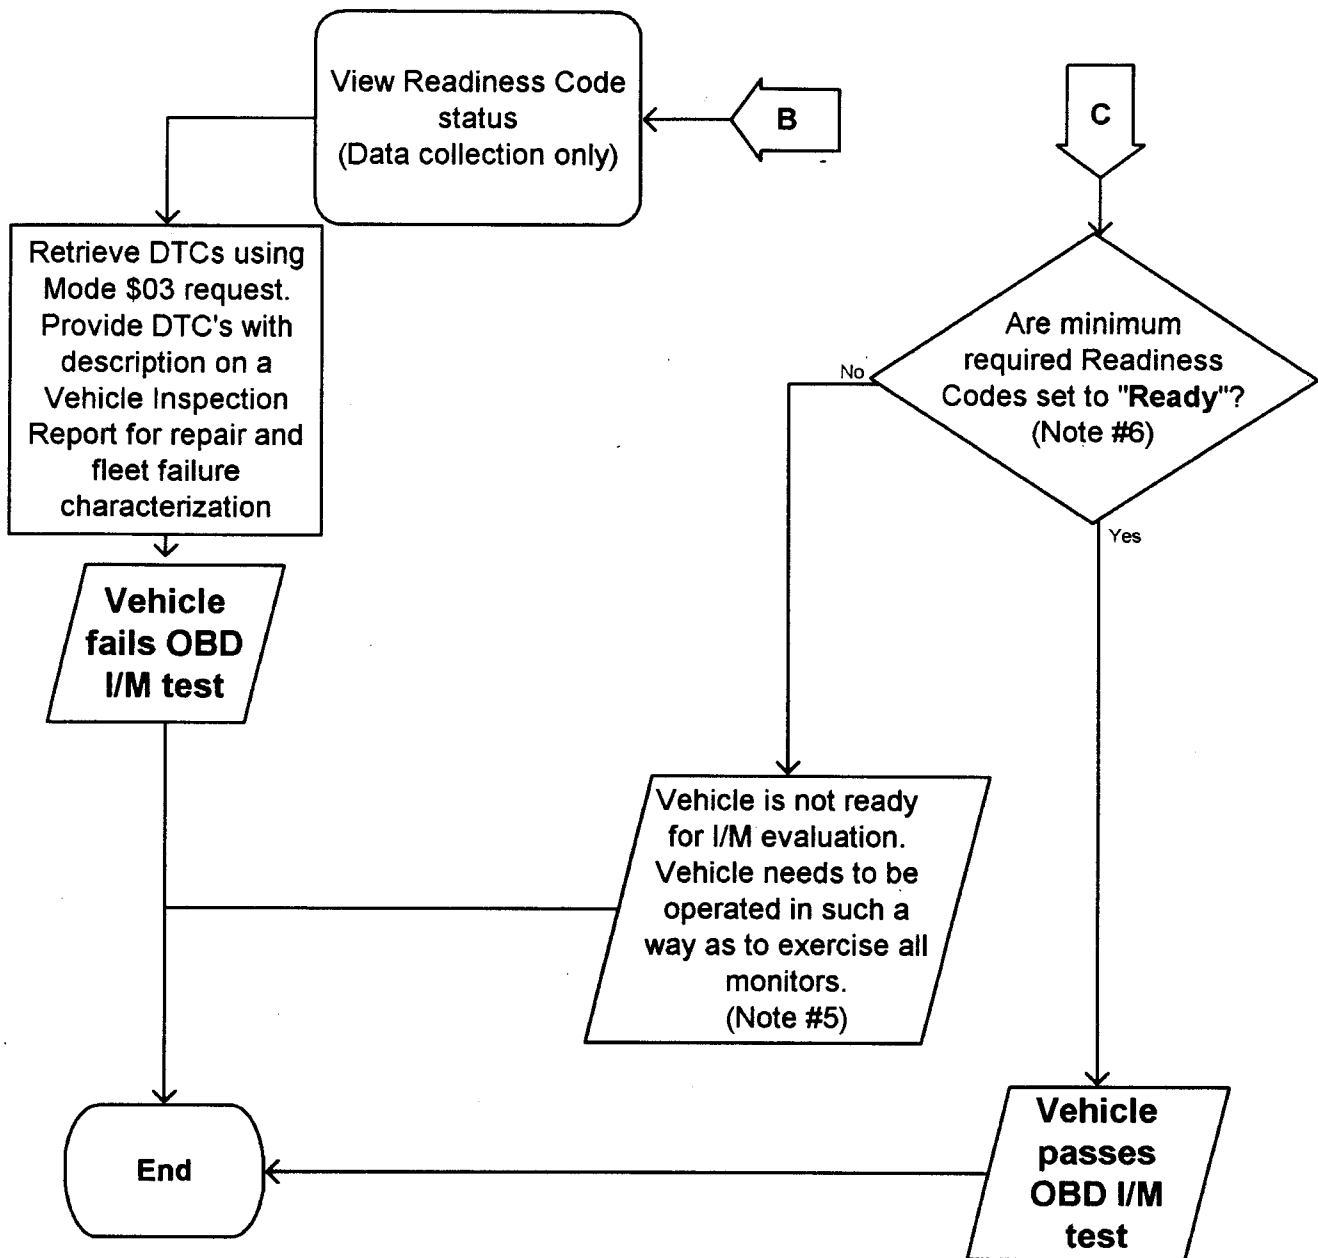
### **OBD-I/M Test Procedure Flow Chart**

OBD I/M RECOMMENDED TEST PROCEDURE FOR 1996 MODEL YEAR AND NEWER VEHICLES (Cont.)

# OBD I/M RECOMMENDED TEST PROCEDURE FOR 1996 MODEL YEAR AND NEWER VEHICLES

## Notes on flow chart:

- Note 1:** The purpose of this step is to verify the On-Board Diagnostic (OBD) system has control of the Malfunction Indicator Light (MIL) and the MIL is functional. Operation of the MIL varies between vehicle manufacturers. Key On Engine Off (KOEO) typically results in the MIL on steady, however, there are systems which will illuminate the MIL only briefly during KOEO. In either situation MIL presence and illumination capability has been established. If the vehicle fails the I/M test at this point, the vehicle inspection report should indicate the MIL problem should be repaired and also include information gathered during the remaining I/M test steps.

- Note 2:** It is important for the I/M testing personnel to verify proper diagnostic equipment operation before failing the vehicle. If the diagnostic equipment is functional then the vehicle's communication problem must be resolved. Without communication between the OBD system and the test equipment the I/M test must be ended and the problem resolved before further interrogation of the vehicle can be performed. This step includes identification of Data Link Connector (DLC) tampering, serial data circuit problems and any other condition that would prevent the OBD system from communicating with the test equipment.

- Note 3:** I/M test failure is a result of MIL illumination even though the OBD system has not commanded the MIL on, or has stored any Diagnostic Trouble Codes (DTCs); e.g., a serial data line failure between the OBD computer and the Instrument Panel.

- Note 4:** I/M test failure is a result of both the actual and commanded state of the MIL. DTCs should be stored since the MIL is commanded on. A vehicle **should not** fail an I/M test when DTCs are stored but there is no MIL on; e.g., the DTC was stored by a loose gas cap which was subsequently tightened.

- Note 5:** Readiness Code status must be identified at this stage in the I/M test to determine whether or not all emission control systems have been tested by the OBD system. If any one (or more) Readiness Code(s) are not set ("ready") the OBD system has not yet completed testing of the system(s) and failures may be present but not yet identified. It is important to understand that the vehicle **does not** fail the I/M test at this point; no emission related faults have been identified. The current state of the vehicle's emission control system is **undetermined**.  
The emission control systems and related components are tested under specific vehicle operating conditions. Therefore, to set the Readiness Codes the vehicle must be operated within these specific conditions (commonly referred to as "enable criteria") for the OBD system tests to be performed. Once testing of an emission control system is complete, the related Readiness Code will be set ("ready"). When all Readiness Codes are set, the vehicle is ready for further I/M testing.

It will be at the states discretion whether to recommend the customer drive the vehicle to set the Readiness Codes or to take the vehicle for service. The state may also choose to use a dynamometer drive cycle.

**Note 6:** EPA has revised the current readiness code requirement to allow states to complete the testing process on model year 1996 thru 2000 vehicles with two or fewer unset readiness codes; for model year 2001 and newer vehicles, the testing process could still be complete provided there is no more than one unset readiness code. It is important to understand that the vehicle **does not** fail the I/M test because an unset readiness code is not itself an indication of an emission problem with the vehicle.
