ARCHEOLOGY IN HERBERT HOOVER'S NEIGHBORHOOD:
1989 EXCAVATIONS AT THE L. MILES AND
E.S. HAYHURST HOUSES, WEST BRANCH, IOWA

Midwest Archeological Center
Technical Report No. 51

This report documents archeological excavations conducted by the Midwest Archeological Center, National Park Service, at two historic properties at Herbert Hoover National Historic Site (HEHO), West Branch, Iowa. This fieldwork occurred in 1989 in support of a major structural restoration program at the Laban Miles and E.S. Hayhurst Houses. These late nineteenth-century structures formed part of a West Branch neighborhood that would have been familiar to Herbert Hoover during his childhood years. Restoration actions were aimed at returning the structures to an earlier appearance, while adaptively restoring the structures' interiors for modern use. The 1989 archeological project was intended to collect data that might otherwise be lost during components of the restoration program that included ground disturbance around the houses. Those impacts were successfully mitigated through the 1989 archeological data collection program.

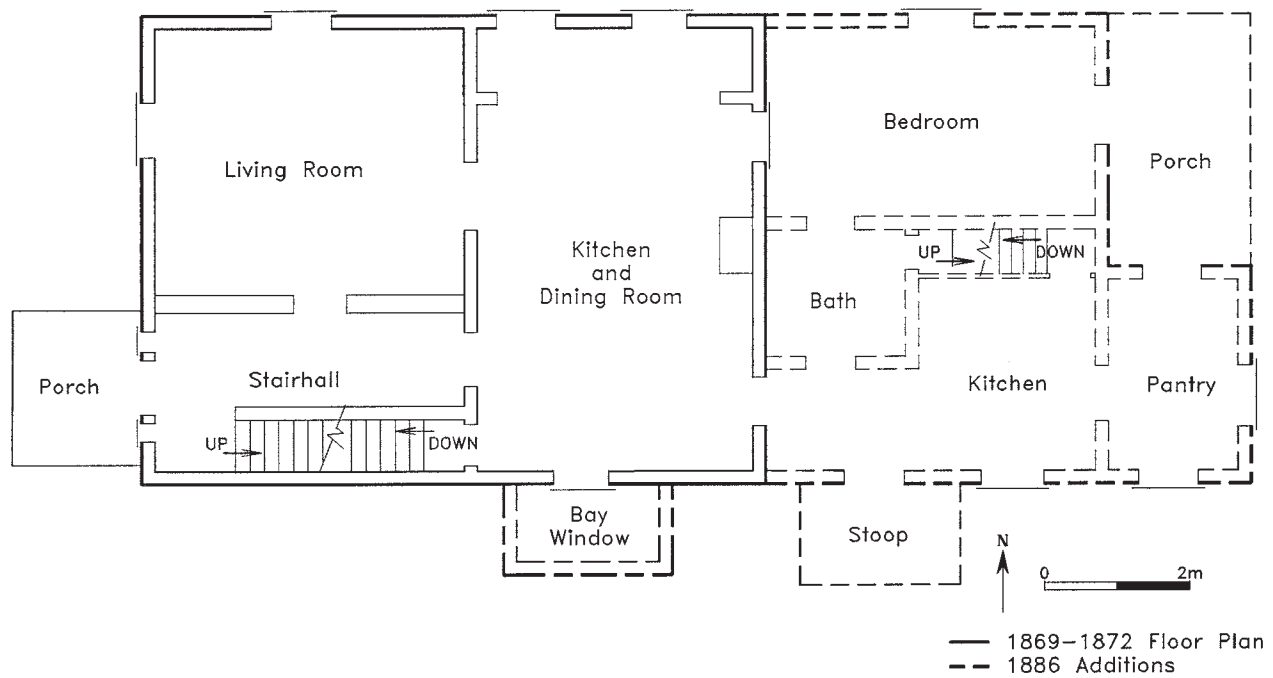
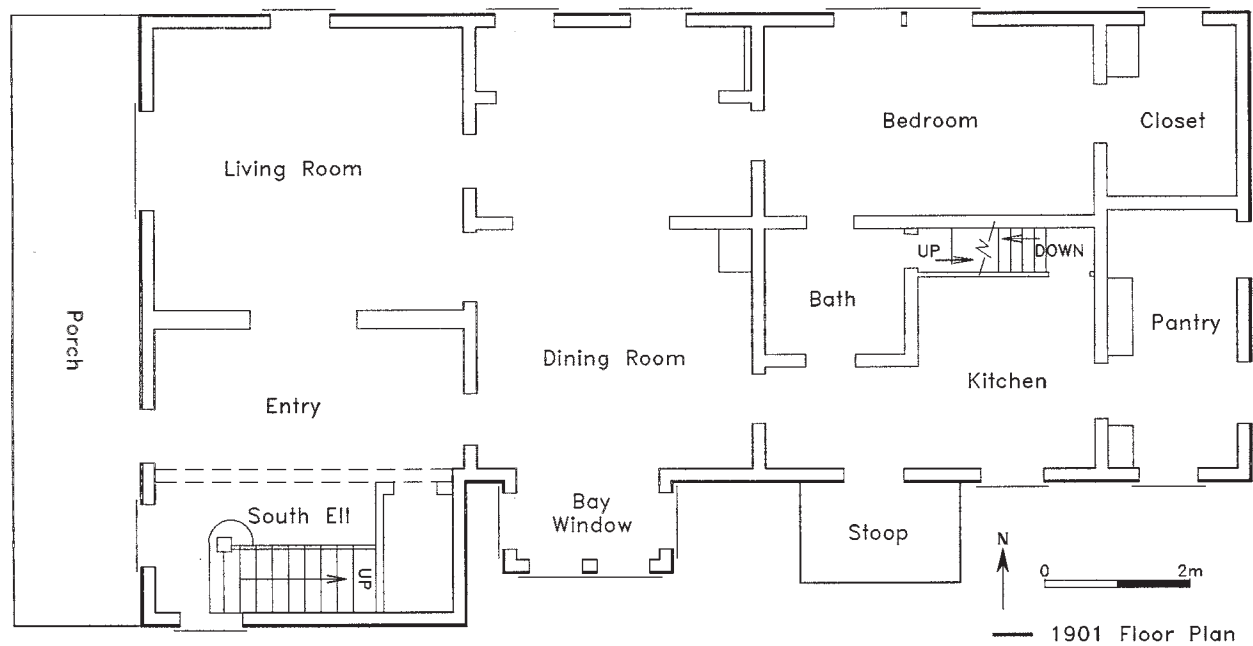
Figure 5. Construction history and staging, HS 6, 1869 to 1901.

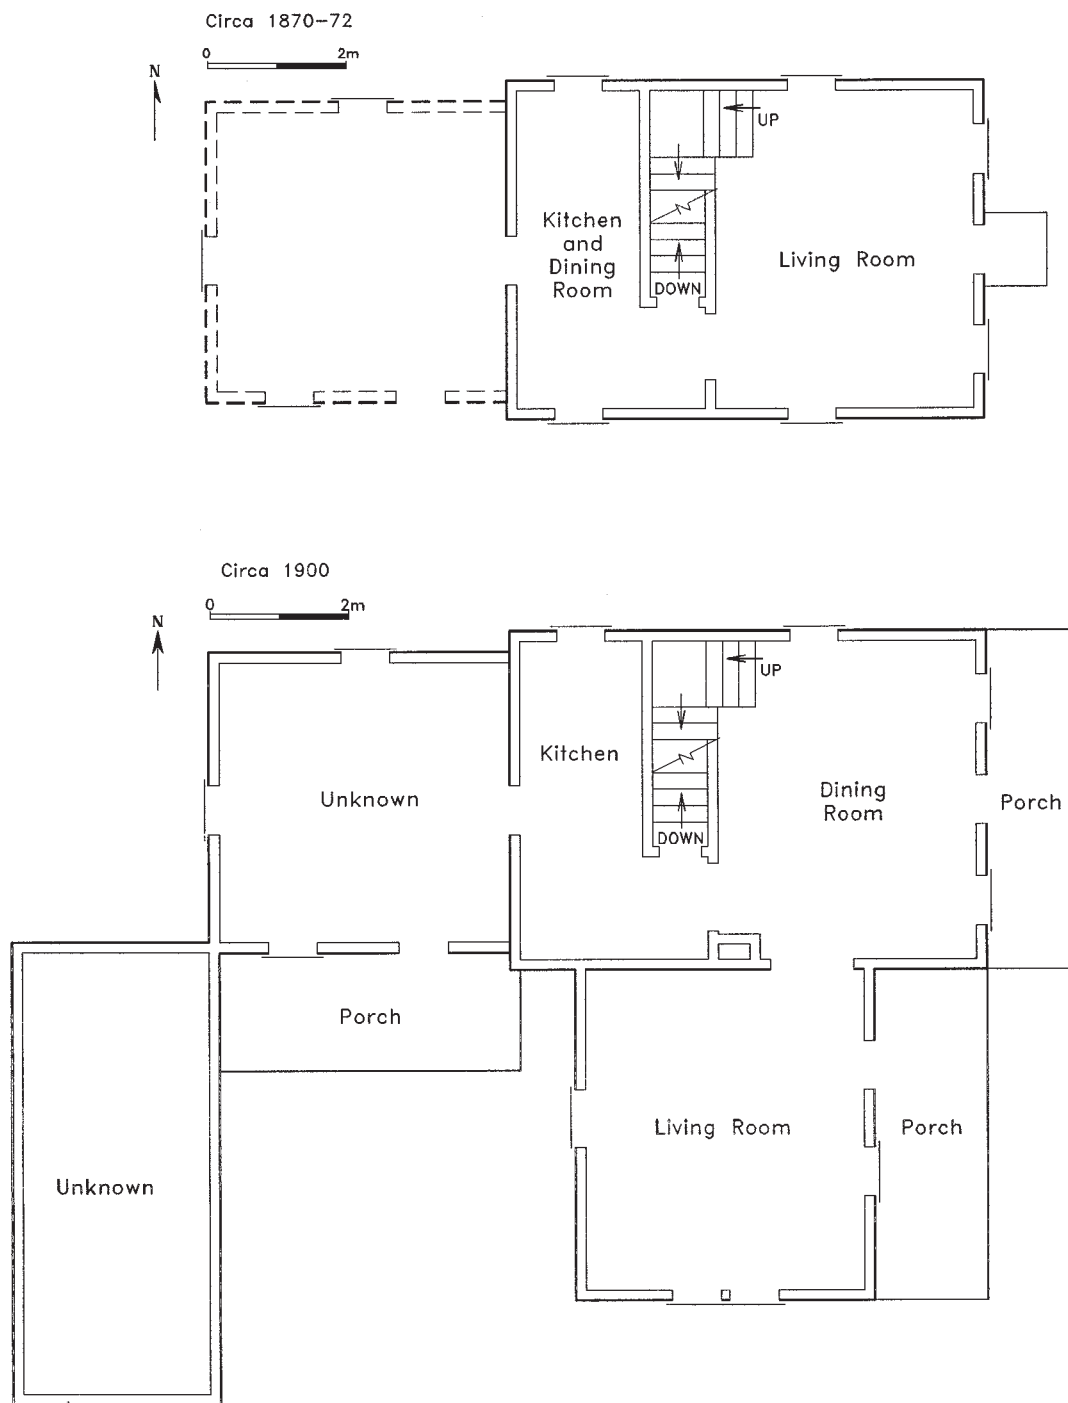
Figure 6. Construction history and staging, HS 10, 1870 to 1978 (above and facing page).

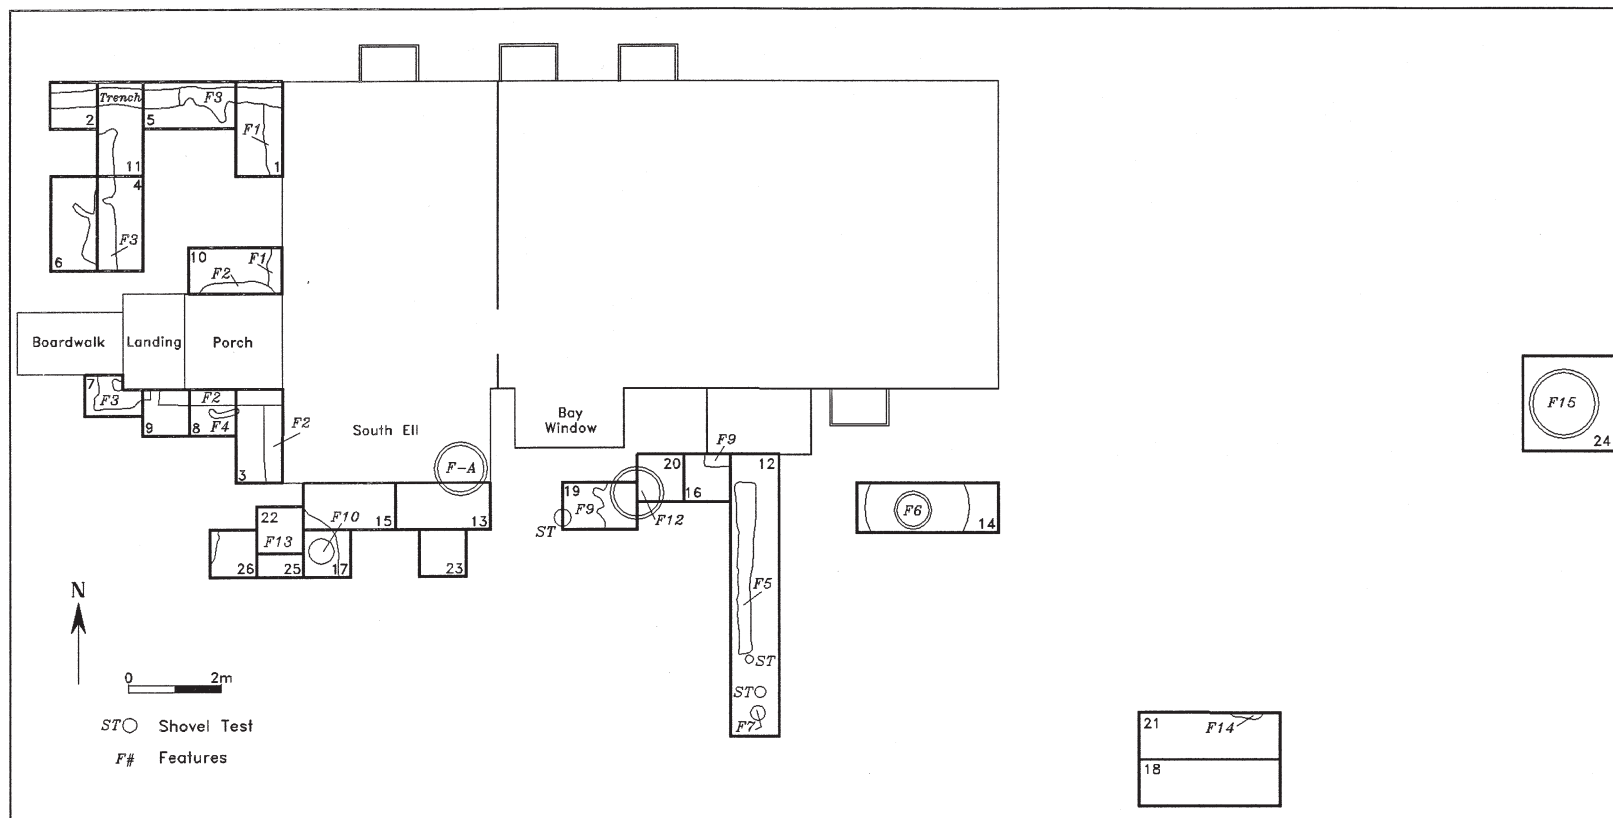
Figure 7. Excavation plan, Miles House.

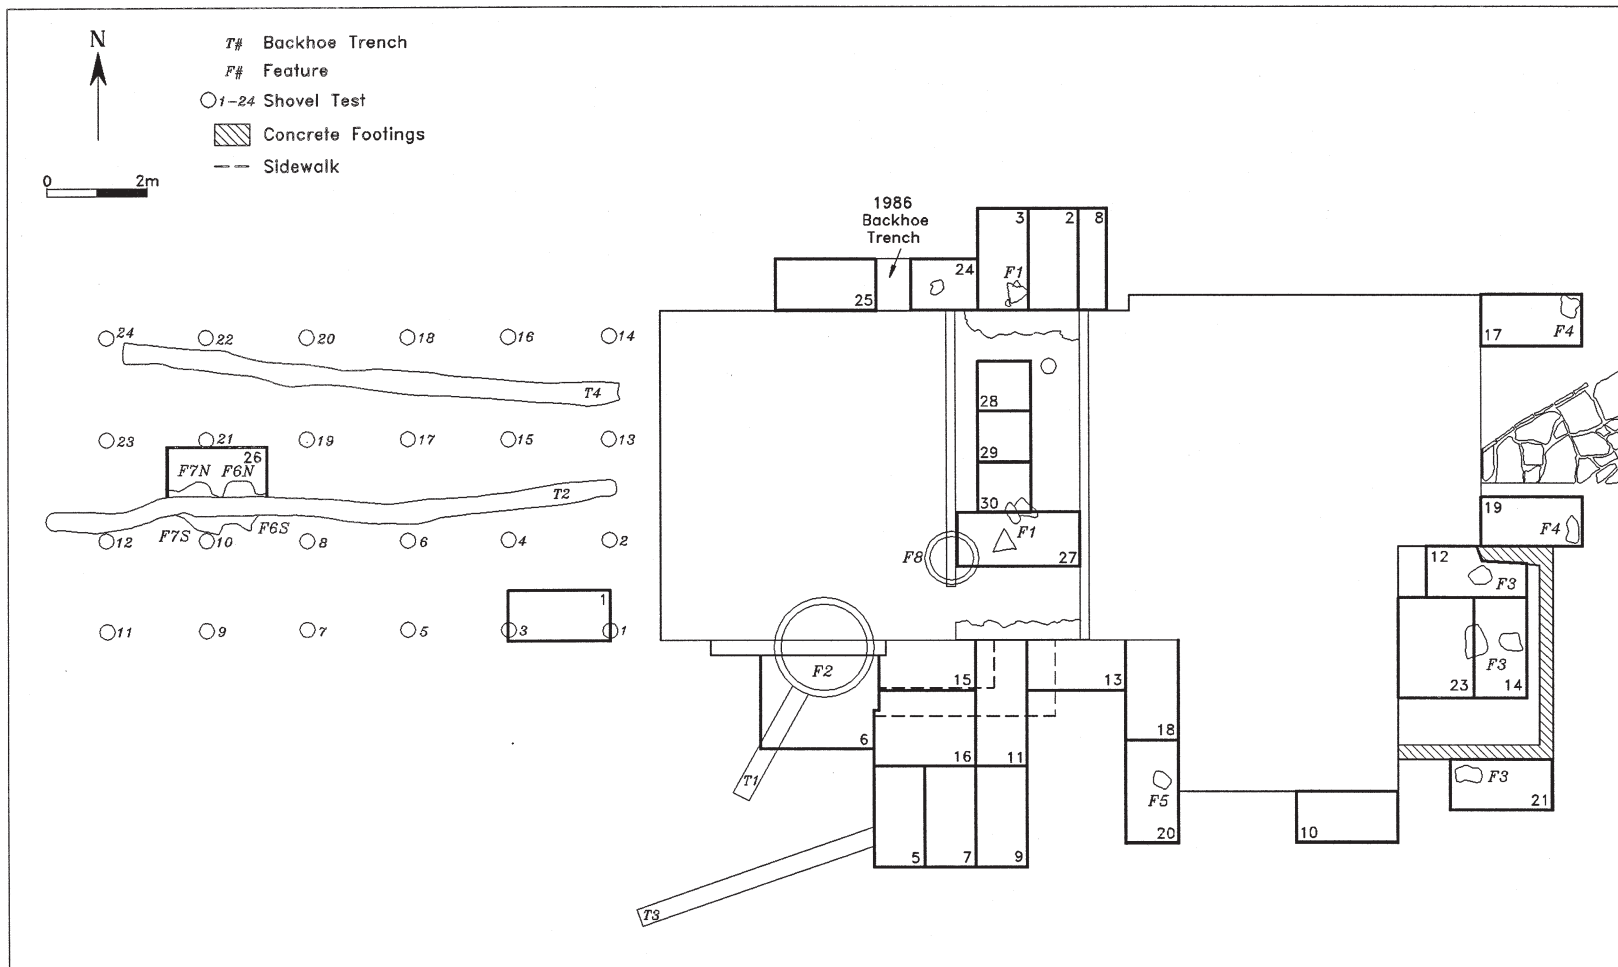
Figure 8. Excavation plan, Hayhurst House.

(Figure 8). Thirteen separate supports were recorded. Since they occur in groups, they were awarded three separate feature designations (Features 1, 3, and 4).

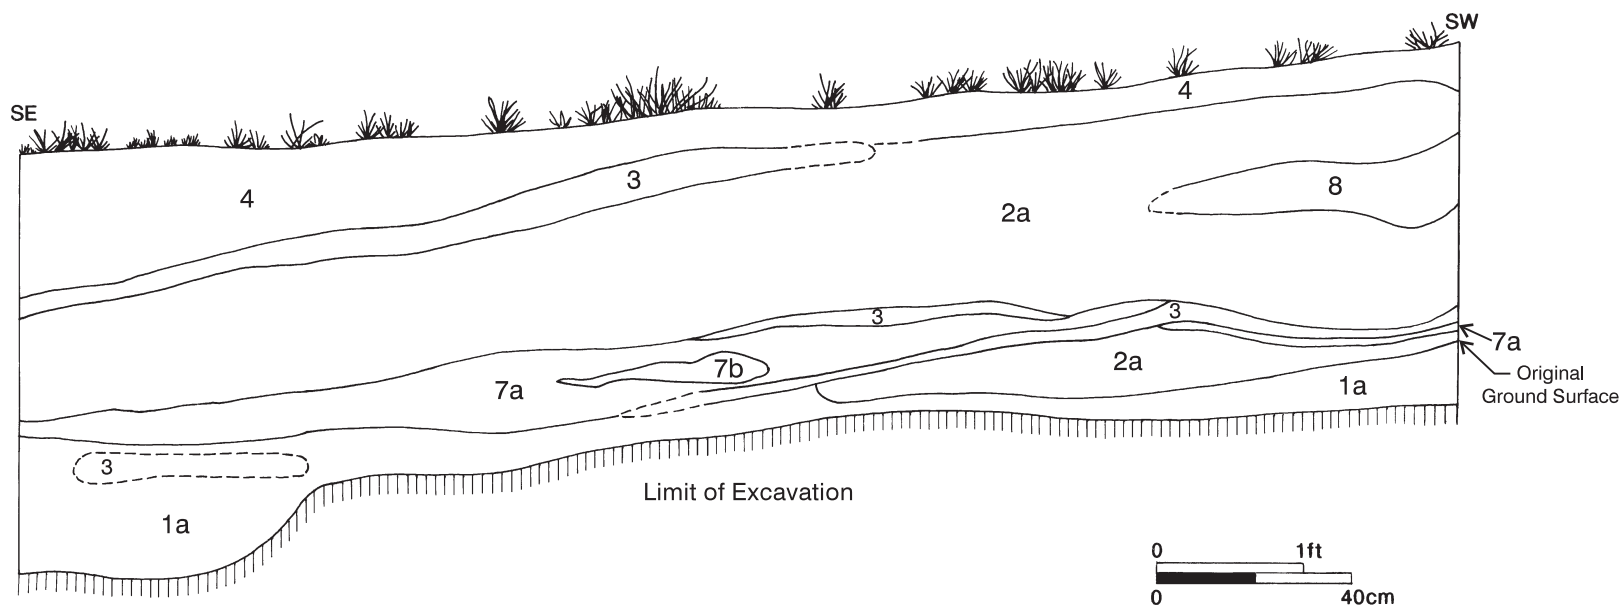
- 1a Dark brown loam (buried A horizon)
- 2a Brown loam with mottled yellow-brown loam (redeposited Strata 1a and 1b)
- 3 Yellow-brown loam (redeposited Stratum 1b)
- 4 Brown loam (modern humus)
- 7a White cinders
- 7b Red cinders
- 8 Black loam

Figure 9. South wall profile, Unit 18, HS 6.

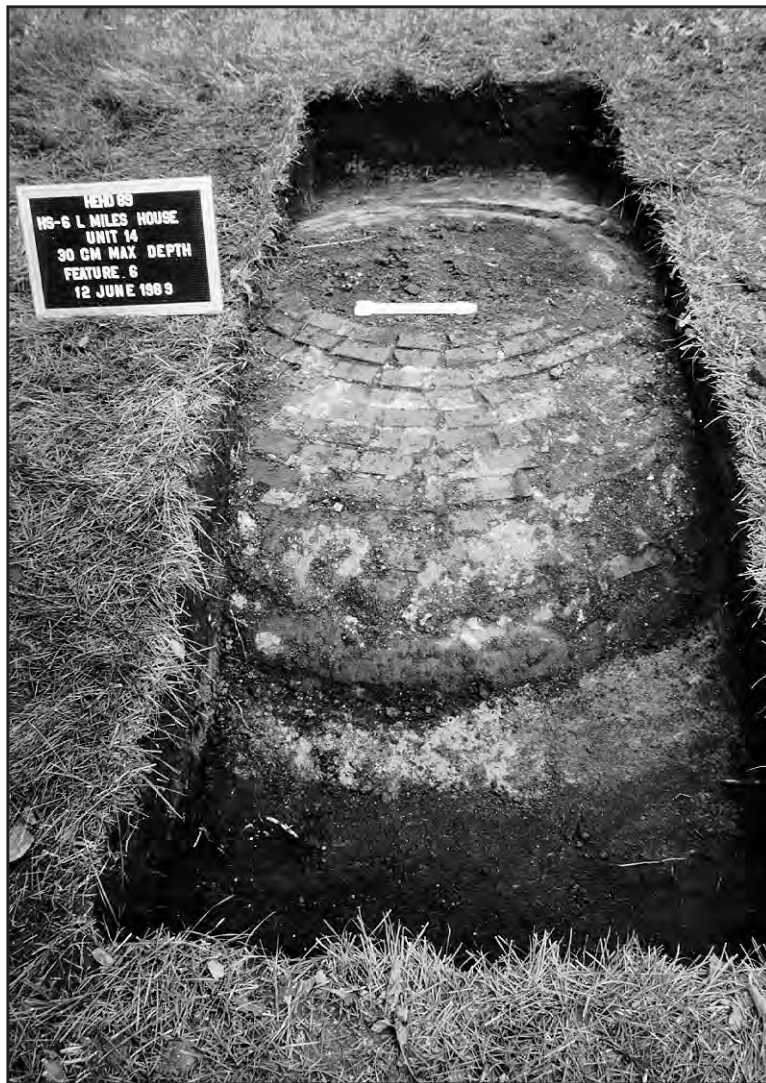
Figure 10. Cistern, Feature 6, HS 6.

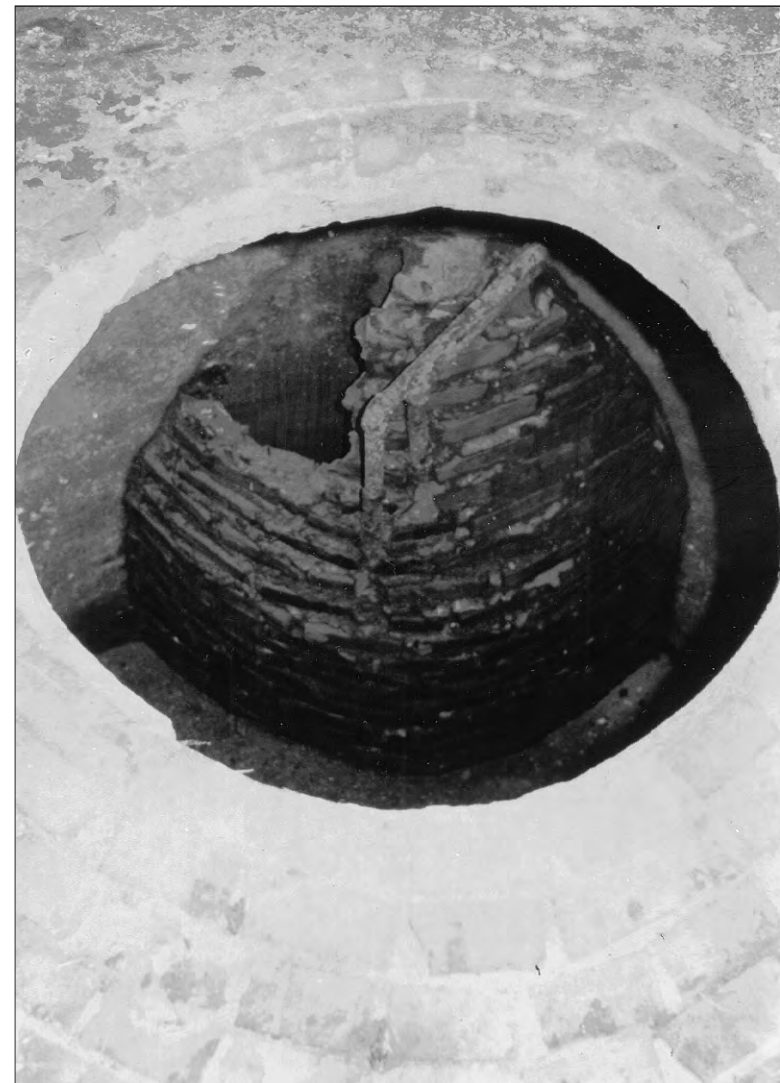
Figure 11. Interior of cistern, Feature 6, HS 6 after excavation. Note filtration chamber.

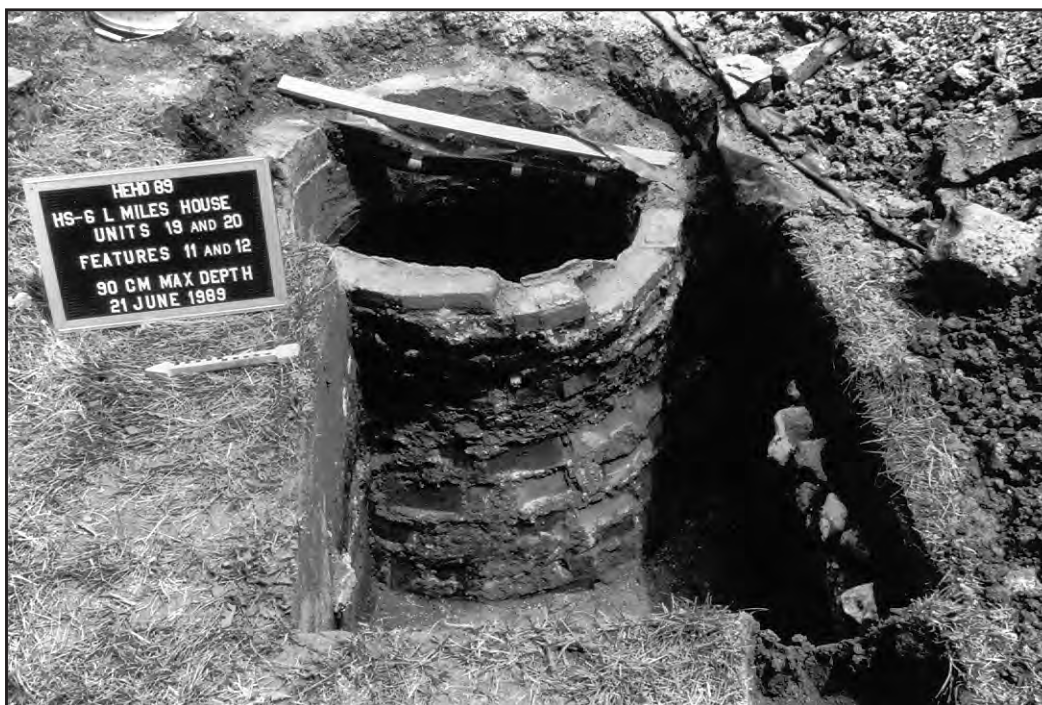
Figure 12. Cistern, Feature 12, HS 6.

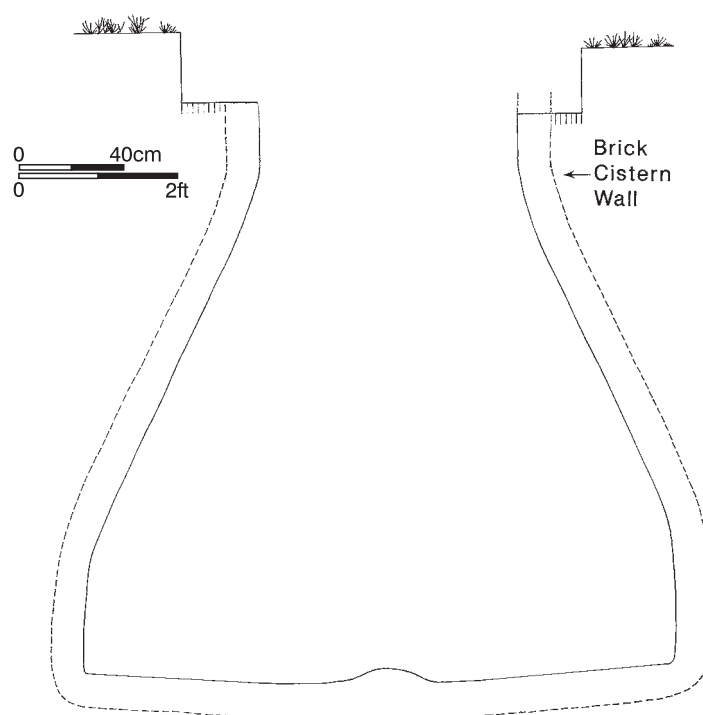
Figure 13. Cistern, Feature 12, HS 6 profile.

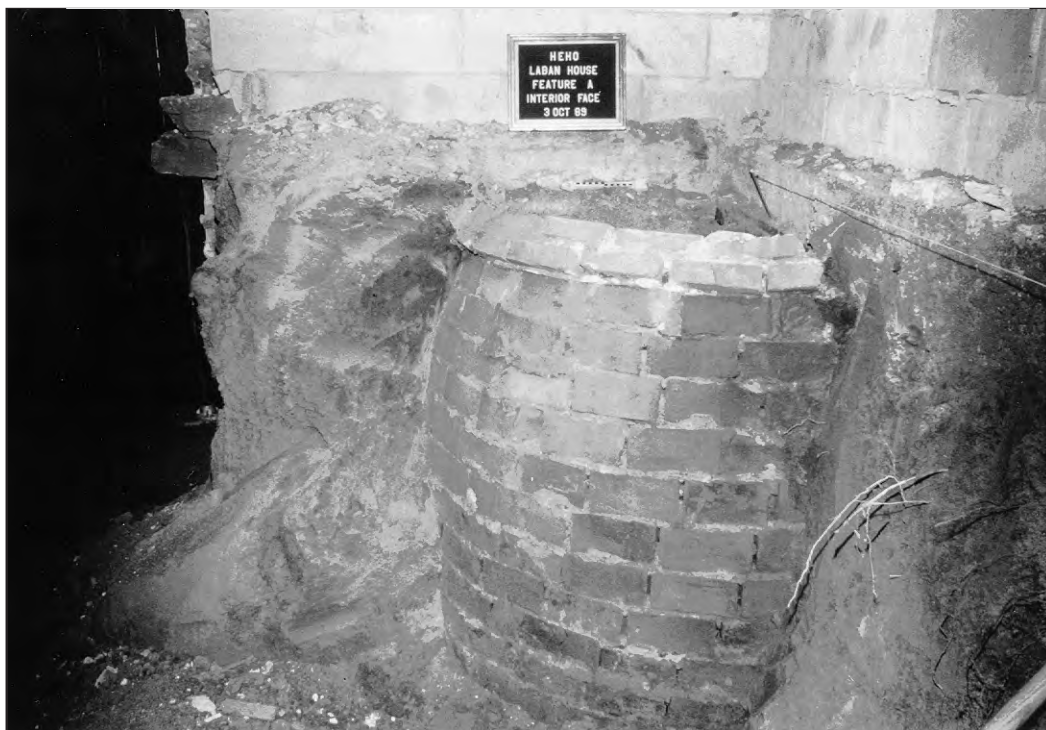
Figure 14. Cistern, Feature 16, HS 6.

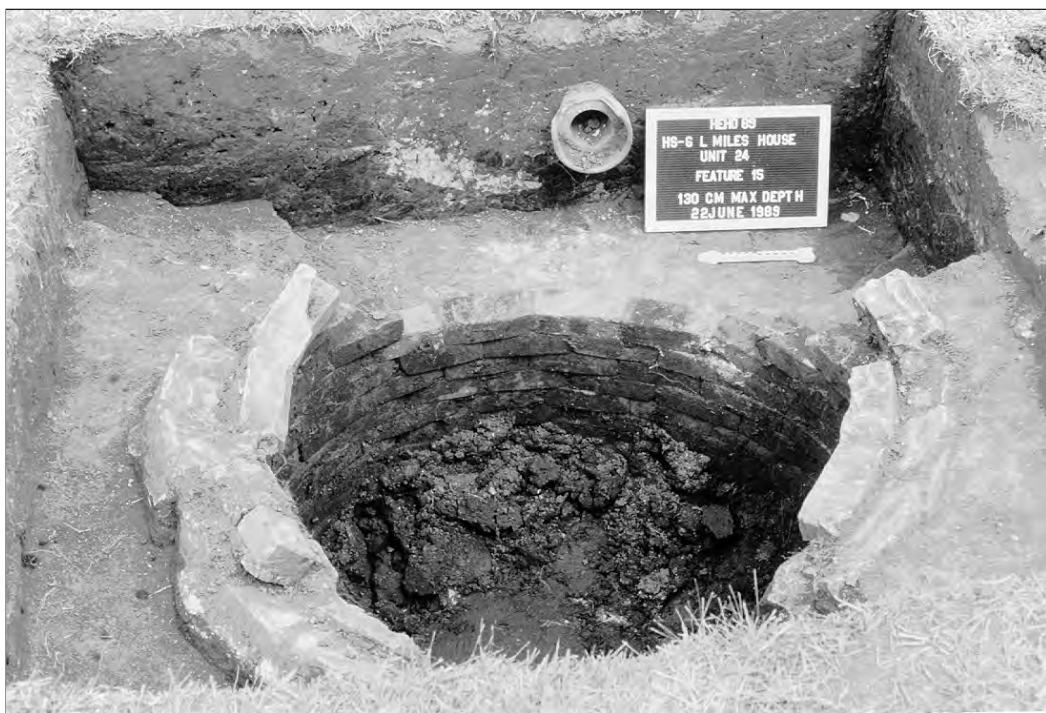
Figure 15. Septic tank, Feature 15, HS 6. Note arrow points south (view to the west).

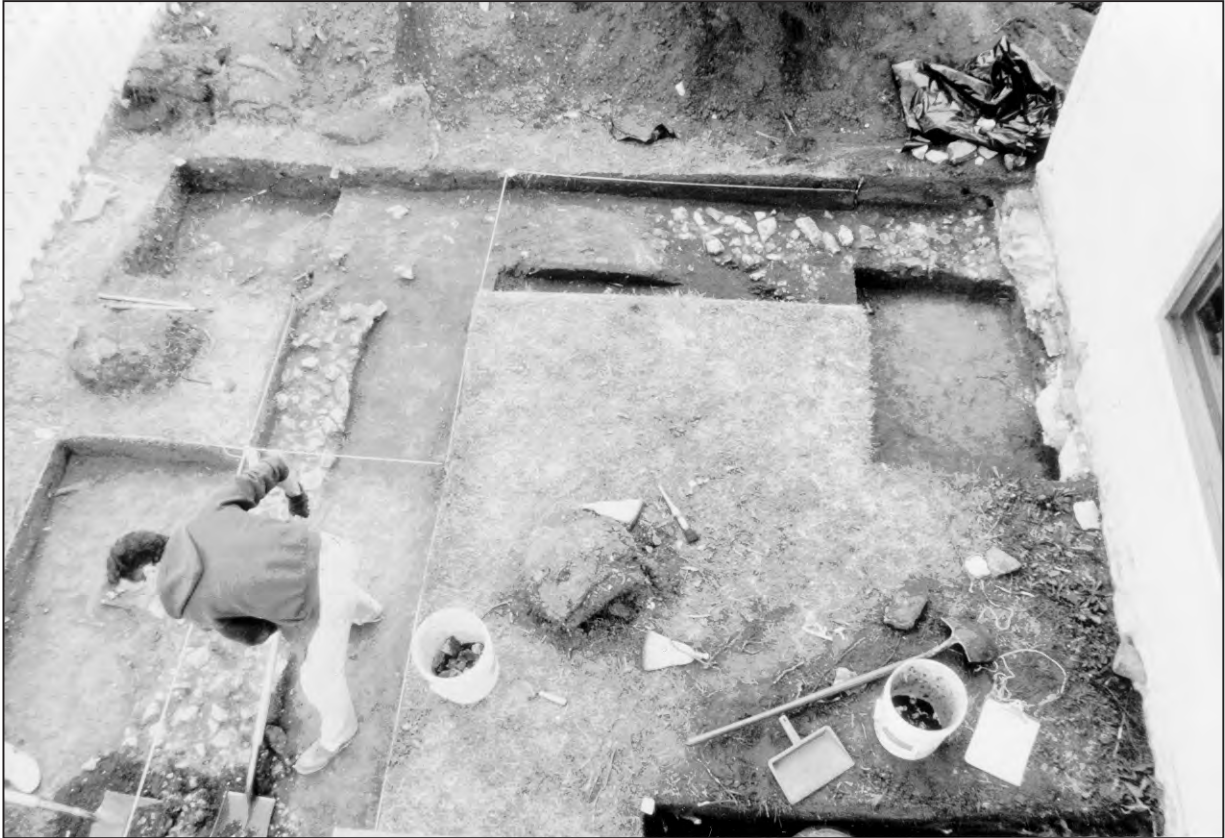
Figure 16. Original foundation, Feature 3, HS 6, looking down from porch roof.

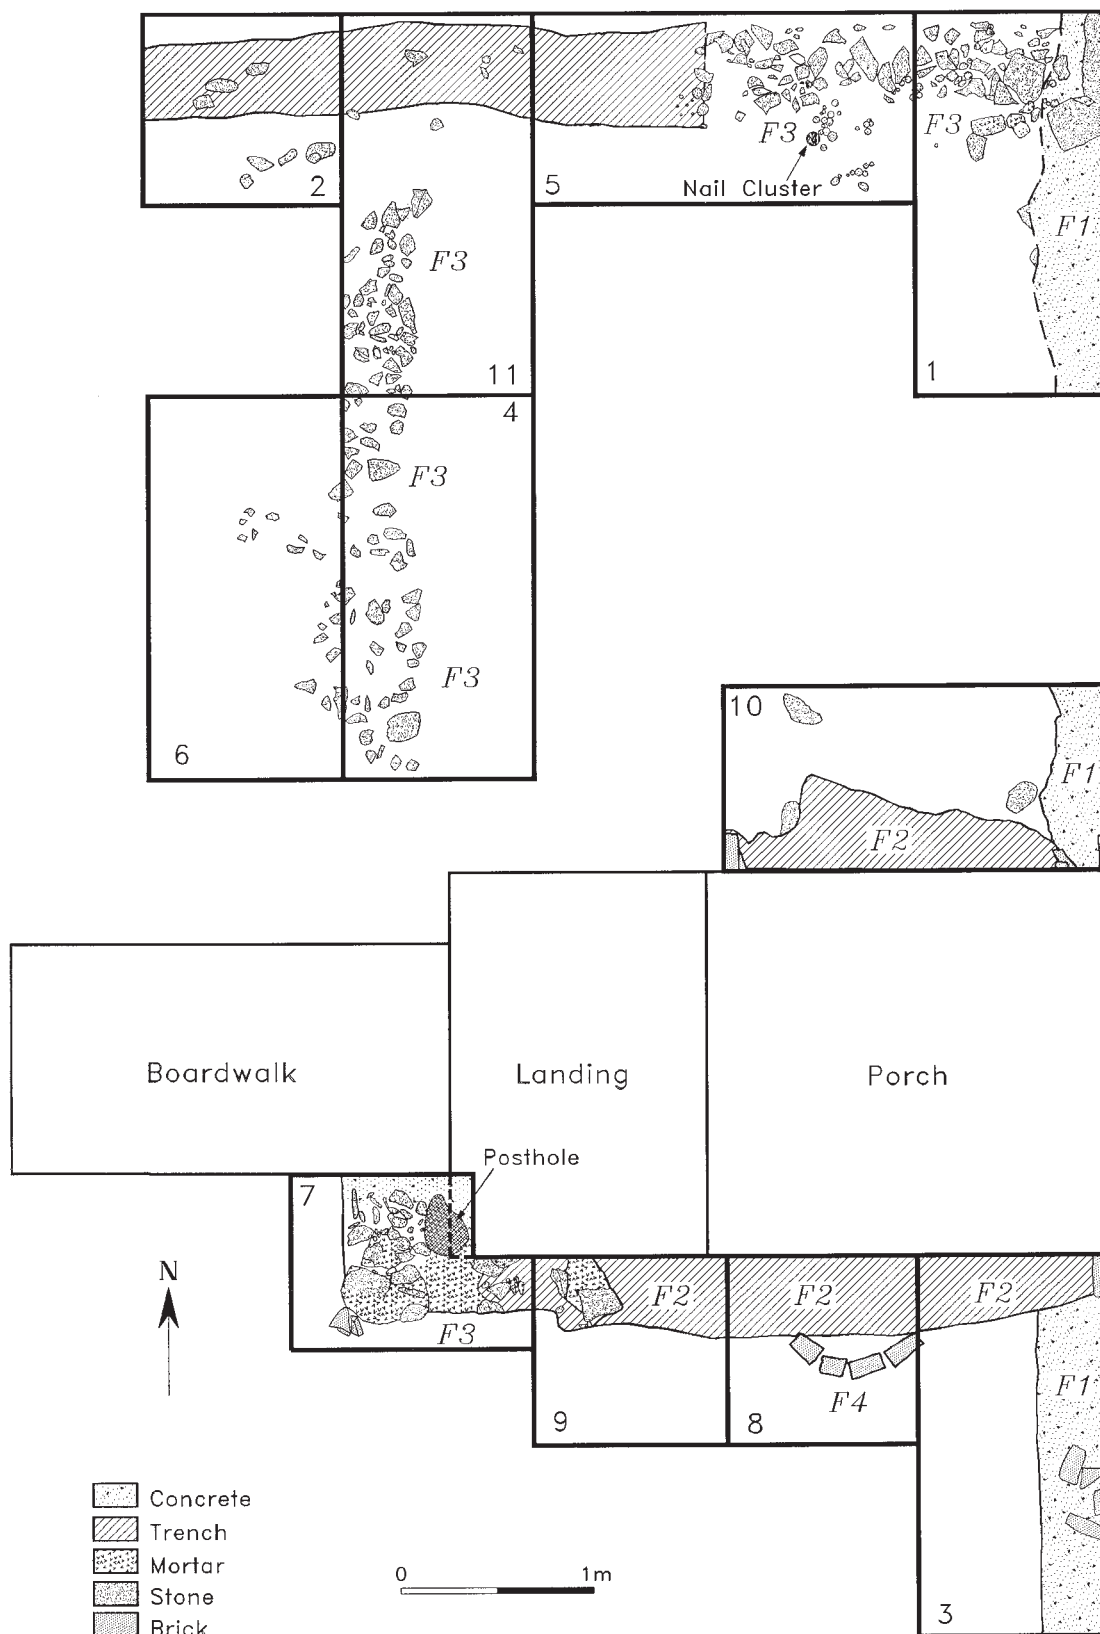
Figure 17. Original foundation, Feature 3, HS 6.

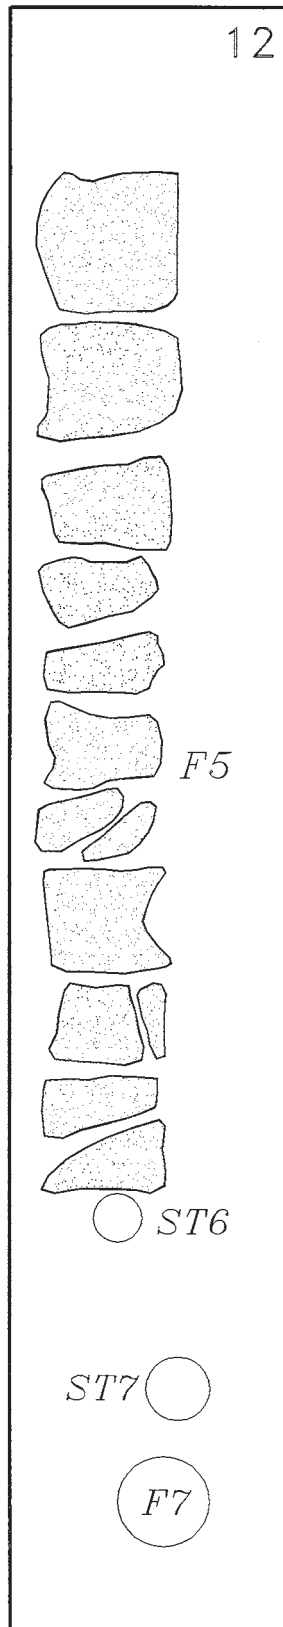
Figure 18. Walkway, Feature 5, HS 6.

No.	Provenience Unit	Size (cm)	Function
1	1, 10, 3, 15, 17	30-40 cm wide	Concrete footer from 1974 foundation replacement and repair
2	3, 7, 8, 9, 10	325 x 40 x 95	Builder's trench for brick arched basement "vault" (1901)
3	1, 5, 11, 2, 4, 6, 7, 9	[see Figure 18]	Stone foundation for original west half of house 1870-1901
4	3, 8	76 x 9 x 23	Curved brick alignment, basement window well from pre-1901 era
5	12	380 x 50 x 10	Stone walkway (post-1901)
6	14	240 x 240 x 270	Cylindrical brick cistern (post-1901?)
7	12	undetermined	Lens of plaster
8	15, 17	145 x 80 x 10	Midden containing glass beads and other items
9	16	80 x 5 x 5	Parallel stains from rotted wood. Stringers from boardwalk(?)
10	17	50 x 50 x 43	Pit with loose, dark fill
11	19	>100 x >100 x 10	Rubble "pavement" around Feature 12
12	19, 20	225 wide, 245 deep	Bell-shaped brick cistern filled with cinders and artifacts
13	17, 22, 25, 26	full dimensions undetermined	Very large pit with rubble at base. Fill contains artifacts

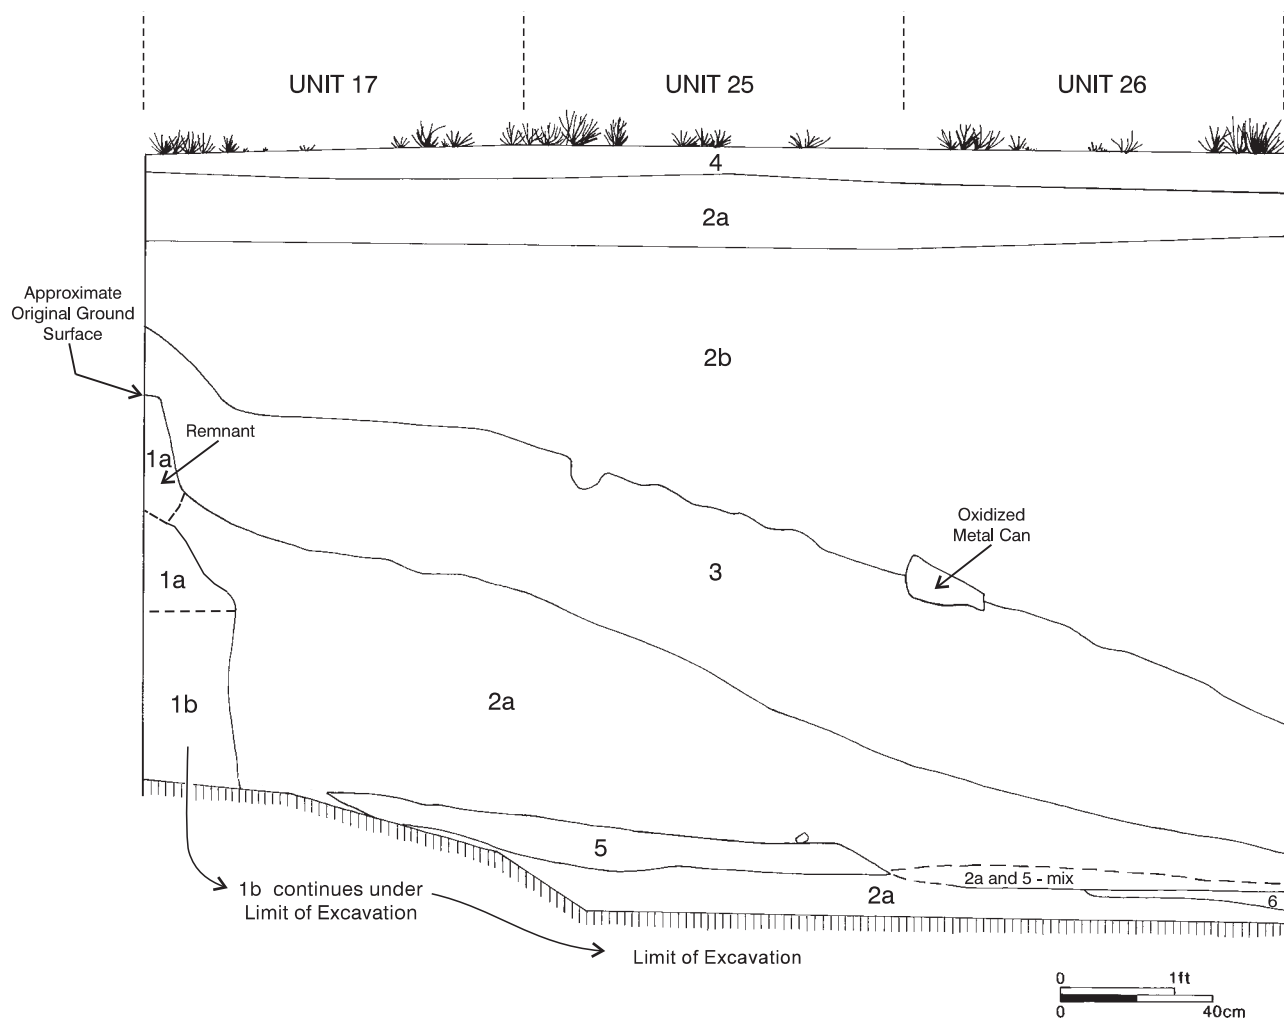
- 1a Dark brown loam (buried A horizon)
- 1b Yellow-brown loam (B horizon)
- 2a Brown loam with mottled yellow-brown loam (redeposited Strata 1a and 1b)
- 2b Dark brown loam with mottled yellow-brown loam (redeposited Strata 1a and 1b)
- 3 Yellow-brown loam (redeposited Stratum 1b)
- 4 Dark brown loam (modern humus)
- 5 Limestone rubble with some mortar
- 6 Mortar

Figure 19. Pit profile, Feature 13, HS 6 (south wall of Units 17, 25 and 26).

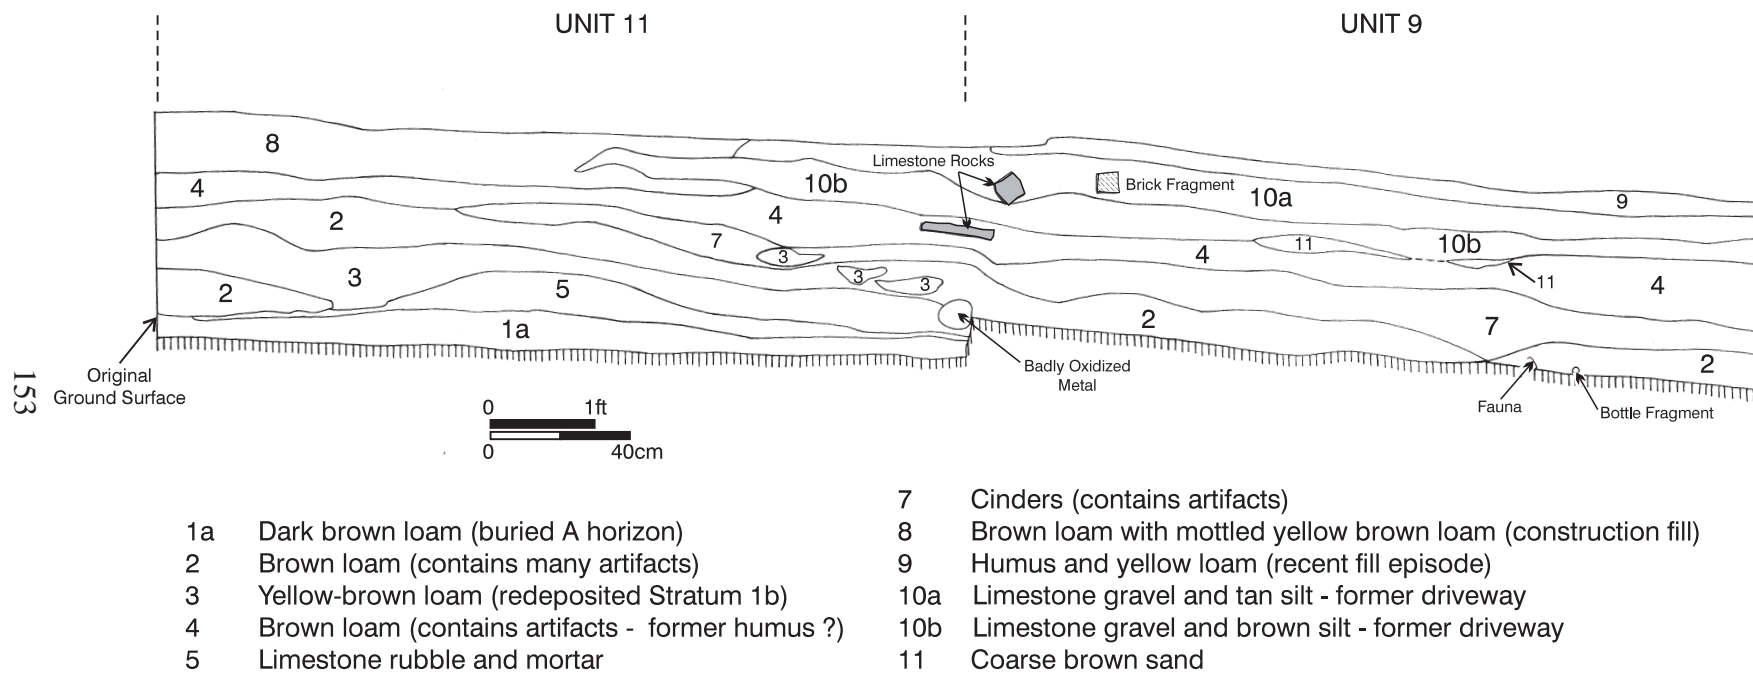
Figure 21. Profile, east wall, Units 9 and 11, HS 10.

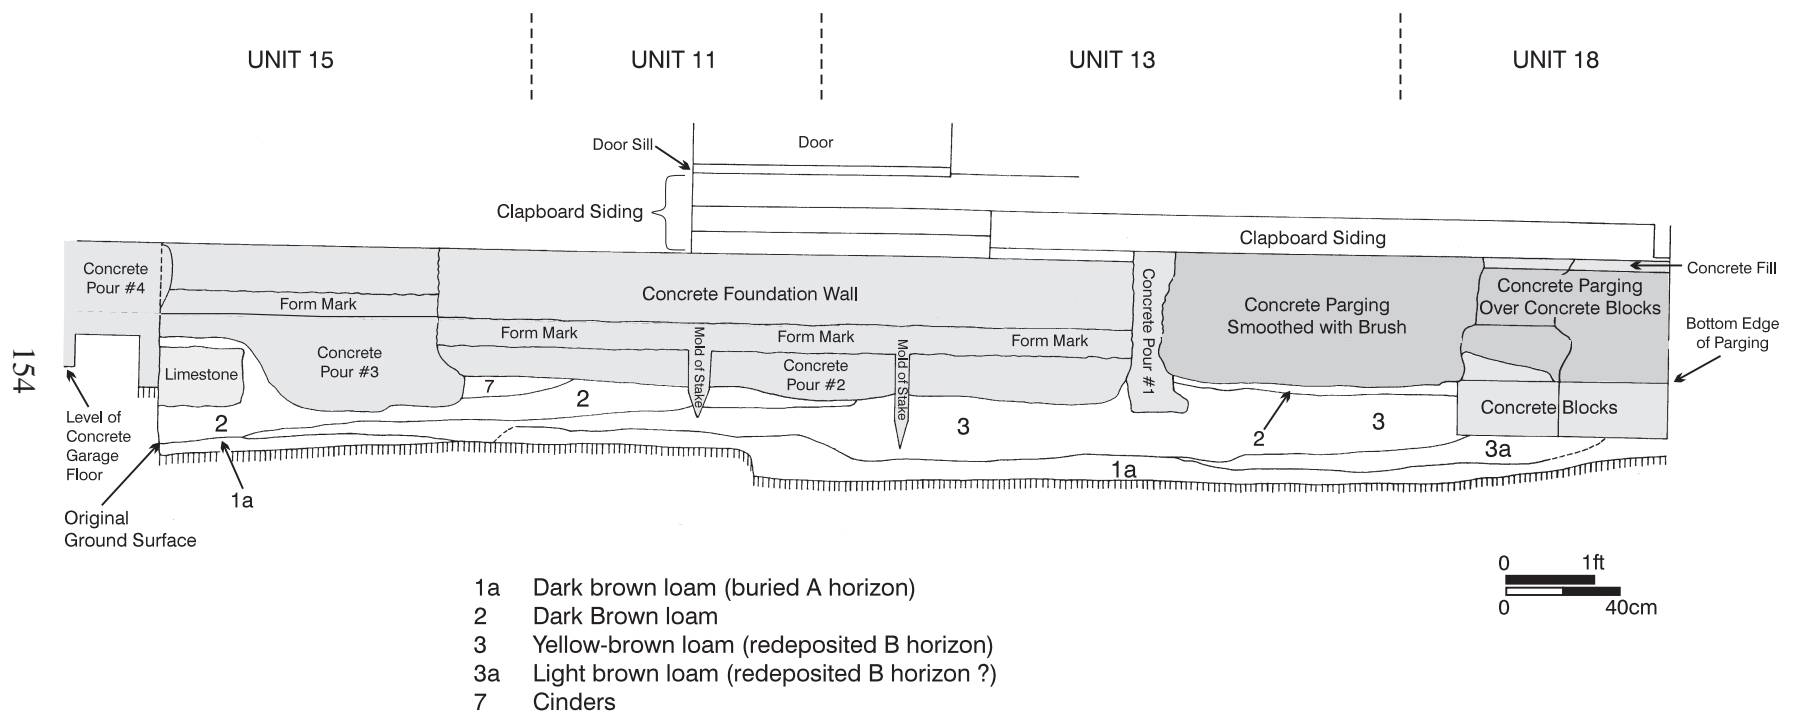
Figure 22. Profile, south wall of west wing, HS 10 (north wall of Units 15, 11, 13, and 18).

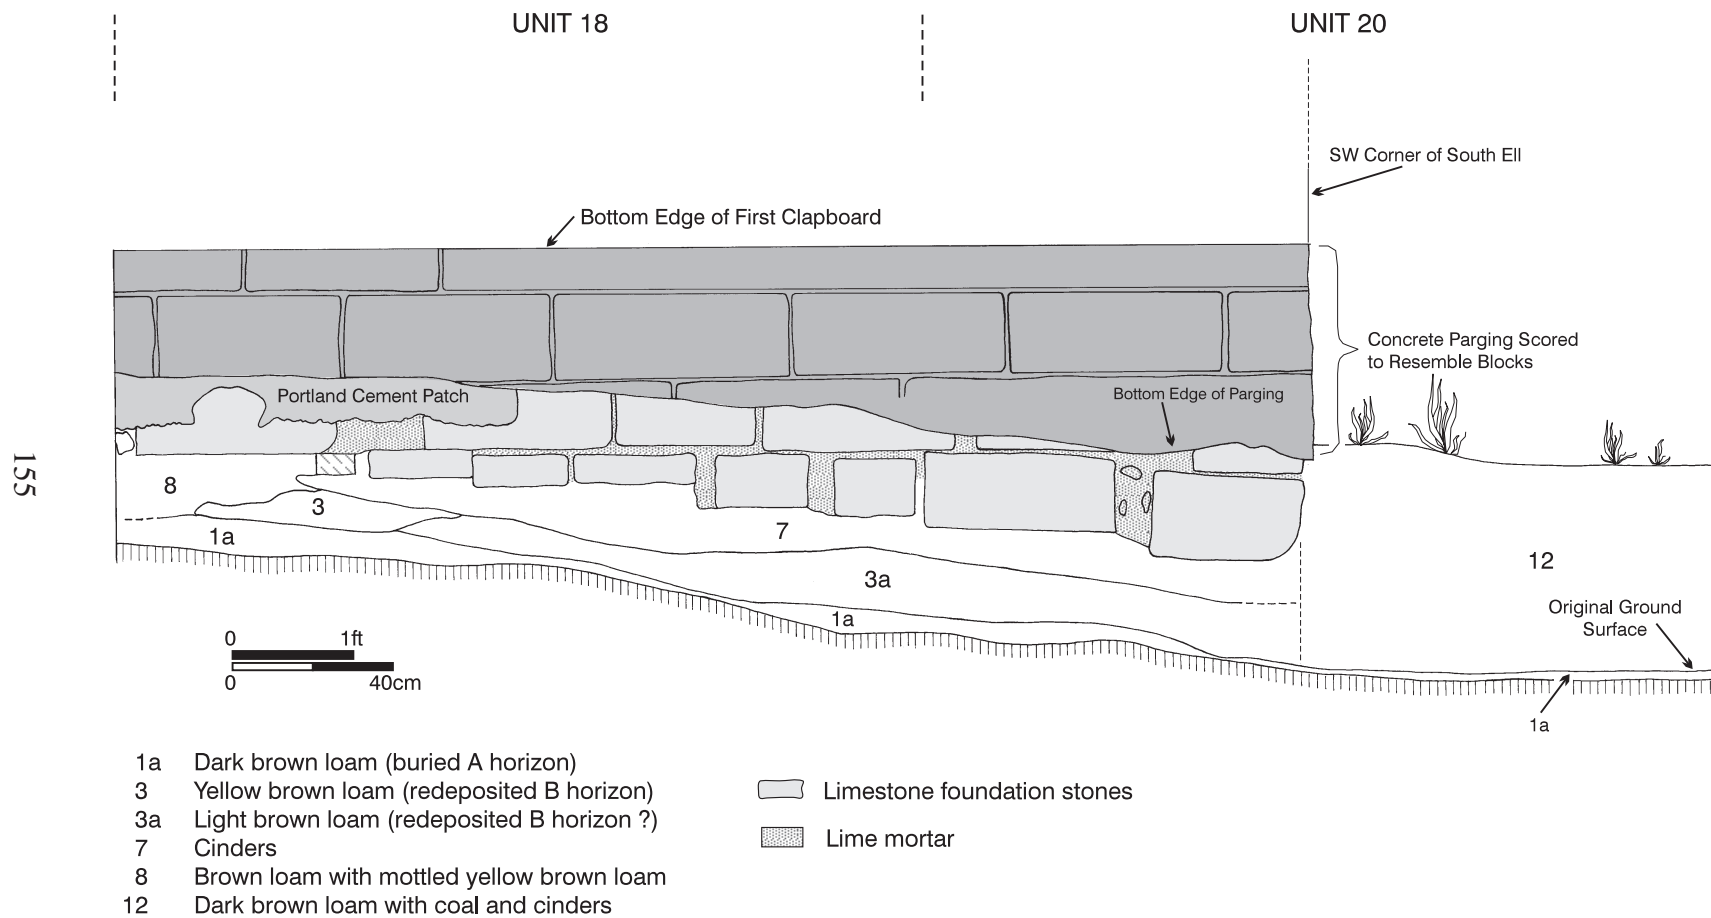
Figure 23. Profile, west wall of south ell, HS 10 (Units 18 and 20).

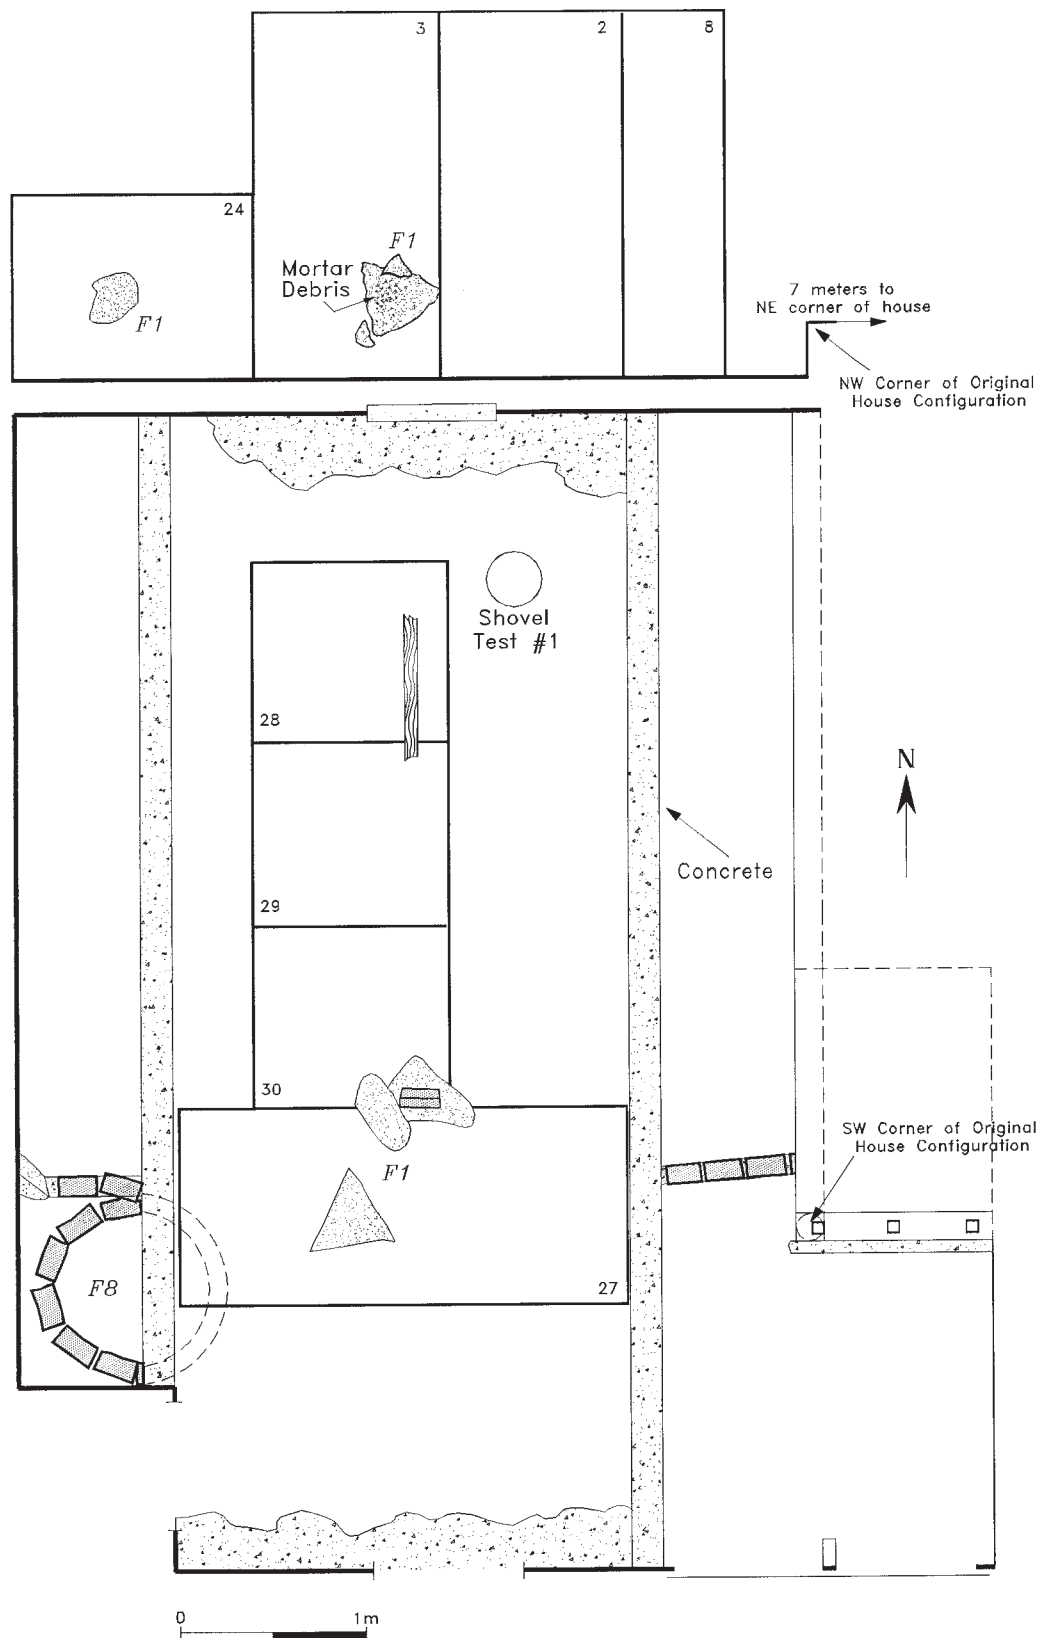
Figure 24. Porch supports, Feature 1, HS 10.

Well. A brick well (Feature 8) was discovered when workmen undertook demolition of the wooden and concrete floors of the west addition (Figure 24). The well is positioned under the west footing for the concrete slab floor which was formerly present when the west wing was used as a garage (1920s-1950). A loose modern fill was present in the well. This fill had been removed to a depth of over 10 feet below surface when safety concerns led to the termination of excavations. Air-filled voids were encountered amidst the fill, suggesting that previous higher water levels in the well had floated portions of the fill to their current positions. Samples of the cultural fill were retained for analysis, although it was apparent that all of the material dated to the mid-twentieth century. Upon further analysis it appears that these materials are contemporary with the fill in the cistern (Feature 2) and date to about 1950. It appears that when Davis extensively modified the west wing, he exposed the west half of the well, and like the cistern, used it for extensive trash discard. Since the bottom of the well was not reached during excavation, there remains the possibility of earlier cultural fills below the excavated portion of the well.
