ARCHEOLOGY IN HERBERT HOOVER'S NEIGHBORHOOD:
1989 EXCAVATIONS AT THE L. MILES AND
E.S. HAYHURST HOUSES, WEST BRANCH, IOWA

Midwest Archeological Center
Technical Report No. 51

This report documents archeological excavations conducted by the Midwest Archeological Center, National Park Service, at two historic properties at Herbert Hoover National Historic Site (HEHO), West Branch, Iowa. This fieldwork occurred in 1989 in support of a major structural restoration program at the Laban Miles and E.S. Hayhurst Houses. These late nineteenth-century structures formed part of a West Branch neighborhood that would have been familiar to Herbert Hoover during his childhood years. Restoration actions were aimed at returning the structures to an earlier appearance, while adaptively restoring the structures' interiors for modern use. The 1989 archeological project was intended to collect data that might otherwise be lost during components of the restoration program that included ground disturbance around the houses. Those impacts were successfully mitigated through the 1989 archeological data collection program.

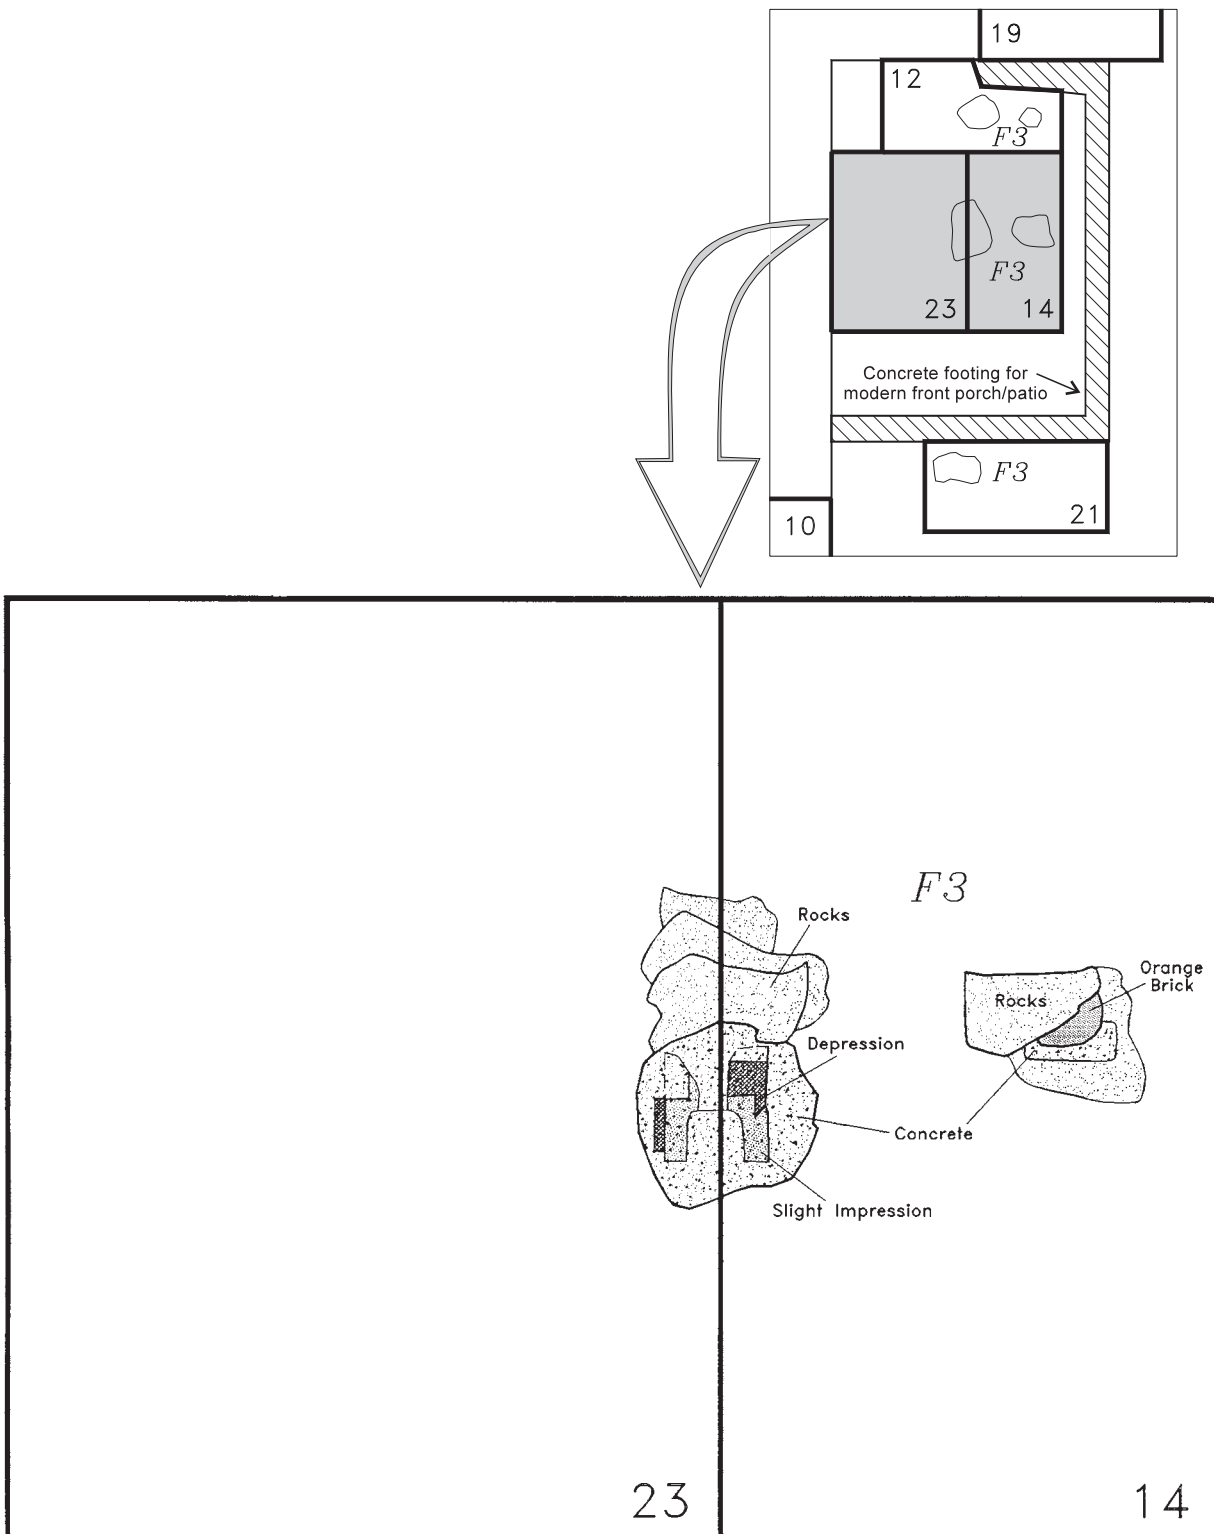
Figure 25. Porch supports, Feature 3, HS 10.

construction of the ell is unclear. Wagner uses Sanborn Fire Insurance Company maps to date the ell to pre-1895, prior to Butler's occupancy. Bearss has used newspaper accounts to date the construction of the ell to the winter of 1906-1907 (Bearss 1970:179) during Butler's occupation. Regardless of the precise age of the ell, photographs and maps depict a front porch on the east facade of the ell from about 1900 until 1950. At that date, the new occupant, Davis, removed the porch and replaced it with a large concrete, brick, and flagstone patio. The Sanborn maps indicate that the porch was about 16 feet long (N-S) and slightly over five feet wide (E-W). During fieldwork in 1989, the massive concrete, brick, and stone patio was removed through hand labor and jackhammer. The patio surface was positioned several feet above ground, and it was found to rest upon salvaged foundation stone, sand, and gravel. All of this fill was removed. A dark fill zone was exposed under the modern sand fill zone. The concrete footings for the patio were left in place (Figure 25). Excavation was initiated over most of the area formerly covered by the patio.

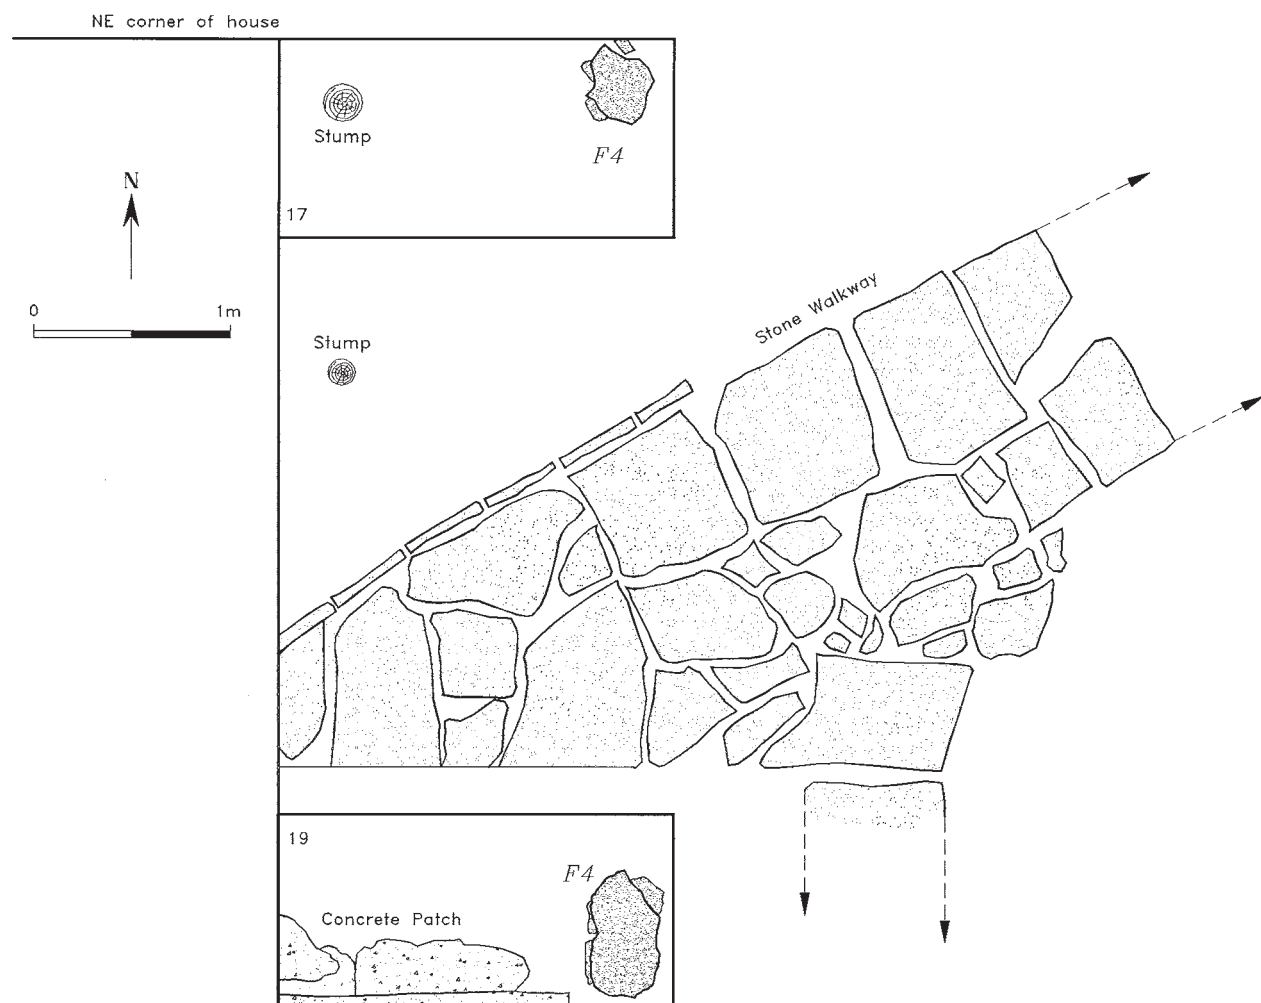
Figure 26. Porch supports, Feature 4, HS 10.

Another porch is represented by Feature 4. This feature consists of two stone porch supports aligned off the north and south corners of the east facade of the original component of the Hayhurst House (Figure 26). The supports are centered about 1.85 m (6.07 ft) east of the front facade of the house. Like the other porch on the east facade, this one was also depicted on Sanborn maps available after 1895. The door opening formerly present in the original house component's east facade has been sealed and covered with siding. However, during much of Butler's occupation, two front doors were in use at the house along with two wooden porches. For part of that period, one of the doors led to a "while-you-wait" shoe repair business operated by Butler. Bearss (1970:112) has described the wooden porch on the east facade as a "shed porch with a decorative gable. This porch extended the length of the front facade." There is evidence that the front porches were not built until after Butler added the south ell. Prior to that date (which is in dispute), the original front facade had only a small stoop. The front porch on the ell was apparently removed soon after 1950, when Tom Davis purchased the house. The large patio was added to the east facade of the ell at that time. The porch on the original facade had apparently been removed prior to 1949 (Bearss 1970:117).

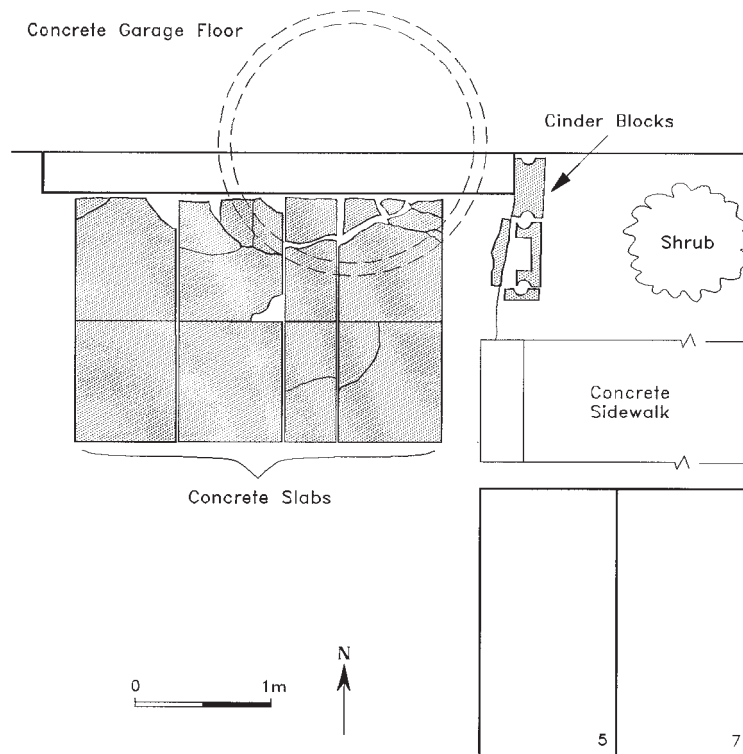
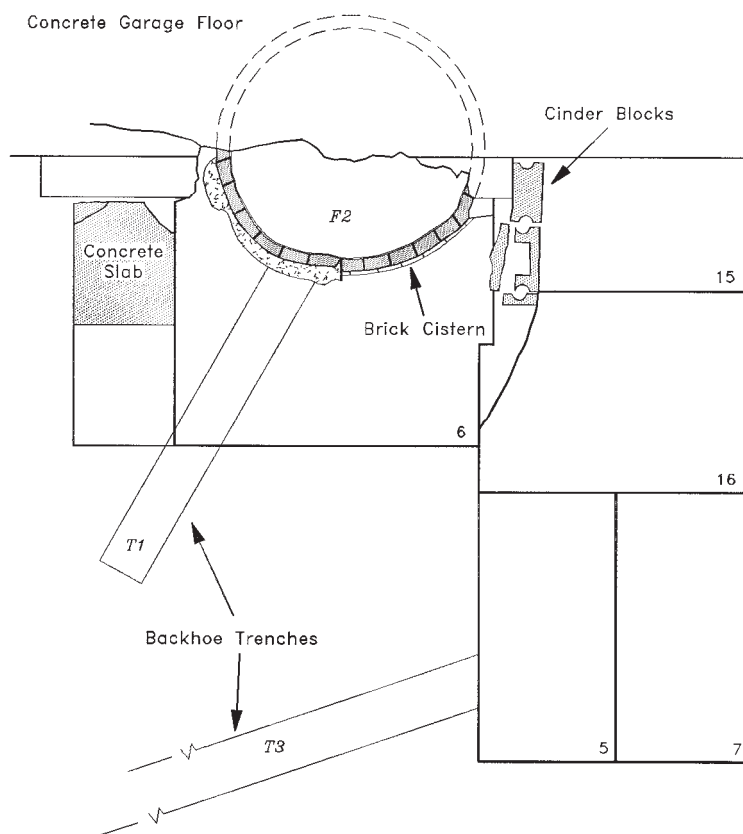
Figure 27. Cistern, Feature 2, HS 10.

Cistern. Excavation under the existing blacktop driveway adjacent to the most recent portion of the west addition exposed a brick cistern (Feature 2). When the thin layer of blacktop was removed, an “apron” of four concrete slabs was exposed. The remainder (south portion) of the driveway is gravel. Close to the thick (20 cm) reinforced-concrete slab of the garage floor three large slabs were found to be broken in a roughly circular pattern (Figure 27a). The broken pieces had settled appreciably. When the slabs were removed, a rubble-filled depression was exposed. Excavation of the 2-m-x-2-m Unit 6 over this area revealed the presence of a brick cistern. The cistern extended well under the garage floor. To expose it for excavation, a portion of the garage floor was removed with considerable difficulty. Its modern poured concrete had reinforcing rod and wire embedded in it. Finally, an area was cut back, exposing about half of the cistern opening to view (Figure 27b).

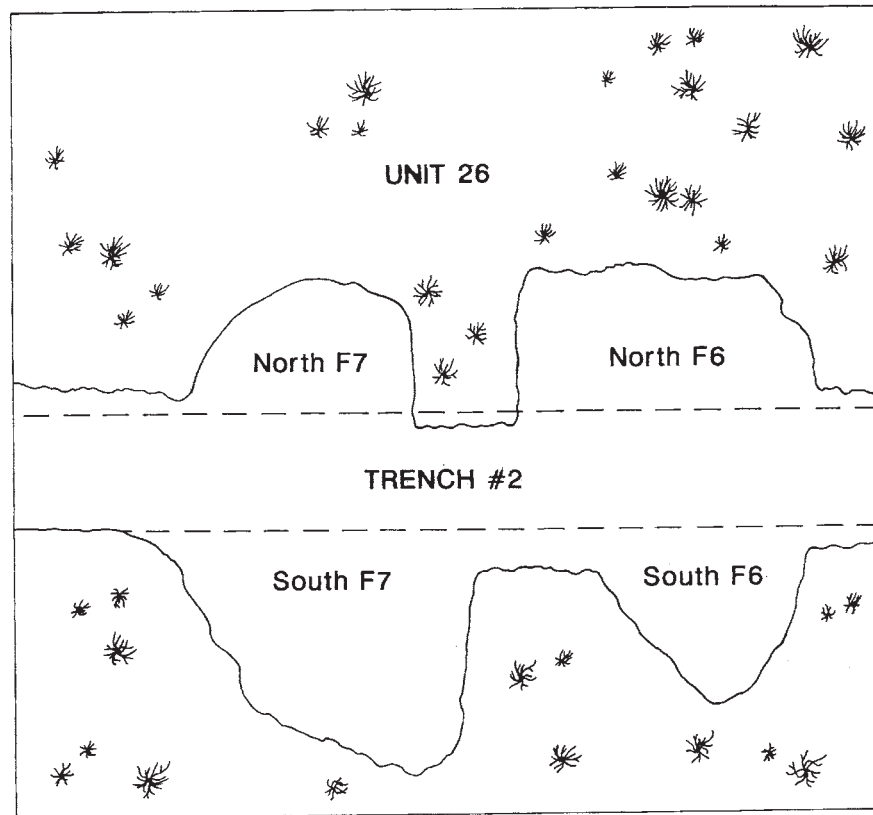
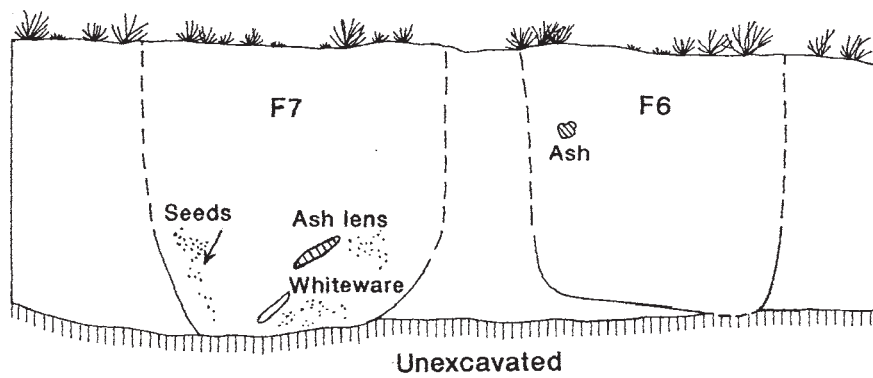
Figure 28. Plan view and profile, Features 6 and 7, HS 10.
