Channel Geometry of Piedmont Streams as Related to Frequency of Floods

GEOLOGICAL SURVEY PROFESSIONAL PAPER 422-E

By F. A. KILPATRICK *and* H. H. BARNES, JR.

PHYSIOGRAPHIC AND HYDRAULIC STUDIES OF RIVERS

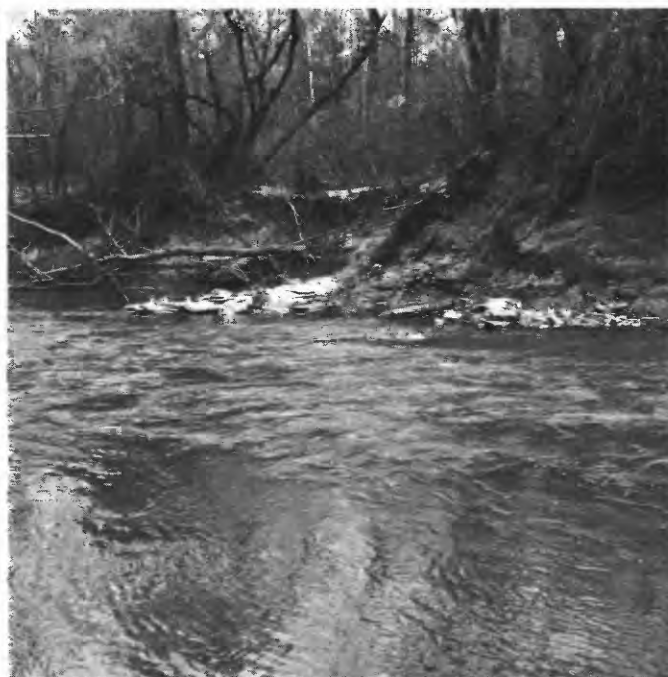
FIGURE 3.—View of rock outcrop below cross section 11 at Stevens Creek. These rock outcrops are typical of Piedmont streams.

The stream channels are deeply entrenched in many places, the present position being controlled by outcrops of rock. Even where the benches are broad and active meandering might be expected to occur, rock exposures are found in the streambed and along the channel banks (fig. 3).

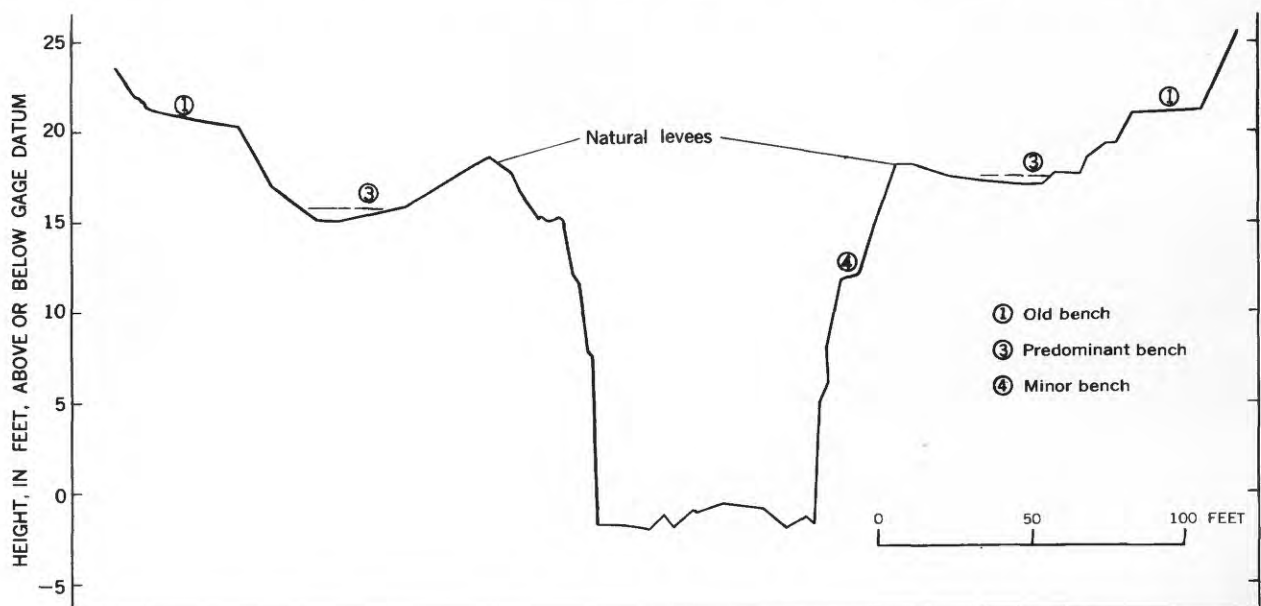
FIGURE 4.—Cross section 11 at Stevens Creek.

Natural levees and a complex system of benches exist at all sites. For example, the cross section of Stevens Creek in figure 4 shows natural levees and three separate benches at different elevations. The benches are also delineated in figure 2. The photograph shown as figure 5 was taken on the left bank of cross section 11 looking upstream. The mean annual flood corresponds to a stage about 4 feet above the top of the levee and 6 to 7 feet above the bench.

1. The numbers corresponding to the various bench levels in the valley reach. Bench levels are numbered from highest to lowest in the manner illustrated in figures 2, 4 and 8.

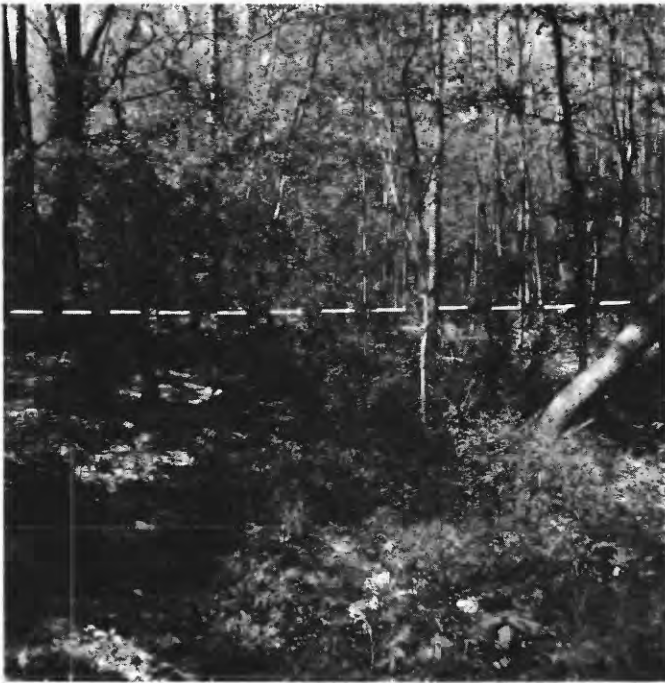
FIGURE 5.—View from left bank looking upstream toward natural levee at cross section 11 at Stevens Creek. The tape is stretched horizontally from the top of the levee toward the edge of the predominant bench.

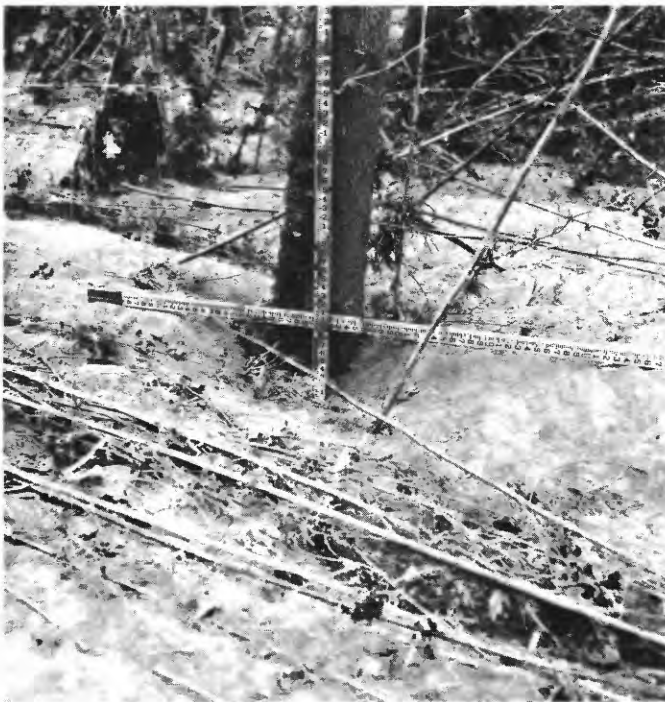
FIGURE 6.—View of deposition on the natural levee below cross section 11 at Stevens Creek.

Another phenomenon noted at Stevens Creek was the active deposition of mud and fine silt on the natural levees. The amount of deposition on the levee just below cross section 11 is easily discernible in figure 6. The trees stand in "sinkholes" formed by deposition occurring everywhere except in the immediate vicinity of the tree trunks, where local velocities are higher. The reach on Stevens Creek has a very flat slope, which may explain the large amount of deposition, but deposition also occurs on the immediate banks of many of the streams regardless of channel width, depth, or slopes.

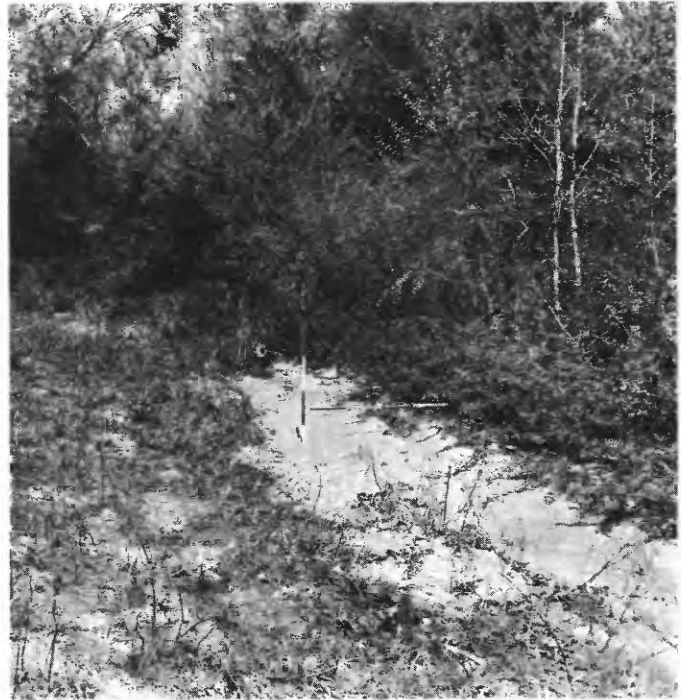
FIGURE 7.—Formation of natural levee by deposition in the immediate vicinity of the stream bank at Murder Creek near Monticello, Ga.

This was noted particularly at the site on Murder Creek near Monticello, Ga., immediately after the flood of June 2, 1959. Silt and sand were deposited adjacent to the banks of the creek and formed new levees or added to old ones. One of these deposits is shown in figure 7. The thick undergrowth may have increased the deposition.

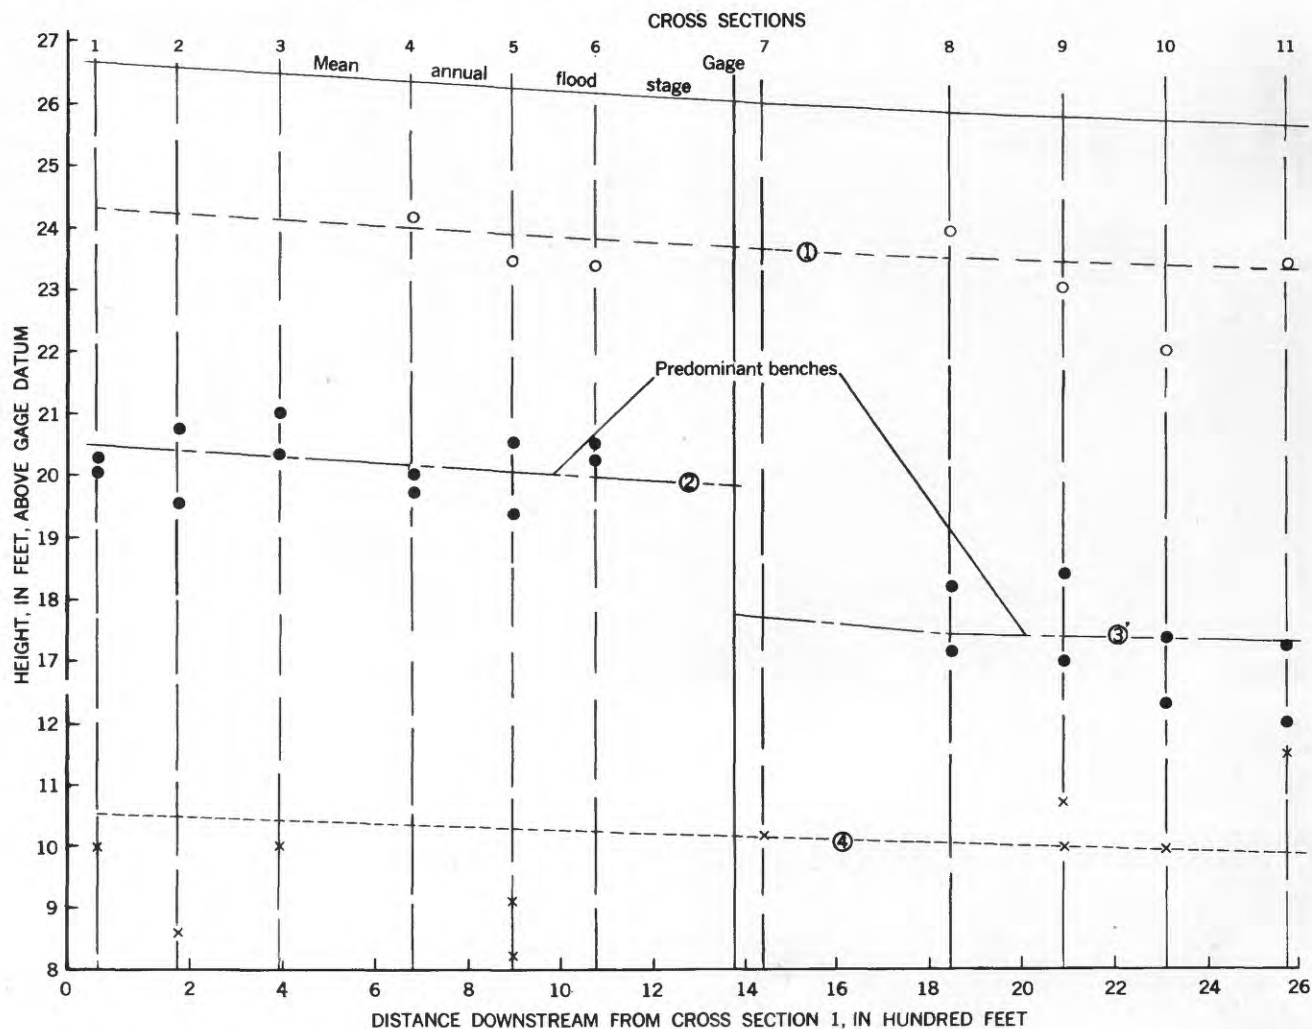
FIGURE 8.—Profiles of mean annual flood stage and various bench levels for Stevens Creek.

When bankfull stages so defined were plotted against distance along the channel, discontinuities were evident where there were major changes in the slope of the channel bed. This is illustrated in figure 8 by the profiles of benches 2 and 3 along Stevens Creek. In this instance benches 2 and 3 are clearly predominant in the respective upstream and downstream reaches. It should be noted that a higher and lower bench are identifiable but not prominent enough that either could be associated with bankfull stage. There is a drop of about 3 feet between the predominant benches where the slope of the channel bed flattens. Because the bench elevations appear to be associated with the slope of the channel, reaches were subdivided into lengths of reasonably constant slope.

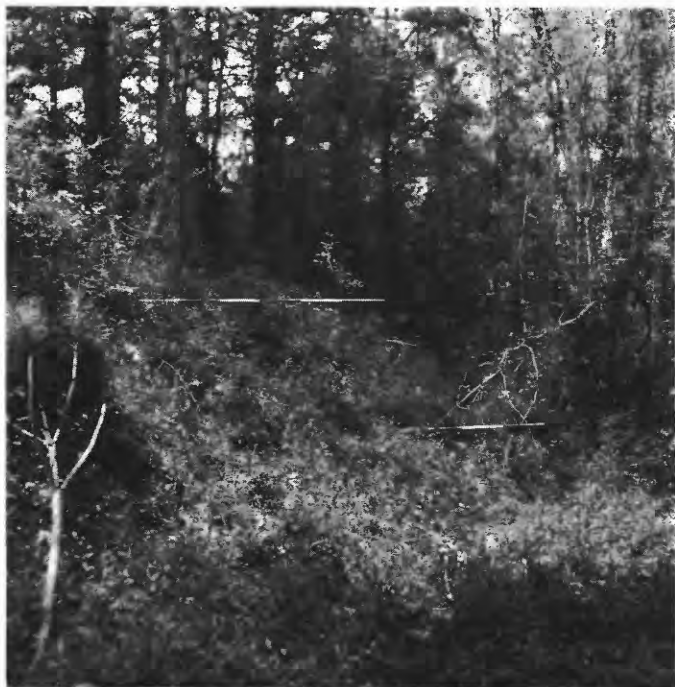
FIGURE 9.—Photograph indicating two prominent benches at Murder Creek.

exist, and two equally valid bankfull profiles were determined. The two benches are indicated in figure 9. The water-surface profile existing at the higher bench level was much steeper than the water-surface profile at the level of the lower bench. The two benches are thus associated with different slopes—an unusual occurrence where a section control is effective up to an extreme stage.

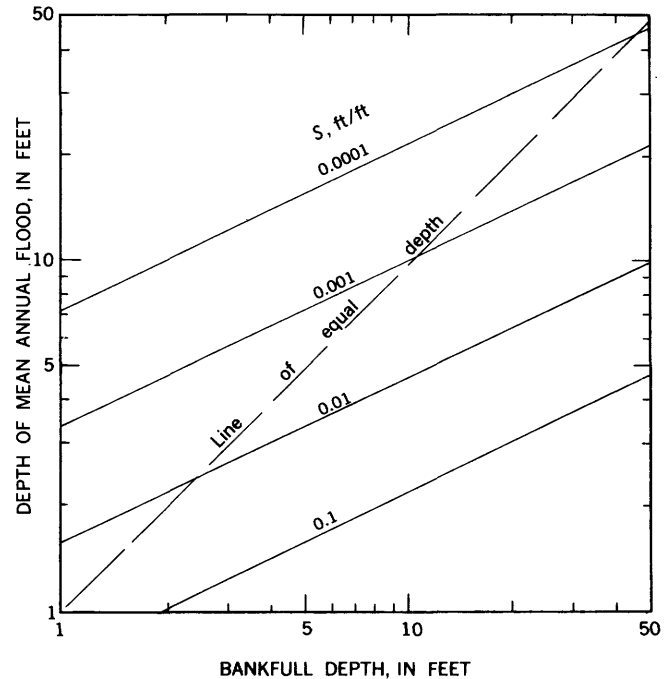
FIGURE 10.—Relation of bankfull depth to depth of mean annual flood for Piedmont streams.

The effect of channel slope on the character of the benches and the frequency of their inundation is illustrated in figure 10. This graph which is based on data for the 34 reaches as given in table 3 shows the relation between bankfull depth, the depth of mean annual flood, and slope. The data for streams on which the higher bench was predominant tend to plot to the right of the equal depth line, and data for streams on which a lower bench was predominant plot to the left. The mean annual flood on streams having steep slopes is contained within the channel, but on streams of mild slope it covers the predominant bench to a considerable depth.

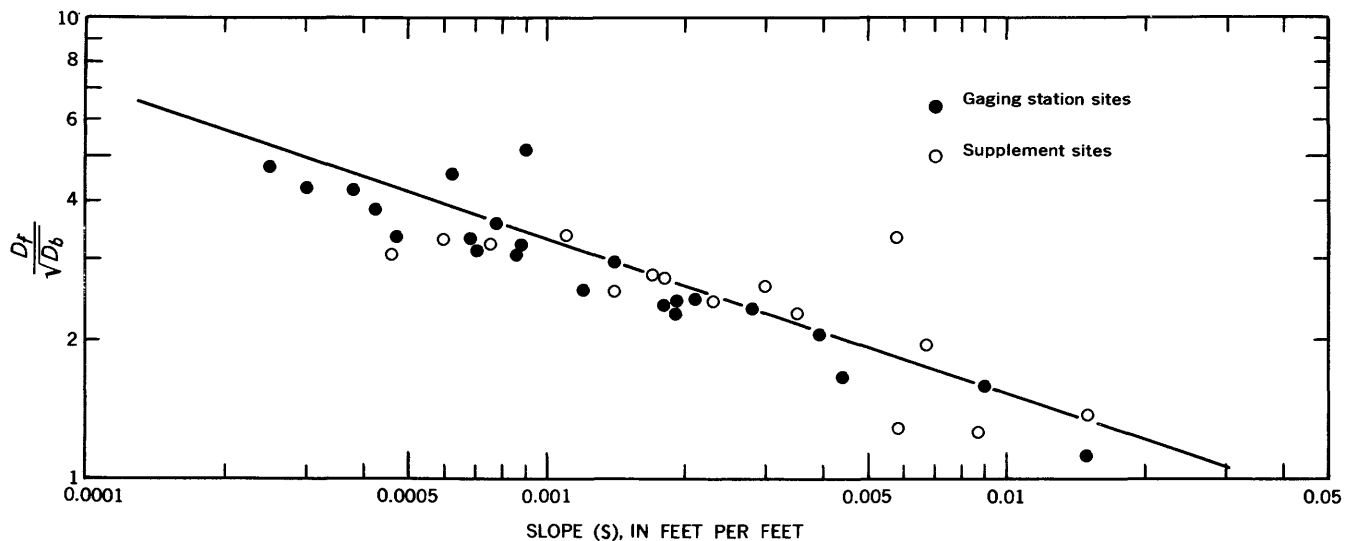
FIGURE 11.—Comparison of the data for 34 sites in the Piedmont with the graph of equation 1.

The standard error is 12 percent and the regression coefficients are significant to the 0.001 level. The data for the predominant benches are compared with equation 1 in figure 11. The data based on extensive surveys at the gaging-station sites display less scatter than the data for the supplementary sites. This difference emphasizes the accuracy needed in determining the predominant bench and thus the bankfull stage.

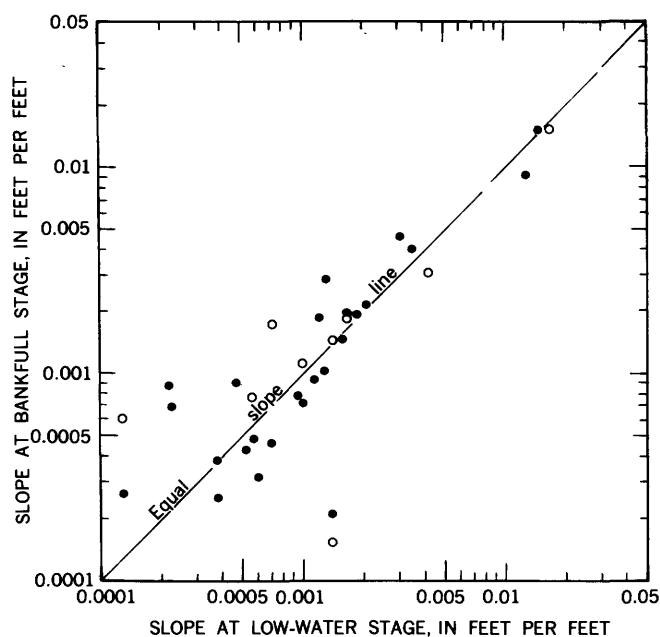
FIGURE 12.—Relationship between water surface slope at low stage and at bankfull stage. Solid dot, data from table 1; open dot, data from table 2.

The water surface slope as used in this report is for bankfull stage. It is recognized that the slope of the water surface in a particular reach will vary with an increase in depth or discharge, as the pools and riffles which control low water flows are no longer individually effective. A comparison of the slope at low stage, and at bankfull stage, for the 34 reaches is given in figure 12. The plot indicates that the slope at low stage may be considerably greater or less than the slope at bankfull stage, if the channel slope is less than 0.002 ft per ft. On streams of greater slope, the low water slope may be used in lieu of the slope at bankfull stage in the ap-
