NIST NCSTAR 1-1

**Federal Building and Fire Safety Investigation of the
World Trade Center Disaster**

Design, Construction, and Maintenance of Structural and Life Safety Systems

H. S. Lew
Richard W. Bukowski
Nicholas J. Carino

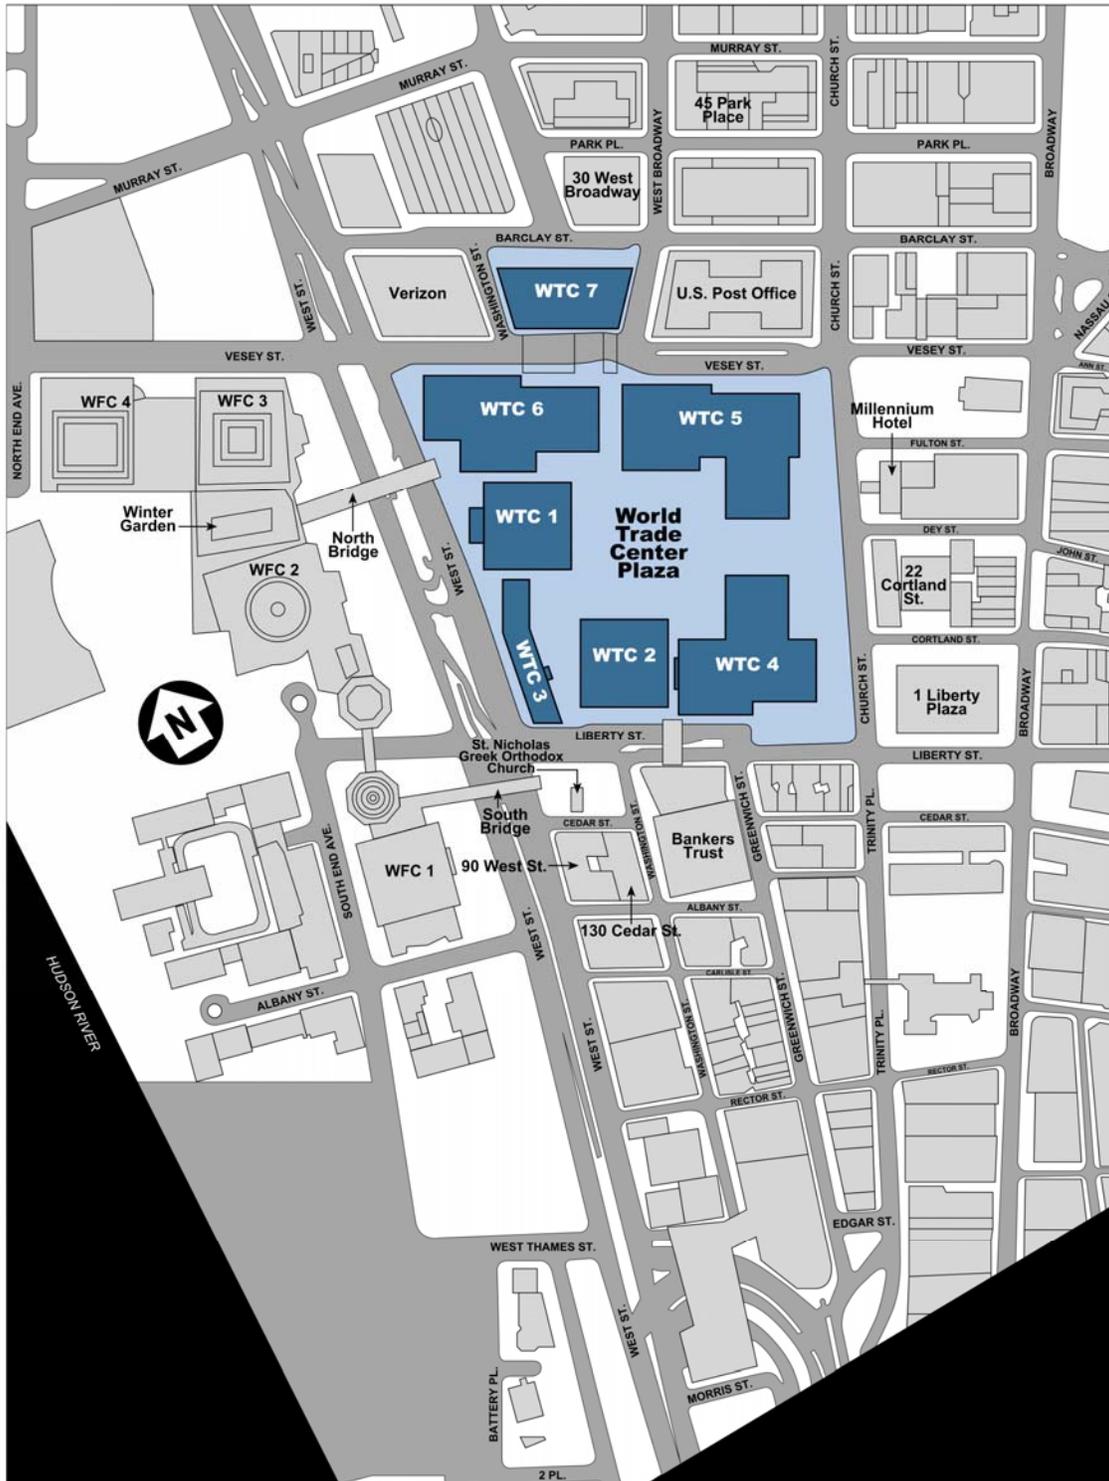
Figure 2-1. WTC site plan.

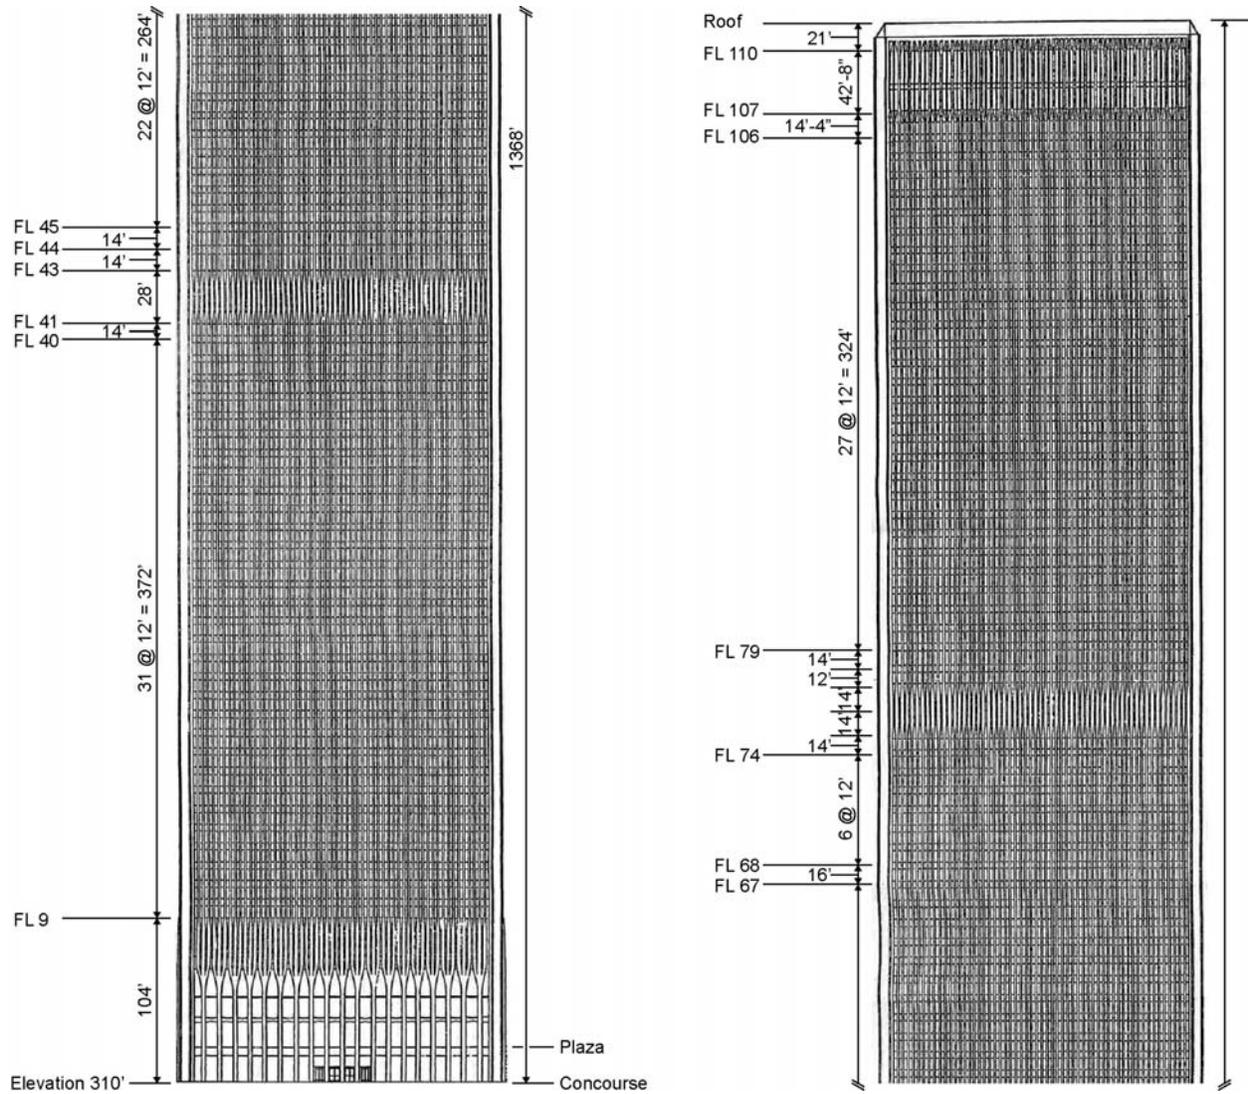
Figure 2-2. West elevation of WTC 1.

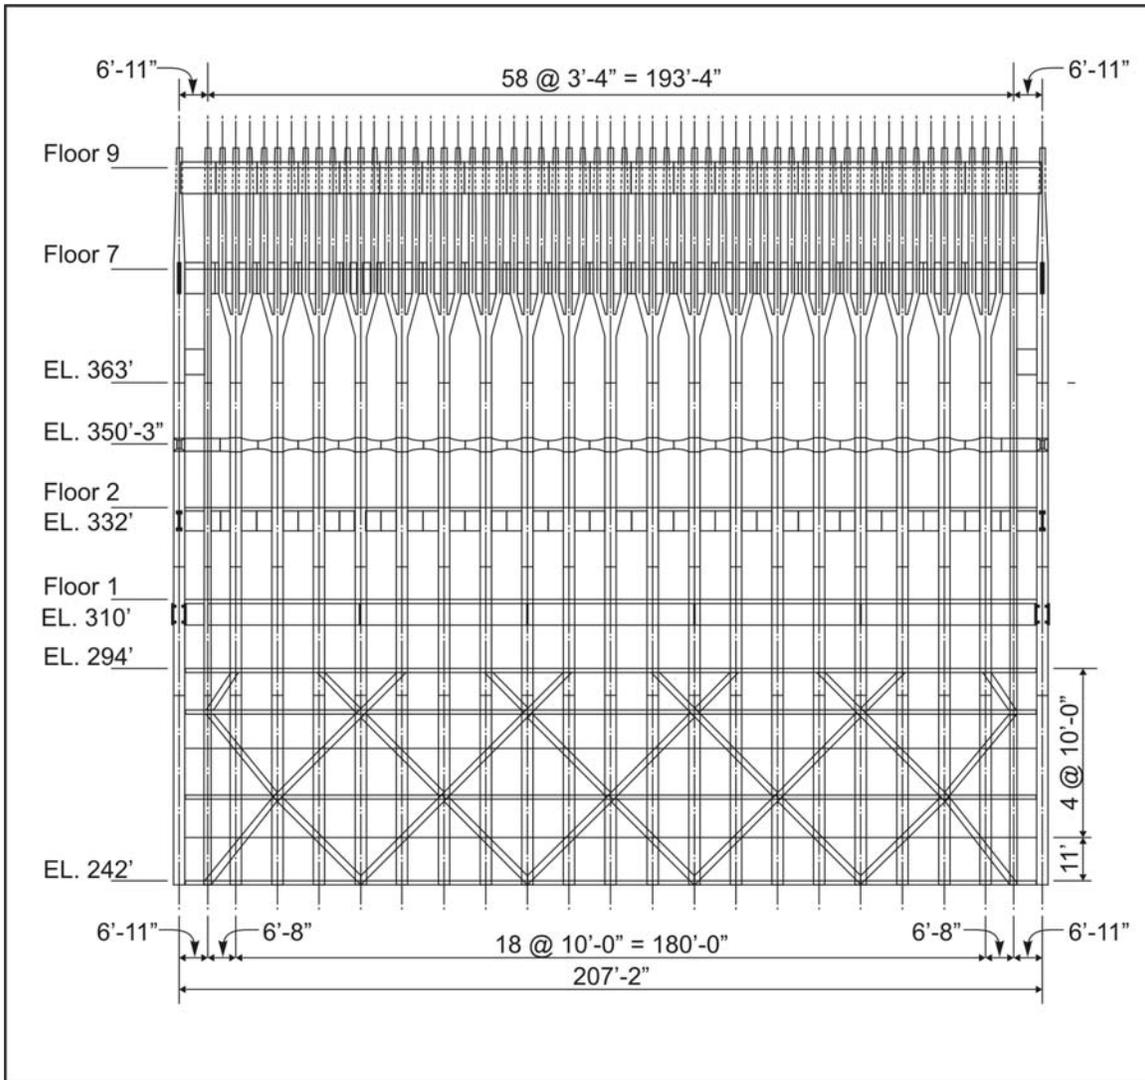
Figure 2-3. Elevation of exterior wall from foundation to floor 9.

The exterior wall columns, built-up of steel plates, from the foundation level up to Elevation 363 ft (column splice point below floor 7, see Fig. 2-3) were spaced 10 ft on center, and they were connected by spandrels. Between the Concourse Level and the foundation, these columns were braced diagonally to form braced frames in the plane of the exterior walls (Fig. 2-3). Between Elevation 363 ft and floor 7, single exterior wall columns spaced 10 ft on center transitioned to three columns spaced 3 ft 4 in. on center (Fig. 2-8) to form “tree” assemblies.

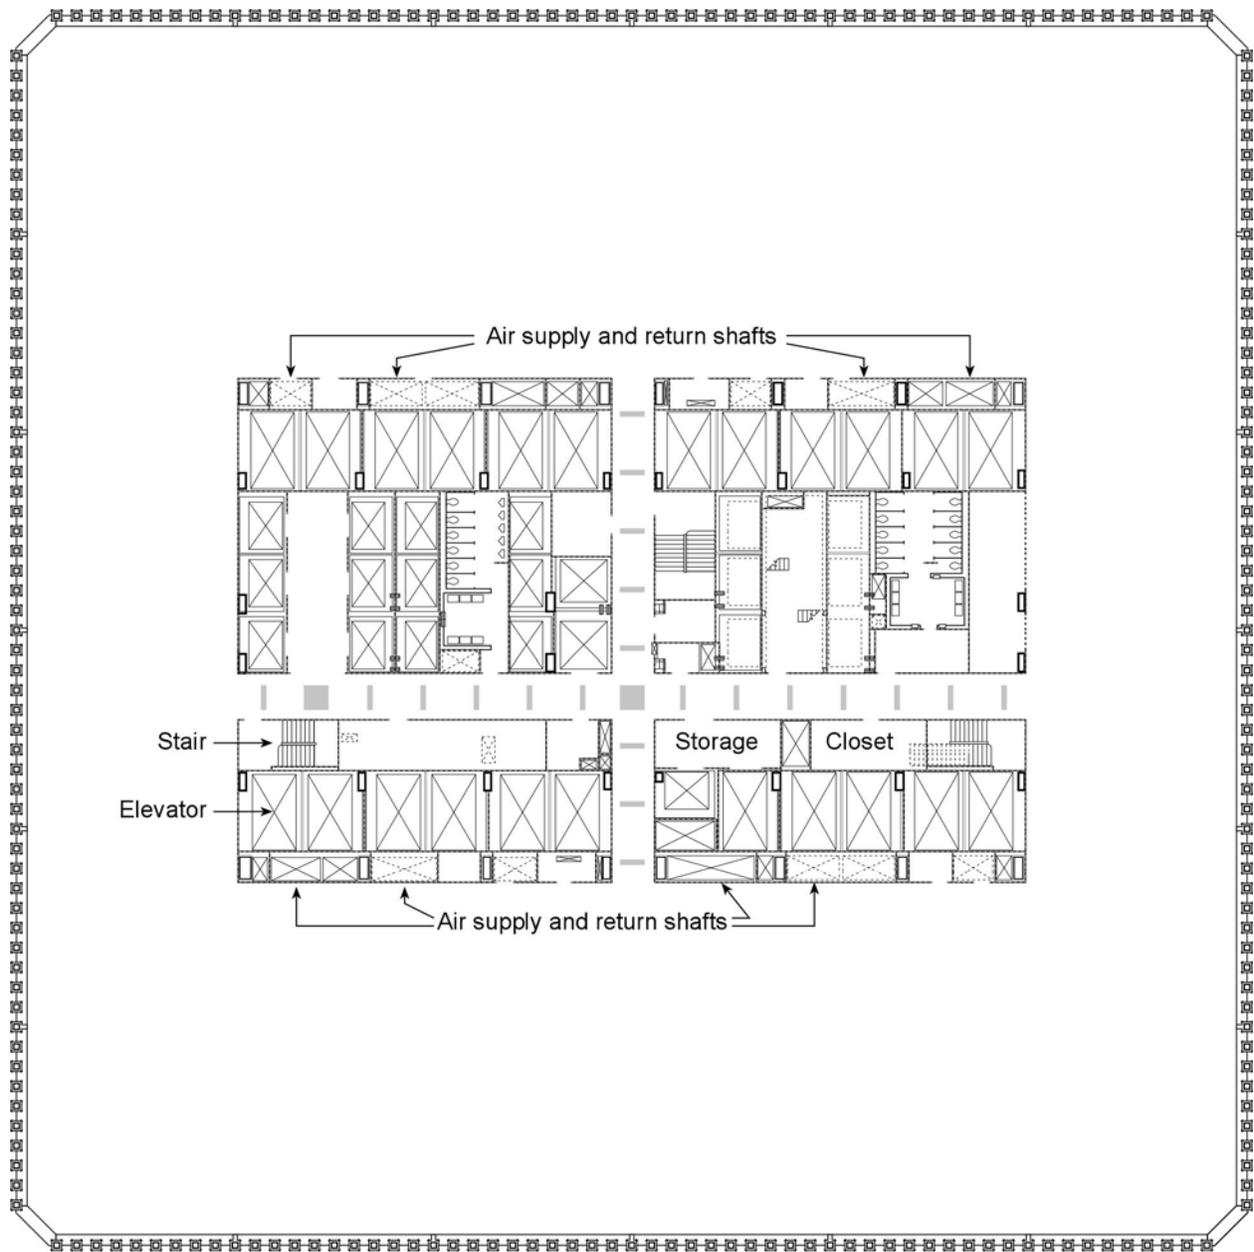
Figure 2–4. Typical WTC tower architectural floor plan.

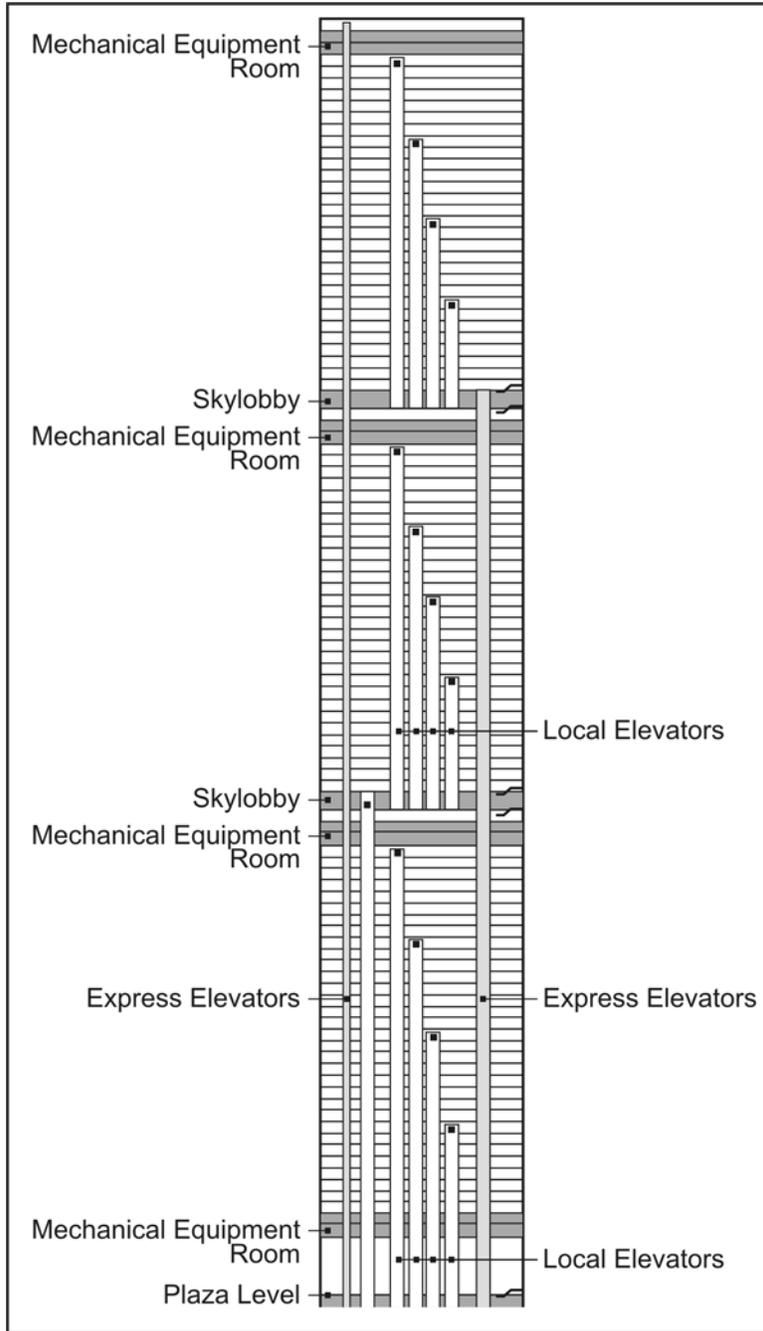
Figure 2-5. Arrangement of express and local elevators.

Elevators were the primary mode of routine ingress and egress from the towers for tens of thousands of people on a daily basis. In order to minimize the total floor space needed for elevators, each tower was divided into three zones by the skylobbies, which served to distribute passengers among express and local elevators (for details, see NIST NCSTAR 1-7). In this way, the local elevators within a zone were placed on top of one another within a common shaft. Figure 2-5 shows the elevator riser diagram for WTC 1 and WTC 2. People transferred from express elevators to local elevators at the skylobbies which were located on the 44th and 78th floors in the both towers. Each tower had 99 elevators within the core of the building, including seven freight elevators, most serving a particular zone, and dedicated express

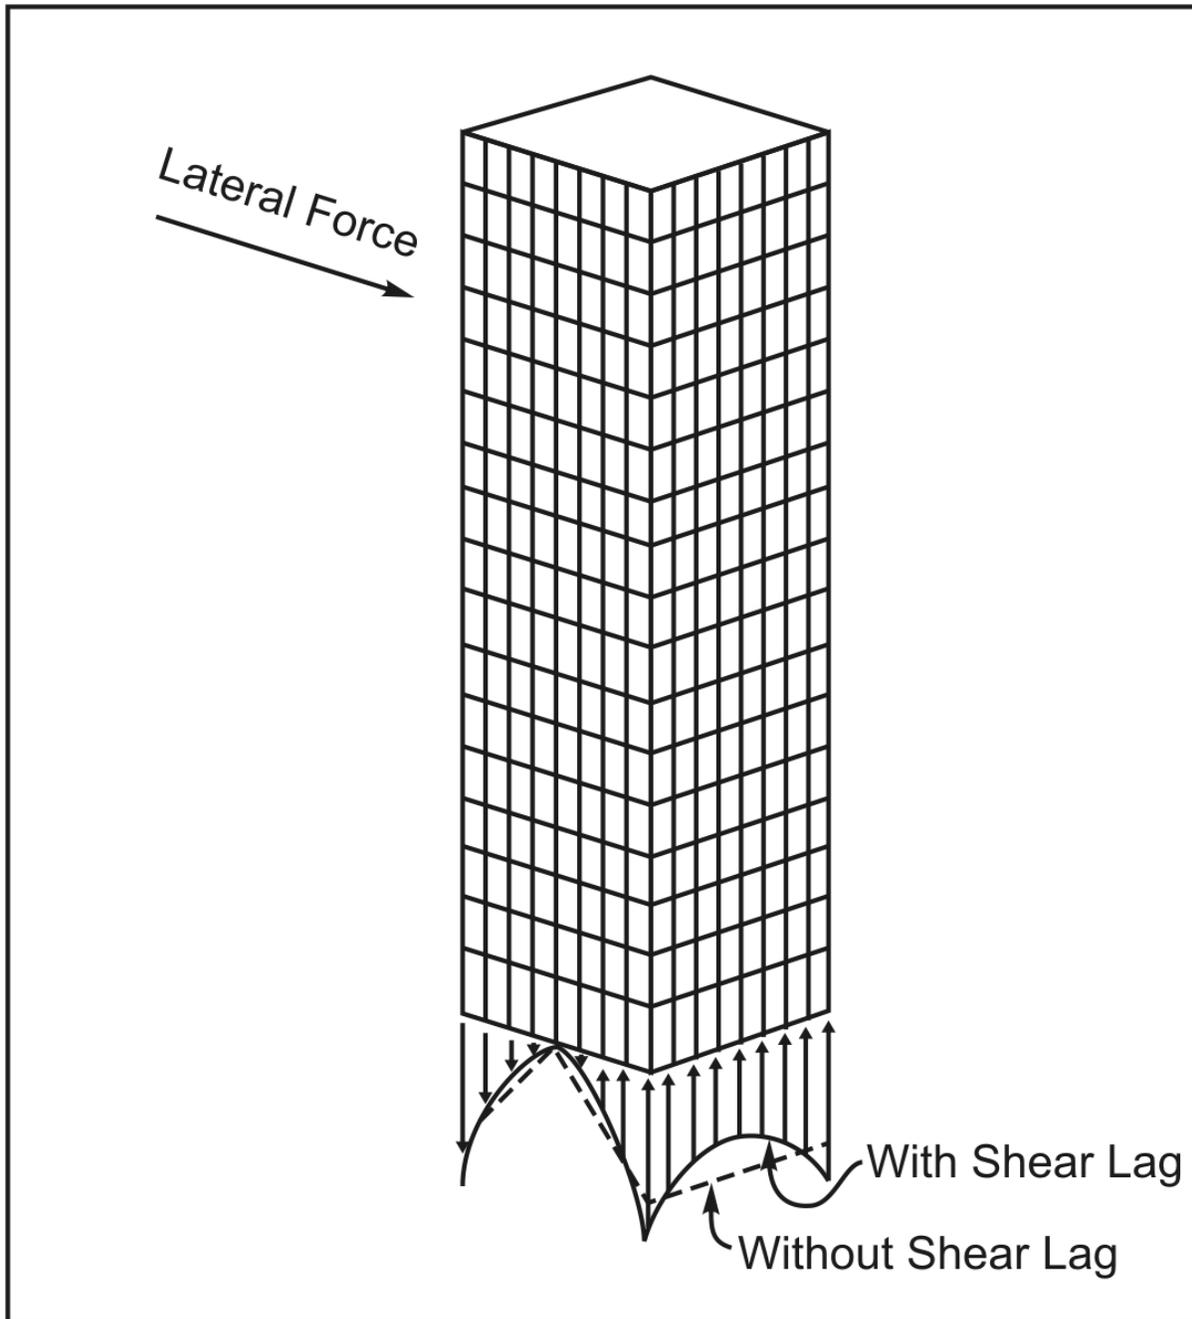
Figure 2-6. Framed tube system.

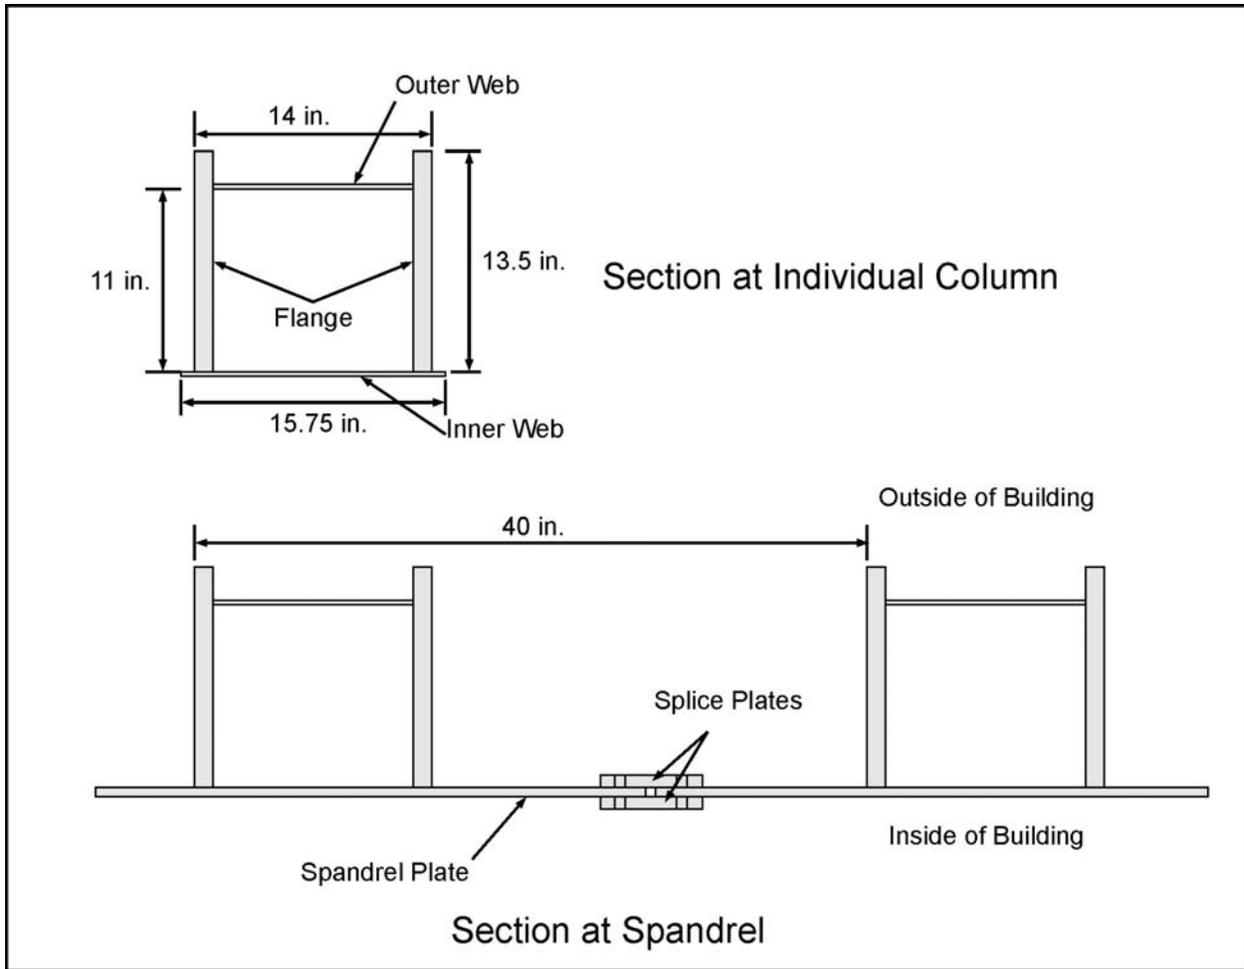
Figure 2-7. Cross section of perimeter columns.

Between floors 9 and 107, the perimeter structure consisted of closely spaced, built-up box columns. Each building face consisted of 59 columns. The columns were fabricated by welding plates of steel to form an approximately 14 in. square section (Fig. 2-7). The columns were interconnected at each floor level by 52 in. deep spandrel plates to form a 10 ft wide and 36 ft tall panel (Fig. 2-9). Heavy end, or “butt” plates of 1.375 in. to 3 in. thick were welded to the top and bottom of each column. Fillet welds were used inside the columns along three edges, with a groove weld on the fourth, outside edge. The exterior walls were erected by connecting the prefabricated panels. The panels were field-bolted to adjacent panels with dual splice plates (see Fig. 2-7), and columns were bolted to the adjacent columns, using ASTM International (ASTM) A 325 bolts except for the heaviest butt plates, where ASTM A 490 bolts were used. Other than at the mechanical floors, panels were staggered so that only one third of the columns were spliced (i.e., connected) in any one story (Fig. 2-10). At the mechanical floors, the perimeter columns were spliced at the same level (i.e. floors 74 and 77). These splices were both welded and bolted.

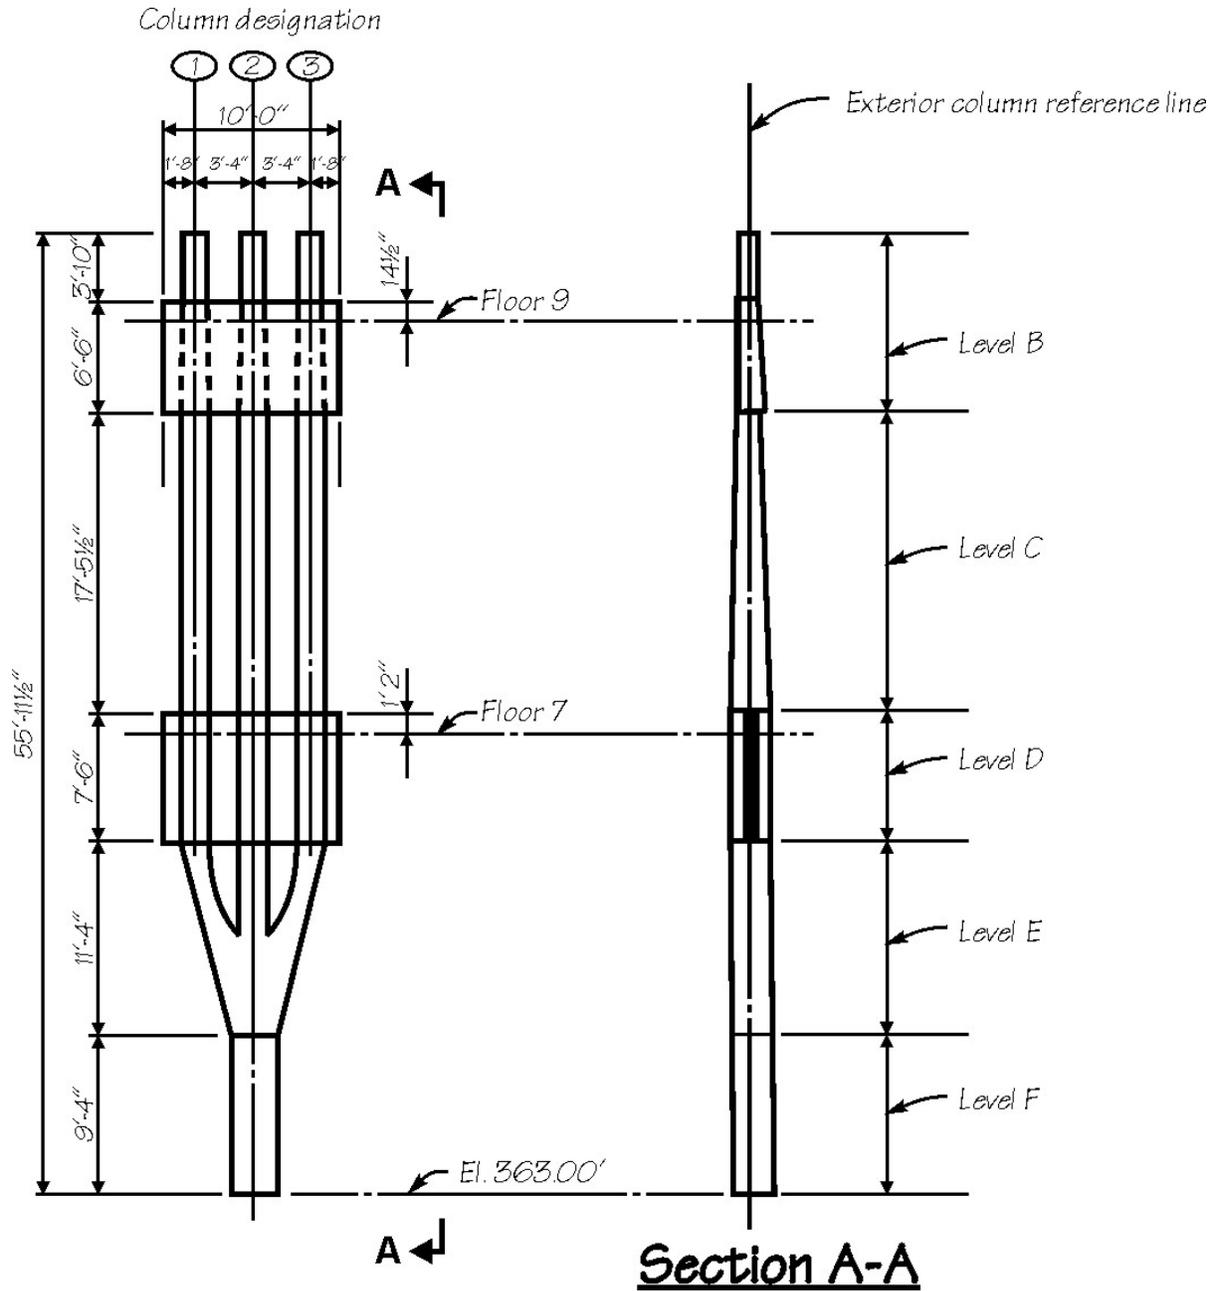
Figure 2-8. Typical WTC tower exterior wall tree panel.

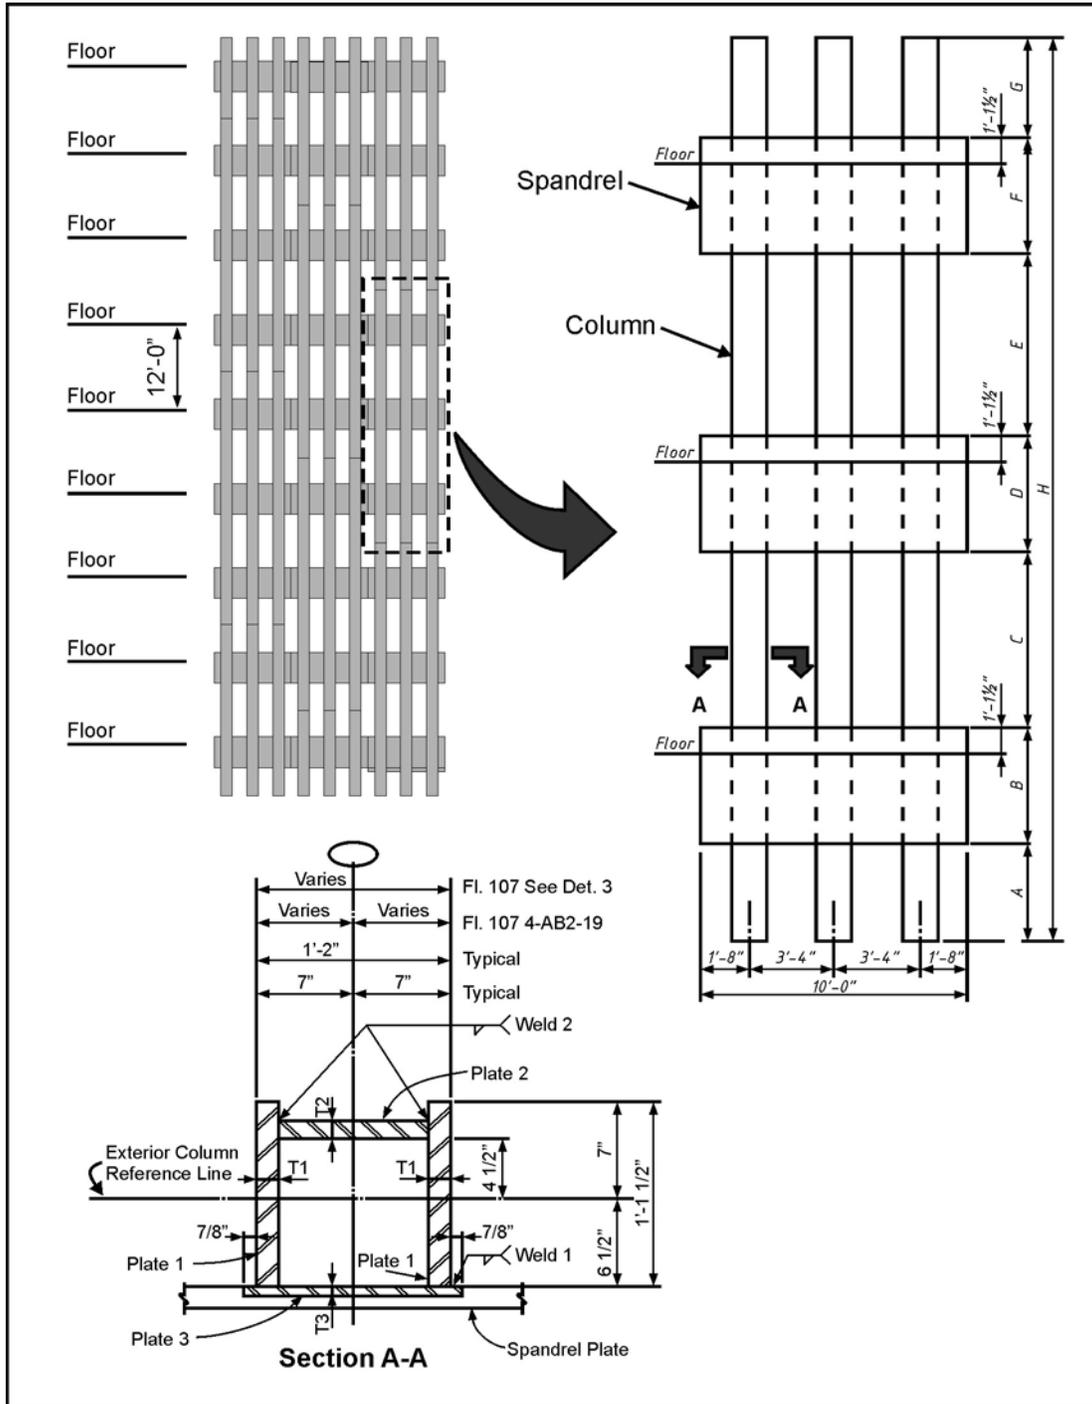
Figure 2-9. Typical WTC tower exterior wall panel.

Each tower had a square plan with the side dimension of approximately 207 ft. The exterior columns (perimeter columns) were placed with respect to the column reference lines, wherein the geometric centers of the exterior columns were offset from the column reference lines (see Sec. A-A, Fig. 2-9). The four reference lines surrounding the base of the tower established the footprint of the building. The column reference lines were spaced at 207 ft 2 in. The corners of the tower were chamfered 6 ft 11 in.

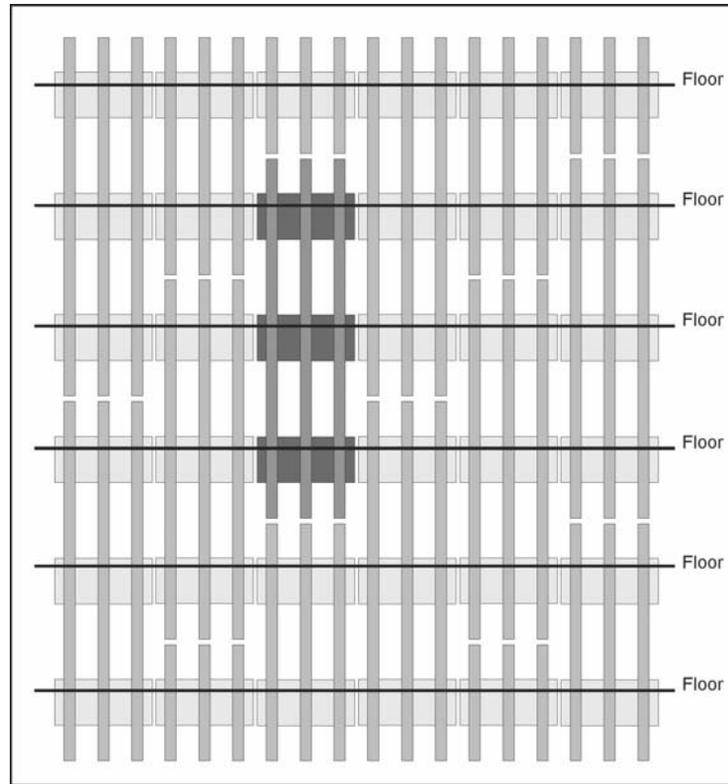
Figure 2–10. Elevation of exterior wall frame illustrating staggered panel construction.

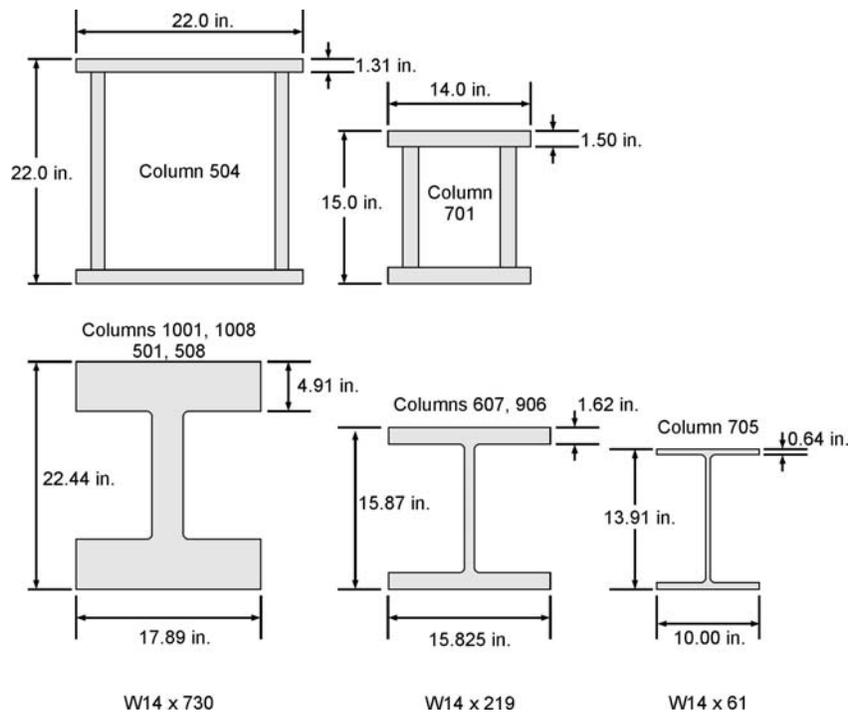
Figure 2–11. Typical welded box members and rolled shapes between floor 83 and floor 86.

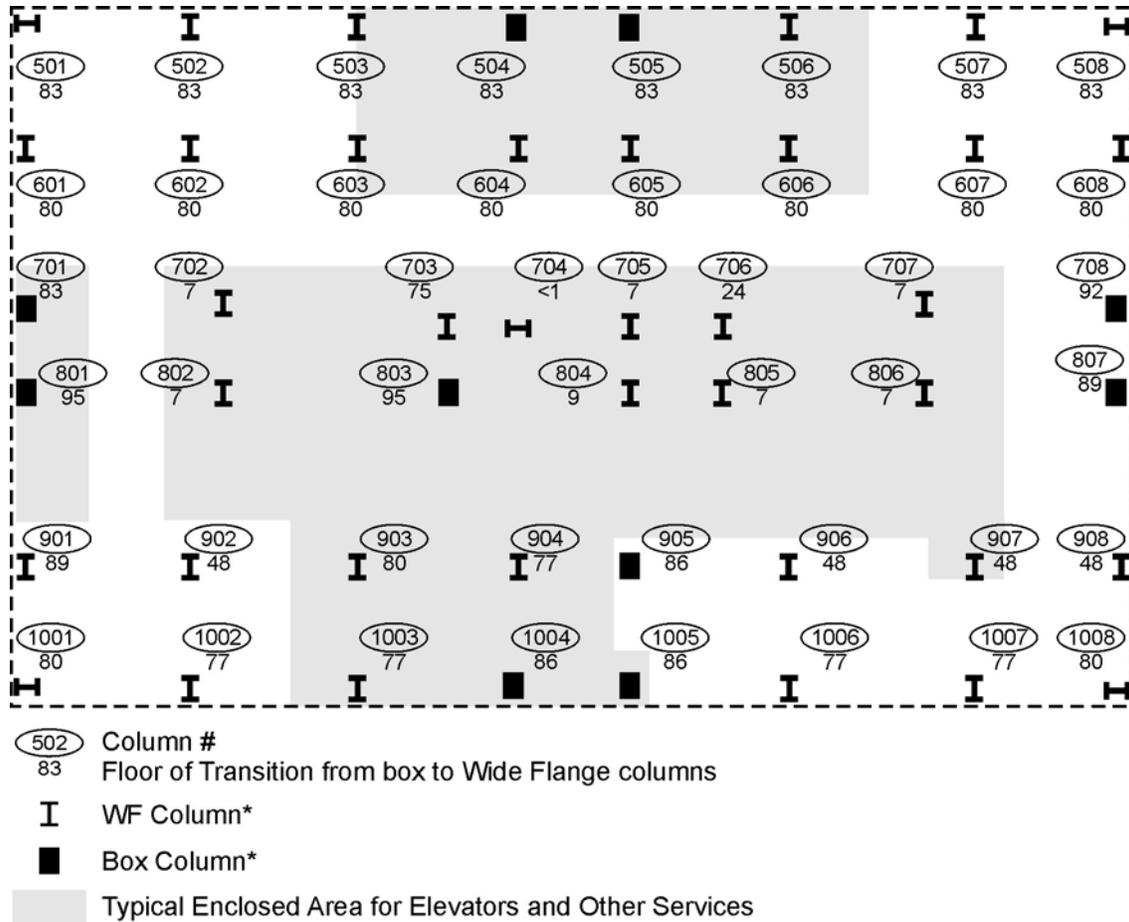
*Shape of Column at the 84th Floor

Figure 2–12. Core column layout in WTC towers.

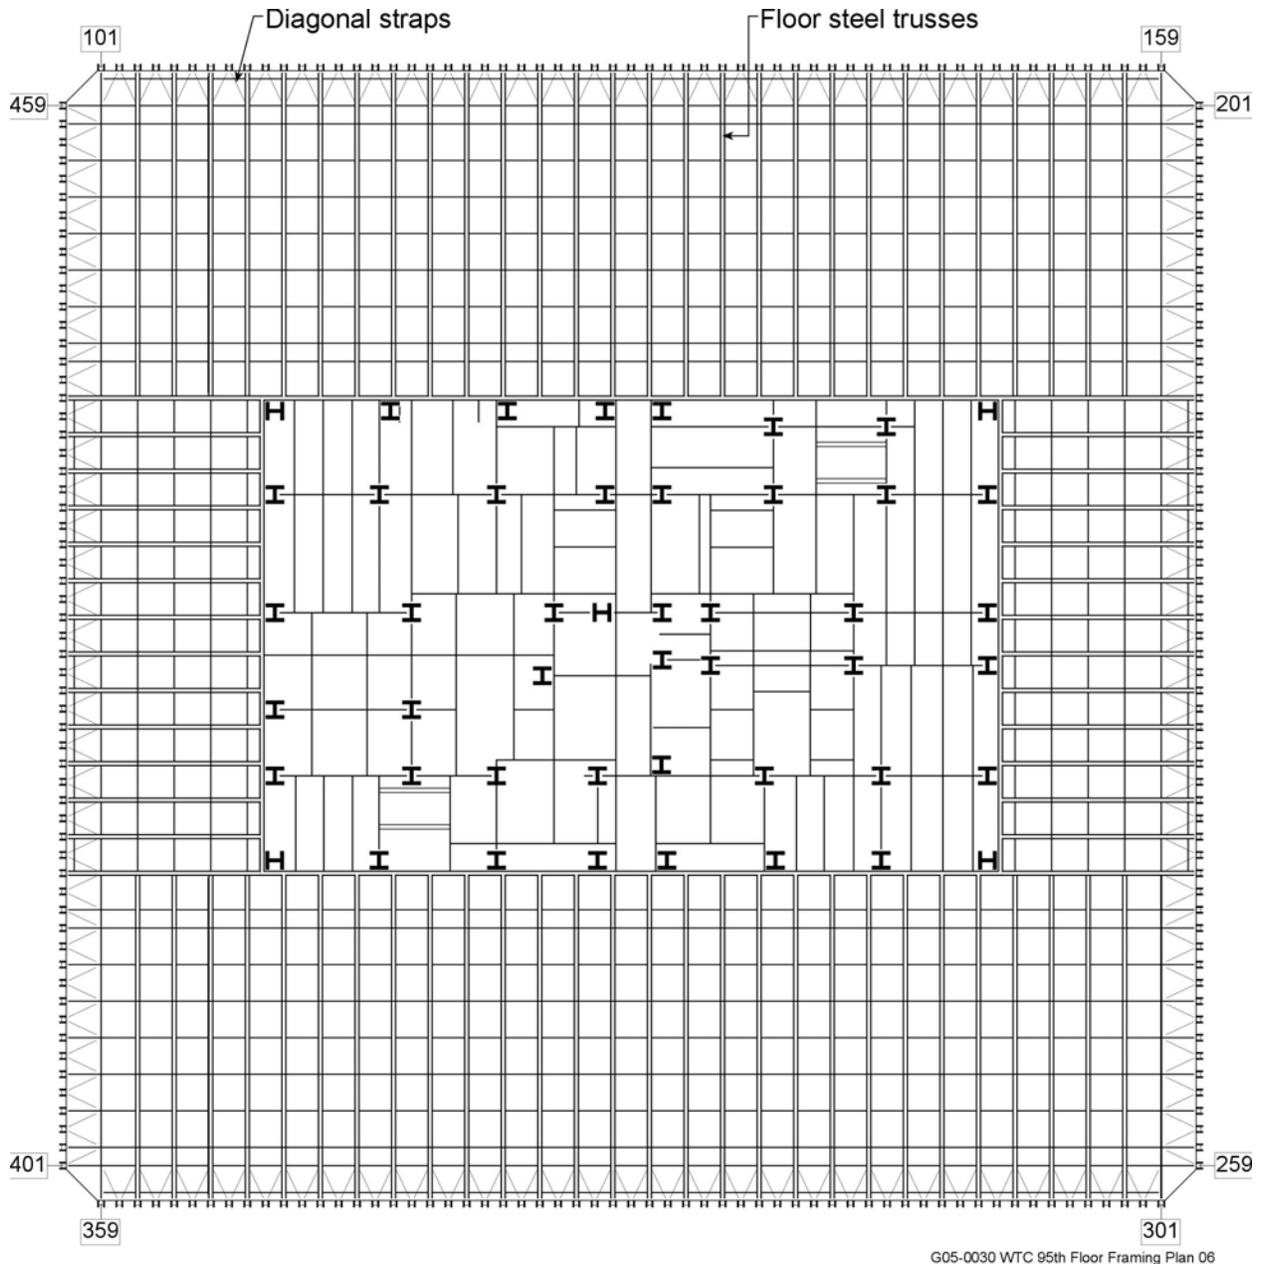
G05-0030 WTC 95th Floor Framing Plan 06

Figure 2-13. Typical floor-framing plan.

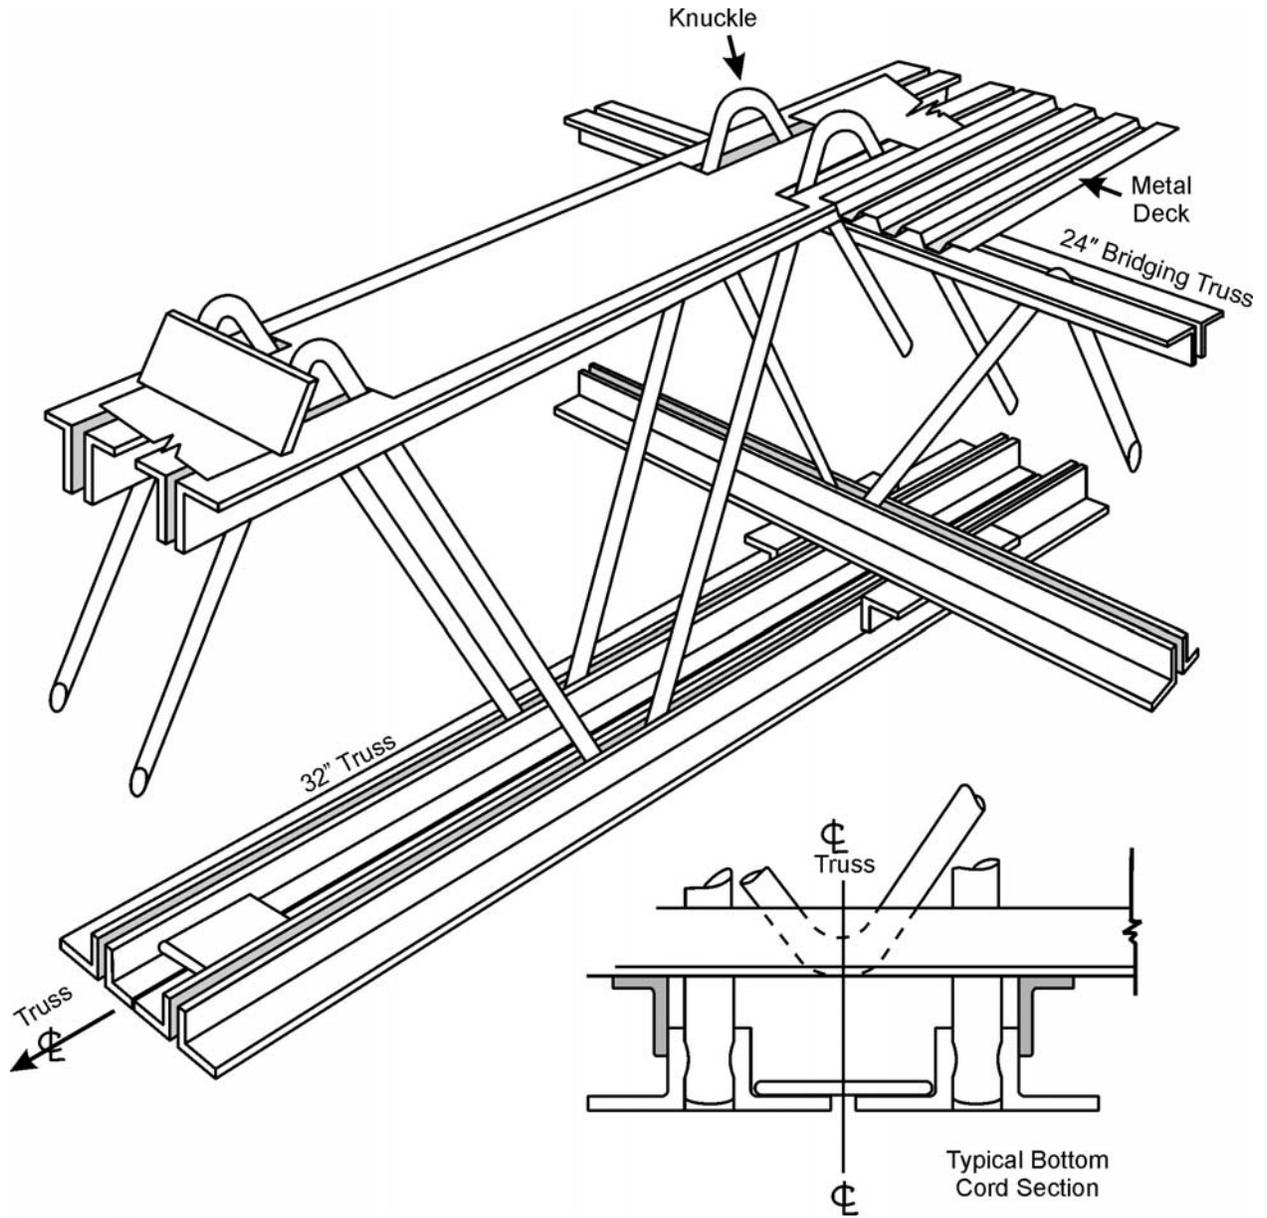
Figure 2-14. Prefabricated floor panel used in WTC 1 and WTC 2.

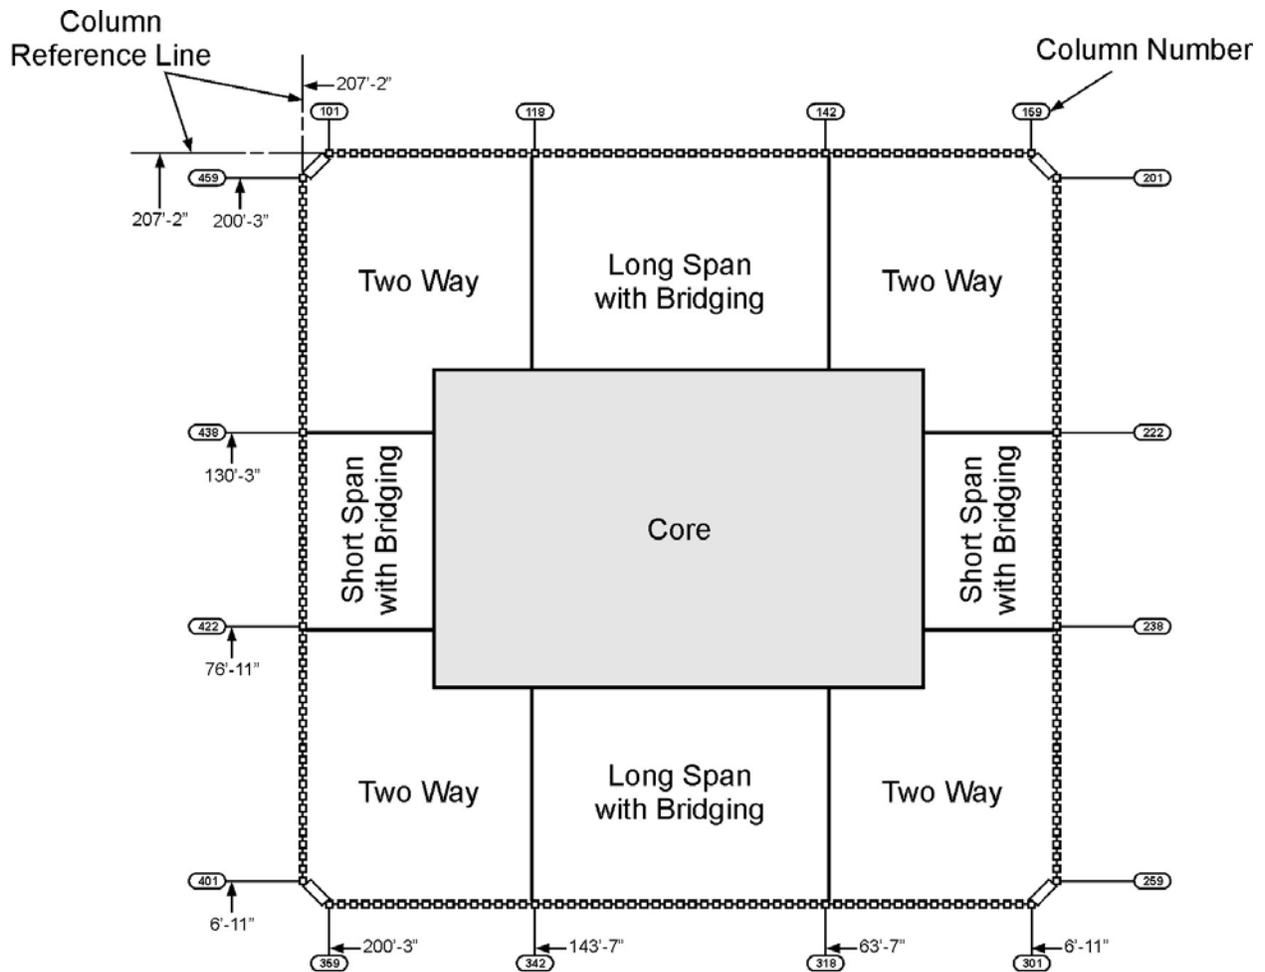
Figure 2-15. Typical WTC floor truss framing zone.

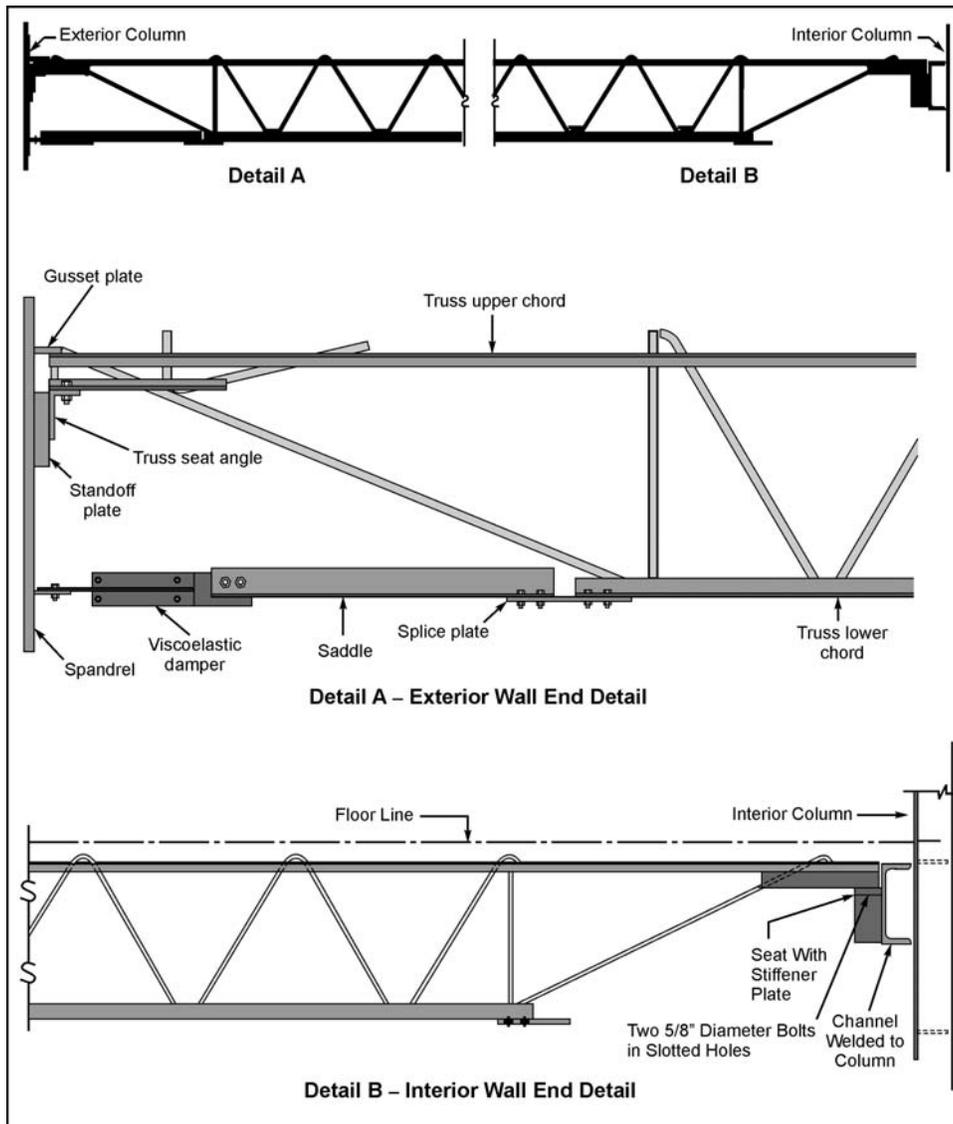
Figure 2-16. Position of viscoelastic damper.

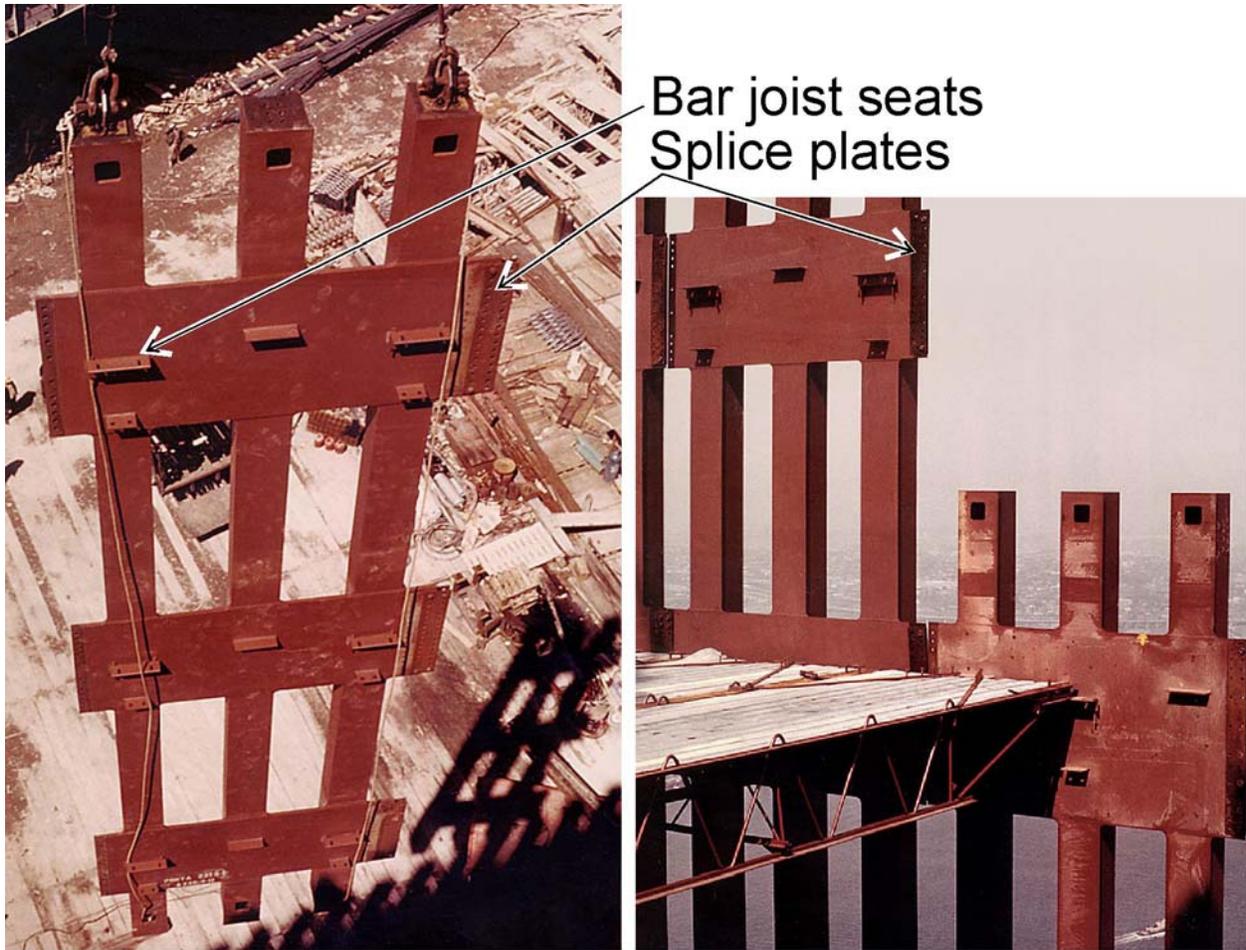
Figure 2–17. Perimeter column wall panel and steel truss floor modules.
