NIST NCSTAR 1-1

**Federal Building and Fire Safety Investigation of the
World Trade Center Disaster**

Design, Construction, and Maintenance of Structural and Life Safety Systems

H. S. Lew
Richard W. Bukowski
Nicholas J. Carino

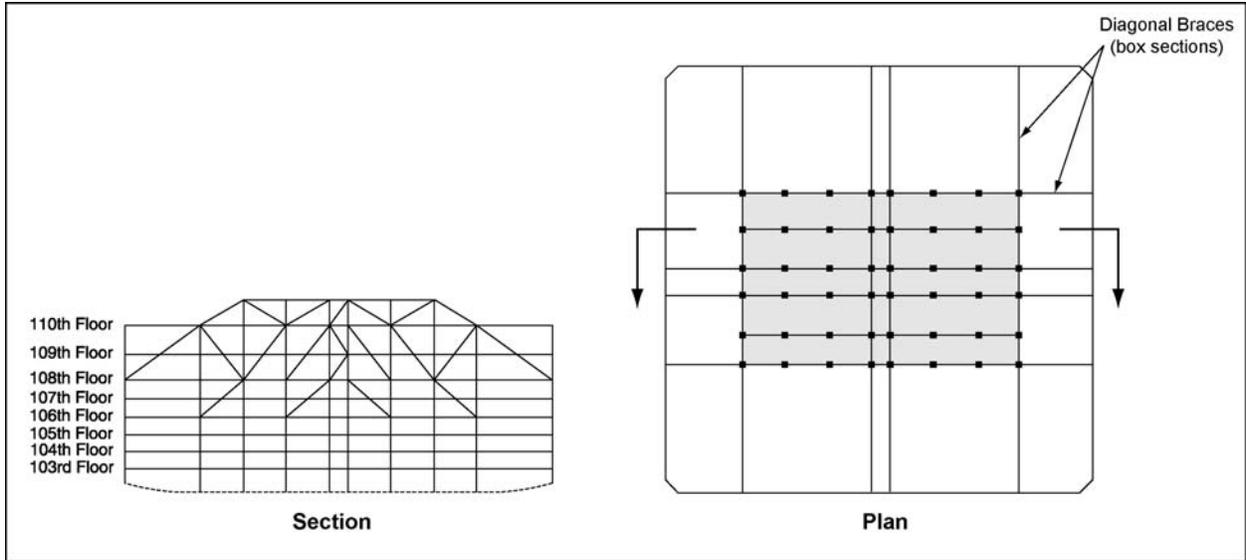
Figure 2-18. Hat truss.

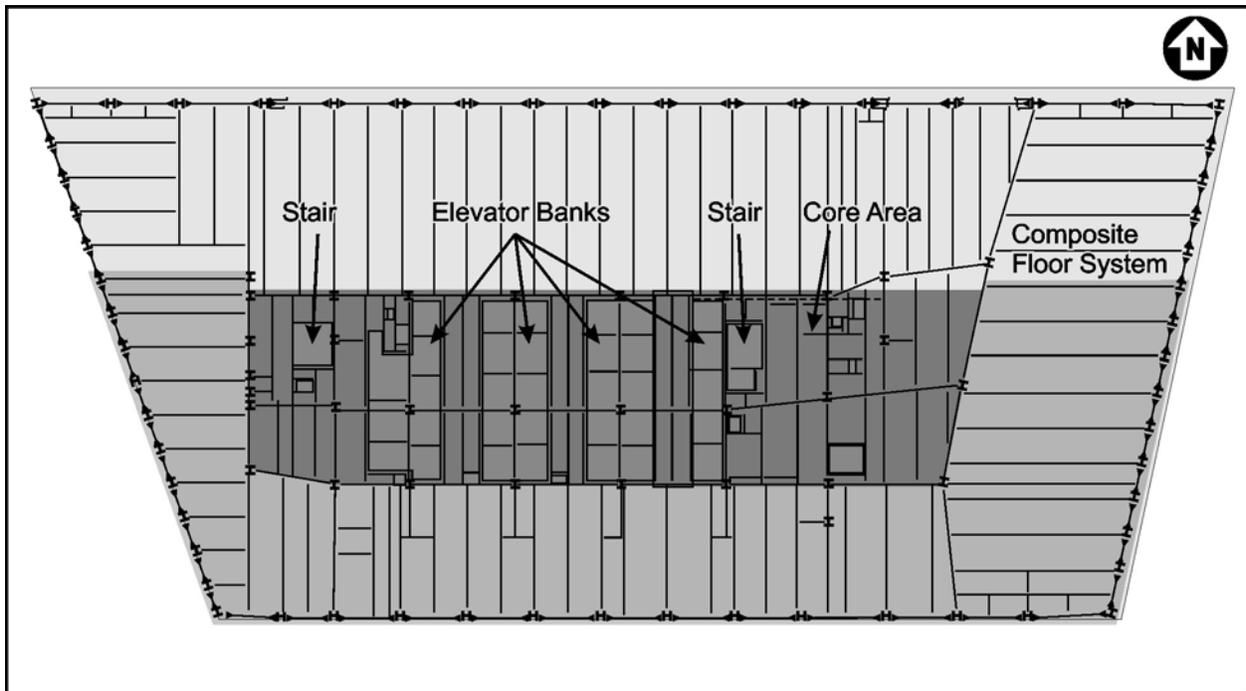
Figure 2-19. Typical floor plan above floor 7.

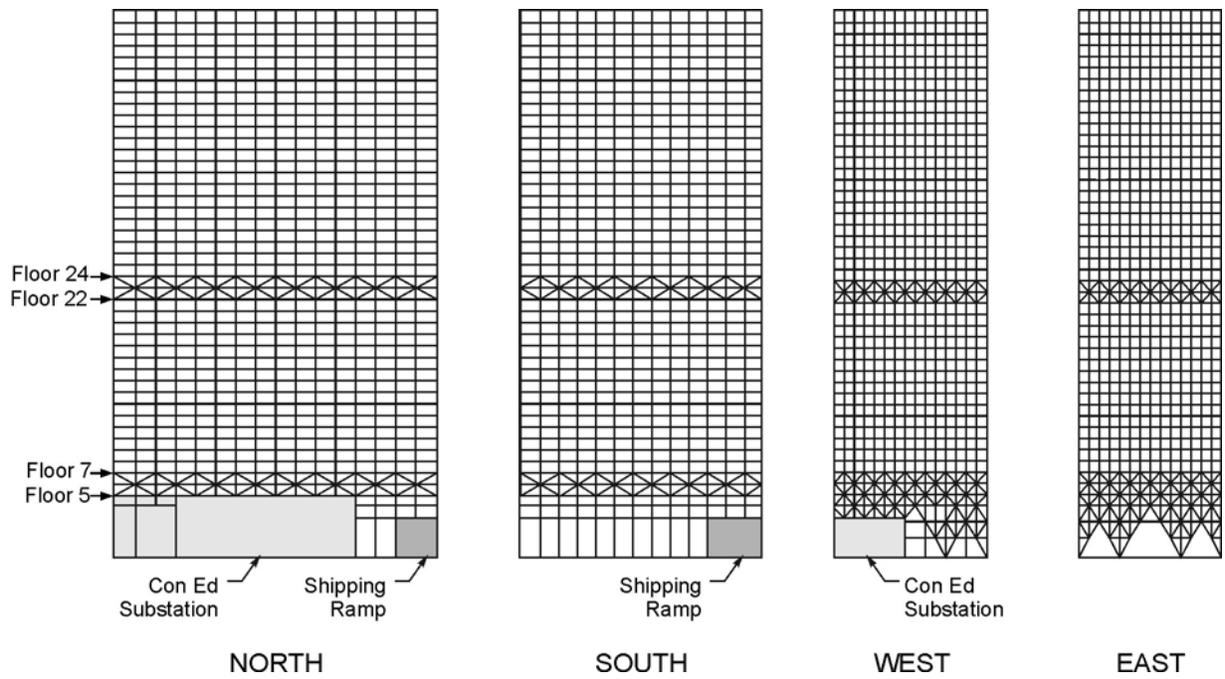
Figure 2-20. Perimeter elevations of WTC 7.

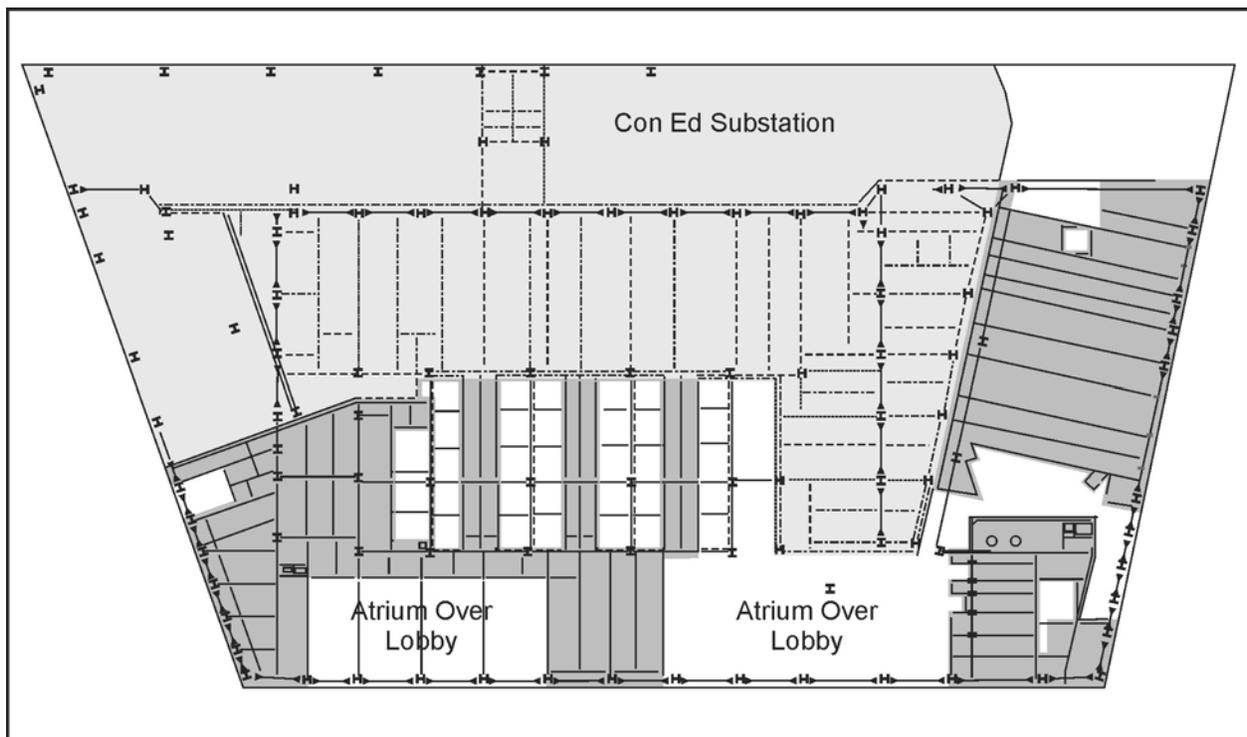
Figure 2-21. Floor 1 plan of WTC 7.

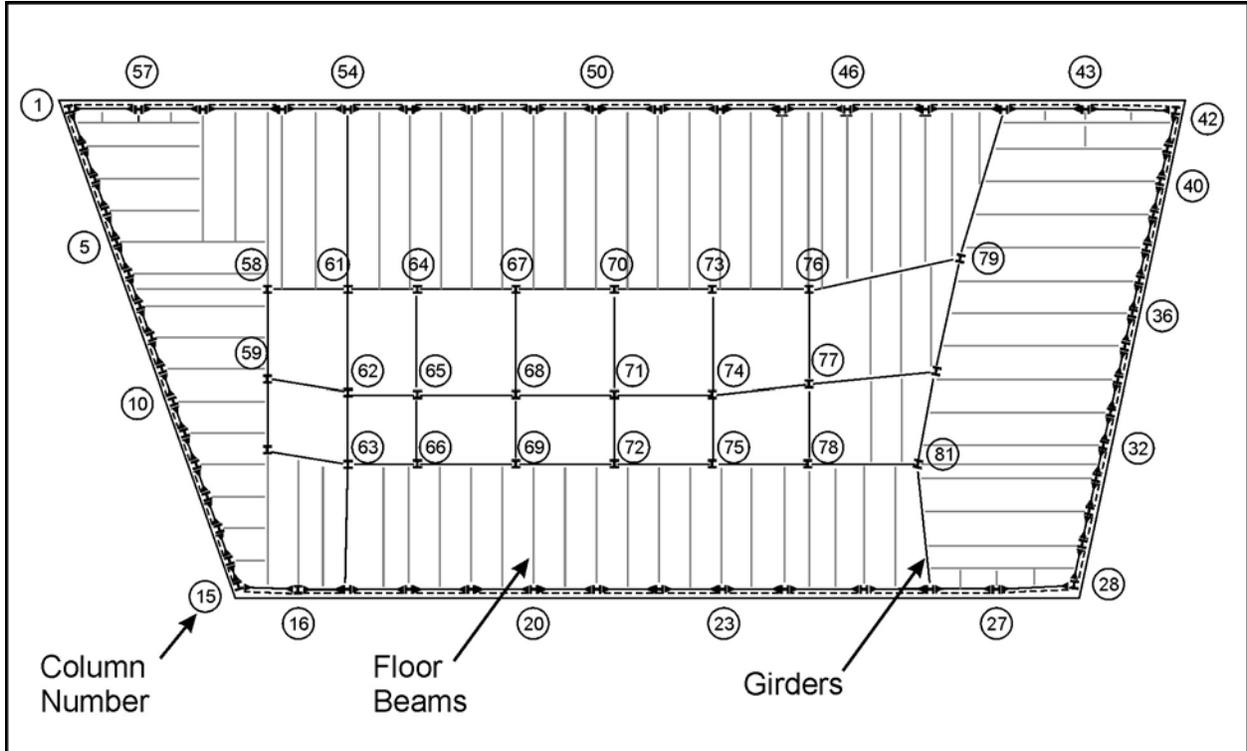
Figure 2-22. Framing plan for floor 8 through floor 45.

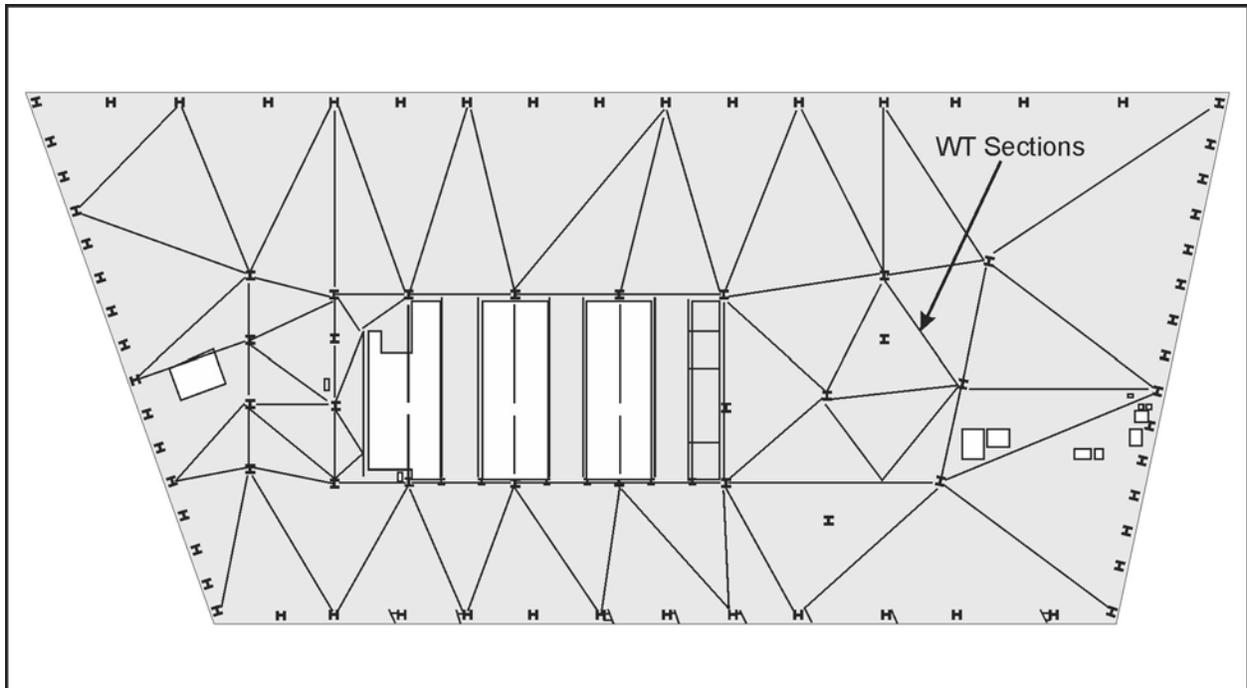
Figure 2-23. Floor 5 diaphragm plan.

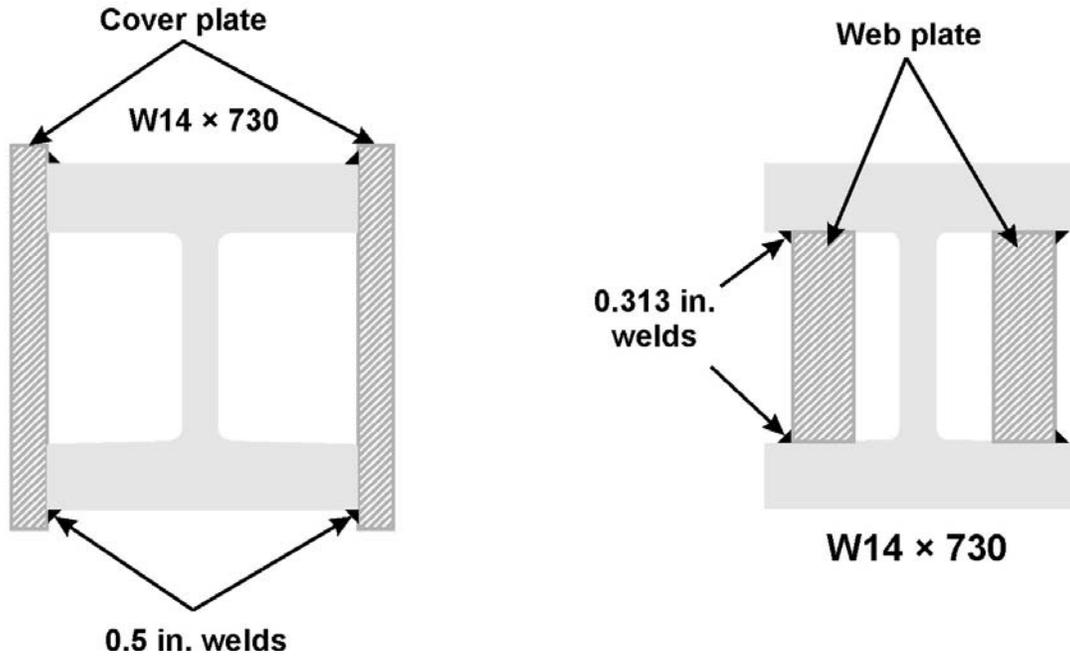
Figure 2-24. Typical built-up column details.

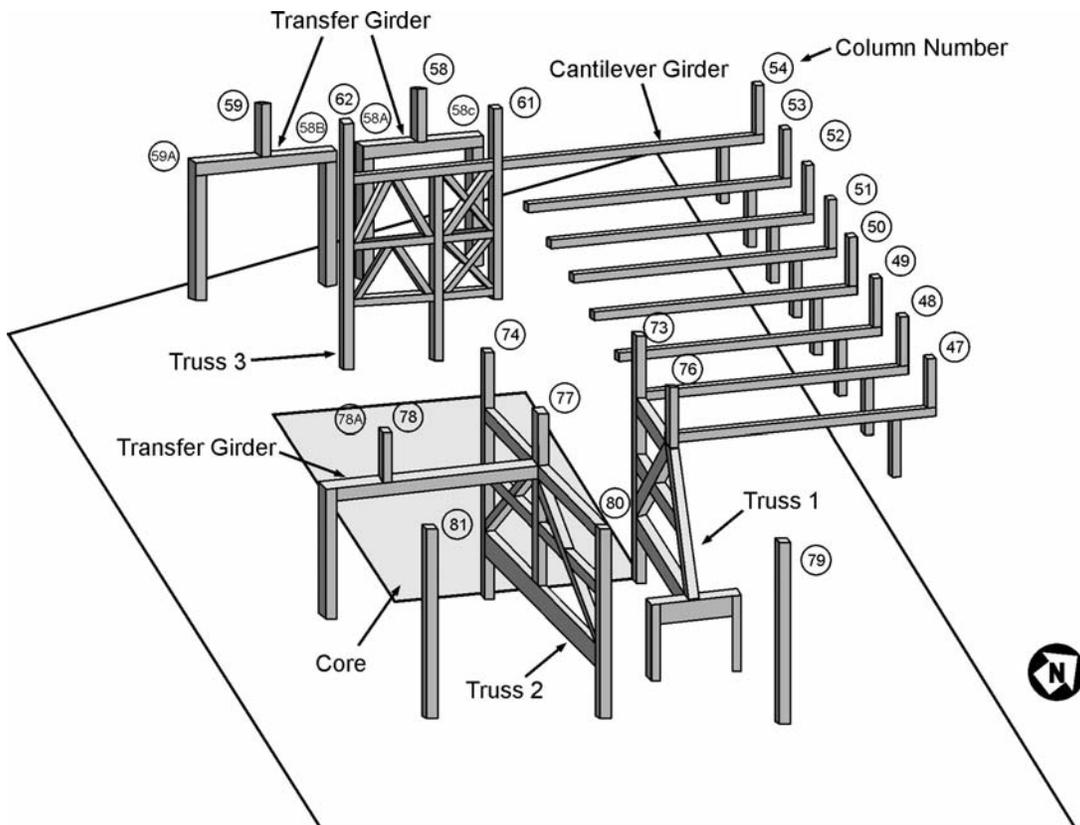
Figure 2-25. Schematic view of transfer trusses and girders between floors 5 and 7.

Columns 58, 59, and 78 were transferred by simply supported girders at floor 7. Column 78 was supported at floor 7 by a transfer girder that was supported at its north end by truss #2. Column 77 was also supported by truss #2. Truss #2 was supported by column 74 at its west end and by column 80 at its east end.

Column 61 was supported by truss #3. Truss #3 runs north-south and was supported by columns 62 and 61A. Truss #3 has a 10 ft cantilever span between column 61 and column 61A and an 18 ft back-span to column 62.

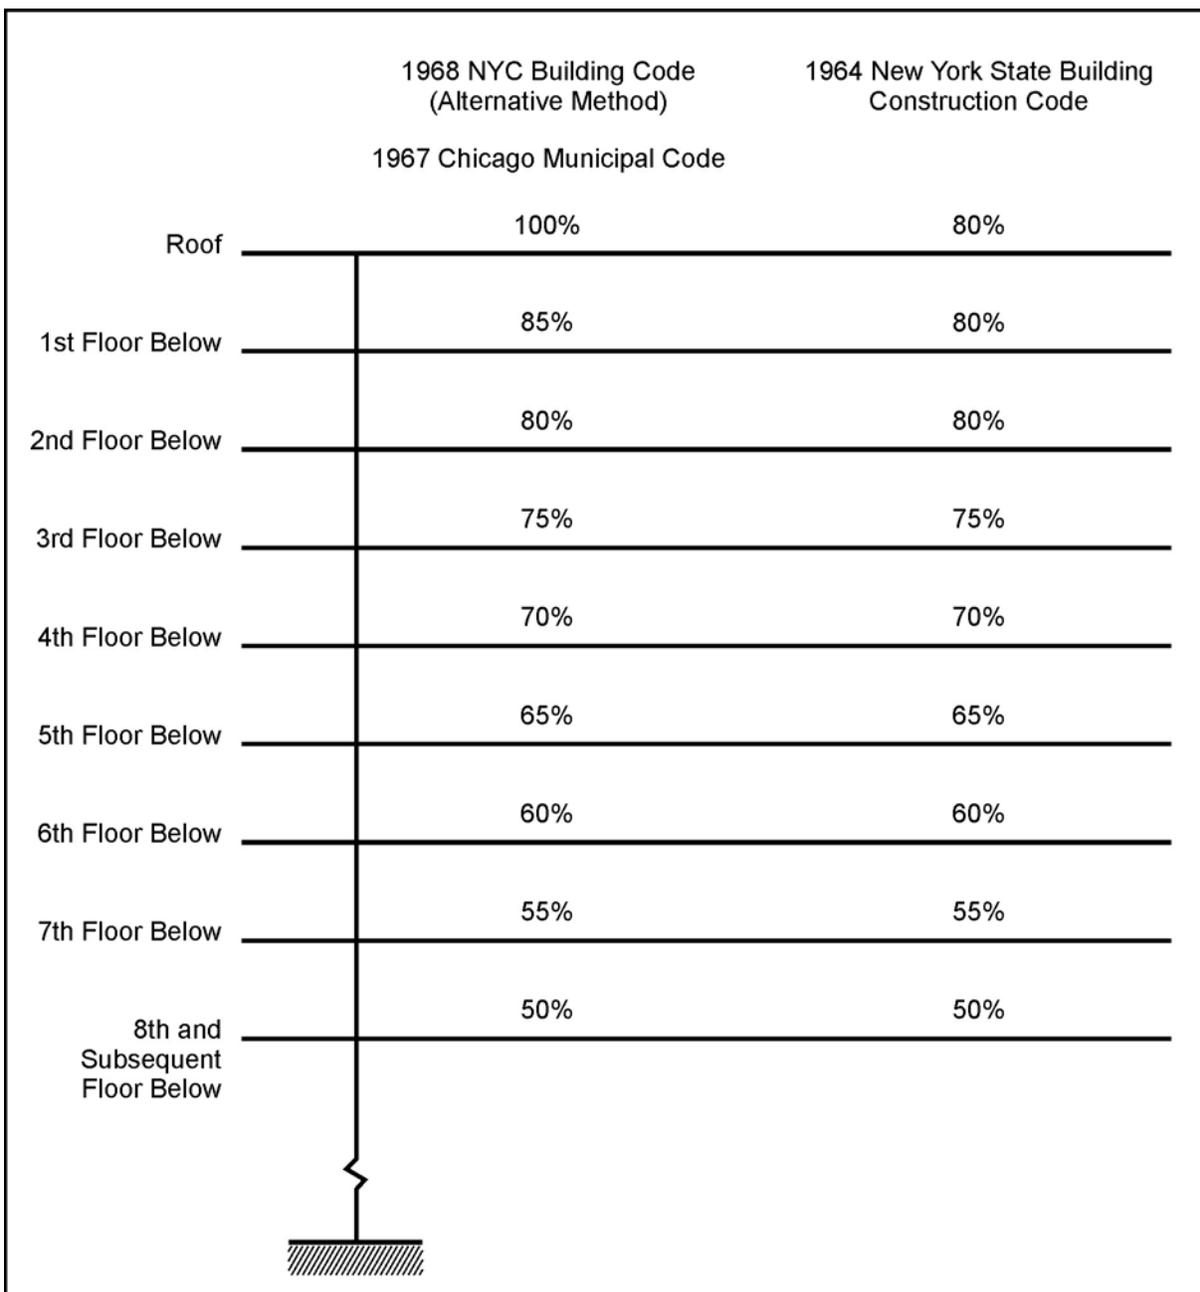
Figure 4–1. Reduced live load as a function of floor location based on the percentage method (for columns, walls, and piers).

Figure 4–1 compares the reduced live load for columns, walls, and piers on the basis of the percentage method for three of the codes. The permitted reductions are similar with the exception of the roof and top floor, where the 1968 NYC Building Code and the 1967 Municipal Code of Chicago are more conservative (less reduction permitted) than the 1964 New York State Building Construction Code.

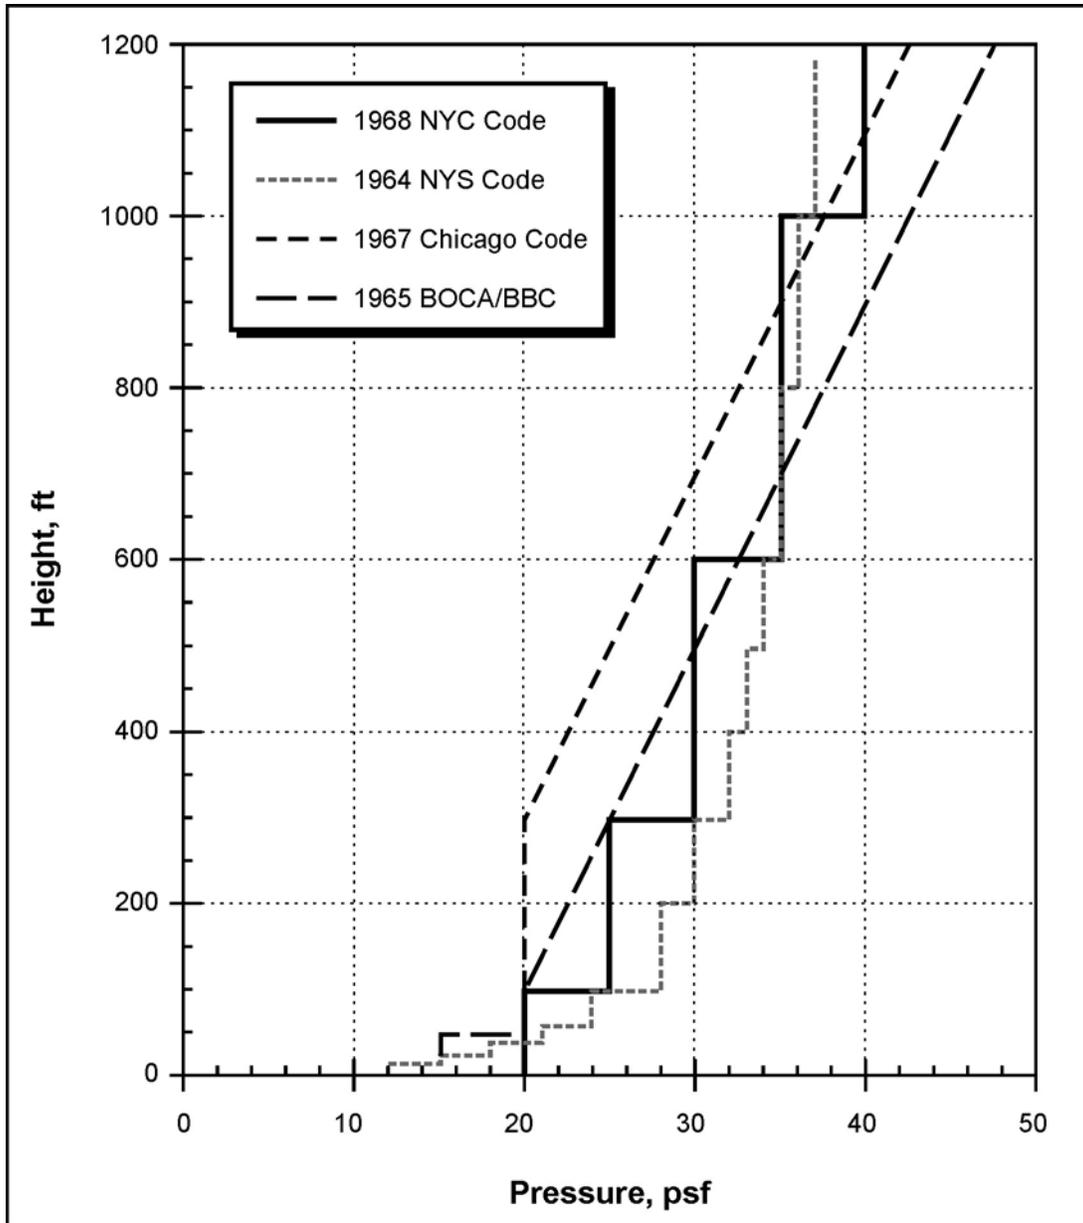
Figure 4-2. Wind load pressure versus elevation.

The pressure due to wind varies with the square of the wind speed, and wind speed increases with height. Thus building codes specify minimum design wind pressures that increase with elevation. The variations of pressure with height, however, are not the same among the building codes compared. Figure 4–2 compares the specified wind pressure versus height relationships for the four selected codes. Several observations are noted:

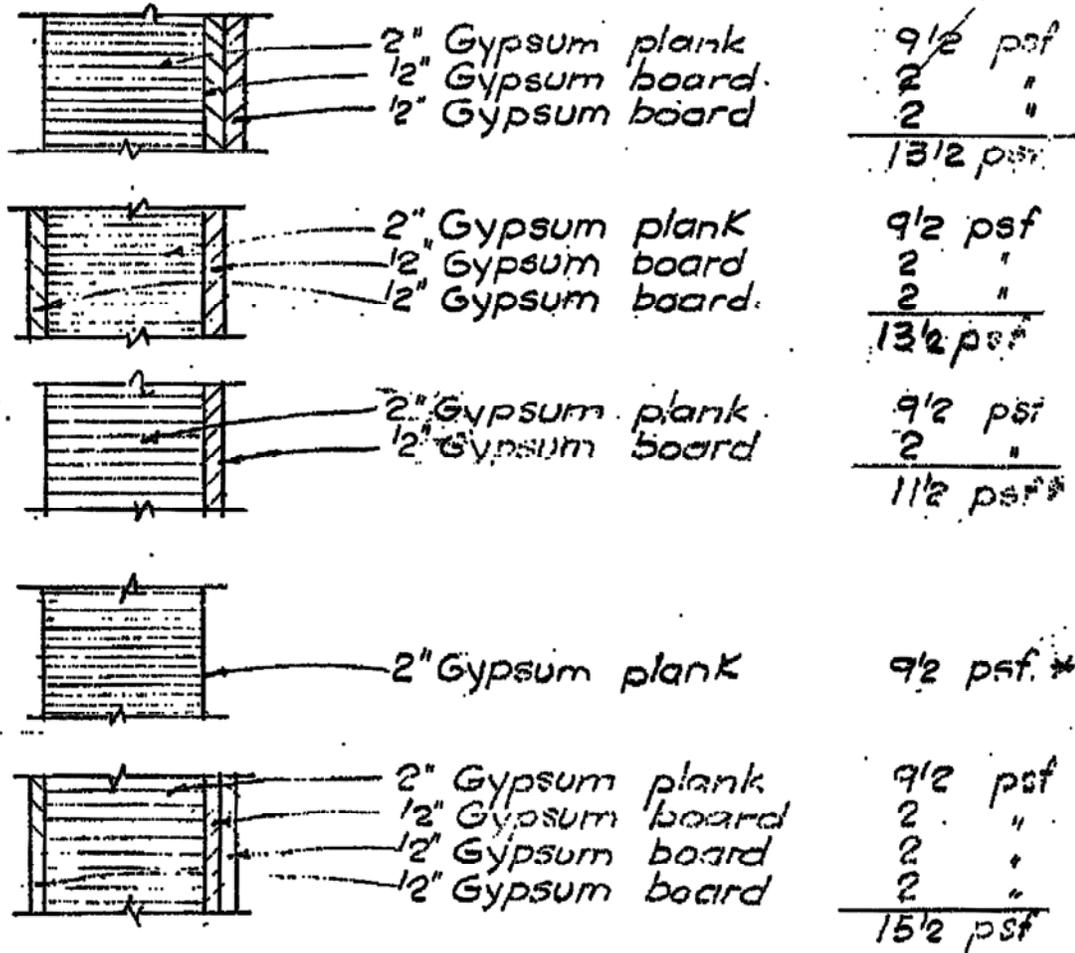
**CRITERIA FOR DESIGN -
FLOOR INSIDE OF CORE -
PARTITION WEIGHT
2" GYPSUM PLANK**

* Plus Arch. Finish
Ceramic Tiles (8' high only) 15 psf

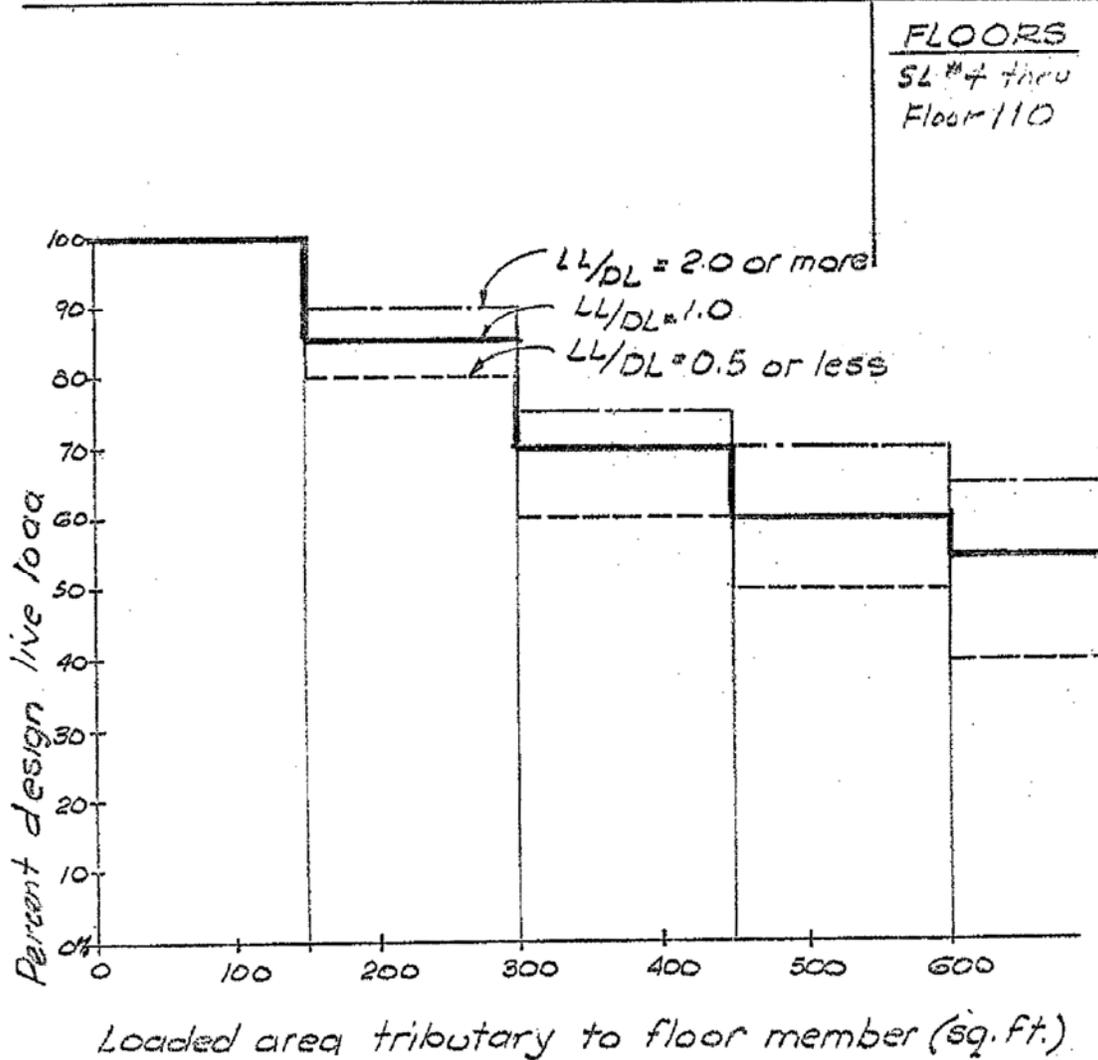
CRITERIA FOR DESIGN - DESIGN LOAD
FLOOR INSIDE OF CORE
 (EXCEPT TENANT AREAS)
LIVE LOAD REDUCTION

Figure 5-11. Live-load reduction criteria for floors inside of core, except for tenant areas.

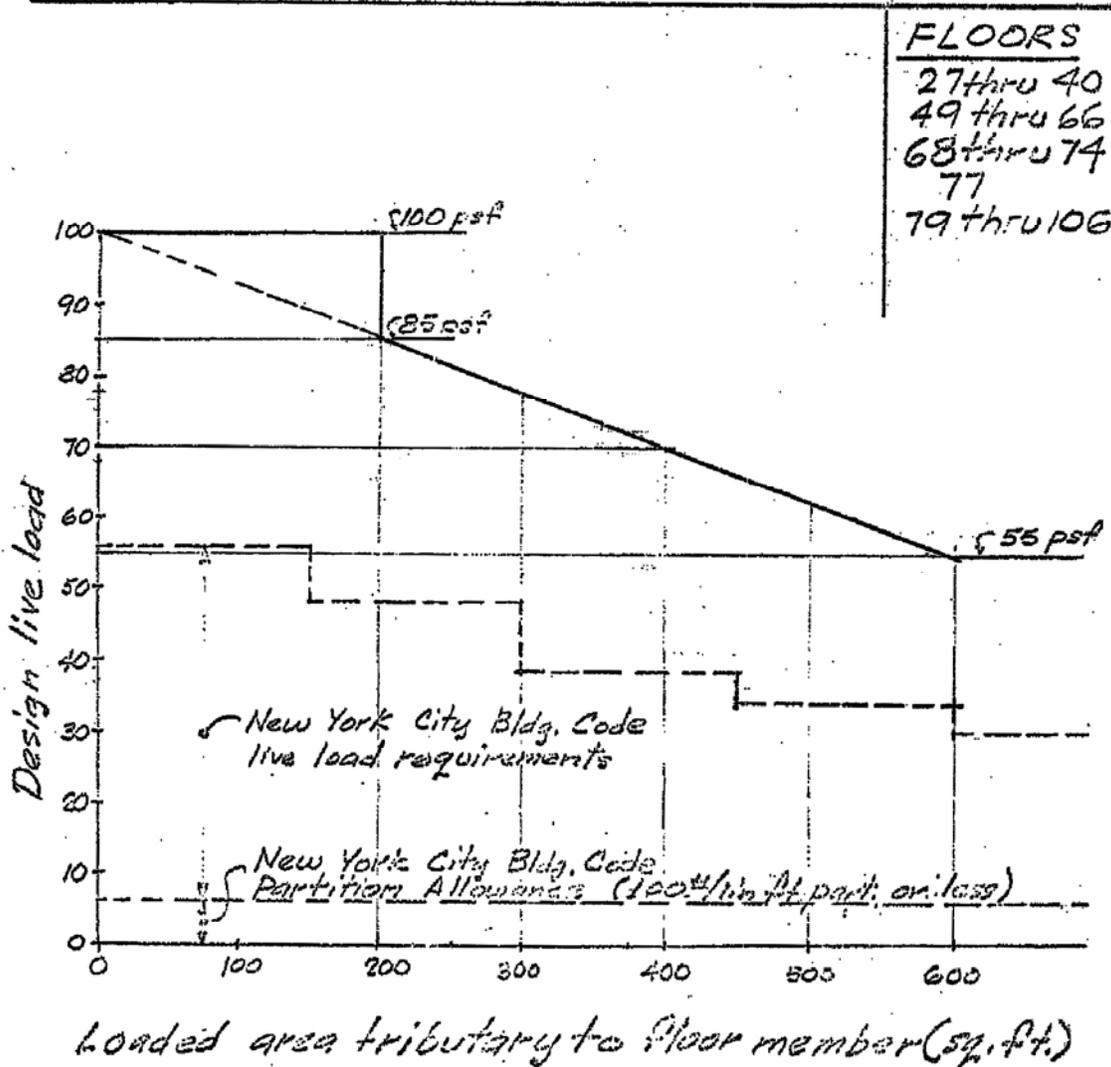
CRITERIA FOR DESIGN-DESIGN LOAD FLOOR INSIDE OF CORE TENANT SPACE LIVE LOAD REDUCTION

Figure 5-12. Live-load reduction criteria for floors inside of core, tenant areas.

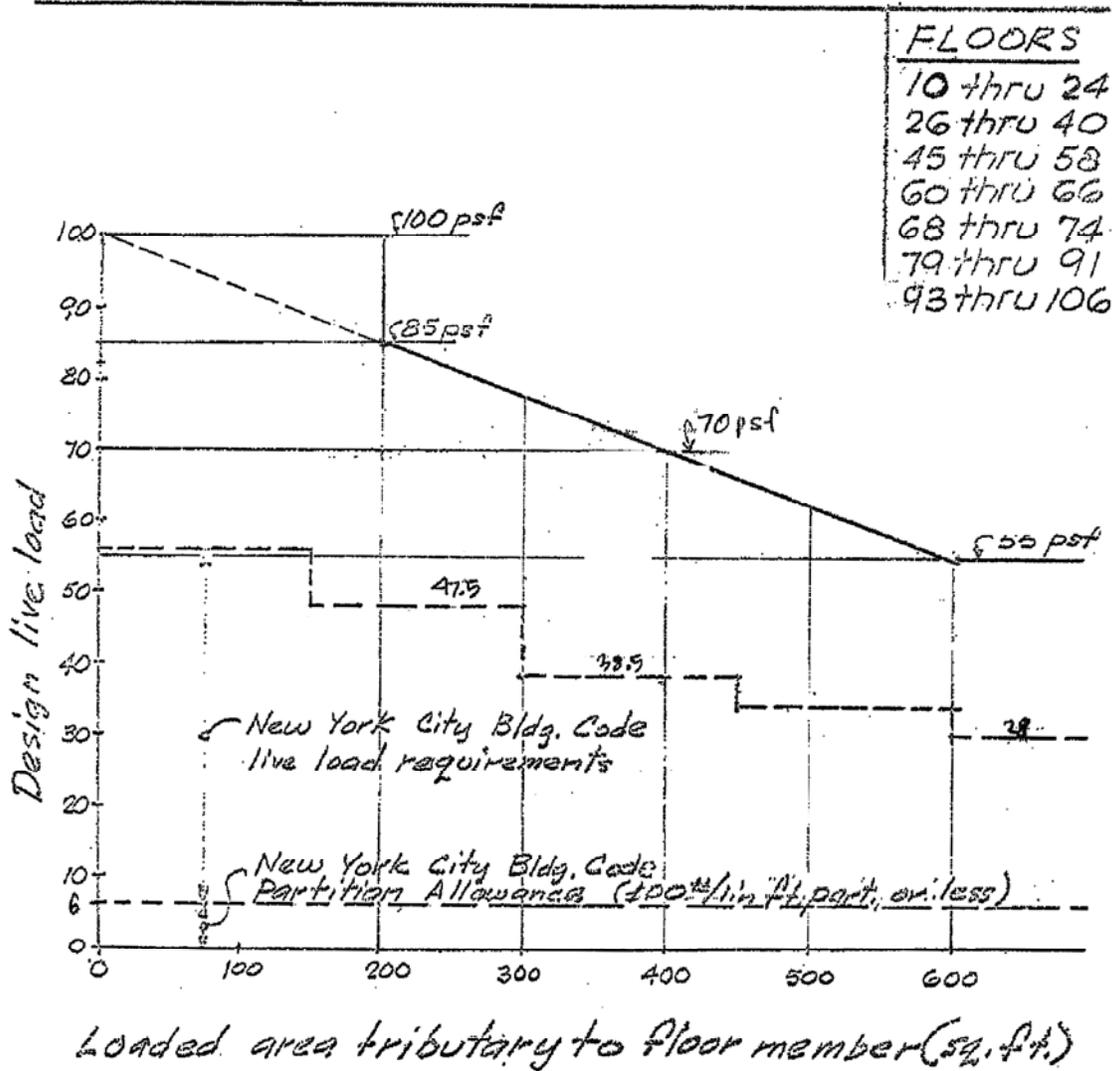
CRITERIA FOR DESIGN-DESIGN LOAD
 FLOOR OUTSIDE OF CORE
 TENANT AREA
 LIVE LOAD REDUCTION

Figure 5-13. Live-load reduction criteria for floors outside of core.

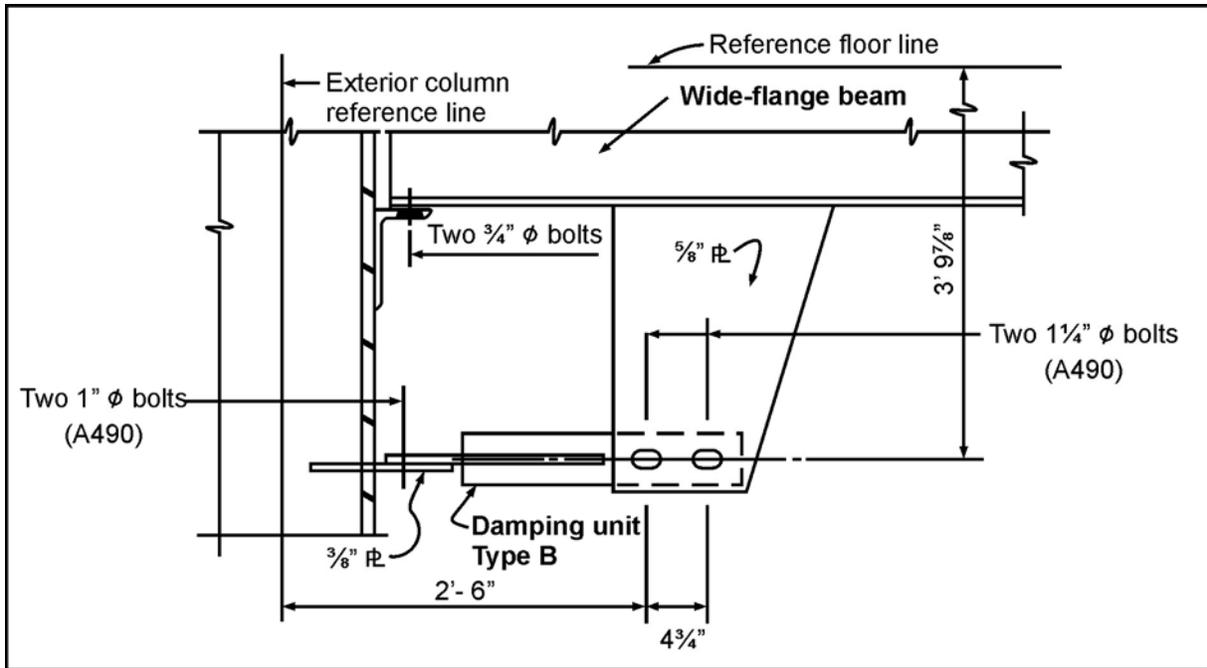
Figure 6–1. Wide-flange beam member with Type B damping unit.

floors 7, 9, 41, 43, 75, 77, and 107). This type of damping unit was located between the bottom flanges of the floor beams and the outside wall, as shown in Fig. 6–1. The use of dampers increased significantly the critical damping ratio of the towers. The reduction of oscillation during strong winds was estimated to be about 12 percent of the amplitudes without dampers. Expected time period during which building oscillation might be perceived by the occupants was estimated to be reduced by about 34 percent (SHCR 1967).

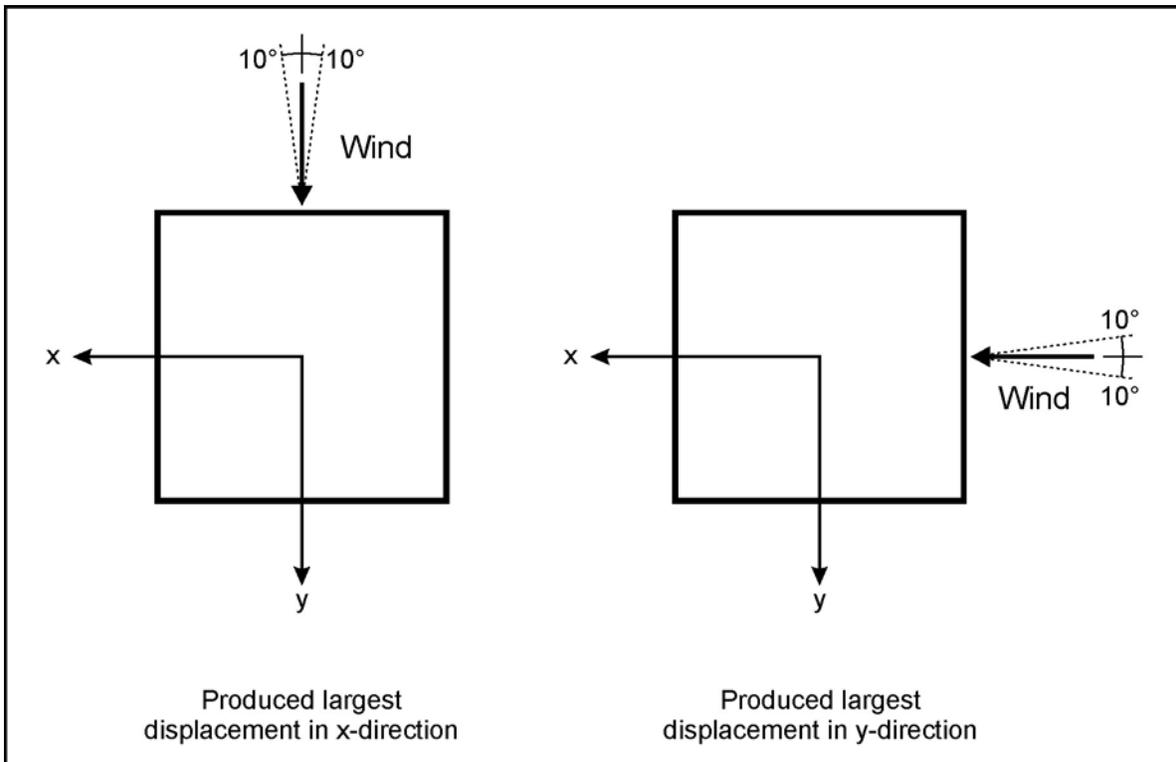
Figure 6–2. Wind directions that produced the greatest displacements at the top of the tower during the wind tunnel tests.

The tests also indicated that large lateral deflections at the top of the building occurred for wind velocities in the range of 125 mph to 130 mph for angles of incidence within approximately 10 degrees of normal (see Fig. 6–2). The results are plotted in Figs. 19 and 20 in WSHJ (1965c). The deflections showed a consistent dependence on the degree of damping and were shown to be inversely proportional to the damping ratio.

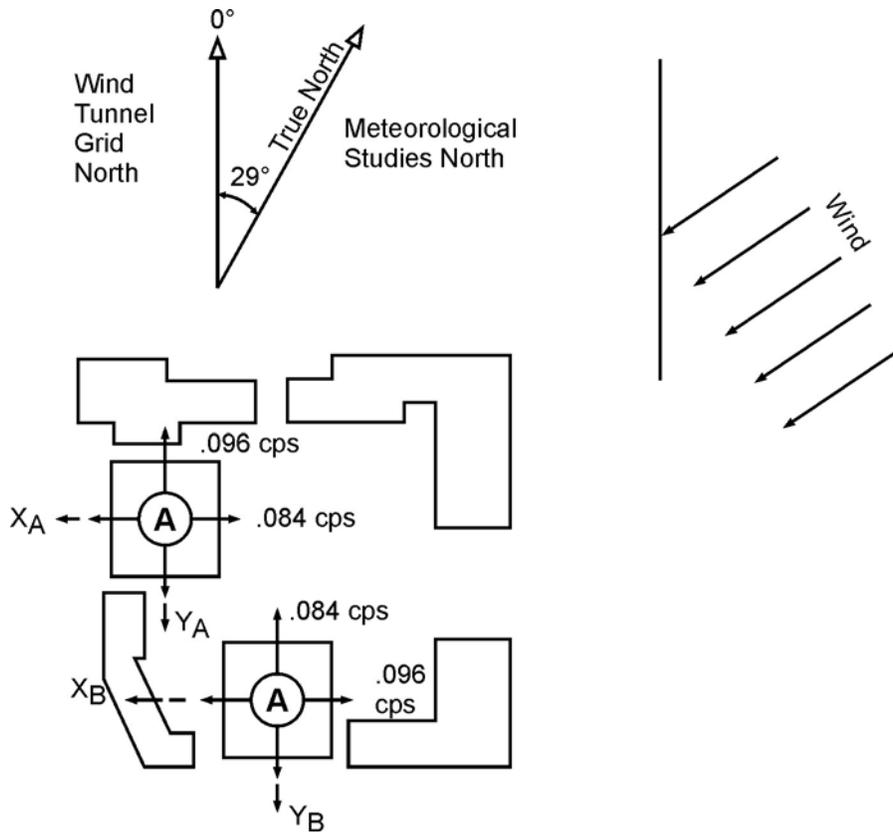
Figure 6–3. Definition of grid system and tower configurations for wind tunnel tests at Colorado State University.

Tests were also conducted at CSU using the southeast and southwest models of lower Manhattan subjected to turbulent flow conditions (WSHJ 1966c).³⁰ Both single-tower and twin-tower configurations were considered. Definition of the grid system and tower configurations used in the tests is illustrated in Fig. 6–3. Also shown in the figure are the experimentally determined fundamental frequencies of the towers in the two principal directions in cycles per second (cps). Included in these tests were measurements of the maximum deflections at the tops of the towers (aeroelastic tests; wood models) and pressures along the height of the towers (thermoplastic models).

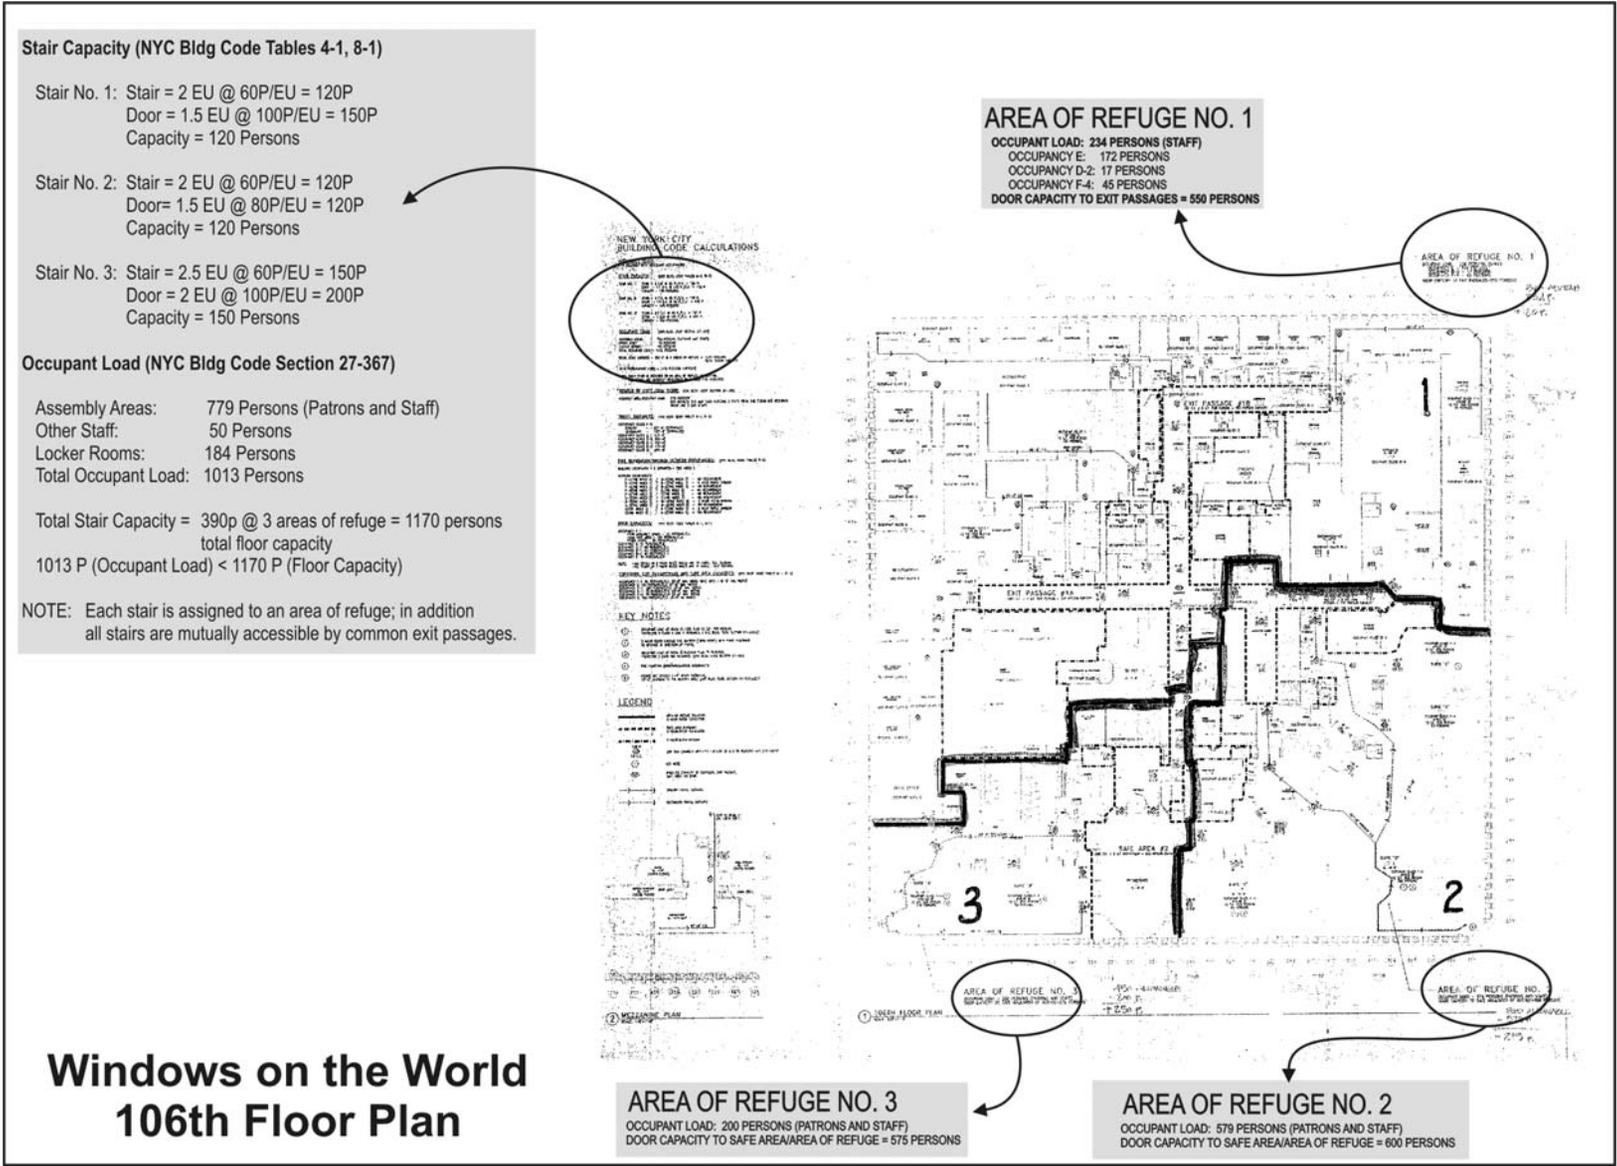
Figure 10–1. Arrangement of floor 106 egress.

Attached to (and referenced in) the letter were two plans entitled “106th Floor Egress Plan” and “107th Floor Egress Plan” that detailed the arrangement. The 2 h separation walls snaked across the floors and were not aligned on the two floors. Some areas that needed to remain open to free passage were protected with so-called Won-doors (accordion doors that are fire rated and are closed automatically on activation of the fire alarm system). Details of the egress system design calculations and corresponding NYC Building Code requirements are included on the plans to demonstrate that they met code requirements. Figures 10–1 and 10–2 are the actual attachments to the letter which included both diagrams of the arrangement of the rated partitions and the calculation of occupant loads for the 106th and 107th floors, respectively. Important details of the calculations have been enlarged by NIST.

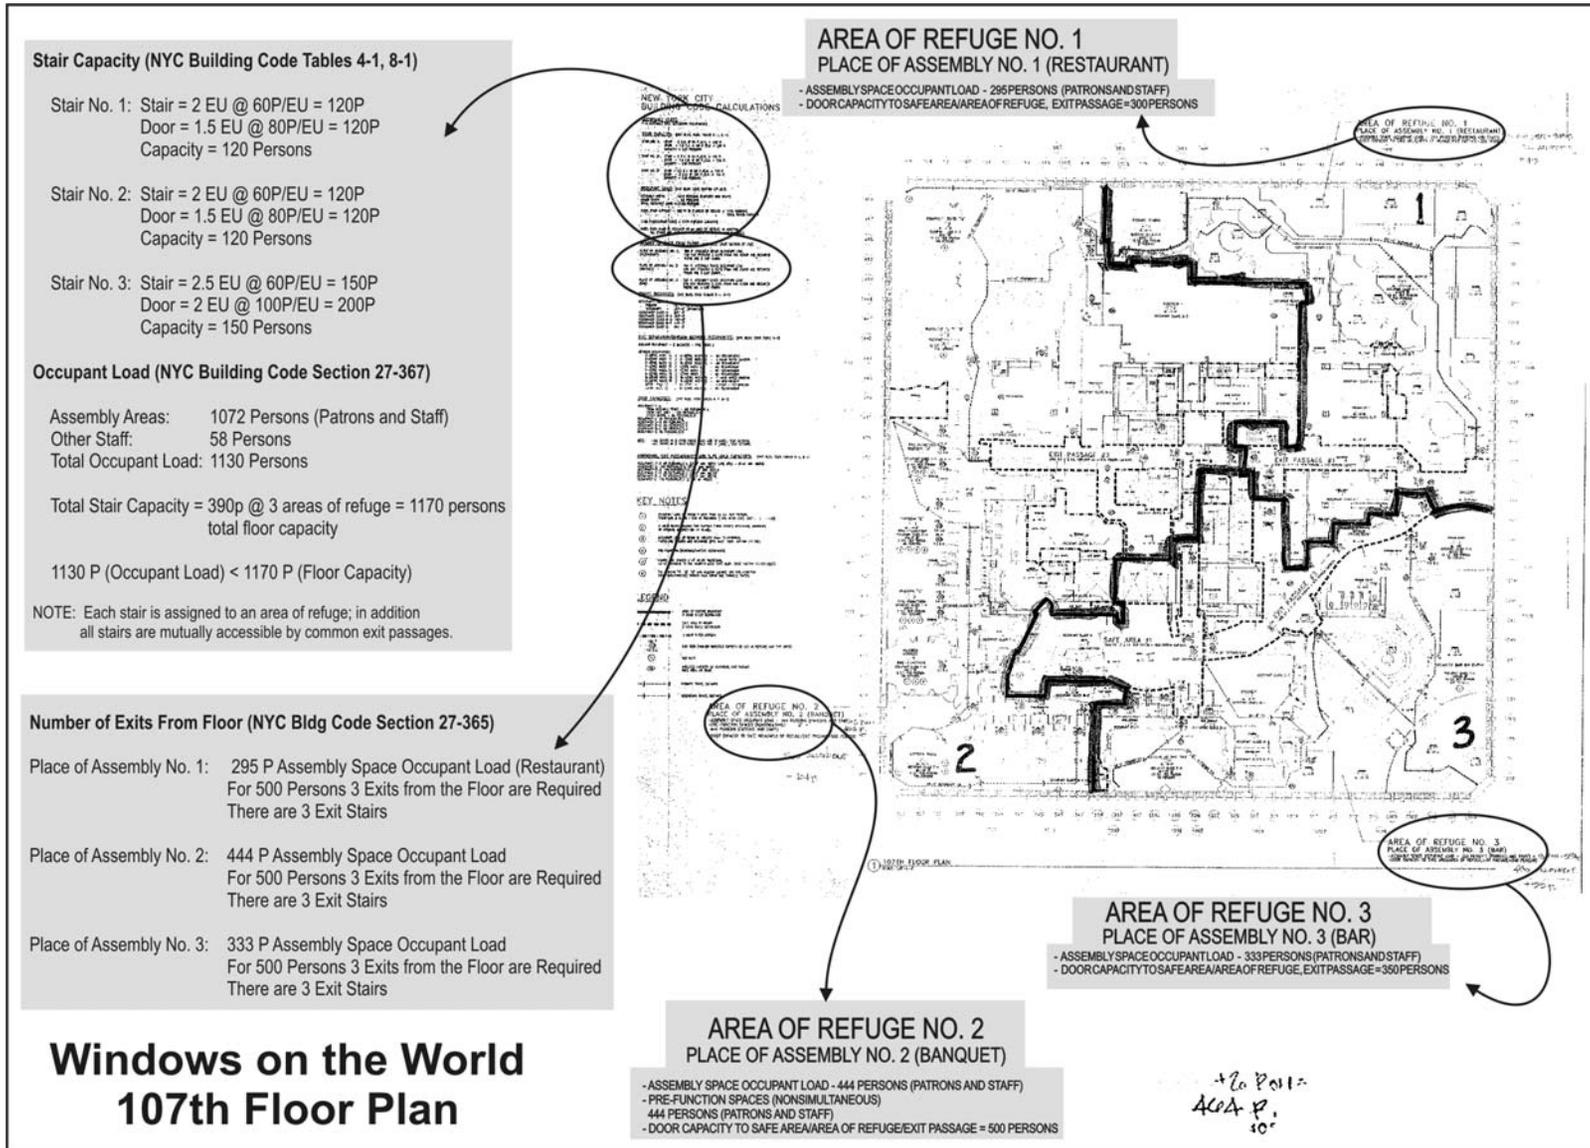
Figure 10-2. Arrangement of floor 107 egress.

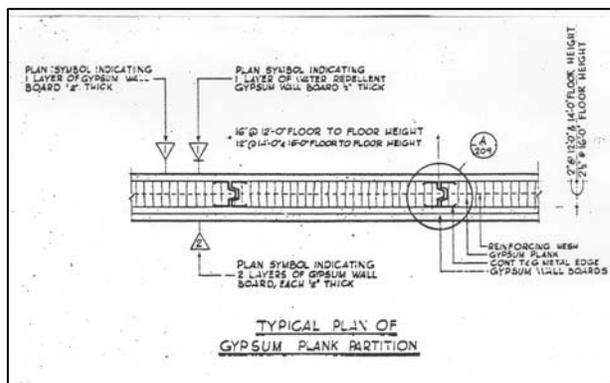
Figure 10–3. Gypsum plank shaft partition.

Vertical shafts surrounding stairs, mechanical shafts (carrying supply and return air), elevator hoistways, and utility shafts were all contained within the building core, and were enclosed by gypsum planking similar to fire separations commonly used today in single-family attached housing. While similar to other gypsum shaft wall systems and firewalls, this system was unique and innovative in that it eliminated the need for any framing. The gypsum planks were solid 2 in. thick (2½ in. on floors with 16 ft ceiling heights) and 16 in. wide, with metal tongue or groove channels attached to the long sides that served as wall studs (see Fig. 10–3). Where planks were cut to a narrower width, the cut edge was covered with a 2 in. by 2 in. metal C channel fastened with drywall screws at the top and bottom. Each plank had a mesh layer at its mid thickness and were likely custom fabricated for this job as NIST found no mention of similar products in gypsum industry literature of the time or since. Planks were provided in 12 ft, 14 ft, and 16 ft lengths to run full height. The planks were placed into metal L channels at the bottom and into metal top channels of various shapes depending on the construction element with which it needed to interface (see Fig. 10–4).
