NIST NCSTAR 1-1

**Federal Building and Fire Safety Investigation of the
World Trade Center Disaster**

Design, Construction, and Maintenance of Structural and Life Safety Systems

H. S. Lew
Richard W. Bukowski
Nicholas J. Carino

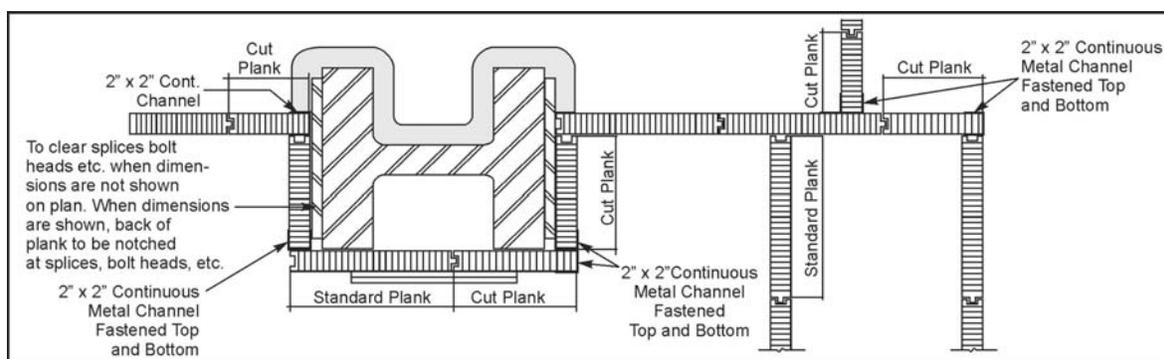
Figure 10–4. Gypsum plank installation.

Vertical shafts surrounding stairs, mechanical shafts (carrying supply and return air), elevator hoistways, and utility shafts were all contained within the building core, and were enclosed by gypsum planking similar to fire separations commonly used today in single-family attached housing. While similar to other gypsum shaft wall systems and firewalls, this system was unique and innovative in that it eliminated the need for any framing. The gypsum planks were solid 2 in. thick (2½ in. on floors with 16 ft ceiling heights) and 16 in. wide, with metal tongue or groove channels attached to the long sides that served as wall studs (see Fig. 10–3). Where planks were cut to a narrower width, the cut edge was covered with a 2 in. by 2 in. metal C channel fastened with drywall screws at the top and bottom. Each plank had a mesh layer at its mid thickness and were likely custom fabricated for this job as NIST found no mention of similar products in gypsum industry literature of the time or since. Planks were provided in 12 ft, 14 ft, and 16 ft lengths to run full height. The planks were placed into metal L channels at the bottom and into metal top channels of various shapes depending on the construction element with which it needed to interface (see Fig. 10–4).

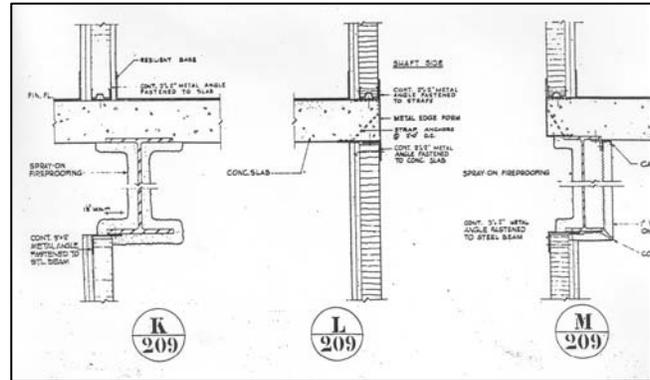
Figure 10–5. Typical finish details.

A large number of detail drawings were provided for attaching the planks to various ceiling constructions (A*A* 209 through A*A*212, see Fig. 10–5). Finish layers were either one or two layers of ½ in. gypsum board (moisture resistant was specified in some locations). Two layers on one side were specified in locations where the other side was a shaft or other unoccupied space, and two layers on one side with a single layer on the other was specified where both sides were in occupied spaces. The required number of layers was indicated on construction drawings (e.g., A*A*20, A*A* 50) by the numbers 1 or 2 in triangles (see Fig. 10–6).

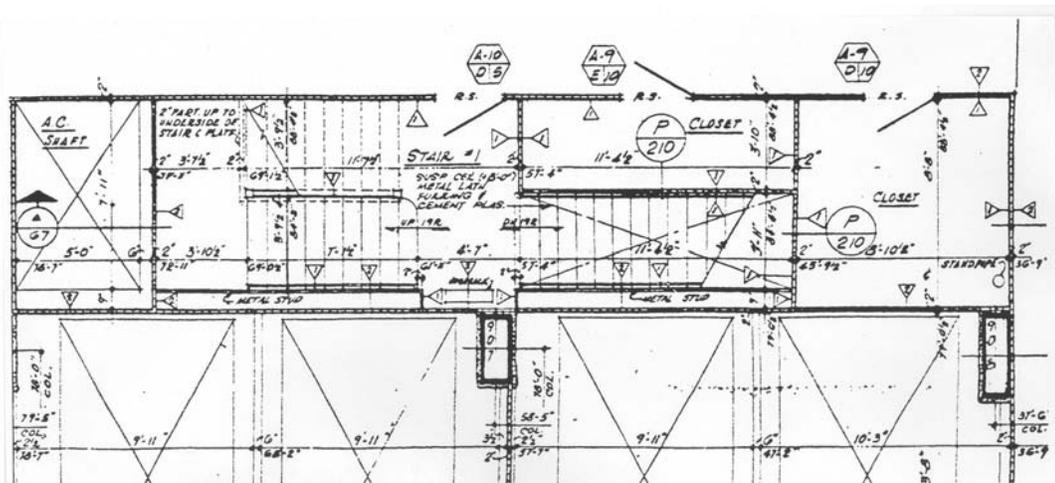
Figure 10–6. Stairway detail at 26th floor.

Source: WTC 1&2 26th Floor Core Plan drawing A*A*50. Reproduced with permission of The Port Authority of New York and New Jersey.
