REPORT BMS31

Structural Properties of
"Insulite" Wall and "Insulite"
Partition Constructions
Sponsored by The Insulite Co.

HERBERT L. WHITTEMORE
and AMBROSE H. STANG

NATIONAL
BUREAU OF STANDARDS

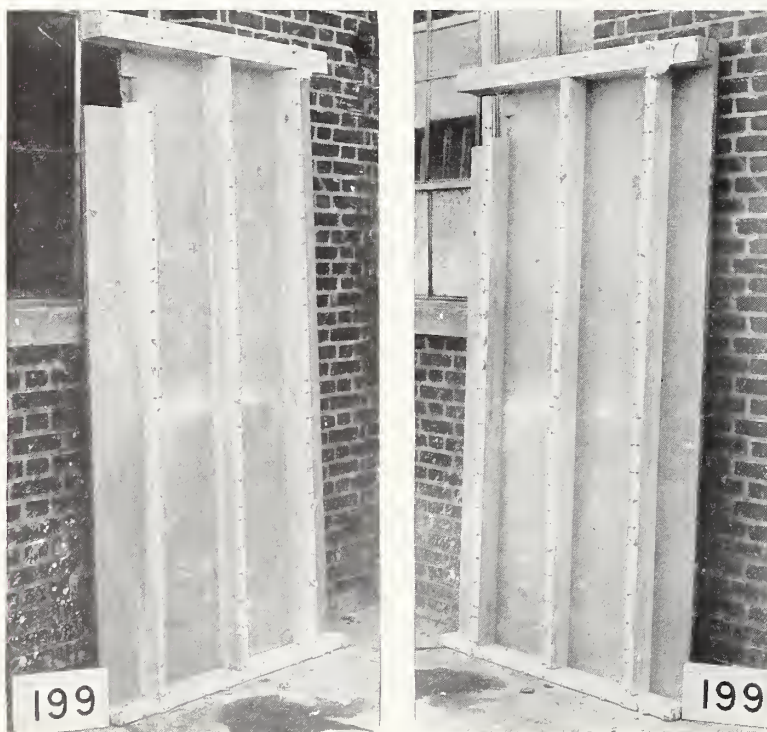
FIGURE 1.—Frame of wall specimen BK-14.

Almost straight grain with few knots.

Forest Products Laboratory.—After each specimen was tested, one face was removed to expose the studs and photographs were taken showing the knots and failures. The grade of the wood framing was determined from these photographs. The studs ranged from almost straight grain with few knots, as shown in figure 1, to many knots, as shown in figure 2. A typical frame is shown in figure 3.

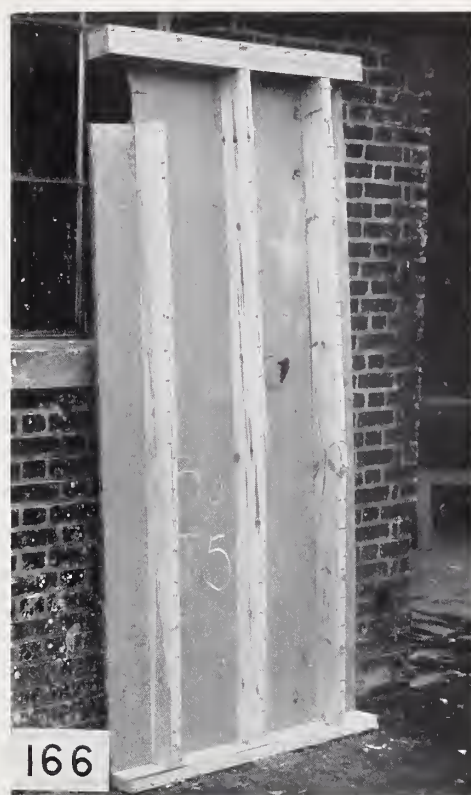
FIGURE 2.—Frame of wall specimen BJ-T5.

Many knots.

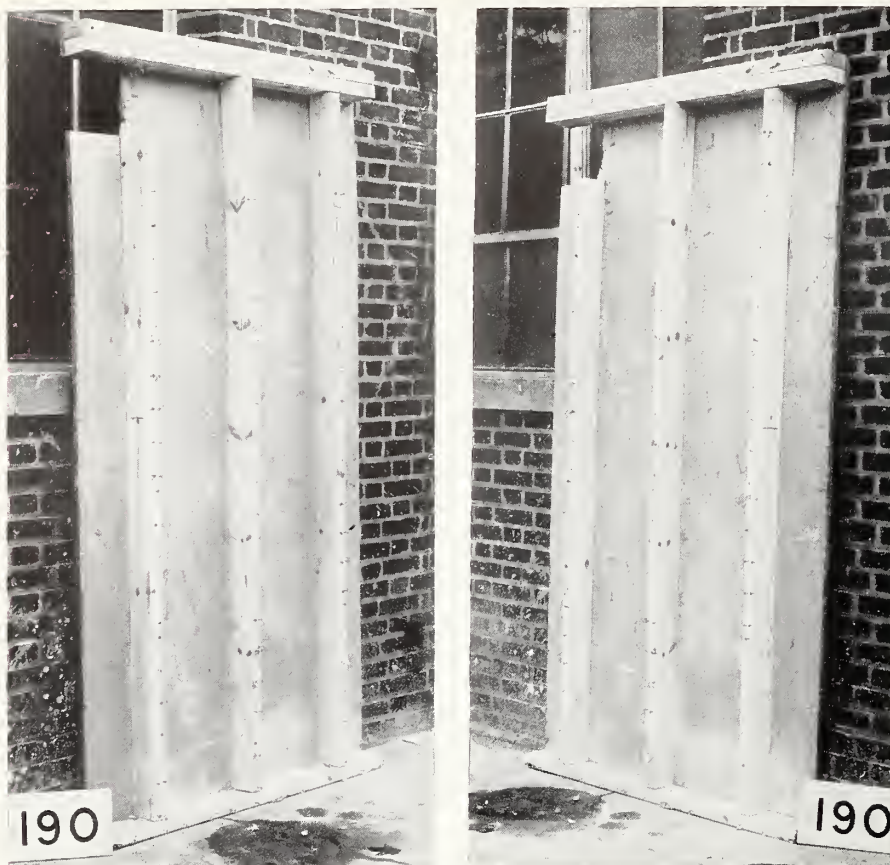
FIGURE 3.—Frame of wall specimen BK-T5.

A typical frame.

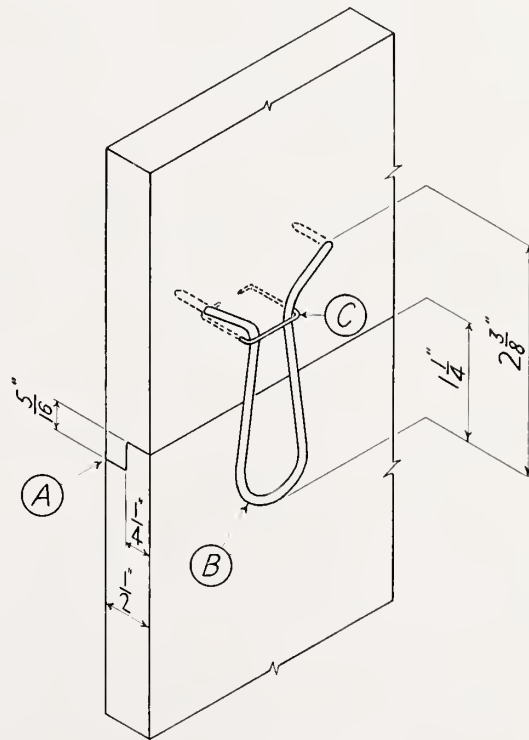
FIGURE 4.—"Lok-Joint" lath.

A, shiplapped joint; B, "Lok" with prongs projecting into the lath; C, staple passing through the lath and clinched.

Rigid insulation board made as described under (a), 1/2 in. thick, 1 ft 6 in. by 4 ft 0 in., shiplapped along each of the longer edges as shown at A, figure 4. There were three "Loks," spaced about 1 ft 4 in. on one shiplapped edge of each lath. The "Lok," B, was a loop of galvanized steel wire, No. 12 (0.1055-in. diam before galvanizing), reinforced by a staple, C, of steel wire No. 19 (0.041-in. diam). The "Loks" were attached to the lath to prevent lateral displacement with respect to the adjacent lath, particularly when the plaster was applied.

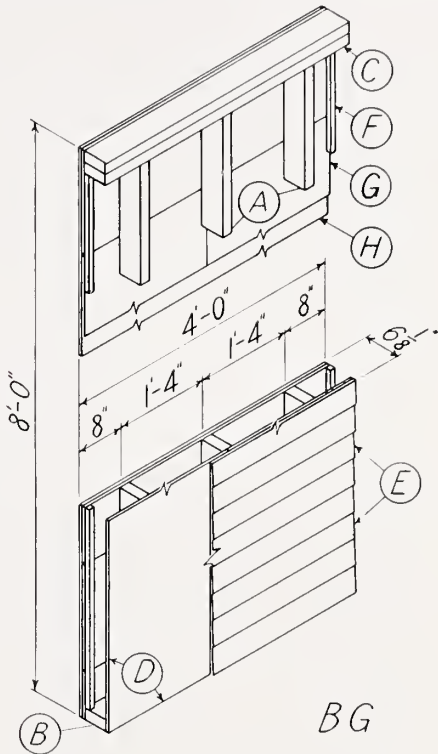
FIGURE 5.—Four-foot wall specimen BG.

A, stud; *B*, floor plate; *C*, top plate; *D*, sheathing; *E*, bevel siding; *F*, nailing strip; *G*, lath; *H*, plaster.

The 4-ft wall specimens were 8 ft 0 in. high, 4 ft 0 in. wide, and 6½ in. thick. Each specimen consisted of a wood frame to which the faces were fastened. The frame consisted of three studs, *A*, shown in figure 5, fastened to a floor plate, *B*, and a top plate, *C*, by nails. The outside face consisted of insulating-board sheathing, *D*, and wood bevel siding, *E*. The inside face

consisted of wood nailing strips, *F*, insulating-board lath, *G*, and plaster, *H*. The specimens were not painted.

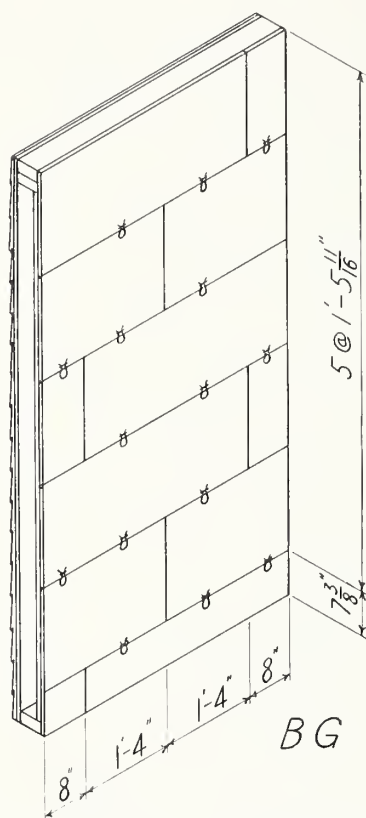
FIGURE 6.—Four-foot wall specimen BG.

Inside face, showing “Lok-Joint” lath.

Lath.—The lath, *G*, consisted of “Lok-Joint” lath, five full courses and one course cut to a height of $7\frac{3}{8}$ in., as shown in figure 6. The plaster was on the burlap-textured sur-

Lath.—The lath, *I*, was “Lok-Joint” lath, five full courses and one course cut to a height of $7\frac{3}{4}$ in., as shown in figure 6. The plaster was applied to the burlap-textured surface. There was a vertical joint in each course, centered on a stud, with $\frac{3}{16}$ -in. clearance between the ends of the lath. The horizontal joints (shiplapped) were reinforced by “Loks”, three at each joint. The lath was fastened to the studs, floor plates, top plate, and nailing strips by plaster board nails spaced 4 in., about $\frac{1}{2}$ in. from the edges of the lath.

Lath.—The lath, *G*, consisted of “Lok-Joint” lath, five full courses and one course cut to a height of 7¾ in., as shown in figure 6. The plaster was on the burlap-textured surface. There was a vertical joint in each course, centered on a stud, with 3/16-in. clearance between

Lath.—The lath, *H*, consisted of “Lok-Joint” lath, five full courses and one course cut to a height of $7\frac{7}{8}$ in., as shown in figure 6. The plaster was applied to the burlap-textured surface. There was a vertical joint in each course, centered on a stud, with $\frac{3}{16}$ -in. clearance between the ends of the lath. The horizontal joints (shiplapped) were reinforced by “Loks,” three at each joint. The lath was fastened to the studs, floor plate, top plate, and nailing strips by plasterboard nails spaced 4 in., about $\frac{1}{2}$ in. from the edges of the lath.

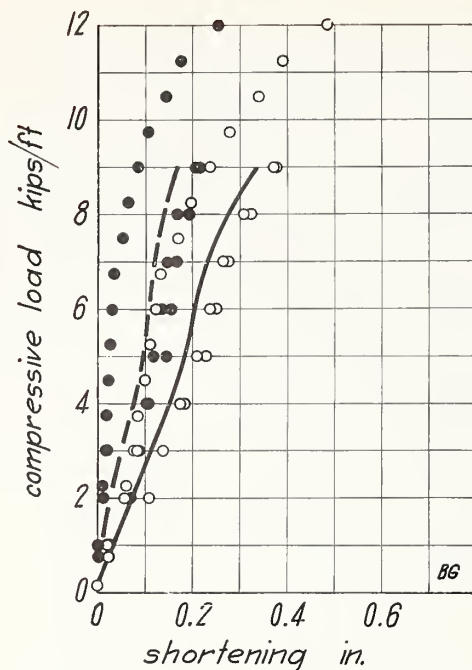
FIGURE 7.—Compressive load on wall BG.

Load-shortening (open circles) and load-set (solid circles) results for specimens BG-C1, C2, and C3. Load applied one-third the thickness (1.21 in.) from the inside surface of the studs. The loads are in kips per foot of actual width of specimen.

The results for wall specimens *BG-C1*, *C2*, and *C3* are shown in table 13 and in figures 7 and 8.

Each of the specimens failed by crushing of the edges of the plaster at one or both ends of the specimen and local crushing of the lower member of the top plate at the inside edge of the studs. The top plate rotated and the specimens pushed out under load without breaking the studs.

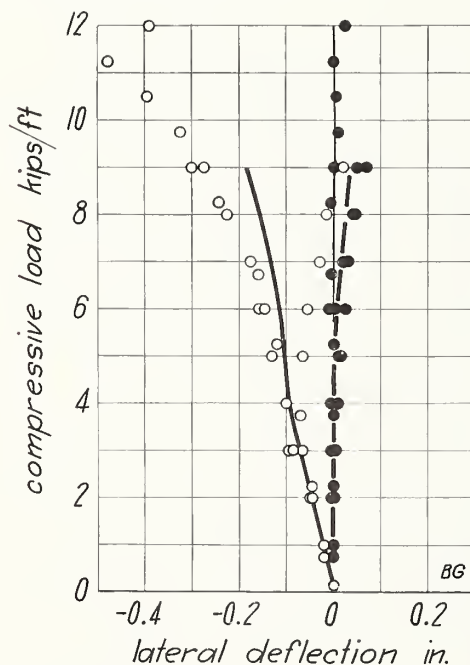
FIGURE 8.—Compressive load on wall BG.

Load-lateral deflection (open circles) and load-lateral set (solid circles) results for specimens BG-C1, C2, and C3. Load applied one-third the thickness (1.21 in.) from the inside surface of the studs. The loads are in kips per foot of actual width of specimen.

The lateral deflections shown in figure 8 were plotted to the right of the vertical axis for deflections of the specimens toward the outside face (positive deflection) and to the left for deflections toward the inside face (negative deflection).

Although the load was eccentric toward the inside face, each of the specimens deflected initially toward the inside face, probably because the stiffness of the plaster counteracted the effect of the eccentric load. As the maximum load was approached, the deflections toward the inside face decreased. At

the maximum load the deflection of specimen C1 was zero and the deflection of specimens C2 and C3 was toward the outside face. These deflections are not shown in figure 8. The change in the direction of the deflection curve probably indicates progressive local failure of the inside face.

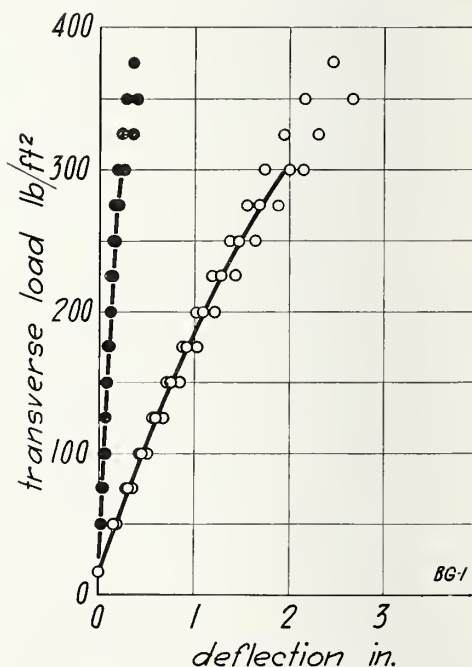
FIGURE 9. Transverse load on wall BG, load applied to inside face.

Load-deflection (open circles) and load-set (solid circles) results for specimens BG-T1, T2, and T3 on the span 7 ft 6 in.

The results are shown in table 13 and in figure 9 for wall specimens BG-T1, T2, and T3, loaded on the inside face, and in figure 10 for wall specimens BG-T4, T5, and T6, loaded on the outside face.

In each of the specimens T1, T2, and T3, loaded on the inside (plastered) face, the plaster cracked longitudinally along each outer stud and transversely across the specimen in several

places. The first longitudinal cracks occurred at loads of 225, 150, and 75 lb/ft² and deflections of 1.43, 0.75, and 0.28 in. in specimens T1, T2, and T3, respectively. The first transverse cracks occurred at lath joints near midspan and were observed after loads of 225, 225, and 275 lb/ft² and deflections of 1.43, 1.28, and 1.55 in. for specimens T1, T2, and T3, respectively. At the maximum load, specimen T1 failed by rupture of one outer stud near a loading roller, rupture of the sheathing transversely across the specimen where the stud ruptured, and splitting of the siding on one edge at the same place. Specimen T2 failed by rupture of all three studs near midspan, rupture of the sheathing, and splitting of two pieces of siding at the same place. Specimen T3 failed by rupture of one outer stud near midspan, rupture of the sheathing, and splitting of the siding near the same place.

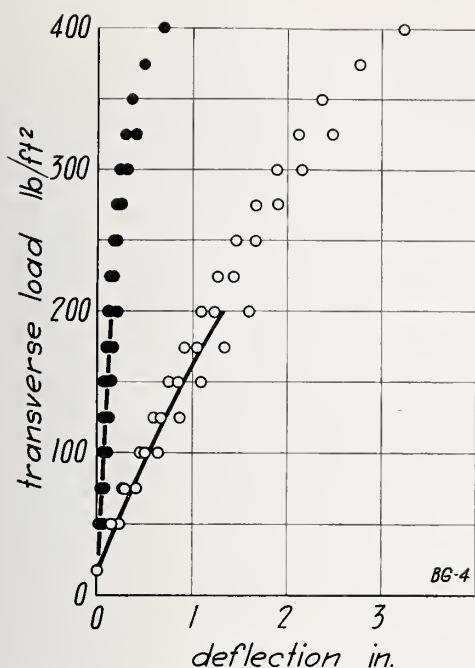
FIGURE 10—Transverse load on wall BG, load applied to outside face.

Load-deflection (open circles) and load-set (solid circles) results for specimens BG-T4, T5, and T6 on the span 7 ft 6 in.

In each of the specimens T4, T5, and T6, loaded on the outside (bevel siding) face, the plaster cracked transversely across the speci-

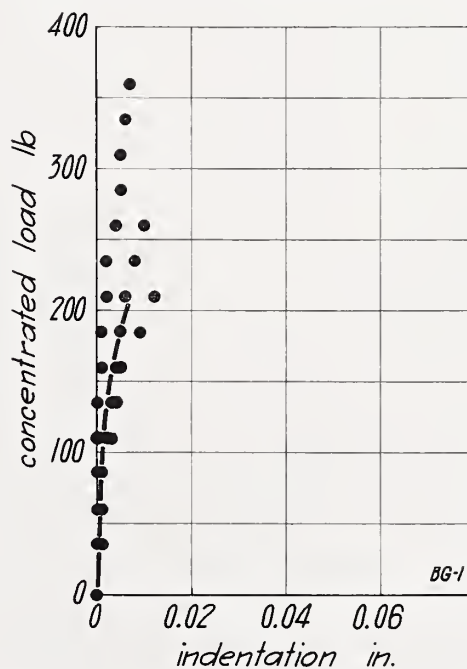
FIGURE 11.—Concentrated load on wall BG, load applied to inside face.

Load-indentation results for specimens BG-P1, P2, and P3.

The results are shown in table 13 and in figure 11 for wall specimens BG-P1, P2, and

The concentrated loads were applied to the inside face of specimens *P1*, *P2*, and *P3* on the plaster midway between two studs and about 1 ft 8 in. from the upper end of the specimen. On *P1* the load was applied over a lath joint. Each of the specimens failed by punch-

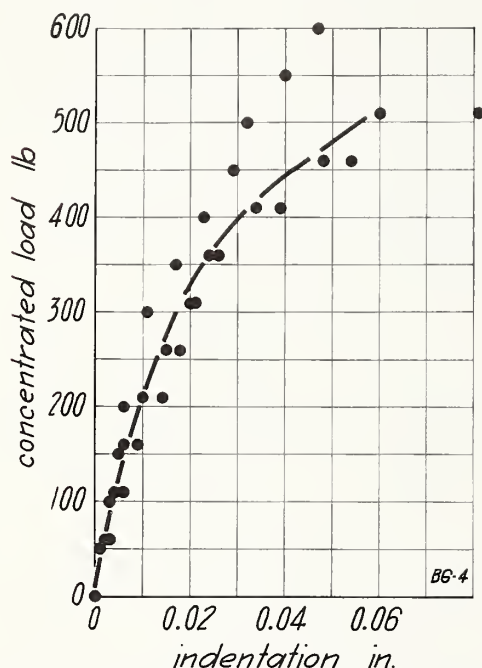
FIGURE 12.—Concentrated load on wall BG, load applied to outside face.

Load-indentation results for specimens *BG-P4*, *P5*, and *P6*.

P3, loaded on the inside face, and in figure 12 for wall specimens *BG-P4*, *P5*, and *P6*, loaded on the outside face.

The concentrated loads were applied to the outside face of specimens *P4*, *P5*, and *P6* on the wood bevel siding $3\frac{1}{2}$, $2\frac{1}{2}$, and $1\frac{1}{2}$ in., respectively, from the edge of a strip of siding midway between two studs and about 2 ft 2 in. from the upper end of the specimen. In specimen *P4*, at a load of 435 lb, and in specimen *P5*, at a load of 210 lb, the siding split along the grain at one edge of the disk. At the maximum loads each of the specimens failed by splitting of the siding along the grain at opposite edges of the disk and rupture across the grain under the disk.

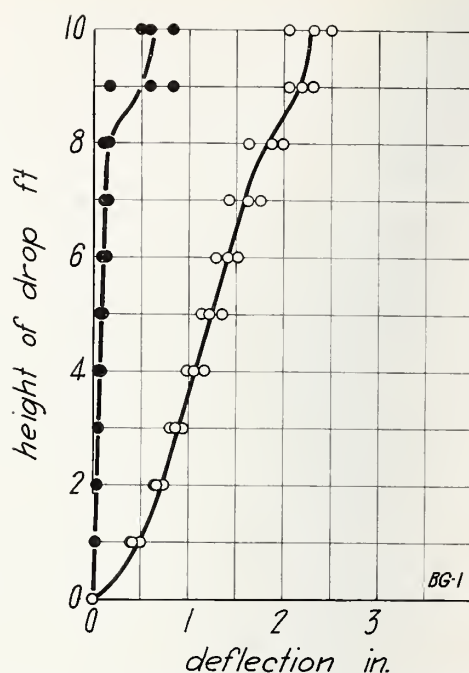
FIGURE 13.—Impact load on wall BG, load applied to inside face.

Height of drop-deflection (open circles) and height of drop-set (solid circles) results for specimens *BG-11*, *12*, and *13* on the span 7 ft 6 in.

The results are shown in table 13 and in figure 13 for wall specimens *BG-I1*, *I2*, and *I3*, loaded on the inside face, and in figure 14 for wall specimens *BG-I4*, *I5*, and *I6*, loaded on the outside face.

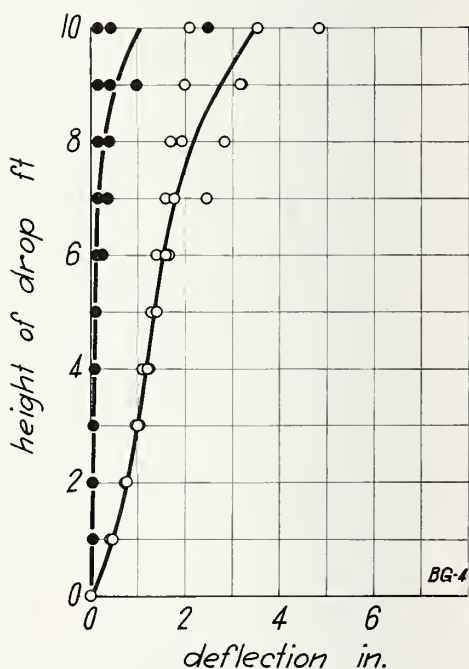
FIGURE 14.—Impact load on wall BG, load applied to outside face.

Height of drop-deflection (open circles) and height of drop-set (solid circles) results for specimens *BG-14*, *15*, and *16* on the span 7 ft 6 in.

The impact loads were applied to the center of the outside face of specimens *I4*, *I5*, and *I6*, the sandbag striking the bevel siding directly over the center stud. In each of the specimens *I4*, *I5*, and *I6* at drops of 2.5, 1, and 1 ft and deflections of 0.85, 0.50, and 0.49 in., respectively, the plaster cracked transversely across each specimen at a lath joint near midspan. At drops of 4, 3, and 3 ft for specimens *I4*,

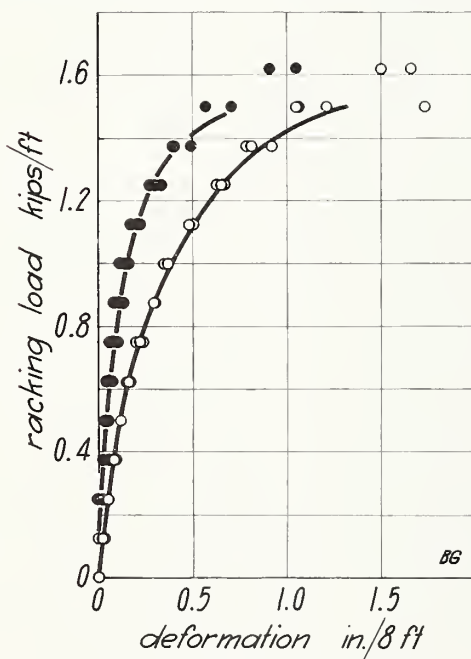
FIGURE 16.—Racking load on wall *BG*.

Load-deformation (open circles) and load-set (solid circles) results for specimens *BG-R1*, *R2*, and *R3*. The loads are in kips per foot of the face width of specimen (8 ft 0 in.).

specimens *BG-R1*, *R2*, and *R3* are shown in table 13 and in figure 16.

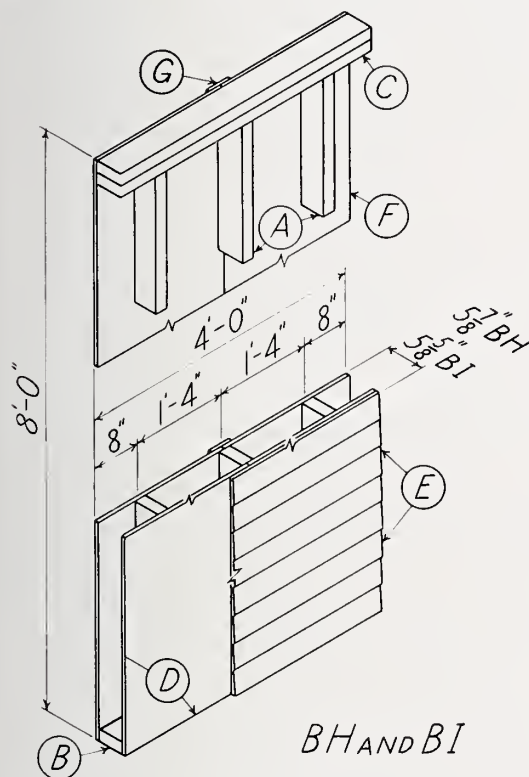
FIGURE 17.—Four-foot wall specimens BH and BI.

A, stud; B, floor plate; C, top plate; D, sheathing; E, bevel siding; F, interior board; G, batten strip.

The 4-ft wall specimens were 8 ft 0 in. high, 4 ft 0 in. wide, and $5\frac{1}{2}$ in. thick. Each specimen consisted of a wood frame to which the faces were fastened. The frame consisted of three studs, *A*, shown in figure 17, fastened to a floor plate, *B*, and a top plate, *C*, by nails. The outside face consisted of insulating-board sheathing, *D*, and wood bevel siding, *E*. The inside face was interior board, *F*, with a vertical joint at midwidth covered by a batten strip, *G*. The specimens were not painted.

The 4-ft wall specimens were 8 ft 0 in. high, 4 ft 0 in. wide, and $5\frac{5}{8}$ in. thick. Each specimen consisted of a wood frame to which the faces were fastened. The frame consisted of three studs, *A*, shown in figure 17, fastened to a floor plate, *B*, and a top plate, *C*, by nails. The outside face consisted of insulating-board sheathing, *D*, and wood bevel siding, *E*. The

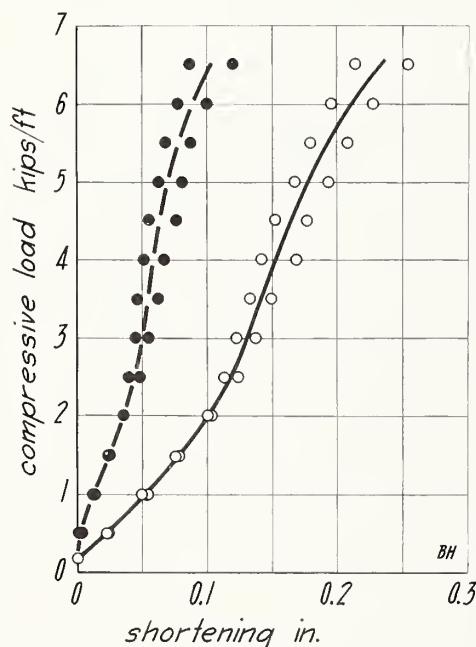
FIGURE 18.—Compressive load on wall BH.

Load-shortening (open circles) and load-set (solid circles) results for specimens *BH-C2* and *C3*. Load applied one-third the thickness (1.21 in.) from the inside surface of the studs. The loads are in kips per foot of actual width of specimen.

The results for wall specimens *BH-C2* and *C3* are shown in table 13 and in figures 18 and 19. The results for specimen *C1* are not reported because the compressometers were attached to the studs and did not measure the local crushing of the floor plate and the top plate. The maximum load for this specimen is not given in table 13 because the clearance for eccentric loading was not sufficient and the loading plates came into contact with the platen of the testing machine before the maximum load could be definitely ascertained. With the loading plate in contact with the platen, the load was increased to a maximum of 11.0 kips/ft. At this load one outer stud broke at midheight.

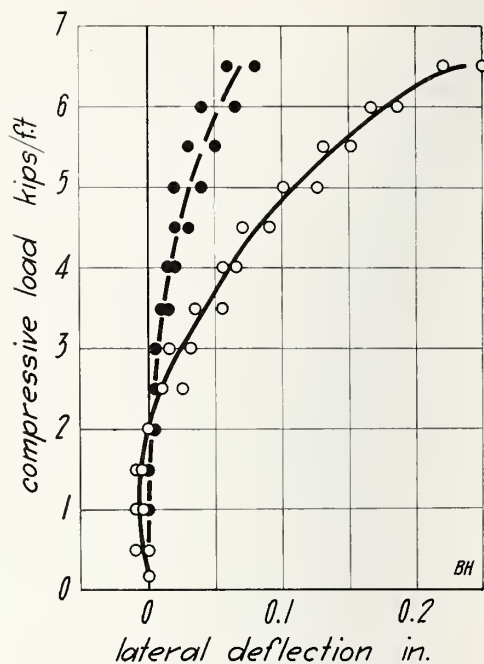
FIGURE 19.—Compressive load on wall BH.

Load-lateral deflection (open circles) and load-lateral set (solid circles) results for specimens *BH-C2* and *C3*. Load applied one-third the thickness (1.21 in.) from the inside surface of the studs. The loads are in kips per foot of actual width of specimen.

The lateral deflections shown in figure 19 were plotted to the right of the vertical axis for

deflections of the specimens toward the outside face and to the left for deflections toward the inside face. No explanation was found for the deflection of the specimens toward the inside face under loads less than 2 kips/ft.

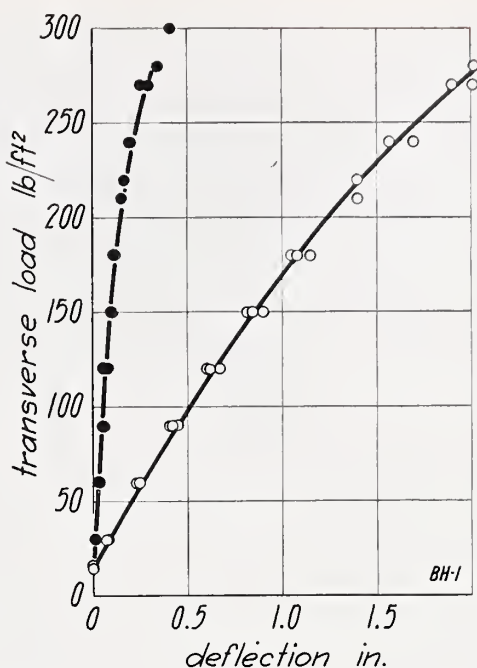
FIGURE 20.—Transverse load on wall *BH-I*, load applied to inside face.

Load-deflection (open circles) and load-set (solid circles) results for specimens *BH-I1*, *T2*, and *T3* on the span 7 ft 6 in.

The results are shown in table 13 and in figure 20 for wall specimens *BH-T1*, *T2*, and *T3*, loaded on the inside face, and in figure 21 for wall specimens *BH-T4*, *T5*, and *T6*, loaded on the outside face.

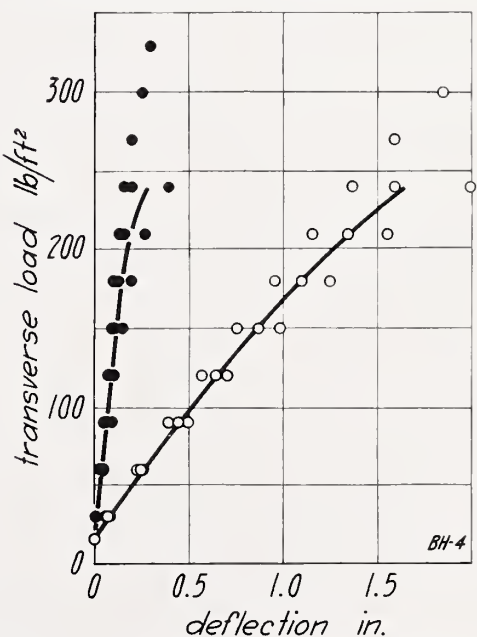
FIGURE 21.—Transverse load on wall *BH-4*, load applied to outside face.

Load-deflection (open circles) and load-set (solid circles) results for specimens *BH-I4*, *T5*, and *T6* on the span 7 ft 6 in.

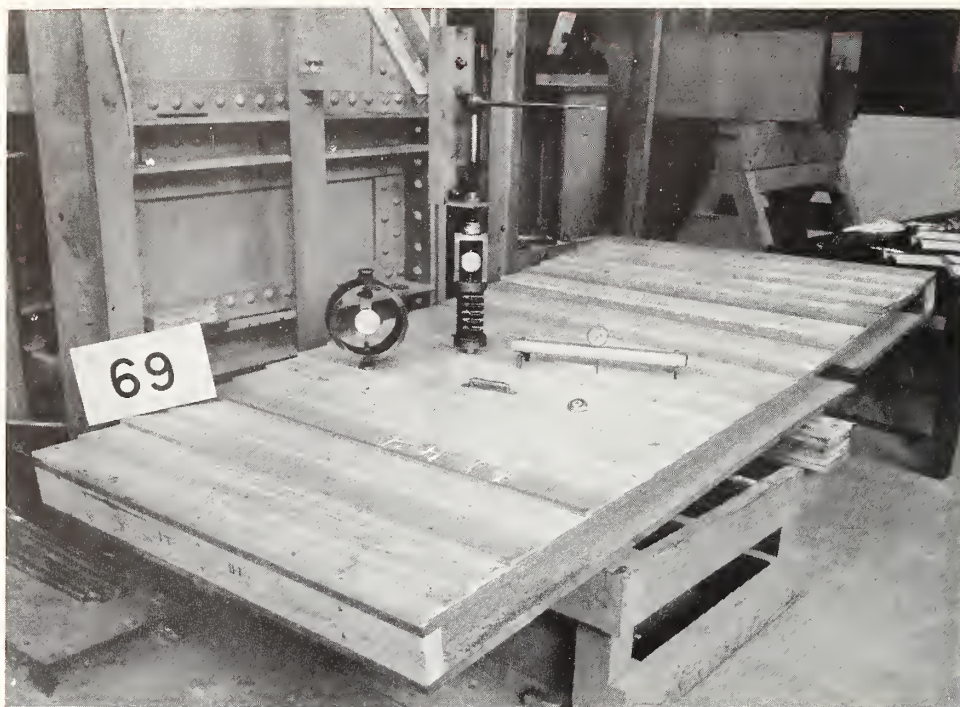
FIGURE 22.—Wall specimen BH-P₄ under concentrated load.

This specimen was an undamaged portion of specimen BH-T₄.

Wall specimen *BH-P4* under concentrated load is shown in figure 22. The results are shown in table 13 and in figure 23 for wall specimens *BH-P1*, *P2*, and *P3*, loaded on the inside face, and in figure 24 for wall specimens *BH-P4*, *P5*, and *P6*, loaded on the outside face.

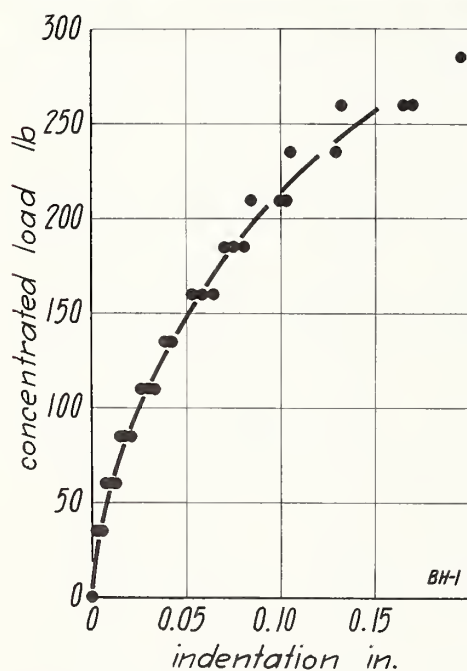
FIGURE 23.—Concentrated load on wall BH, load applied to inside face.

Load-indentation results for specimens BH-P₁, P₂, and P₃.

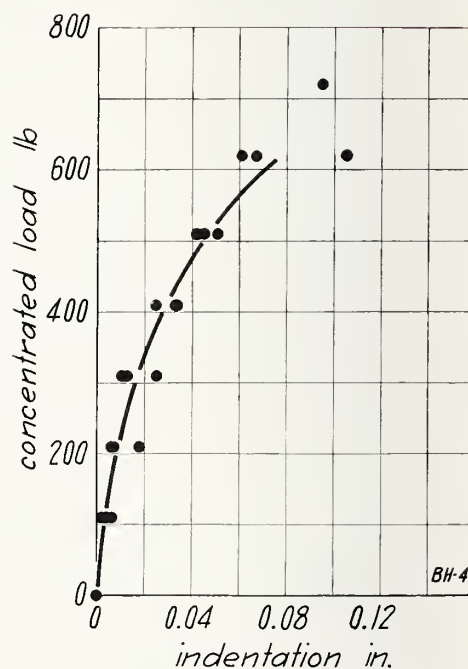
FIGURE 24.—Concentrated load on wall BH, load applied to outside face.

Load-indentation results for specimens BH-P₄, P₅, and P₆.

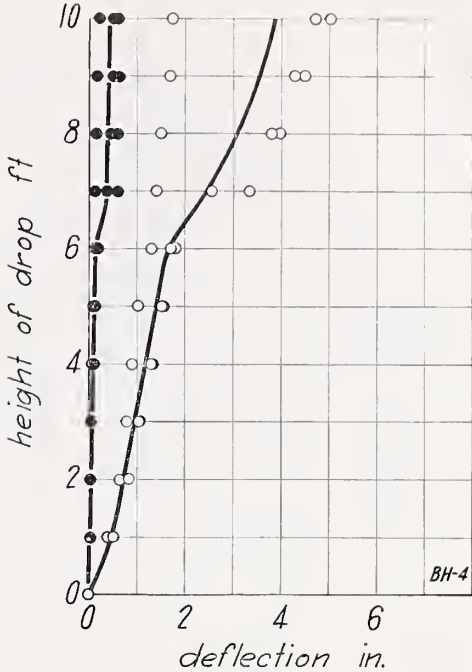
FIGURE 26.—Impact load on wall BH, load applied to outside face.

Height of drop-deflection (open circles) and height of drop-set (solid circles) results for specimens BH-14, 15, and 16 on the span 7 ft 6 in.

The results are shown in table 13 and in figure 25 for wall specimens *BH-I1*, *I2*, and *I3*, loaded on the inside face, and in figure 26 for wall specimens *BH-I4*, *I5*, and *I6*, loaded on the outside face.

The impact loads were applied to the center of the outside face of specimens *I4*, *I5*, and *I6*, the sandbag striking the bevel siding directly over the center stud. At drops of 6, 6, and 5 ft for specimens *I4*, *I5*, and *I6*, respectively, the interior board of each specimen started to separate from the outer studs at midspan. In each of the specimens *I4* and *I6* the center stud broke at midspan and the inside face failed

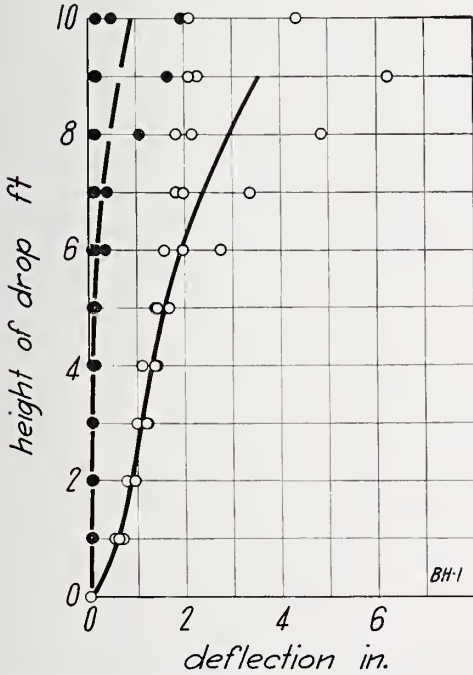
FIGURE 25.—Impact load on wall BH, load applied to inside face.

Height of drop-deflection (open circles) and height of drop-set (solid circles) results for specimens BH-11, 12, and 13 on the span 7 ft 6 in.

The impact loads were applied to the center of the inside face of specimens *I1*, *I2*, and *I3*, the sandbag striking the batten strip and interior board directly over the center stud. In specimen *I1* the center stud broke at midspan at a drop of 9.5 ft. The set after a drop of 10 ft was 0.49 in., the interior board was dented

where the edge of the sandbag struck, and the sheathing on the opposite face was ruptured transversely across the specimen at midspan. In specimen *I2* the inside face failed at a drop of 9.5 ft by rupture of the interior board where the edge of the sandbag struck. The set after a drop of 10 ft was 0.16 in.; the studs and outside face were undamaged. In specimen *I3* the center stud broke at midspan at a drop of 5.5 ft. At a drop of 7.5 ft one outer stud broke at midspan and the outside face failed by splitting of the siding and rupture of the sheathing transversely across the specimen at midspan. The set after a drop of 10 ft was 1.95 in., and the interior board was cracked but not ruptured where the edge of the sandbag struck.

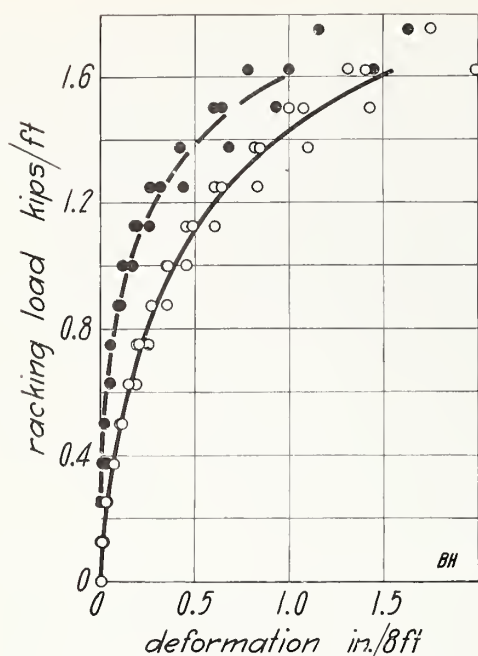
FIGURE 27.—Racking load on wall BH.

Load-deformation (open circles) and load-set (solid circles) results for specimens BH-R1, R2, and R3. The loads are in kips per foot of the face width of specimen (8 ft 0 in.).

The results for wall specimens BH-*R1*, *R2*, and *R3* are shown in table 13 and in figure 27.

The racking loads were applied to the top plate only, and the stop was in contact with the floor plate only. At loads of 1.625, 1.726 (maximum load), and 1.375 kips/ft there was noticeable vertical displacement between the two sheathing boards at the joint. At the maximum load each of the specimens failed by the top plate pulling the nails from the studs and through the edges of the sheathing and interior board.

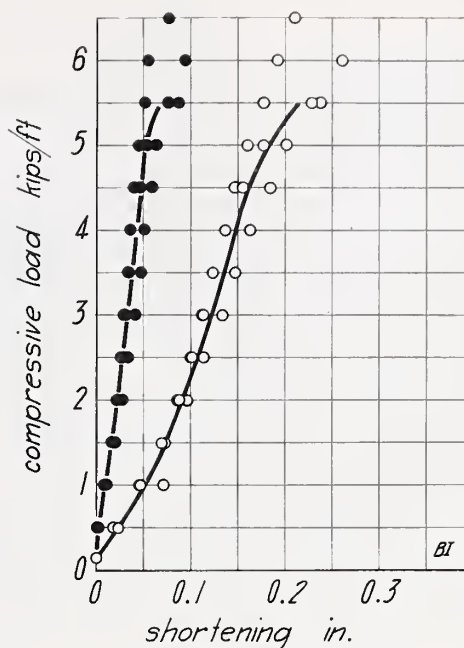
FIGURE 28.—Compressive load on wall *BI*.

Load-shortening (open circles) and load-set (solid circles) results for specimens *BI-C1*, *C2*, and *C3*. Load applied one-third the thickness (1.21 in.) from the inside surface of the studs. The loads are in kips per foot of actual width of specimen.

The results for wall specimens *BI-C1*, *C2*, and *C3* are shown in table 13 and in figures 28 and 29.

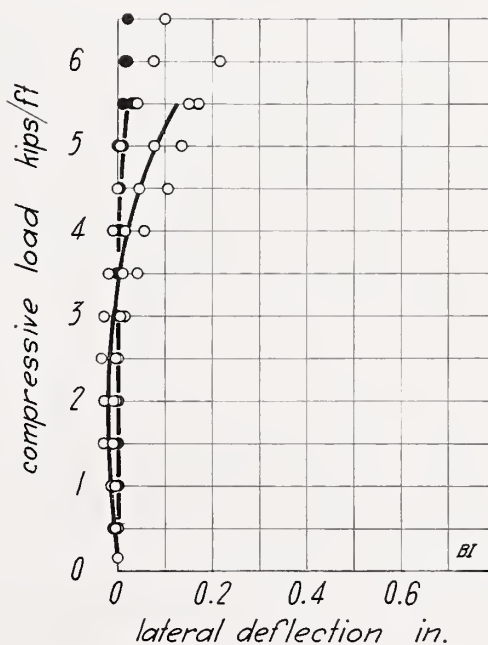
FIGURE 29.—Compressive load on wall *BI*.

Load-lateral deflection (open circles) and load-lateral set (solid circles) results for specimens *BI-C1*, *C2*, and *C3*. Load applied one-third the thickness (1.21 in.) from the inside surface of the studs. The loads are in kips per foot of actual width of specimen.

The lateral deflections shown in figure 29 are plotted to the right of the vertical axis for deflections of the specimens toward the outside face and to the left for deflections toward the inside face. No explanation was found for the deflection of the specimens toward the inside face under loads less than 4 kips/ft.

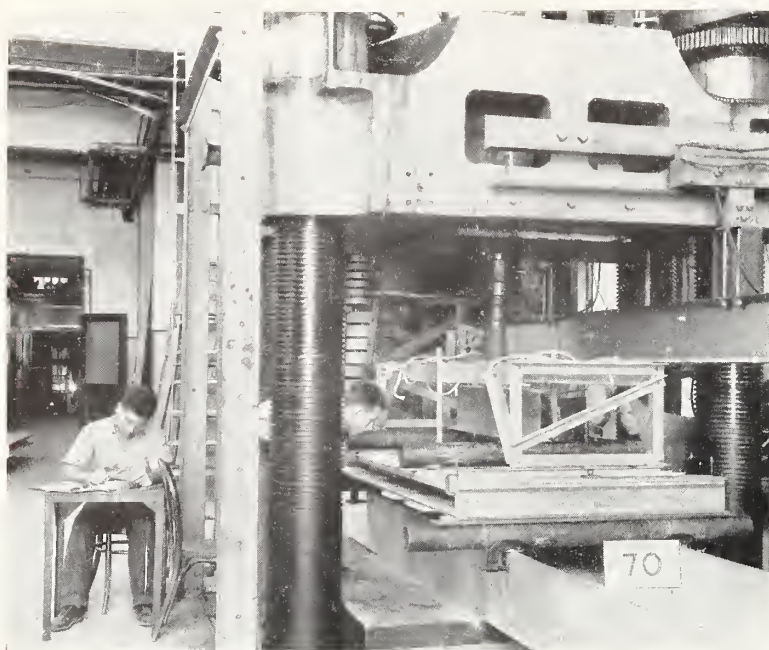
FIGURE 30.—Wall specimen *BI-T6* under transverse load.

Wall specimen *BI-T6* under transverse load is shown in figure 30. The results are shown in table 13 and in figure 31 for wall specimens *BI-T1*, *T2*, and *T3*, loaded on the inside face, and in figure 32 for wall specimens *BI-T4*, *T5*, and *T6*, loaded on the outside face.

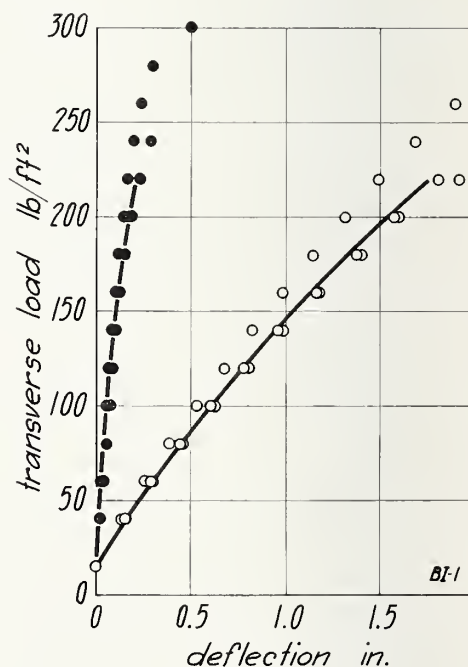
FIGURE 31.—Transverse load on wall *BI*, load applied to inside face.

Load-deflection (open circles) and load-set (solid circles) results for specimens *BI-T1*, *T2*, and *T3* on the span 7 ft 6 in.

Specimen *T1* failed by rupture of the center stud and one outer stud at a loading roller and rupture of both the interior board and the sheathing halfway across the specimen at the same place. Specimen *T2* failed by rupture of all three studs under a loading roller and rupture of the sheathing and siding at the same

place. Specimen *T3* failed by rupture of the center stud and one outer stud at a loading roller and rupture of the sheathing and siding transversely across the specimen at the same place.

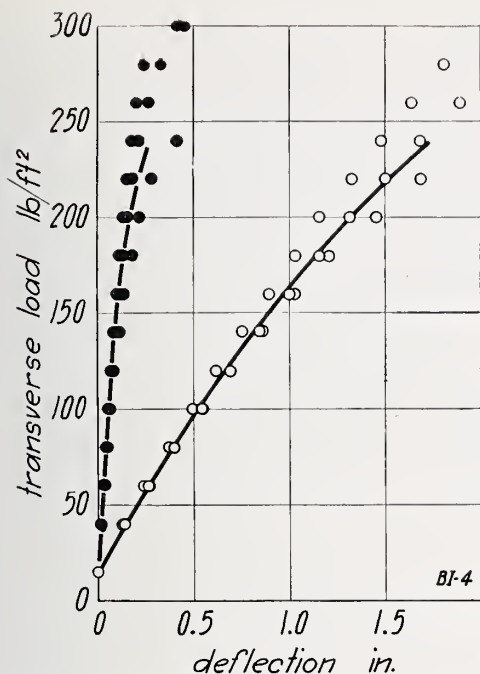
FIGURE 32.—Transverse load on wall BI, load applied to outside face.

Load-deflection (open circles) and load-set (solid circles) results for specimens BI-T4, T5, and T6 on the span 7 ft 6 in.

Specimens T4 and T5 failed by rupture of the center stud, one outer stud, and the interior board between the loading rollers. Specimen T6 failed by rupture of one outer stud at midspan, splitting of the center stud along the grain from midspan to the top plate, and rupture of the interior board at midspan.

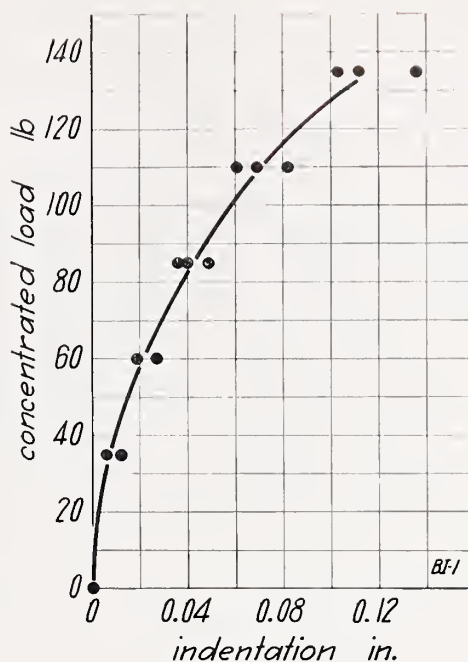
FIGURE 33.—Concentrated load on wall BI, load applied to inside face.

Load-indentation results for specimens BI-P1, P2, and P3.

The concentrated loads were applied to the inside face of specimens P1, P2, and P3 on the interior board midway between two studs and 3 to 3½ ft from one end. Each of the specimens failed by punching of the disk through the interior board.

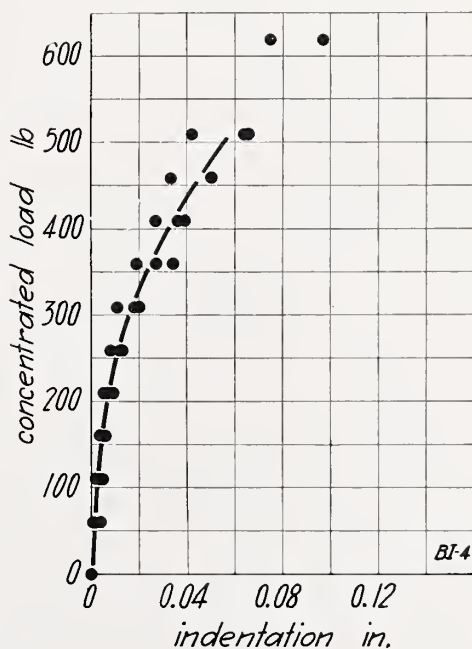
FIGURE 34.—Concentrated load on wall BI, load applied to outside face.

Load indentation results for specimens BI-P4, P5, and P6.

The concentrated loads were applied to the outside face of specimens P4, P5, and P6 on the bevel siding 1½ in. from the edge of a strip of siding midway between two studs and 2½ to

3½ ft from one end. Each of the specimens failed by splitting of the siding for about 8 in. along the grain on opposite edges of the disk.

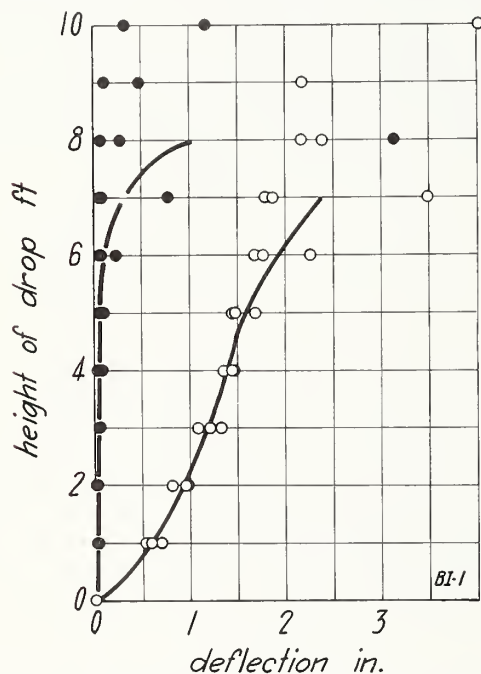
FIGURE 35.—Impact load on wall *BI*, load applied to inside face.

Height of drop-deflection (open circles) and height of drop-set (solid circles) results for specimens *BI-I1*, *I2*, and *I3* on the span 7 ft 6 in.

The impact loads were applied to the center of the inside face of specimens *I1*, *I2*, and *I3*, the sandbag striking the batten strip and interior board directly over the center stud.

In specimen *I1* at a drop of 5.5 ft the interior board separated from the outer studs at midspan; at 8.5 ft the siding on the opposite face cracked at midspan; at 9 ft both faces failed, the inside face by rupture of the interior board where the sandbag struck, the outside face by cracking of both the siding and sheathing at midspan. At 9.5 ft one outer stud broke at midspan. At 10 ft the set was 1.19 in. and the center stud was broken. In specimen *I2* at

a drop of 5.5 ft the interior board started to separate from the studs at midspan; at 7 ft one outer stud broke and both faces failed, the inside face by breaking of the interior board where the sandbag struck, the outside face by rupture of the sheathing. At 7.5 ft all three studs were broken, and at 9 ft the specimen broke in two pieces at midspan. In specimen *I3* at a drop of 6.5 ft the interior board separated from the outer studs near midspan, and at 9 ft the interior board cracked where the edge of the sandbag struck. At 10 ft the inside face failed by rupture of the interior board where the sandbag struck; the center stud broke at midspan, but the outside face did not fail.

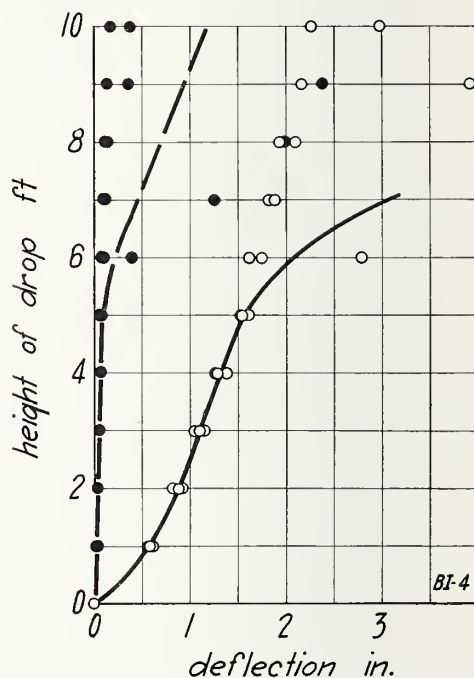
FIGURE 36.—Impact load on wall *BI*, load applied to outside face.

Height of drop-deflection (open circles) and height of drop-set (solid circles) results for specimens *BI-I4*, *I5*, and *I6* on the span 7 ft 6 in.

The impact loads were applied to the center of the outside face of specimens *I4*, *I5*, and *I6*, the sandbag striking the wood bevel siding directly over the center stud. In specimen *I4* at a drop of 4 ft the interior board on the opposite face separated from the studs at midspan, at 5.5 ft the center stud broke at midspan, and at 6 ft the inside face failed by rupture of the interior board transversely across the specimen. At 6.5 ft one outer stud broke at mid-

span and at 7 ft the outside face failed by opening of the siding at midspan. After a drop of 10 ft the set was 2.98 in., three siding strips were cracked, and the sheathing was ruptured halfway across the specimen. In specimen *I5* at a drop of 3 ft the interior board separated from one outer stud at midspan and at 9.5 ft the siding cracked where the sandbag struck. After a drop of 10 ft the set was 0.16 in. and neither the faces nor the studs had failed. In specimen *I6* at a drop of 2.5 ft the interior board separated from the studs at midspan, at 8.5 ft the center stud failed at midspan, and at 9 ft the inside face failed by rupture of the interior board transversely across the specimen at midspan. The set after a drop of 10 ft was 0.38 in., and the outside face was undamaged.

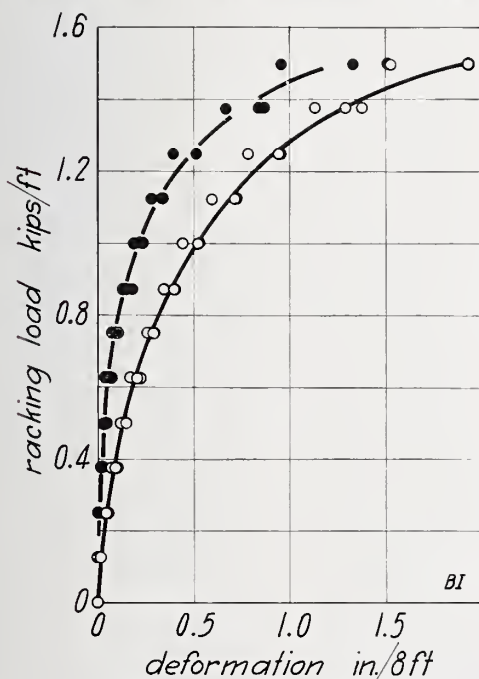
FIGURE 37.—Racking load on wall *BI*.

Load-deformation (open circles) and load-set (solid circles) results for specimens *BI-R1*, *R2*, and *R3*. The loads are in kips per foot of the face width of specimen (8 ft 0 in.).

The results for wall specimens *BI-R1*, *R2*, and *R3* are shown in table 13 and in figure 37.

placement between the interior boards at the joint and one interior board was cracked at the upper end near the loaded edge. In specimens *R2* and *R3* at a load of 1.375 kips/ft there was noticeable vertical displacement at the joint between the interior boards, some nails in the top plate pulling through the edge of the interior boards. At the maximum loads each of the specimens failed by the top plate pulling the nails from the studs and through the edges of the sheathing and interior board.

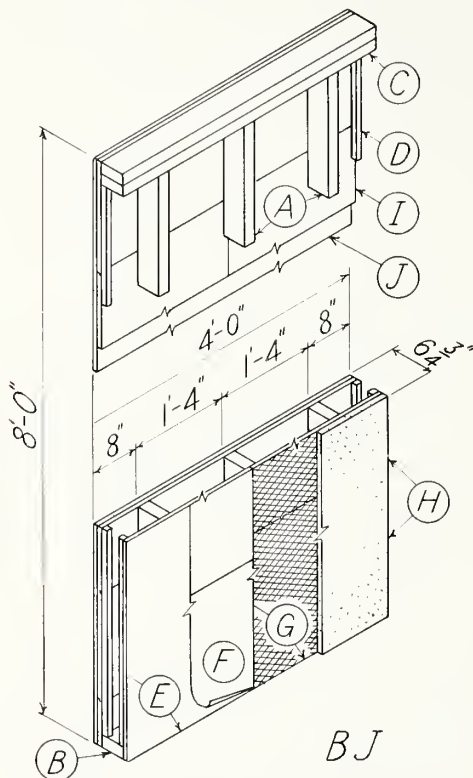
FIGURE 38.—Four-foot wall specimen BJ.

A, stud; B, floor plate; C, top plate; D, nailing strip; E, sheathing; F, sheathing paper; G, metal lath; H, stucco; I, lath; J, plaster.

The 4-ft wall specimens were 8 ft 0 in. high, 4 ft 0 in. wide, and 6 3/4 in. thick. Each specimen consisted of a wood frame to which the faces were fastened. The frame consisted of three studs, *A*, shown in figure 38, fastened to a floor plate, *B*, and a top plate, *C*, by nails. The outside face consisted of wood nailing strips, *D*, insulating-board sheathing, *E*, sheathing paper, *F*, metal lath, *G*, and stucco, *H*. The inside face consisted of wood nailing strips, *D*, insulating-board lath, *I*, and plaster, *J*. The specimens were not painted.

Studs.—The studs, *A*, were red pine, 1 1/2 by 3 5/8 in. (nominal 2 by 4 in.), 7 ft 7 1/8 in. long, spaced 1 ft 4 in. on centers. The lower end of each stud was fastened to the floor plate by two 16d common nails driven from the bottom of the plate (not toenailed), and the upper end of each stud was fastened to the top plate by two 16d common nails driven from the top of the lower member of the plate.

Top plate.—The top plate, *C*, consisted of two pieces of red pine, $1\frac{1}{8}$ by $3\frac{3}{8}$ in. (nominal 2 by 4 in.), 4 ft 0 in. long, fastened by ten 10d common nails driven from the top of the plate.

Nailing strips.—The nailing strips, *D*, were red pine, $\frac{3}{4}$ by $\frac{3}{4}$ in., 7 ft 7 in. long. In the

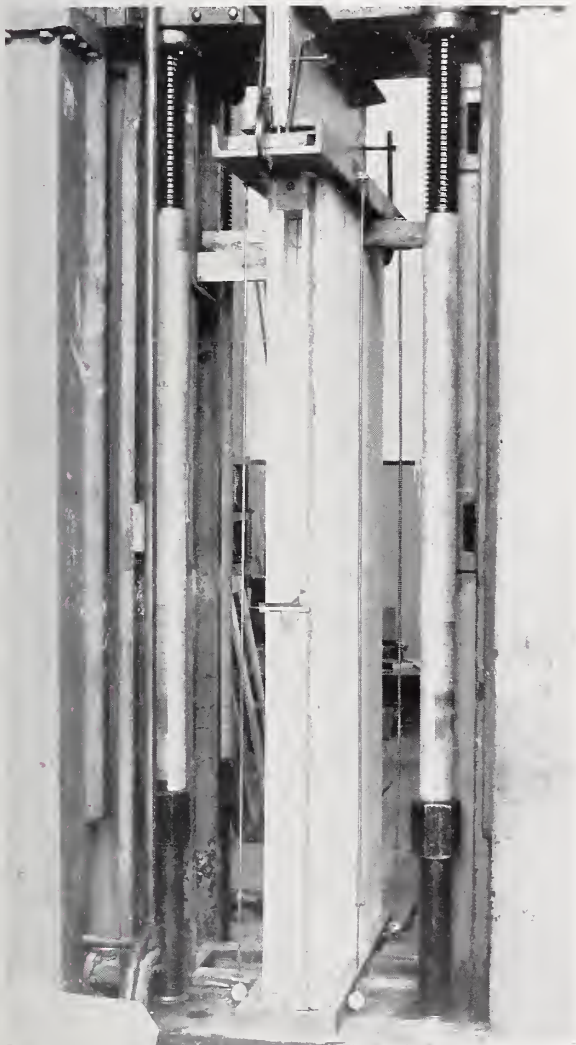
FIGURE 39.—Wall specimen *BJ-C2* under compressive load.

Wall specimen *BJ-C2* under compressive load is shown in figure 39. The results for wall

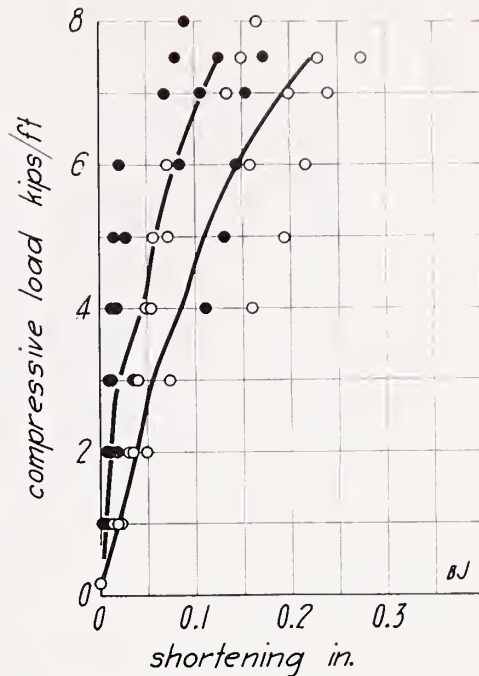
FIGURE 40.—Compressive load on wall *BJ*.

Load-shortening (open circles) and load-set (solid circles) results for specimens *BJ-C1*, *C2*, and *C3*. Load applied one-third the thickness (1.21 in.) from the inside surface of the studs. The loads are in kips per foot of actual width of specimen.

specimens *BJ-C1*, *C2*, and *C3* are shown in table 13 and in figures 40 and 41.

At loads of 6.5, 3.5, and 6 kips/ft on specimens *C1*, *C2*, and *C3*, respectively, the plaster spalled at one end of the specimen. At a load of 7.5 kips/ft on specimen *C3* the stucco cracked transversely across the specimen about 6 in. from the upper end. At the maximum loads specimens *C1* and *C3* failed by crushing of the lower member of the top plate locally at the inside edge of the studs. Specimen *C2* failed by the top plate crushing locally at the inside edge of the studs and separating at the outside edge. In specimen *C2* this rotation pulled the nails from the studs, ruptured the sheathing transversely across the specimen, and allowed the specimen to push out under load without breaking the studs.

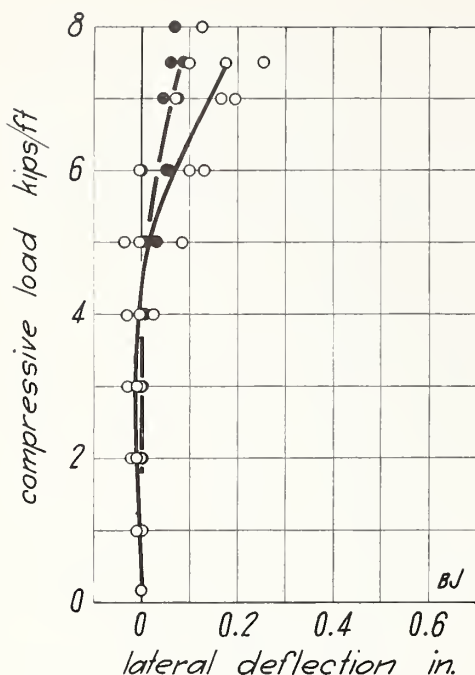
FIGURE 41.—Compressive load on wall BJ.

Load-lateral deflection (open circles) and load-lateral set (solid circles) results for specimens BJ-C1, C2, and C3. Load applied one-third the thickness (1.21 in.) from the inside surface of the studs. The loads are in kips per foot of actual width of specimen.

The lateral deflections shown in figure 41 are plotted to the right of the vertical axis for deflections of the specimens toward the outside face and to the left for deflections toward the inside face. No explanation was found for the deflections of the specimens toward the inside face under loads less than 6 kips/ft.
