REPORT BMS31

Structural Properties of
"Insulite" Wall and "Insulite"
Partition Constructions
Sponsored by The Insulite Co.

HERBERT L. WHITTEMORE
and AMBROSE H. STANG

NATIONAL
BUREAU OF STANDARDS

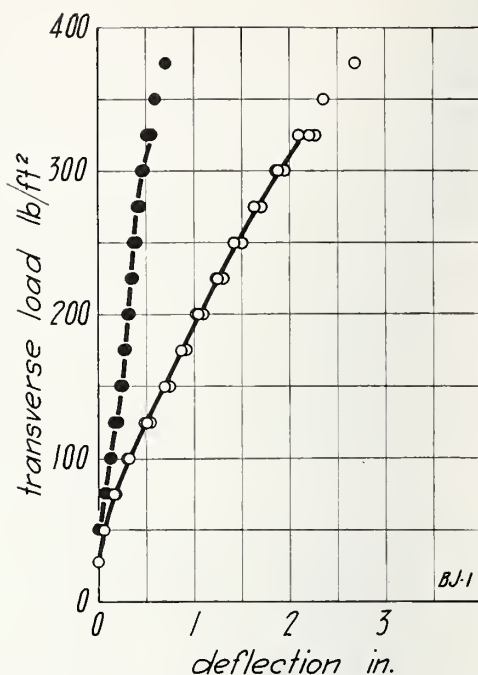
FIGURE 42.—Transverse load on wall BJ, load applied to inside face.

Load-deflection (open circles) and load-set (solid circles) results for specimens BJ-T1, T2, and T3 on the span 7 ft 6 in.

The results are shown in table 13 and in figure 42 for wall specimens BJ-T1, T2, and T3, loaded on the inside (plastered) face, and in figure 43 for wall specimens BJ-T4, T5, and T6, loaded on the outside (stuccoed) face.

In each of the specimens T1, T2, and T3 the stucco cracked transversely across the specimen in several places either near or between the loading rollers. The first cracks occurred at loads of 97 lb/ft² on each specimen and deflections of 0.30, 0.28, and 0.30 in. in specimens T1, T2, and T3, respectively. In each of the specimens the plaster cracked longitudinally along the studs at the loading rollers and transversely across the specimen in several places. The first longitudinal cracks occurred at loads of 250, 275, and 150 lb/ft² and deflections of 1.50, 1.63, and 0.69 in. in specimens T1, T2, and T3, respectively. The first transverse cracks occurred at loads of 300, 275, and 300 lb/ft² and deflections of 1.95, 1.63,

and 1.87 in. in specimens *T1*, *T2*, and *T3*, respectively. About one-half of the transverse cracks in the plaster occurred at lath joints. At the maximum loads specimens *T1* and *T3* failed by rupture of the center stud, one outer stud, and the sheathing at a loading roller. Specimen *T2* failed by rupture of all three studs and the sheathing at a loading roller.

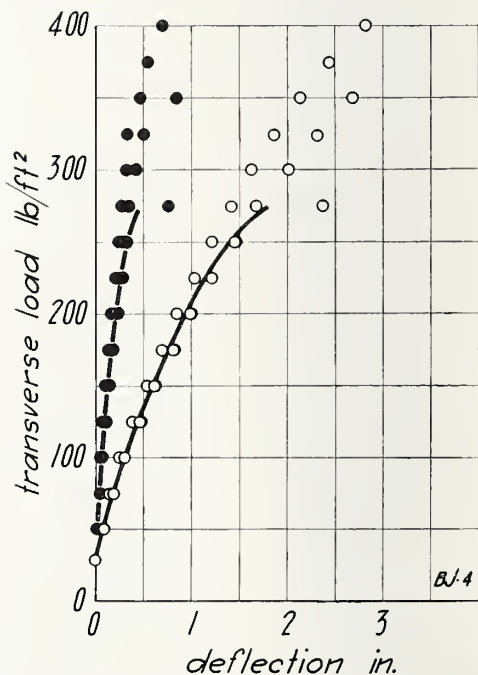
FIGURE 43.—Transverse load on wall BJ, load applied to outside face.

Load-deflection (open circles) and load-set (solid circles) results for specimens BJ-T4, T5, and T6 on the span 7 ft 6 in.

In each of the specimens *T4*, *T5*, and *T6* (loaded on the stuccoed face) the plaster cracked transversely across the specimen at each of the lath joints and also between some of the lath joints. The first cracks occurred at loads of 100, 70, and 100 lb/ft², and deflections of 0.24, 0.15, and 0.31 in. in specimens *T4*, *T5*, and *T6*, respectively. For each of the specimens the stucco cracked transversely across the specimen at one or both loading rollers. The first cracks occurred at loads of 375, 250, and 200 lb/ft² and deflections of 2.43, 1.45, and 1.00 in. in specimens *T4*, *T5*, and *T6*, respectively. At the maximum load, specimen *T4* failed by rupture of all three studs at a loading roller. Specimen *T5* failed by rupture of the center stud and one outer stud between the loading rollers. Specimen *T6* failed by rupture of both outer studs between the loading rollers.

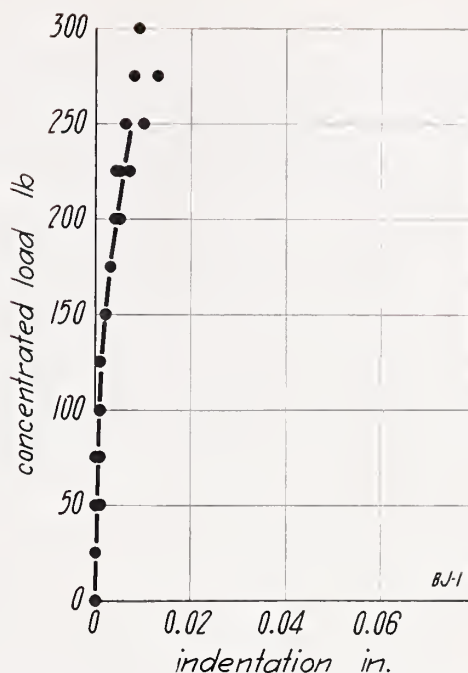
FIGURE 44.—Concentrated load on wall BJ, load applied to inside face.

Load-indentation results for specimens *BJ-P1*, *P2*, and *P3*.

The results are shown in table 13 and in figure 44 for specimens *BJ-P1*, *P2*, and *P3*, loaded on the inside (plastered) face, and in figure 45 for specimens *BJ-P4*, *P5*, and *P6*, loaded on the outside (stuccoed) face.

The concentrated loads were applied to the inside face of specimens *P1*, *P2*, and *P3* on the plaster midway between two studs and about 4 ft from one end. Each of the specimens failed by punching of the disk through the plaster and into the lath.

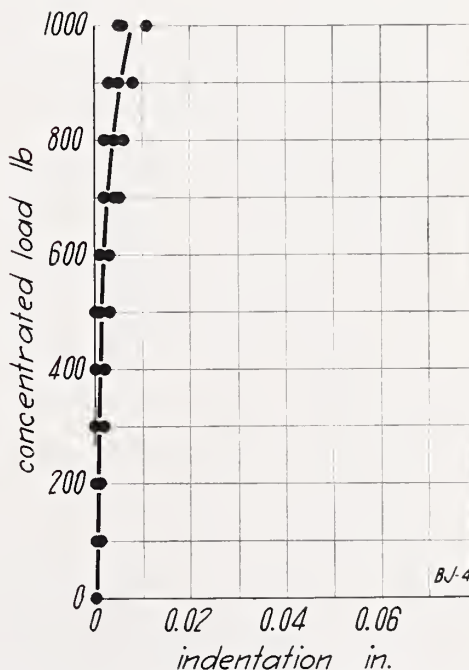
FIGURE 45.—Concentrated load on wall BJ, load applied to outside face.

Load-indentation results for specimens *BJ-P4*, *P5*, and *P6*.

The concentrated loads were applied to the outside face of specimens *P4*, *P5*, and *P6* on the stucco midway between two studs and about 4 ft from the lower end. The indentations after a load of 1,000 lb had been applied were 0.005, 0.006, and 0.011 in. in specimens *P4*, *P5*, and *P6*, respectively, and no other effect was observed.

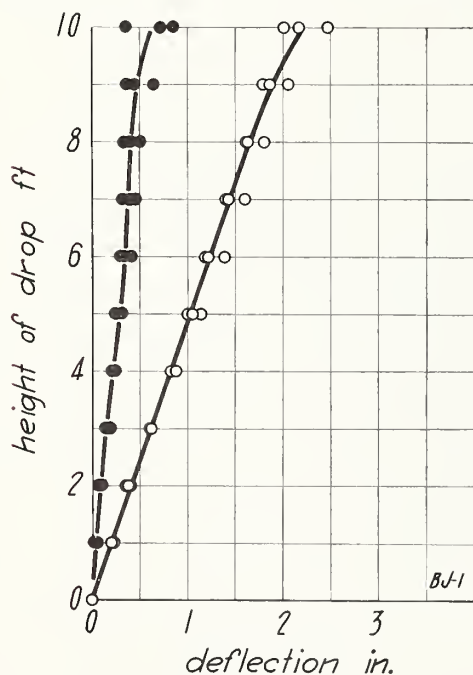
FIGURE 46.—Impact load on wall *BJ*, load applied to inside face.

Height of drop-deflection (open circles) and height of drop-set (solid circles) results for specimens *BJ-I1*, *I2*, and *I3* on the span 7 ft 6 in.

The results are shown in table 13 and in figure 46 for wall specimens *BJ-I1*, *I2*, and *I3*, loaded on the inside face, and in figure 47 for wall specimens *BJ-I4*, *I5*, and *I6*, loaded on the outside face.

The impact loads were applied to the center of the inside face of specimens *I1*, *I2*, and *I3*, the sandbag striking the plaster directly over the center stud. In each of the specimens *I1*, *I2*, and *I3* at drops of 2.5, 2, and 2.5 ft and deflections of 0.49, 0.40, and 0.47 in., respectively, the stucco cracked either along or diagonally across the center stud. At drops of 3, 4.5, and 4 ft, respectively, the inside face of each specimen failed by rupture of the plaster where the sandbag struck. At drops of 4, 8, and 6 ft and deflections of 0.88, 1.61, and 1.22 in., respectively, the stucco cracked transversely across each specimen near midspan. In specimens *I1* and *I3* at a drop of 8 ft the outside face of each specimen failed by opening of the cracks in the stucco. In specimen *I1* the center stud broke at midspan at a drop of 9.5 ft. The sets after

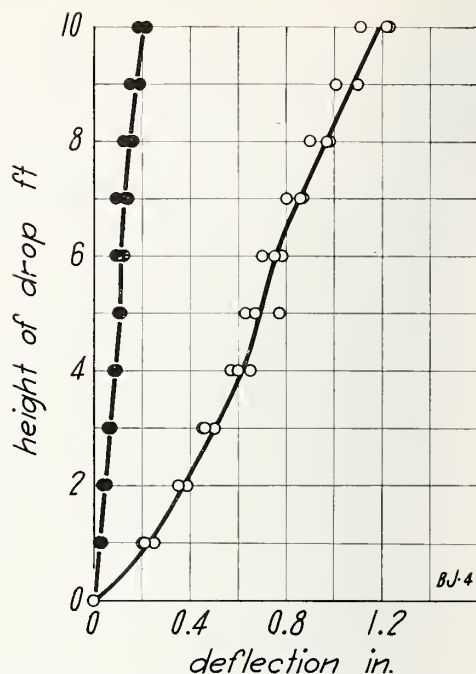
FIGURE 47.—Impact load on wall *BJ*, load applied to outside face.

Height of drop-deflection (open circles) and height of drop-set (solid circles) results for specimens *BJ-I4*, *I5*, and *I6* on the span 7 ft 6 in.

The impact loads were applied to the center of the outside face of specimens *I4*, *I5*, and *I6*, the sand bag striking the stucco directly over the center stud. In each of the specimens *I4*, *I5*, and *I6* at drops of 3.5, 1, and 3.5 ft and deflections of 0.58, 0.20, and 0.54 in., respectively, the plaster cracked transversely across each specimen at a lath joint near midspan. At drops of 6.5, 5.5, and 5 ft for specimens *I4*, *I5*, and *I6*, respectively, the inside face of each specimen failed by opening of the cracks in the plaster. In each of the specimens the stucco cracked longitudinally at drops of 6.0, 6.5, and 6.5 ft and deflections of 0.78, 0.75, and 0.79 in., respectively, and transversely at drops of 7.5, 8.5, and 10 ft and deflections of 0.90, 0.95, and 1.23 in., respectively. In specimen *I4* the outside face failed by opening of a longitudinal crack over the center stud. The sets after a drop of 10 ft were 0.18, 0.22, and 0.22 in. in specimens *I4*, *I5*, and *I6*, respectively, and the studs and sheathing and lath were undamaged.

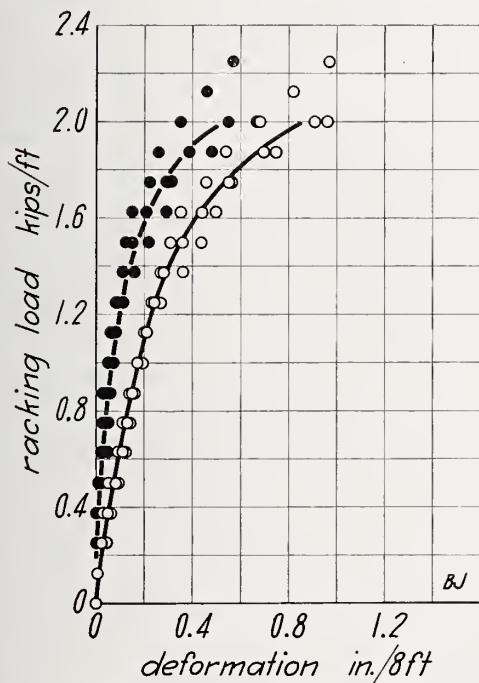
FIGURE 48.—Racking load on wall *BJ*.

Load-deformation (open circles) and load-set (solid circles) results for specimens *BJ-R1*, *R2*, and *R3*. The loads are in kips per foot of the face width of specimen (8 ft 0 in.).

The results for wall specimens *BJ-R1*, *R2*, and *R3* are shown in table 13 and in figure 48.

The racking loads were applied to the top plate only, and the stop was in contact with the floor plate only. In each of the specimens the plaster cracked in several places approximately parallel to a diagonal from the point of application of load to the stop. The first cracks occurred at loads of 1.625, 1.750, and 1.750 kips/ft and deformations of 0.50, 0.46, and 0.56 in./8 ft in specimens *R1*, *R2*, and *R3*, respectively. At the maximum load each of the specimens failed by shearing of the plaster from the lath, pulling of some of the nails through the edges of the sheathing, and pulling the top plate from the studs. The stucco was undamaged.

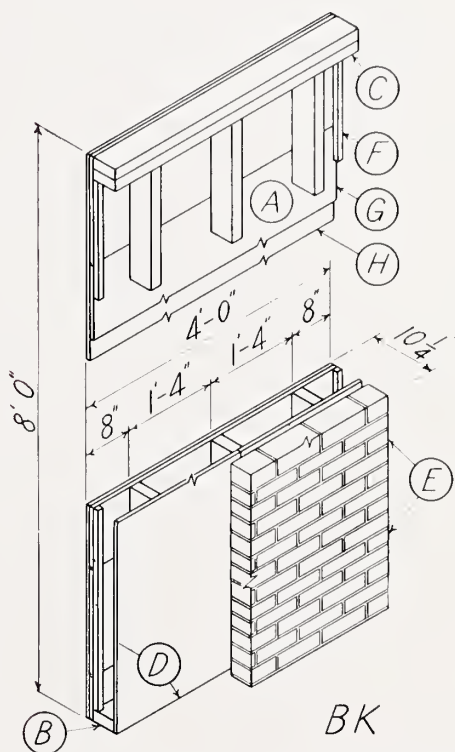
FIGURE 49.—Four-foot wall specimen *BK*.

A, stud; *B*, floor plate; *C*, top plate; *D*, sheathing; *E*, brick veneer; *F*, nailing strips; *G*, lath; *H*, plaster.

The 4-ft wall specimens were 8 ft 0 in. high, 4 ft 0 in. wide, and 10¼ in. thick. Each speci-

men consisted of a wood frame to which the faces were fastened. The frame consisted of three studs, *A*, shown in figure 49, fastened to a floor plate, *B*, and a top plate, *C*, by nails. The outside face consisted of insulating-board sheathing, *D*, and brick veneer, *E*, fastened to the studs by wall ties. The inside face consisted

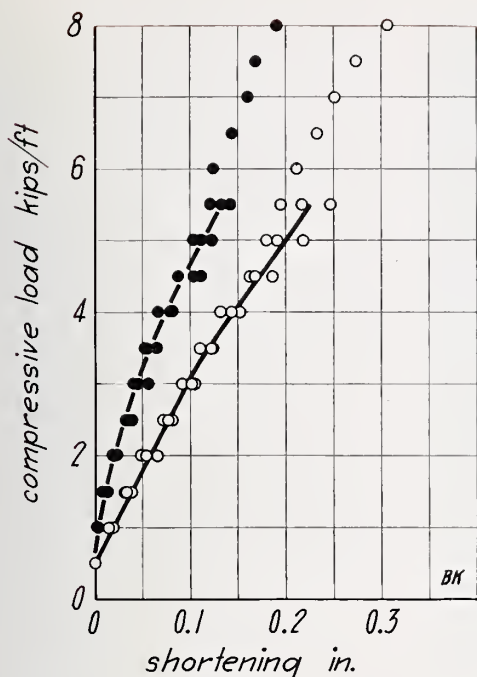
FIGURE 50.—Compressive load on wall BK.

Load-shortening (open circles) and load-set (solid circles) results for specimens BK-C1, C2, and C3. Load applied to the wood frame only, one-third the thickness (1.21 in.) from the inside surface of the studs. The loads are in kips per foot of actual width of specimen.

The results for wall specimens *BK-C1*, *C2*, and *C3* are shown in table 13 and in figures 50 and 51.

Each of the specimens failed by the top plate crushing locally at the inside edge of the studs and separating at the outside edge. This rotation of the top plate pulled the nails from the studs, ruptured the sheathing transversely across most of the width of the specimen, and either ruptured the lath or separated it from the upper ends of the studs. No failure of the brick veneer was observed.

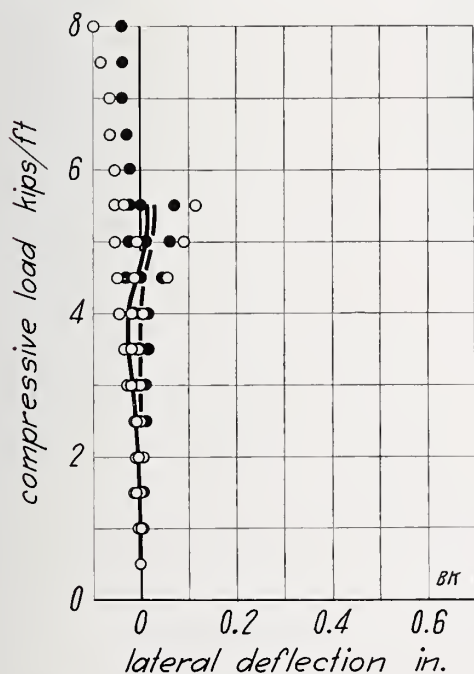
FIGURE 51.—Compressive load on wall BK.

Load-lateral deflection (open circles) and load-lateral set (solid circles) results for specimens BK-C1, C2, and C3. Load applied to the wood frame only, one-third the thickness (1.21 in.) from the inside surface of the studs. The loads are in kips per foot of actual width of specimen.

The upper loading plate was not in contact with the brick veneer. The lateral deflections shown in figure 51 are plotted to the right of the vertical axis for deflections of the specimens toward the outside face and to the left for deflections toward the inside face. Specimens *C1* and *C3* deflected toward the inside face for all loads up to and including the maximum load. Specimen *C2* deflected toward the outside face for almost all loads. The lateral deflections of specimens *C1* and *C3* toward the inside face were probably due either to the stiffness of the inside face counteracting the effect of the eccentric loads or to the little resistance afforded by the brick veneer to deflection in this direction.

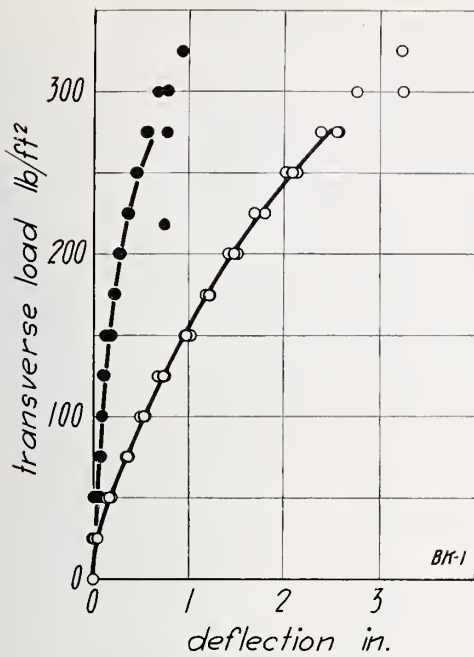
FIGURE 53.—Transverse load on wall BK, load applied to inside face.

Load-deflection (open circles) and load-set (solid circles) results for specimens BK-T1, T2, and T3 on the span 7 ft 6 in.

Wall specimen BK-T3 under transverse load is shown in figure 52. The results are shown in table 13 and in figure 53 for wall specimens BK-T1, T2, and T3, loaded on the inside (plastered) face, and in figure 54 for wall specimens BK-T4, T5, and T6, loaded on the outside (brick-veneer) face.

The deflections of the studs and of the brick veneer were each measured. The lateral deflections shown in figures 53 and 54 are the average of these values.

In each of the specimens T1, T2, and T3 the brick veneer cracked at three or four bed joints owing to rupture of the bond between the brick and the mortar. The first cracks occurred at or between the loading rollers at loads of 75, 50, and 50 lb/ft² and deflections of 0.38, 0.19, and 0.17 in. in specimens T1, T2, and T3, respectively. In each of the specimens the plaster cracked longitudinally along either one or both outer studs and transversely across the specimen at each lath joint. The first longitudinal cracks occurred at loads of 200, 150, and 150 lb/ft² and deflections of 1.41, 0.97, and 1.01 in. in specimens T1, T2, and T3, respectively. The first transverse cracks occurred at or between loading rollers at loads of 150, 175, and 225 lb/ft² and deflections of 0.96, 1.23, and 1.80 in. in specimens T1, T2, and T3, respectively. At the maximum loads each of the specimens T1, T2, and T3 failed by rupture of one outer stud at the upper loading roller and lateral displacement of the lower portion of the brick veneer with respect to the upper portion at a ruptured bed joint.

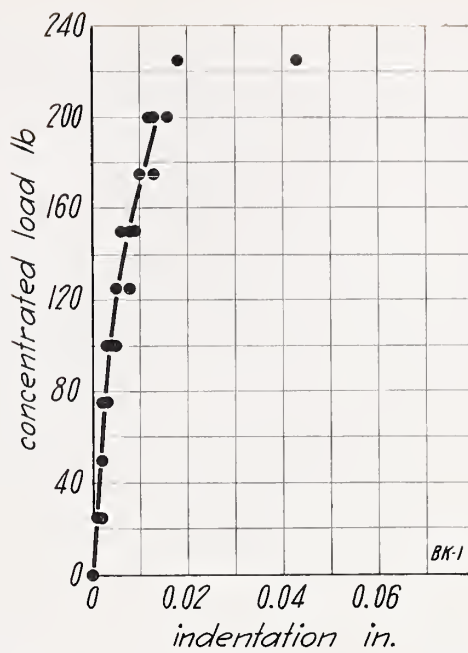
FIGURE 55.—Concentrated load on wall BK, load applied to inside face.

Load-indentation results for specimens BK-P1, P2, and P3.

The results are shown in table 13 and in figure 55 for wall specimens *BK-P1*, *P2*, and *P3*, loaded on the inside face, and in figure 56 for wall specimens *BK-P4*, *P5*, and *P6*, loaded on the outside face.

The concentrated loads were applied to the inside face of specimens *P1*, *P2*, and *P3* on the plaster midway between two studs and about 3 ft from the lower end. Each of the specimens failed by punching of the disk through the plaster and into the lath.

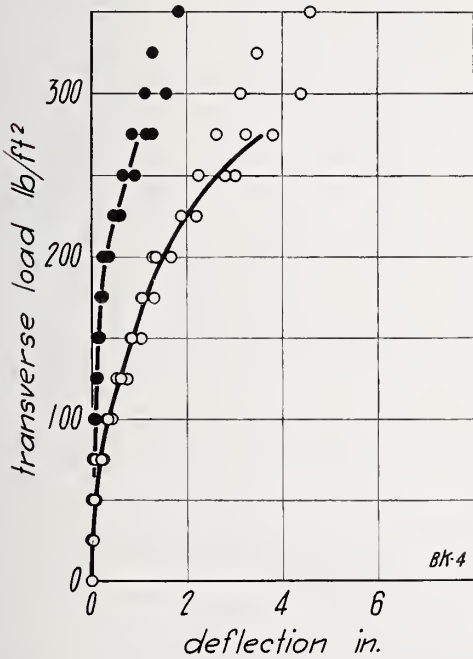
FIGURE 54.—Transverse load on wall BK, load applied to outside face.

Load-deflection (open circles) and load-set (solid circles) results for specimens BK-T4, T5, and T6 on the span 7 ft 6 in.

In each of the specimens T4, T5, and T6 (loaded on the brick veneer) the brick veneer cracked at four or five bed joints owing to rupture of the bond between the brick and the mortar. The first cracks occurred at or near

the upper loading roller at loads of 64, 85, and 75 lb/ft² and deflections of 0.16, 0.17, and 0.21 in. in specimens *T4*, *T5*, and *T6*, respectively. In each of the specimens the plaster cracked transversely across the specimen in several places. About one-half of the cracks were at lath joints. The first cracks occurred near the upper loading roller at loads of 124, 100, and 132 lb/ft² and deflections of 0.76, 0.32, and 0.66 in. in specimens *T4*, *T5*, and *T6*, respectively. At the maximum load specimens *T4* and *T6* failed by rupture of one outer stud at a loading roller and lateral displacement of the brick veneer at a ruptured bed joint. Specimen *T5* failed by rupture of the center stud and one outer stud at midspan.

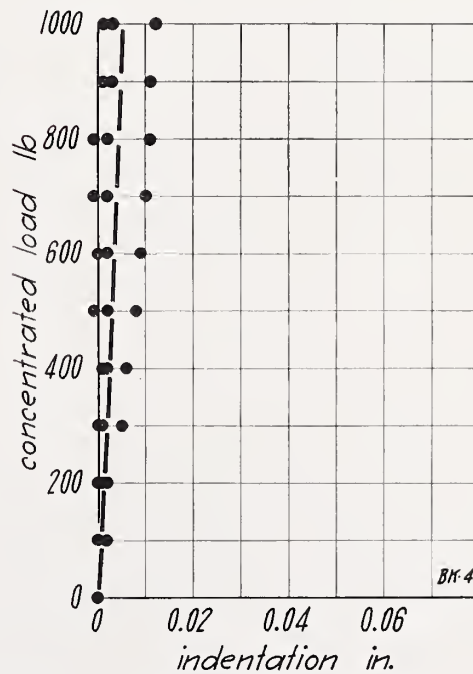
FIGURE 56.—Concentrated load on wall BK, load applied to outside face.

Load-indentation results for specimens BK-P4, P5, and P6.

The concentrated loads were applied to the outside face of specimens *P4*, *P5*, and *P6* on a brick at midwidth in a course midway between

wall ties, about $3\frac{1}{2}$ ft from the lower end. The indentations after a load of 1,000 lb had been applied were 0.001, 0.012, and 0.003 in. in specimens *P*₄, *P*₅, and *P*₆, respectively, and no further effect was observed.

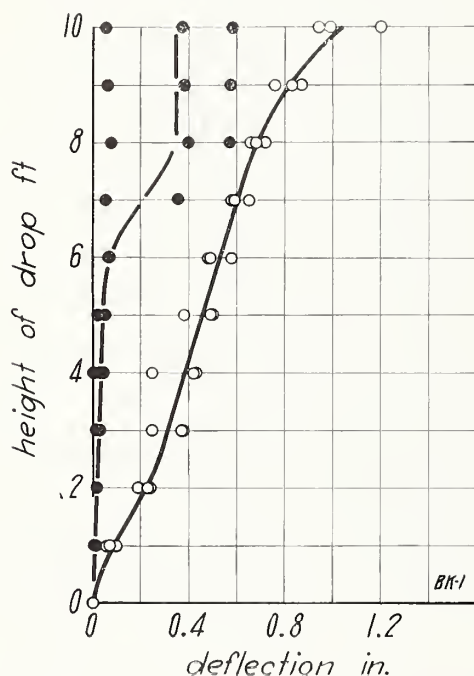
FIGURE 57.—Impact load on wall BK, load applied to inside face.

Height of drop-deflection (open circles) and height of drop-set (solid circles) results for specimens *BK-I1*, *I2*, and *I3* on the span 7 ft 6 in.

The results are shown in table 13 and in figure 57 for wall specimens *BK-I1*, *I2*, and *I3*, loaded on the inside face, and in figure 58 for wall specimens *BK-I4*, *I5*, and *I6*, loaded on the outside face.

The specimens were vertical when tested. The impact loads were applied to the center of the inside face of specimens *I1*, *I2*, and *I3*, the sandbag striking the plaster directly over the center stud. At drops of 3.5, 3.5, and 2.5 ft on specimens *I1*, *I2*, and *I3*, respectively, the inside face failed by rupture of the lath and plaster where the bag struck. At drops of 3, 2.5, and 3.5 ft, and deflections of 0.38, 0.32, and 0.25 in., respectively, the brick veneer of each specimen cracked by rupture of the bond

between the brick and mortar at a bed joint near midspan. At drops of 6, 6, and 7.5 ft on specimens *I1*, *I2*, and *I3*, respectively, the outside face of each specimen failed by lateral displacement of the brick veneer at a ruptured bed joint. The sets after a drop of 10 ft were 0.58, 0.37, and 0.05 in., respectively, and the studs were undamaged.

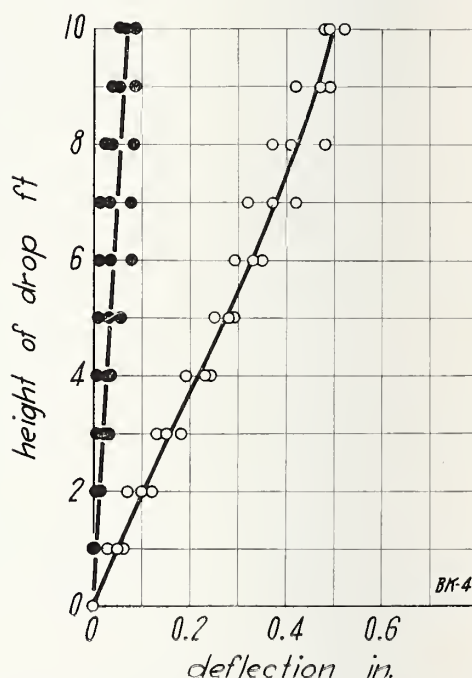
FIGURE 58.—Impact load on wall BK, load applied to outside face.

Height of drop-deflection (open circles) and height of drop-set (solid circles) results for specimens *BK-I4*, *I5*, and *I6* on the span 7 ft 6 in.

The impact loads were applied to the center of the outside face of specimens *I4*, *I5*, and *I6*, the sandbag striking the brick veneer directly over the center stud. In specimens *I4* and *I5* at drops of 7 and 9 ft and deflections of 0.42 and 0.42 in., respectively, the brick veneer of

each specimen cracked owing to rupture of the bond between the brick and the mortar at a bed joint near midspan. In specimen *I4* at a drop of 10 ft and a deflection of 0.52 in., the plaster cracked transversely across the specimen near midspan. The sets after a drop of 10 ft were 0.08, 0.07, and 0.05 in. in specimens *I4*, *I5*, and *I6*, respectively, and neither the faces nor the studs failed.

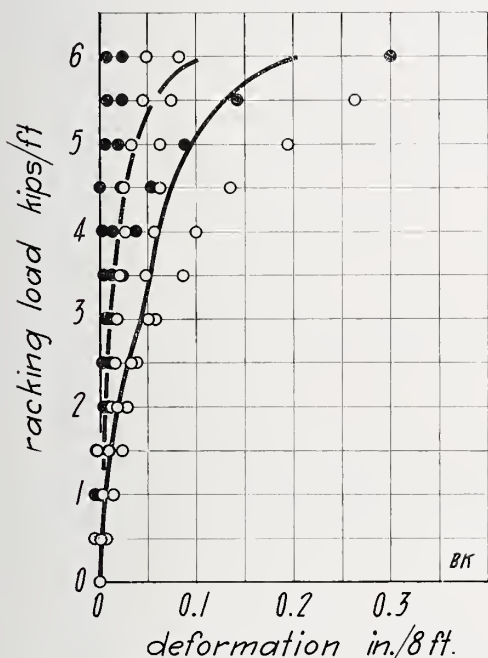
FIGURE 59.—Racking load on wall *BK*.

Load-deformation (open circles) and load-set (solid circles) results for specimens *BK-R1*, *R2*, and *R3*. The loads are in kips per foot of the face width of specimen (8 ft 0 in).

tions and sets shown in figure 59 for a height of 8 ft were computed from the values obtained from the measuring-device readings. The gage length of the vertical measuring device was 6 ft 9 in. The gage length of the horizontal measuring device was 5 ft. The deformations and sets are the averages of the deformations and sets for the wood frame and for the brick veneer measured independently by two sets of deformation-measuring devices.

The results for wall specimens *BK-R1*, *R2*, and *R3* are shown in table 13 and in figure 59.

tionally in several places, approximately parallel to a diagonal from the point of application of load to the stop. There was also noticeable vertical displacement between the sheathing boards at the joint. During the application of the next increment of load the wood frame deformed so much more than the brick veneer that the ring dynamometer slipped out of the frame. The ring dynamometer was then centered 2.5 in. from the outside face, a load of 6.25 kips/ft was applied, and no further effect was observed.

Specimen *R2* failed by rupture of the brick veneer in a stepwise crack approximately along a diagonal from the point of application of load to the stop. The crack usually followed the bed and head joints but went through the brick in a few places. No other failure of the specimen was observed. In specimen *R3* the set after a load of 6.25 kips/ft had been applied was 0.026 in./8 ft, and no further effect was observed.

In specimen *R1* at a load of 6 kips/ft and a deformation of 0.46 in./8 ft, the plaster cracked

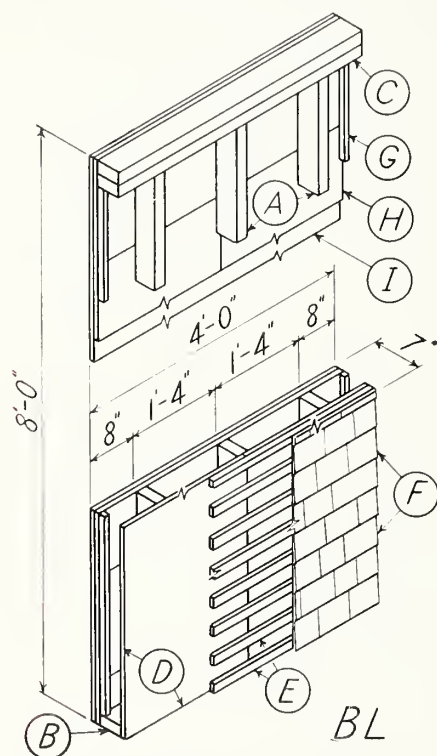
FIGURE 60.—Four-foot wall specimen BL.

A, stud; *B*, floor plate; *C*, top plate; *D*, sheathing; *E*, furring strip; *F*, shingles; *G*, nailing strip; *H*, lath; *I*, plaster.

The 4-ft wall specimens were 8 ft 0 in. high, 4 ft 0 in. wide, and 7 in. thick. Each specimen consisted of a wood frame to which the faces were fastened. The frame consisted of three studs, *A*, shown in figure 60, fastened to a floor plate, *B*, and a top plate, *C*, by nails. The outside face consisted of insulating-board sheathing, *D*, wood furring strips, *E*, and wood shingles, *F*. The inside face consisted of wood nailing strips, *G*, insulating-board lath, *H*, and plaster, *I*. The specimens were not painted.

Studs.—The studs, *A*, were red pine, 1½ by 3½ in. (nominal 2 by 4 in), 7 ft 7½ in. long,

Floor plate.—The floor plate, *B*, was red pine, $1\frac{1}{2}$ by $3\frac{3}{4}$ in. (nominal 2 by 4 in.), 4 ft 0 in. long.

Top plate.—The top plate, *C*, consisted of two pieces of red pine, $1\frac{1}{2}$ by $3\frac{3}{4}$ in. (nominal

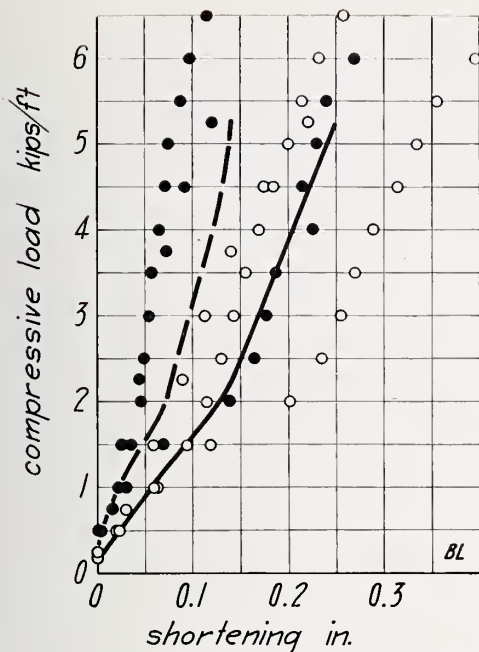
FIGURE 61.—Compressive load on wall BL.

Load-shortening (open circles) and load-set (solid circles) results for specimens *BL-C1*, *C2*, and *C3*. Load applied one-third the thickness (1.21 in.) from the inside surface of the studs. The loads are in kips per foot of actual width of specimen.

The results for wall specimens *BL-C1*, *C2*, and *C3* are shown in table 13 and in figures 61 and 62.

Each of the specimens failed by crushing of the lower member of the top plate, locally, at the inside edge of the studs, causing the plate to rotate and allowing the specimens to push out under load without breaking the studs.

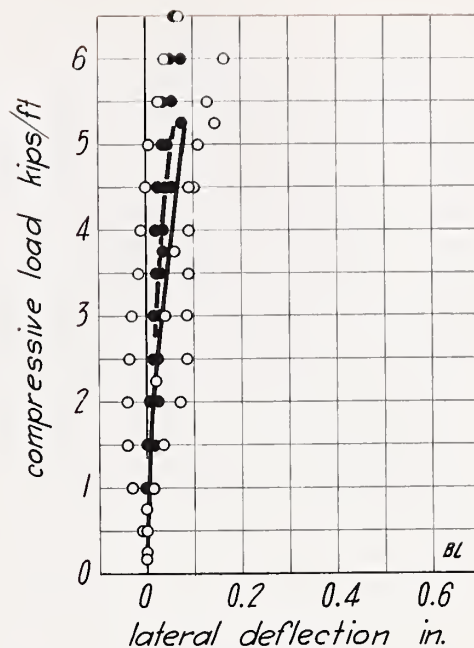
FIGURE 62.—Compressive load on wall BL.

Load-lateral deflection (open circles) and load-lateral set (solid circles) results for specimens *BL-C1*, *C2*, and *C3*. Load applied one-third the thickness (1.21 in.) from the inside surface of the studs. The loads are in kips per foot of actual width of specimen.

The lateral deflections shown in figure 62 were plotted to the right of the vertical axis for deflections of the specimens toward the outside face and to the left for deflections toward the inside face. Specimen *C3* deflected toward the inside face for loads up to 4.5 kips/ft, probably owing to the stiffness of the inside face counteracting the effect of the eccentric load.

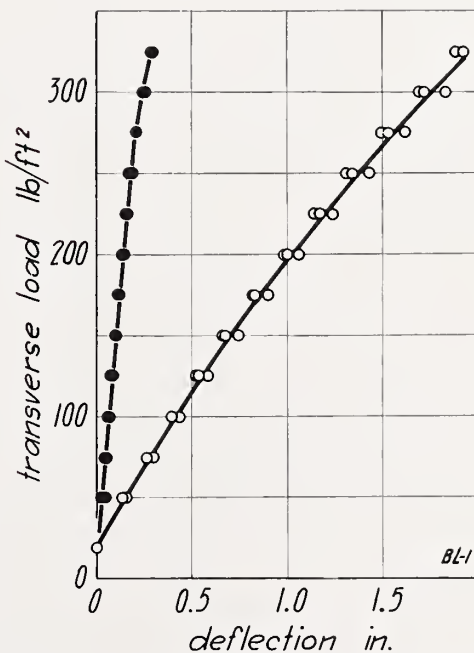
FIGURE 63.—Transverse load on wall BL, load applied to inside face.

Load-deflection (open circles) and load-set (solid circles) results for specimens *BL-T1*, *T2*, and *T3* on the span 7 ft 6 in.

The results are shown in table 13 and in figure 63 for wall specimens *BL-T1*, *T2*, and *T3*, loaded on the inside (plastered) face, and in figure 64 for wall specimens *T4*, *T5*, and *T6*, loaded on the outside (shingled) face.

In each of the specimens *T1*, *T2*, and *T3*, the plaster cracked longitudinally along one or both outer studs and transversely across the specimen in several places. The first longitudinal cracks occurred at loads of 225, 75, and 75 lb/ft² and deflections of 1.14, 0.26, and 0.29 in. in specimens *T1*, *T2*, and *T3*, respectively. Some of the transverse cracks occurred at lath joints. The first transverse cracks occurred at or between the loading rollers at loads of 225, 200, and 175 lb/ft² and deflections of 1.14, 1.00, and 0.90 in. in specimens *T1*, *T2*, and *T3*, respectively. At the maximum loads each of the specimens failed by rupture of the center stud, one outer stud, and the sheathing at or between the loading rollers. In addition, in specimen *T1*, some of the shingles separated from the furring strips where the studs ruptured.

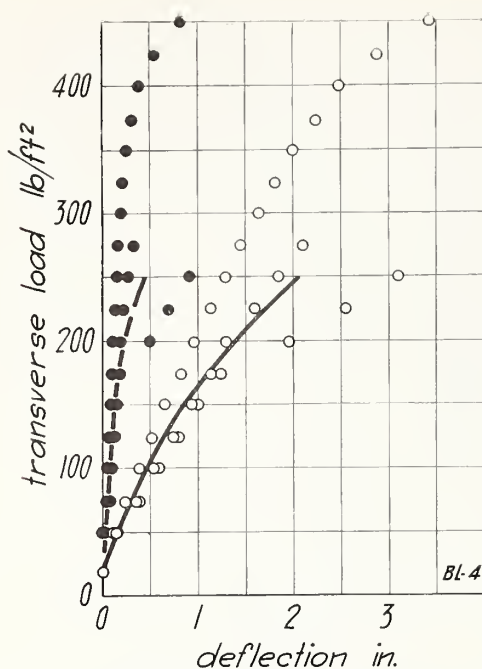
FIGURE 64.—Transverse load on wall BL, load applied to outside face.

Load-deflection (open circles) and load-set (solid circles) results for specimens BL-T4, T5, and T6 on the span 7 ft 6 in.

In each of the specimens *T4*, *T5*, and *T6* (loaded on the shingles) the plaster cracked transversely across the specimen in several places. Some of the cracks occurred at lath

joints. The first cracks occurred at loads of 75, 60, and 75 lb/ft² and deflections of 0.34, 0.24, and 0.23 in. in specimens *T4*, *T5*, and *T6*, respectively. At the maximum load specimen *T4* failed by rupture of one outer stud at mid-span. Specimens *T5* and *T6* failed by rupture of all three studs at or between the loading rollers.

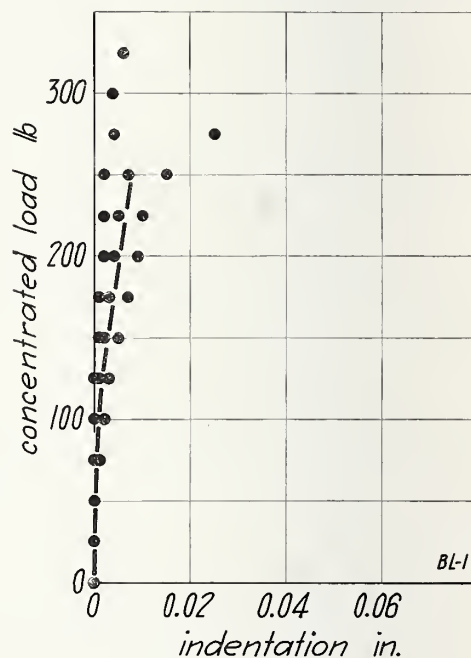
FIGURE 65.—Concentrated load on wall BL, load applied to inside face.

Load-indentation results for specimens BL-P1, P2, and P3.

The results are shown in table 13 and in figure 65 for wall specimens BL-P1, P2, and P3, loaded on the inside (plastered) faces, and in figure 66 for wall specimens BL-P4, P5,

The concentrated loads were applied to the inside face of specimens P1, P2, and P3 on the plaster midway between two studs and 1½ to 2 ft from one end. On specimens P2 and P3 the load was applied over a lath joint. Each of the specimens failed by punching of the disk through the plaster and into the lath.

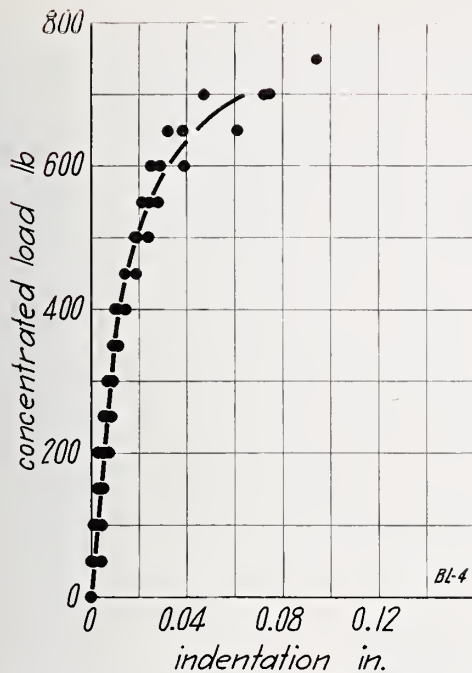
FIGURE 66.—Concentrated load on wall BL, load applied to outside face.

Load-indentation results for specimens BL-P₄, P₅, and P₆.

The concentrated loads were applied to the outside face of specimens P4, P5, and P6 on a

shingle $2\frac{3}{4}$ in. from the lower edge and about $2\frac{1}{2}$ ft from one end of the specimen, midway between two furring strips and two studs. In specimen P₄ at a load of 650 lb and in specimen P₆ at a load of 700 lb the shingle split along the grain at one edge of the disk. At the maximum loads each of the specimens failed by punching of the disk through the shingles.

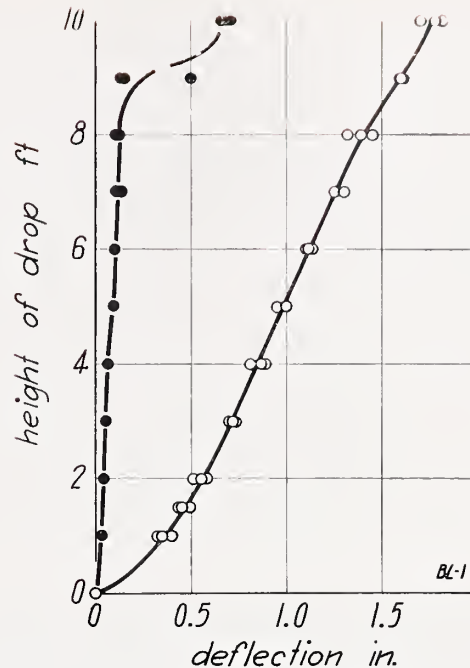
FIGURE 67.—Impact load on wall BL, load applied to inside face.

Height of drop-deflection (open circles) and height of drop-set (solid circles) results for specimens BL-11, 12, and 13 on the span 7 ft 6 in.

The results are shown in table 13 and in figure 67 for wall specimens BL-11, 12, and 13, loaded on the inside face, and in figure 68 for wall specimens BL-14, 15, and 16, loaded on the outside face.

The impact loads were applied to the center of the inside face of specimens 11, 12, and 13, the sandbag striking the plaster directly over the center stud. In each of the specimens 11, 12, and 13 the plaster cracked longitudinally over either one or both outer studs at a drop of 1 ft, and at drops of 2.5, 3, and 2.5, respectively, the inside face of each specimen failed by sagging of the overhanging plaster edges. At drops of 3.5, 2, and 3 ft and deflections of

0.79, 0.69, and 0.72 in. in specimens *I1*, *I2*, and *I3*, respectively, the plaster cracked transversely across each specimen at a lath joint near midspan. The sets after a drop of 10 ft were 0.66, 0.71, and 0.68 in. in specimens *I1*, *I2*, and *I3*, respectively. Some of the furring strips were separated from the sheathing near midspan, but the outside face and the studs did not fail.

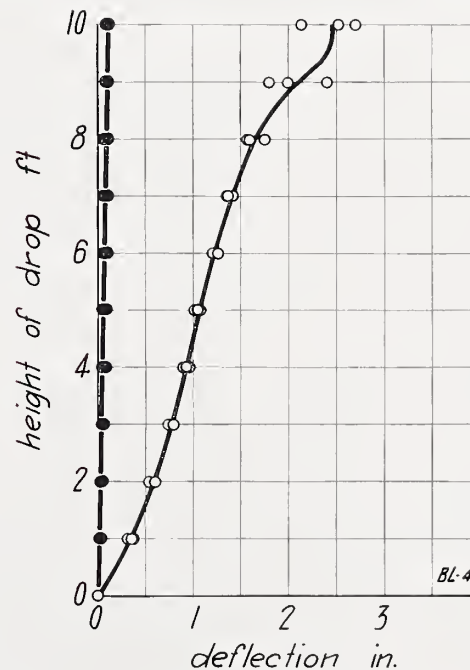
FIGURE 68.—Impact load on wall BL, load applied to outside face.

Height of drop-deflection (open circles) and height of drop-set (solid circles) results for specimens BL-14, 15, and 16 on the span 7 ft 6 in.

The impact loads were applied to the center of the outside face of specimens *I4*, *I5*, and *I6*, the sandbag striking the shingles directly over the center stud. In each of the specimens the plaster cracked transversely across each specimen at several places. The first cracks occurred at lath joints near midspan at drops of 3, 2.5, and 2.5 ft and deflections of 0.79, 0.69, and 0.65 in. in specimens *I4*, *I5*, and *I6*, re-

spectively. At drops of 4, 4.5, and 4 ft, respectively, the inside (plastered) face of each specimen failed by opening of the cracks in the plaster. The sets after a drop of 10 ft were 0.12, 0.08, and 0.08 in. in specimens *I4*, *I5*, and *I6*, respectively. Most of the plaster had fallen, but the outside face and studs were undamaged.

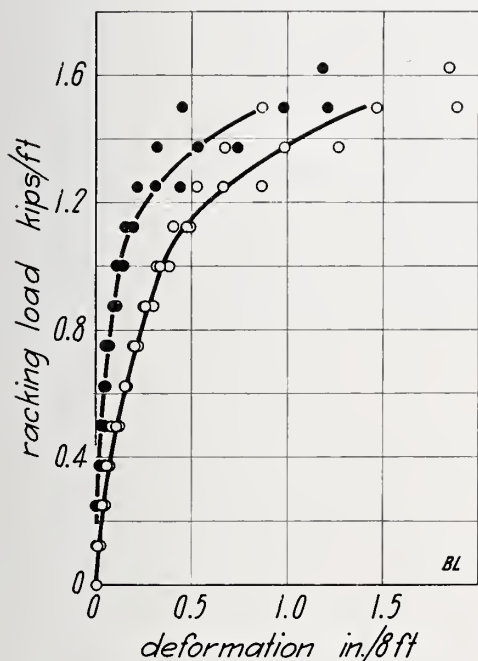
FIGURE 70.—Racking load on wall *BL*.

Load-deformation (open circles) and load-set (solid circles) results for specimens *BL-R1*, *R2*, and *R3*. The loads are in kips per foot of the face width of specimen (8 ft 0 in.).

Wall specimen *BL-R1* under racking load is shown in figure 69. The results for wall specimens *BL-R1*, *R2*, and *R3* are shown in table 13 and in figure 70.

cracks were parallel to a diagonal from the point of application of load to the stop. The first cracks occurred at loads of 1.125, 1.125, and 1.375 kips/ft and deformations of 0.49, 0.47, and 0.67 in./8 ft in specimens *R1*, *R2*, and *R3*, respectively. At a load of 1.50 kips/ft on specimens *R1* and *R2* some of the nails fastening the sheathing to the top plate pulled through the edges of the sheathing. At loads of 1.625, 1.375, and 1.592 (maximum) kips/ft

on specimens *R1*, *R2*, and *R3*, respectively, there was noticeable vertical displacement between the two sheathing boards at the joint. At the maximum loads each of the specimens failed by the top plate pulling the nails from the studs and through the sheathing and lath.

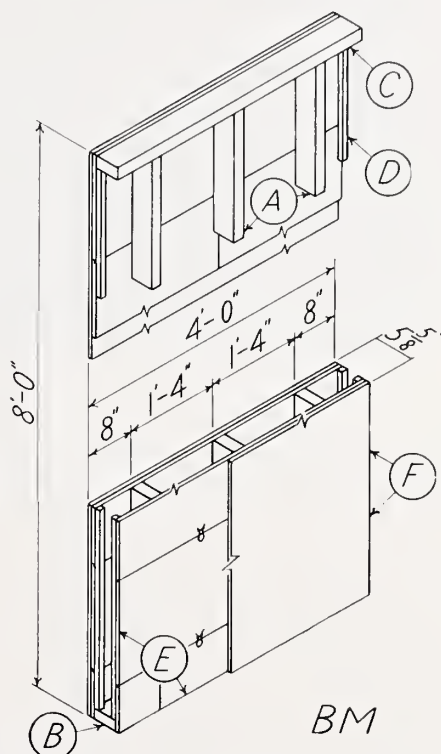
FIGURE 71.—Partition specimen *BM*.

A, stud; *B*, floor plate; *C*, top plate; *D*, nailing strip; *E*, lath; *F*, plaster.

The partition specimens were 8 ft 0 in. high, 4 ft 0 in. wide, and 5½ in. thick. Each specimen consisted of a wood frame to which two like faces were fastened. The frame consisted of three studs, *A*, in figure 71, fastened to a floor

This construction was a wood frame with "Lok-Joint" lath and plaster on both faces. It was similar to wall constructions *BG*, *BJ*, and *BK*, with the exception that the top plate

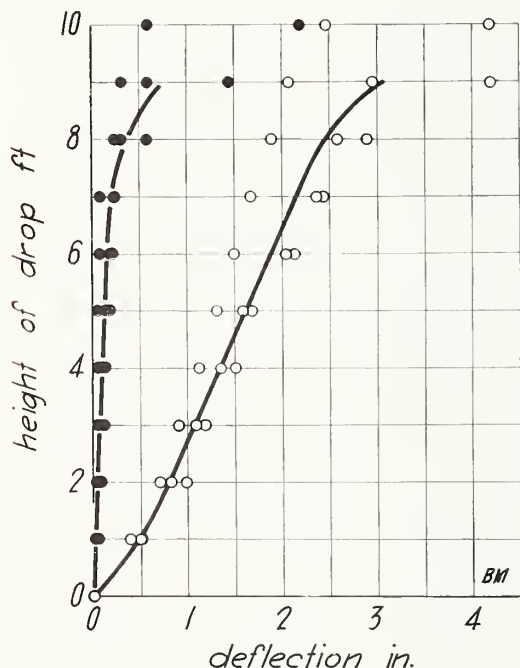
FIGURE 72.—Impact load on partition *BM*.

Height of drop-deflection (open circles) and height of drop-set (solid circles) results for specimens *BM-I1*, *I2*, and *I3* on the span 7 ft 6 in.

The results for partition specimens *BM-I1*, *I2*, and *I3* are shown in table 14 and in figure 72.

The impact loads were applied to the center of one face of each specimen, the sandbag striking the plaster directly over the center stud. In each of the specimens the plaster on both faces cracked longitudinally along the studs and transversely across each specimen in several places. The first transverse cracks in the face opposite the face struck occurred at lath joints near midspan at drops of 2, 1, and 1.5 ft and deflections of 0.70, 0.50, and 0.70 in. in specimens *I1*, *I2*, and *I3*, respectively. The first transverse cracks in the face struck occurred at lath joints near midspan at a drop of 3 ft and deflections of 0.90, 1.08, and 1.18 in. in specimens *I1*, *I2*, and *I3*, respectively. At drops of 4, 5, and 4.5 ft, on specimens *I1*, *I2*, and *I3*, respectively, the face struck by the sandbag failed owing to rupture of the plaster at midspan, especially at the point of impact. At drops of 5.5, 6.5, and 6 ft on specimens *I1*, *I2*, and *I3*, respectively, the face opposite that struck by the sandbag failed by falling of some of the plaster. In each of the specimens the center stud broke at midspan at drops of 10, 9, and 10 ft, respectively. Specimen *I2* failed structurally at a drop of 10 ft by the sandbag passing through the specimen.

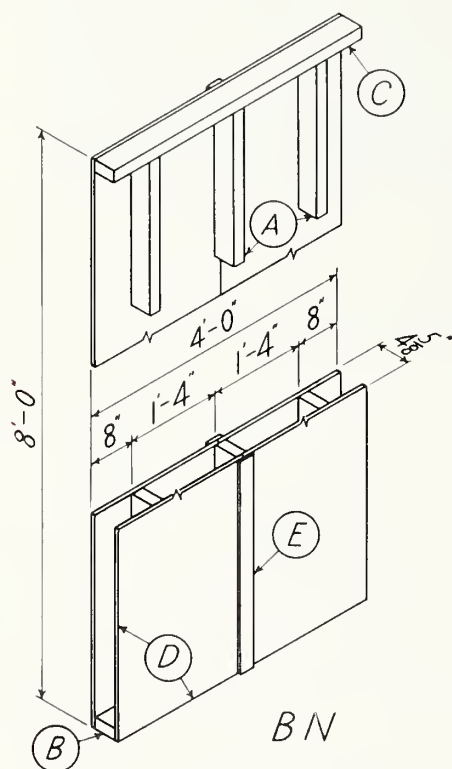
FIGURE 75.—Partition specimen *BN*.

A, stud; *B*, floor plate; *C*, top plate; *D*, interior board; *E*, batten strip.

The partition specimens were 8 ft 0 in. high, 4 ft 0 in. wide, and $4\frac{5}{8}$ in. thick. Each specimen consisted of a wood frame to which two like interior board faces were fastened.

The frame consisted of three studs, *A*, shown in figure 75, fastened to a floor plate, *B*, and a top plate, *C*, by nails. Both faces consisted of

interior board, *D*, with a vertical joint at midwidth covered by a batten strip, *E*. The specimens were not painted.

in., 8 ft 0 in. long, with the linen-textured surface exposed. There was a vertical joint on the center stud with $\frac{1}{8}$ -in. clearance between the edges of the boards on each face. The interior board was fastened to the center stud, floor plate, and top plate by 4d galvanized roofing nails spaced 3 in., about $\frac{1}{2}$ in. from the edges of the board, and to the outer studs by

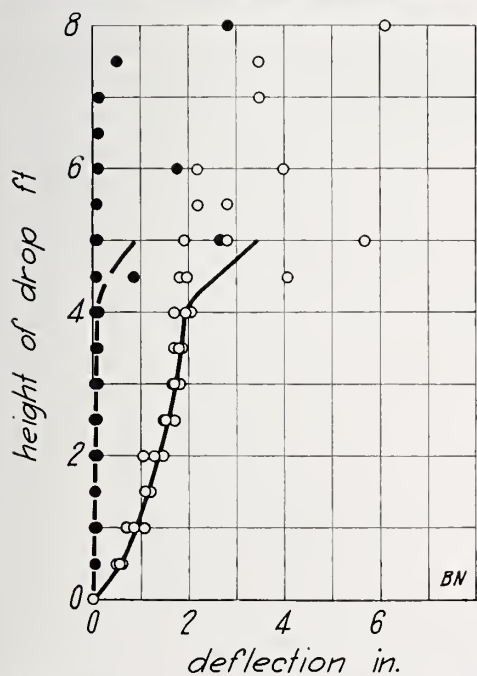
FIGURE 77.—Impact load on partition BN.

Height of drop-deflection (open circles) and height of drop-set (solid circles) results for specimens BN-11, 12, and 13 on the span 7 ft 6 in.

Partition specimen *BN-I2*, during the impact test, is shown in figure 76. The results for partition specimens *BN-I1*, *I2*, and *I3* are shown in table 14 and in figure 77.

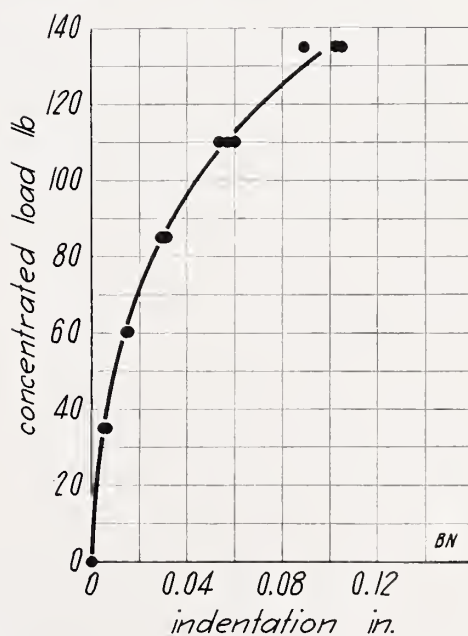
FIGURE 78.—Concentrated load on partition BN.

Load-indentation results for specimens BN-P1, P2, and P3.

The results for partition specimens *BN-P1*, *P2*, and *P3* are shown in table 14 and in figure 78.

The concentrated loads were applied to one face of each specimen on the interior board midway between two studs and about $1\frac{1}{2}$ ft from one end of the specimen. Each of the specimens failed by punching of the disk through the interior board.
