River Technologies LLC 3-Way Decontamination System for Radiological Decontamination

TECHNOLOGY EVALUATION REPORT

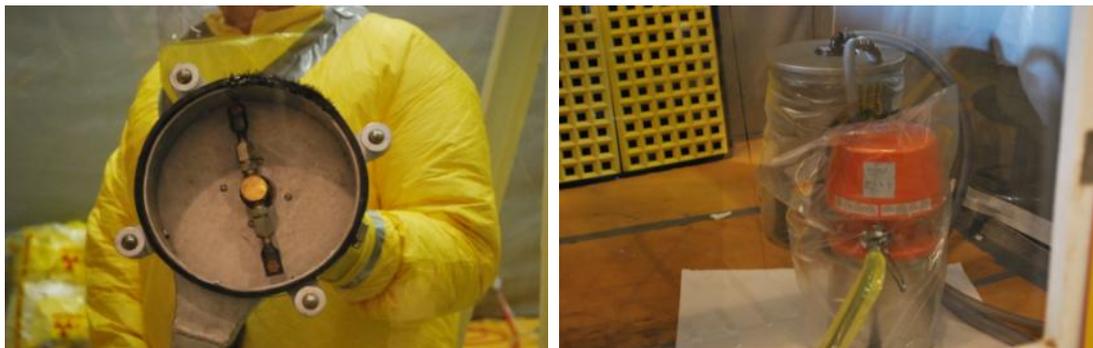
The 3WDS consists of a pressure washer spray tool equipped with rotating spray nozzles enclosed by a vacuum shroud. The spray tool is attached to a gas-powered, diesel-heated high pressure hot water washer (Mi-T-M, Peosta, IA; Model HSP-3504-3), capable of providing pressures of up to 3,500 pounds per square inch (psi) and water at 180 °F. During this evaluation the unit was attached to a compressed air powered vacuum (Nederman, Helsingborg,

Sweden; Model NE52), which requires approximately 250 cubic feet per minute (cfm) of air at approximately 120 psi. A diesel-powered air compressor (LeROI, Sidney, OH; Model 260) was used to provide the compressed air to operate the vacuum necessary for recovery of the water. The air compressor was available at the test location and the pressure washer was rented for the duration of testing. Figure 2-1 shows photographs of the 3WDS spray tool and vacuum used during the evaluation. The metal surrounding the rotating spray nozzles serves as a vacuum shroud to collect the sprayed water.

Figure 2-1. 3WDS rotating spray tool (left). 3WDS vacuum canister and waste collection drum (right).

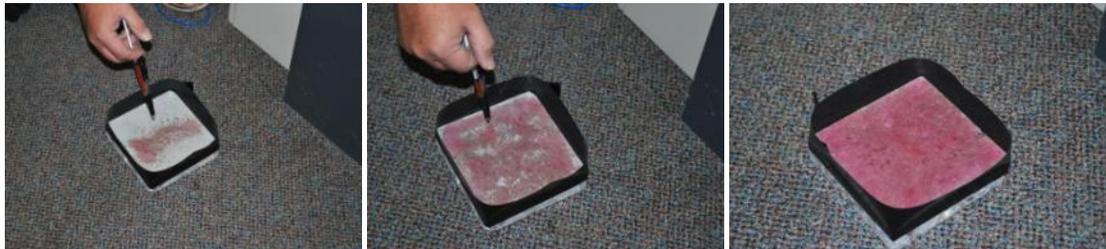
The aerosol delivery device was constructed of two syringes. The plunger and needle were removed from the first syringe and discarded. Then, a compressed air line was attached to the rear of the syringe. The second syringe contained the contaminant solution and was equipped with a 27 gauge needle, which penetrated through the plastic housing near the tip of the first syringe. Compressed air flowing at a rate of approximately 1 - 2 L per minute created

a turbulent flow through the first syringe. When the contaminant solution in the second syringe was introduced, the solution became nebulized by the turbulent air flow. A fine aerosol was ejected from the tip of the first syringe, creating a controlled and uniform spray of fine liquid droplets onto the coupon surface. The contaminant spray was applied all the way to the edges of the coupon, which were taped (after having previously been sealed with polyester resin) to ensure that the contaminant was applied only to the surfaces of the coupons. The photographs in Figure 3-1 show this procedure being performed using a nonradioactive, nonhazardous aqueous dye to demonstrate that the 2.5 mL of contaminant solution is effectively distributed across the surface of the coupon.

Figure 3-1. Demonstration of contaminant application technique.

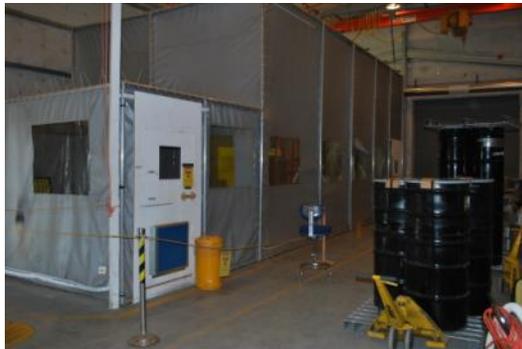
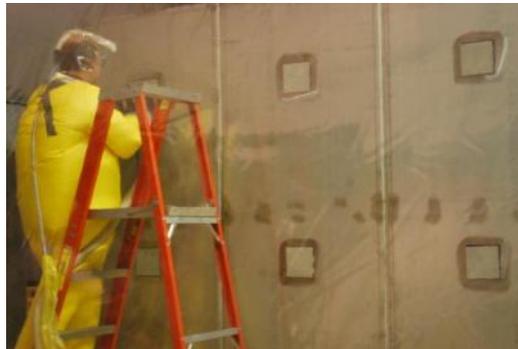
To evaluate the decontamination technologies on vertical surfaces (simulating walls), a stainless steel test stand was fabricated that held three rows of three concrete coupons. The test stand, approximately 9 feet (ft) × 9 ft, was erected within a containment tent. The concrete coupons were placed into holders so their surfaces extended just beyond the surface of the stainless steel face of the

test stand. Eight of the nine coupons placed in the test stand were contaminated with Cs-137, which has a half-life of 30 years. One uncontaminated coupon was placed in the bottom row of the test stand and decontaminated using the 3WDS in the same way as the other coupons. This coupon was placed there to observe possible secondary contamination caused by the decontamination higher on the wall. Figure 3-2 shows the containment tent and the test stand loaded with the concrete coupons.

Figure 3-2. Containment tent: outer view (left) and inner view with test stand containing contaminated coupons (right).

The containment tent consisted of two rooms. One room contained the test stand to hold the contaminated coupons; the other room (the shorter part of the tent as shown in Figure 3-2) held the 3WDS vacuum and collection drum. The vacuum hose extending from the collection drum connected to the vacuum shroud on the spray tool through a small opening in the tent wall between the two rooms. The power washer and air compressor were located outside the containment tent. The high pressure water hose connected to the spray tool through a small opening in the outer tent wall, and traveled through the smaller room and into the test stand room through a small opening in the tent wall between the two rooms. Each of the tent

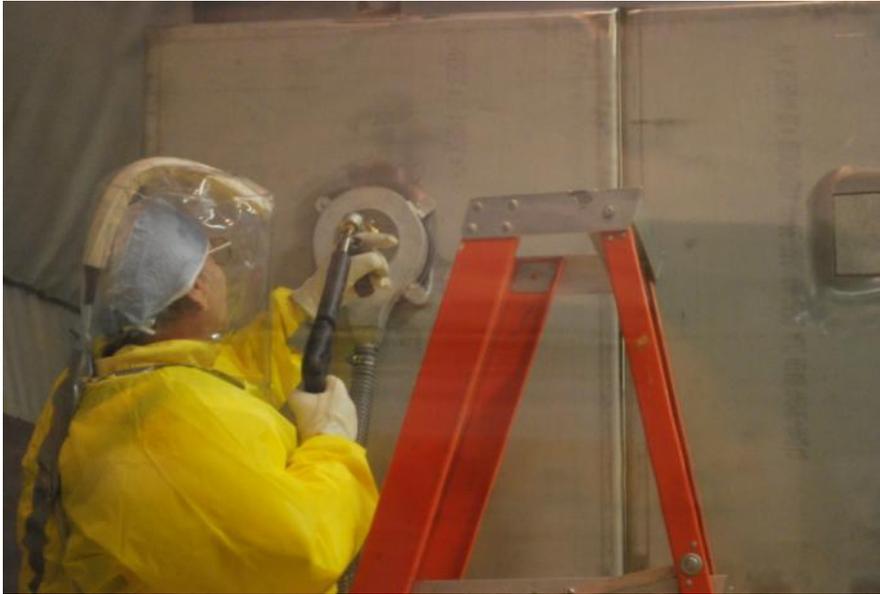
openings was taped closed around the hoses. Figure 3-3 shows the metal tube providing the high pressure water through the top of the spray tool and the larger diameter vacuum hose connecting to the vacuum shroud (which surrounds the spray tool) as the operator applies the 3WDS to a concrete coupon.

Figure 3-3. Operator applying 3WDS to concrete coupon.

The flow of hot, pressurized water was initiated by hand triggering the spray tool; the vacuum flow was continuous (controlled by a valve near the vacuum canister). Upon triggering, there was approximately a two second delay before the water flowed at full strength and caused the nozzles to rotate. Each coupon was then sprayed for approximately 15 seconds, moving the tool back and forth to

ensure that the entire surface of the coupon had been covered. The trigger was released between coupons to stop the flow of water. This application technique would correspond to a rate of 0.1 square meters (m²) per minute. The temperature and relative humidity (RH) were recorded before (17.5 °C, 32% RH) and after (18.6 °C, 32% RH) the approximately one hour test. These conditions did not vary significantly in the room where the evaluation was performed.

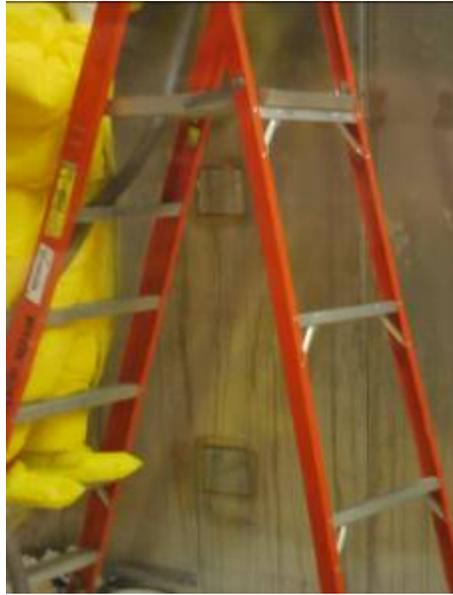
operators. During this evaluation, the radiological control technicians required the operators to wear full anti-contamination personal protective equipment that included a full face respirator with supplied air. The 3WDS created a significant amount of mist around the spray tool that caused water to run down the test stand and caused the operator's outer layer of protective gear to become very wet. The possibility of contaminating the operators with secondary waste or the ground surrounding the surface being contaminated with liquid radiological waste may be a major concern in an actual decontamination event. These concerns were also present during this evaluation, but the radiological control technicians who oversaw the evaluation determined that no measureable cross-contamination occurred due to the water from the 3WDS.

Figure 5-1. Water running onto other coupons.
