# Ten Year Operating Test Results and Post-Test Analysis of a 1/10 Segment Stirling Sodium Heat Pipe

Phase III Final Report

*John H. Rosenfeld, Kenneth G. Minnerly, and Christopher M. Dyson  
Thermacore, Inc., Lancaster, Pennsylvania*

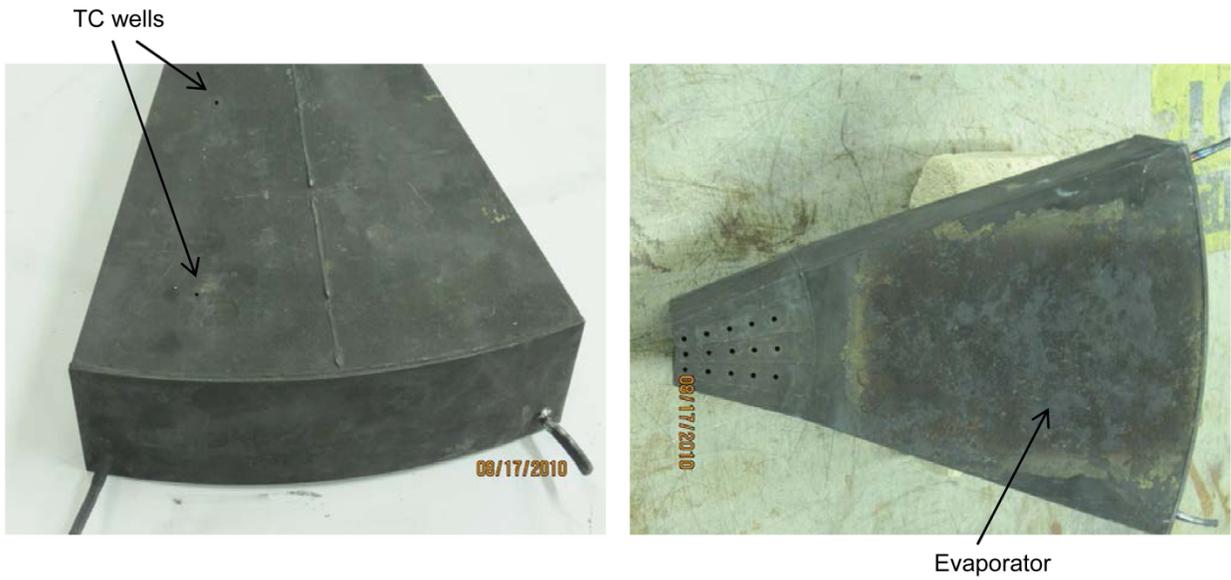
Figure 3.—Heat pipe at the end of life testing.

At the conclusion of testing, a sodium sample was removed from the heat pipe for analysis. After removal from the support test stand, the two heat pipe fill tubes were torch heated to drive liquid sodium out of them. The heat pipe was then placed in an argon-filled glove box, and the fill tubes were cut off. A clean stainless steel vessel with a 1/4 in. connecting tube was welded onto one of the fill tubes on the heat pipe. A tube section with a vacuum valve was welded onto the other fill tube. The heat pipe with these vessels attached to the fill ports is shown in Figure 4. The heat pipe was then heated as shown in Figure 5, and about 10 g of sodium were pushed into the collection vessel under argon pressure. The collection vessel was then placed in an argon glove box, and a solution was prepared by dissolving 1 g in deionized water in a glass Pyrex (Corning, Incorporated, Corning, NY) beaker. The sodium hydroxide solution was then diluted to 500 ml. The resulting solution was acidified to a pH 2.0 using nitric acid, as determined by pH paper.

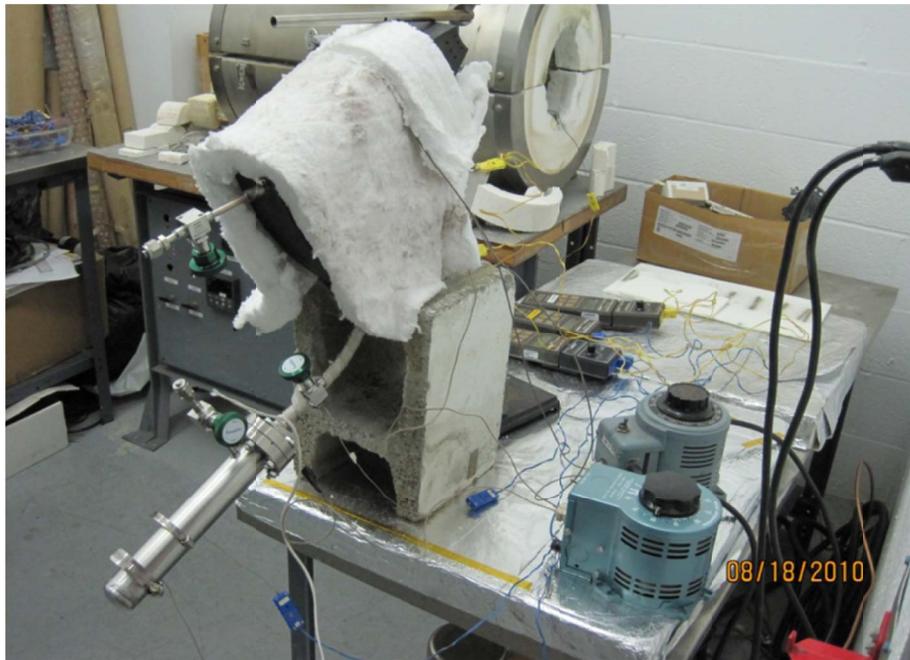
Figure 5.—Heating and draining the sodium from the heat pipe.

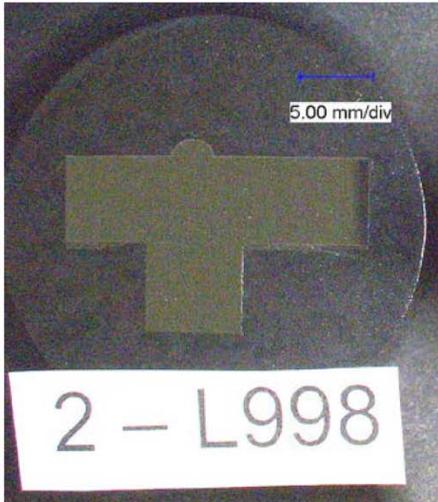
Electron beam weld penetration of 3.5 mm

Figure 29.—Electron beam weld on Sample 2.

The screen wick material was analyzed to determine the effects of long term exposure to the sodium working fluid. Observations of the electron beam welds indicated no evidence of corrosion in the weld metal or heat affected zone. Figures 29 to 32 are images of the electron beam welds observed. Electron beam weld penetrations were measured to be between 3.5 and 5.4 mm. Electron microprobe images of the screen wick material are shown in Figures 33 to 36. Microprobe analysis indicated deposition of sodium, oxygen, and carbon on the surface of the screen wires (Figs. 34 and 36). These elements were most likely residues of sodium hydroxide and sodium methoxide that remained from the sodium removal and disposal process. Some evidence was seen of species migration in the screen wires; this effect did not seem to affect the integrity of the wires. Physical observation showed that the wires retained ductility and did not separate from the envelope inner surfaces near the tack-weld locations.

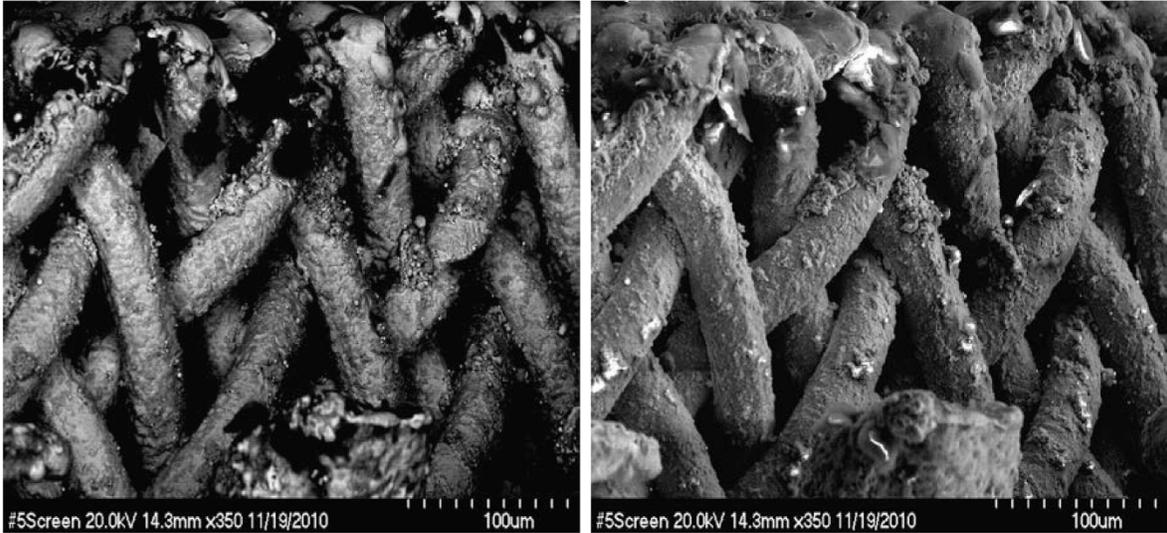
Figure 33.—Electron microprobe images of fine and course stainless steel screens from Sample 5A.

Figure 34.—Concentration chart of major elements and electron microprobe images of the fine stainless steel screen from Sample 5A.

Figure 35.—Higher magnification electron microprobe images of the fine stainless steel screen from Sample 5A.

Figure 36.—Concentration chart of major elements and electron microprobe images of the course stainless steel screen from Sample 5A.
