High-R Walls for New Construction Structural Performance: Wind Pressure Testing

A. DeRenzis and V. Kochkin
NAHB Research Center

January 2013

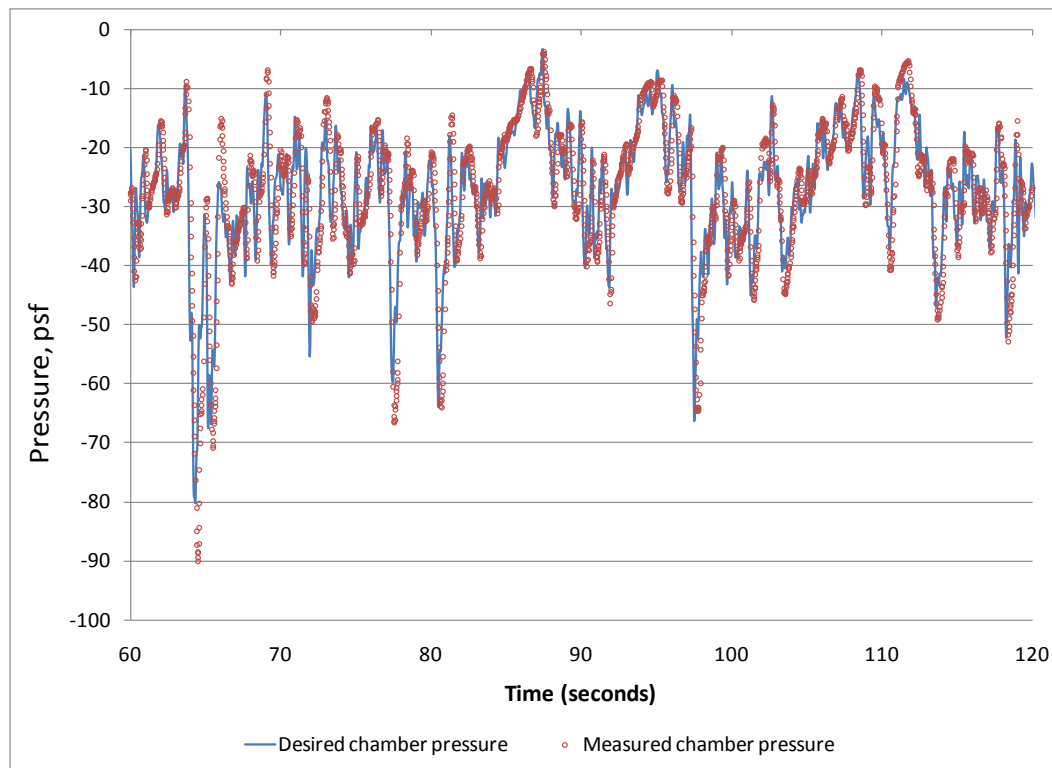
Figure 7. Comparison of desired and measured chamber pressures

To replicate the target wind pressures, the 11-hp PLA fans were operated at a fan speed of 30 to 60 Hz. The pressure was controlled through a proportional integral differential using a servomotor for adjusting the orifice controlling air flow in the system. The PLAs are capable of controlling pressure peaks changing at a frequency of up to 10 Hz. Figure 7 shows a 1-min snapshot comparison of the target and measured chamber pressures.

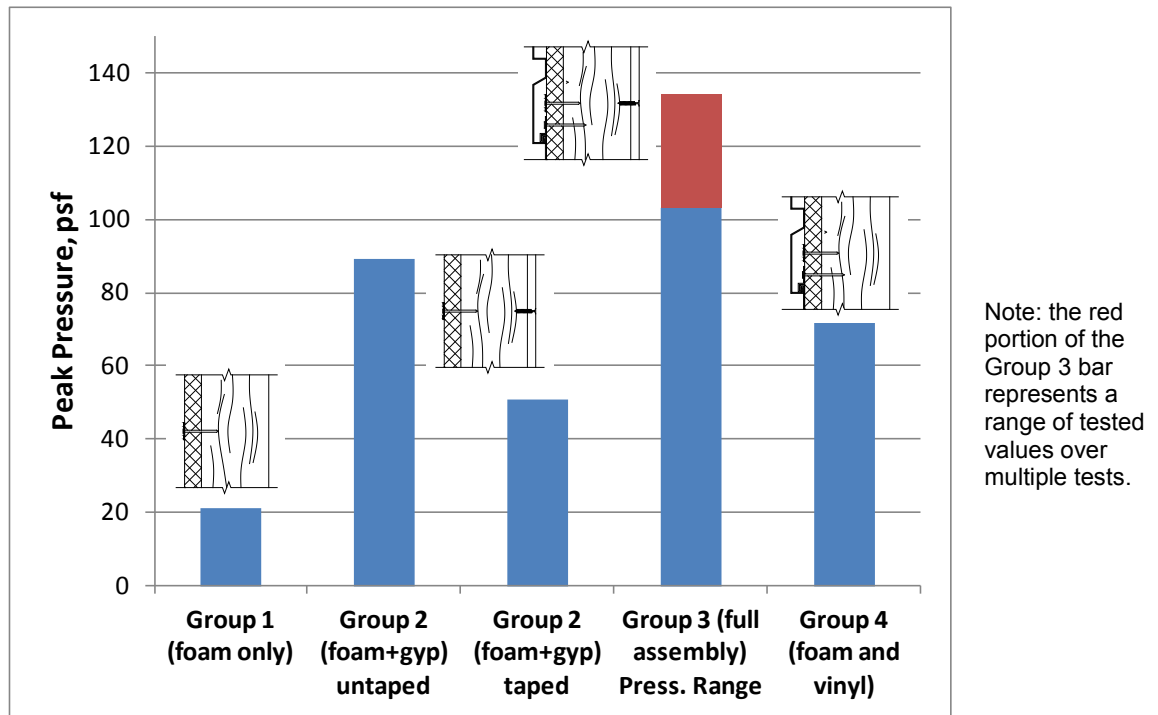
Figure 8. Wall capacities by test group

Table 4 summarizes the results organized by group and configuration, including test wind speeds, peak measured pressures, and descriptions of the observed failure modes. Figure 8 charts peak pressures by test group. The results indicate that the capacity of the wall system (Group 3) is as much as five times higher than the capacity of isolated foam (Group 1).

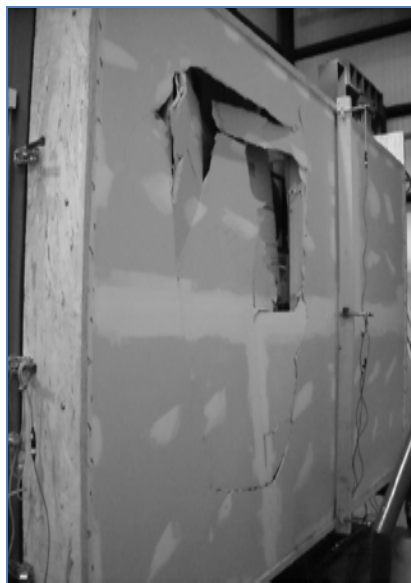
Figure 10. Group 2A failure mode

The addition of gypsum to the wall assembly (Group 2A) more than quadrupled the system capacity (89 psf) compared to the isolated foam (Group 1). The plate-to-stud connections of the wood frame failed and the gypsum broke (Figure 10), a response caused by the gypsum resisting the larger portion of the load. The distribution of the load between the layers occurred because air moved through the foam joints and the connections into the wall cavity, which led to load sharing between the foam and the gypsum.

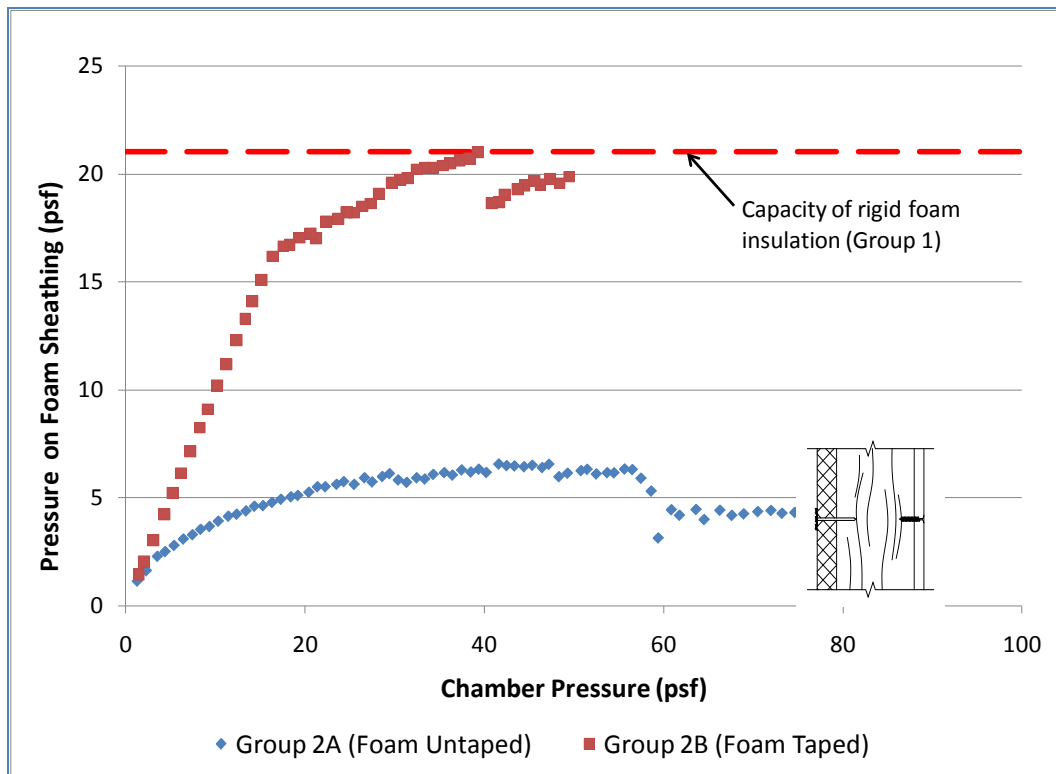
Figure 11. Pressures on rigid-foam insulation for Group 2 specimens

Taping all horizontal and vertical foam sheathing joints (Group 2B) reduced the permeability of the exterior layer. This resulted in higher pressures applied on the foam and reduced the capacity of the overall wall system (51 psf). Figure 11 depicts the pressures on the foam layer for the Group B specimens plotted relative to the chamber pressure. Figure 11 also shows the upper boundary for the isolated foam test (Group 1) as a reference. The maximum pressure on the unsealed rigid-foam sheathing (Group 2A test) did not exceed 8 psf, whereas the pressures on the sealed foam sheathing (Group 2B test) peaked at about 21 psf—exactly the limit determined from the Group 1 test (foam sheathing only). Therefore, because less air moved through the joints of the foam sheathing, the foam sheathing layer experienced a higher portion of the total pressure. In fact, up to about 15 psf, the pressure on the foam followed the chamber pressure (linear portion of Group 2B line) before the onset of pressure equalization. Consistent with this observation, the failure mode was associated with the foam sheathing connections. The failure of the nail plastic caps in the field of the sheathing panel where the fastener tributary area was the highest was followed by the onset of failure of the perimeter nails (Figure 12). Because all foam joints (vertical and horizontal, including the specimen boundaries) were taped with a 3-in.-wide tape, Group 2B represents the most conservative loading case for the exterior foam. In a more typical construction configuration, the boundary joints at the top and/or bottom plates are not taped, allowing air to move in and out of the cavity. Results from Group 3 specimens (discussed next) indicated that taping only the vertical joints resulted in a range of PEFs for the foam more similar to those for the untaped foam configuration than the fully taped foam configuration.

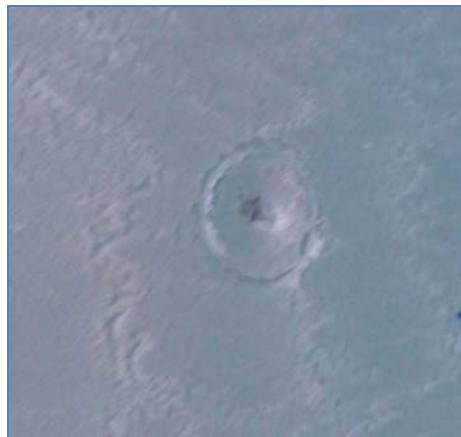
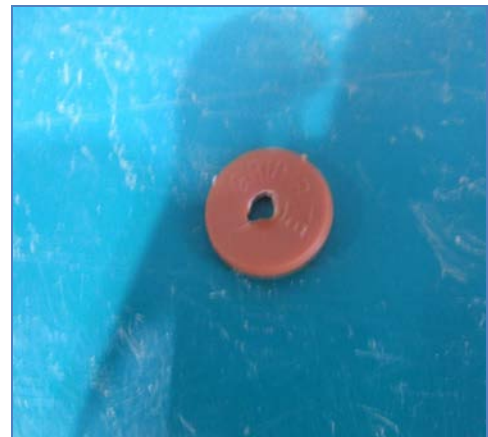
Figure 12. Group 2B failure mode (sheathing nail pull-through)

Washer imprint on sheathing

Washer after failure

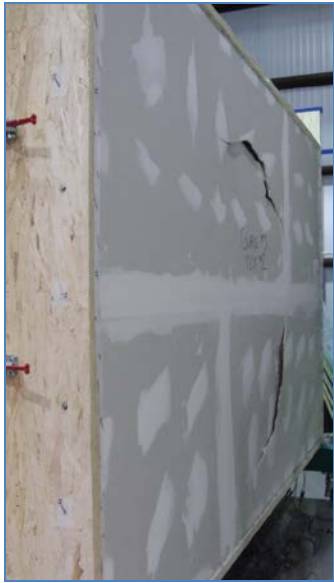
Figure 14. Group 3B failure mode

The capacity of the rest of Group 3 specimens (B, C, D, and E) was limited by the capacity of the framing and/or framing connections (Figure 14, Figure 15, and Figure 16). This led to a collapse of the wall system and damage to interior drywall and the exterior layers. Where predrilled studs were used for the specimen with electrical outlets, the bending failure of the studs occurred at the predrilled holes. Note that a different batch of lumber was used starting on Specimen 3B. The observed change of failure mode from the wall's exterior sheathing fasteners to the framing members and connections again indicates that this system was close to a balanced design. Although Group 3 test variables had some small impact on the pressure equalization profile as discussed later in the report, the variance in capacity of system among the specimens appeared more affected by other factors such as the variance in framing lumber strength.

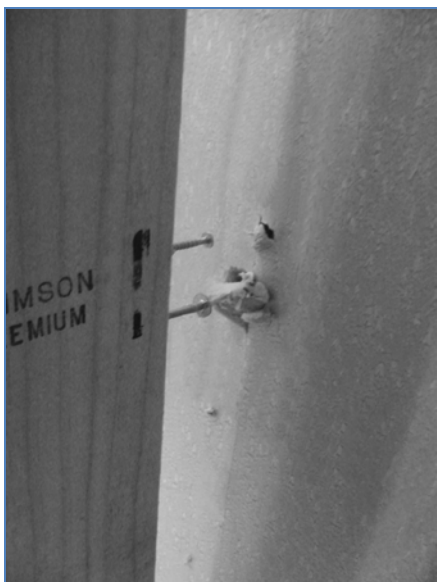
Figure 17. Group 4A failure mode, nail pull-through

Although the capacity of the Group 4 specimen of 73 psf is a reduction of 30% or more compared to the full-wall assemblies (Group 3), it was a 3.5 times increase over the isolated foam sheathing test (Group 1). This comparison indicates that the vinyl siding fasteners contribute to the capacity of the foam sheathing. The failure mode of the Group 4 specimen was associated with pull-through of sheathing and siding fasteners in the field of the center panel (Figure 17) and showed on the exterior as bulging of the vinyl siding (Figure 18).

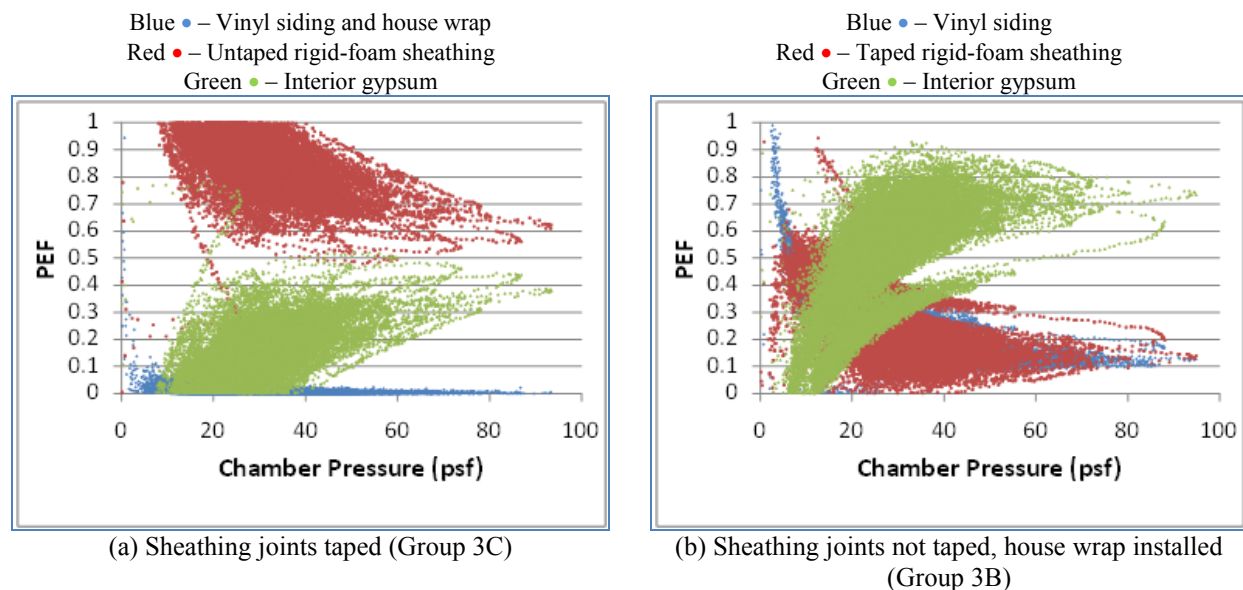
Figure 19. Sample PEFs by individual layers for Group 3 specimens

Figure 19 gives sample PEF graphs by layer for Specimen 3C (taped) and Specimen 3B (untaped) under a single wind pressure trace. These charts demonstrate that the PEFs are a function of the chamber pressure trace and the configuration of the wall system. For example, at pressures below 40 psf for the wall assembly with foam fully taped, the peak PEF across the foam sheathing layer was as high as 1.0 (Figure 19b). This means that the foam resisted as much as 100% of the total pressure at specific times along the pressure trace. As the pressure increased, the peak PEF for the rigid-foam insulation dropped below 0.7. For the wall assembly with untaped foam insulation and a house wrap (Figure 19a), the pressure gradient across foam was substantially reduced with the PEF trending below 0.40 at chamber pressures above 40 psf.

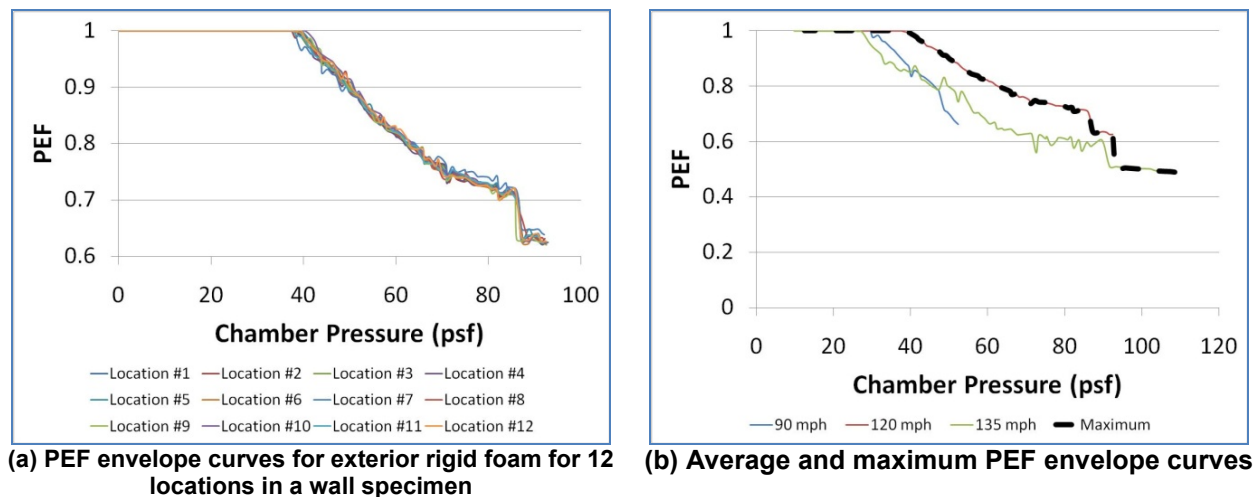
Figure 20. PEF analysis for rigid-foam insulation

Figure 20a compares PEFs for 12 pressure sensor locations in the same wall for one of the specimens (refer to Figure 5 for locations of pressure sensors). The chart shows consistent results between various locations, indicating that there was little variability in response between different locations in the same wall. This conclusion holds true for all tested specimens.

To characterize the PEF of a wall layer over the range of test pressures and to enable consistent comparison of PEFs among different wall assemblies, PEF envelope curves for each wall layer were developed as follows: (1) for each pressure trace, individual envelope curves were generated for each of the 12 pressure sensors in a wall specimen, (2) envelope curves were averaged across the 12 pressure sensors, and (3) the highest PEF factor for a given pressure was selected among all pressure traces (Figure 20b).

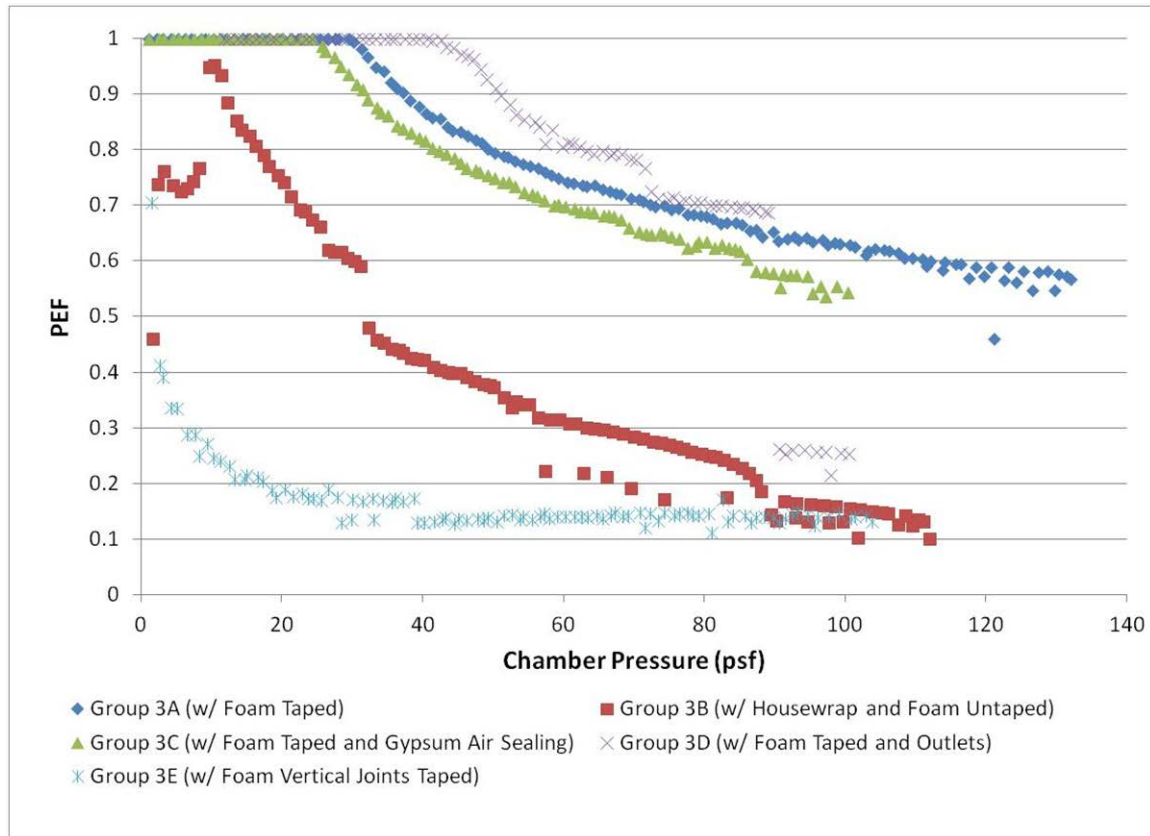
Figure 21. Envelope PEFs for rigid-foam sheathing for full-wall assemblies (Group 3 specimens)

Figure 21 plots the envelope PEFs for rigid-foam sheathing for all Group 3 configurations (full-wall assembly). For configurations with foam fully taped (configurations A, C, and D), the PEF trends for the foam sheathing ranged from 1.0 at low pressures (0 psf to 30–50 psf) to 0.55–0.70 at peak pressures (80+ psf). For configurations with foam untaped (Configuration 3B) or taped at vertical joints only (Configuration 3E), a more rapid decrease in the foam sheathing PEF was observed. Here, the PEF started at lower pressure thresholds (less than 5 psf) and reached levels below 0.2 at system capacity. For Configuration 3B, house wrap was applied as a continuous sheet and taped at the edges of the specimen. This effectively functioned as an air barrier and imposed a larger load onto the siding fasteners (refer to Figure 19b). For Configuration 3E, the gypsum sheathing resisted more than 80% of the load at pressures above 20 psf... This suggests that systems that are not fully taped respond more as untaped systems, allowing the air to move behind the foam.

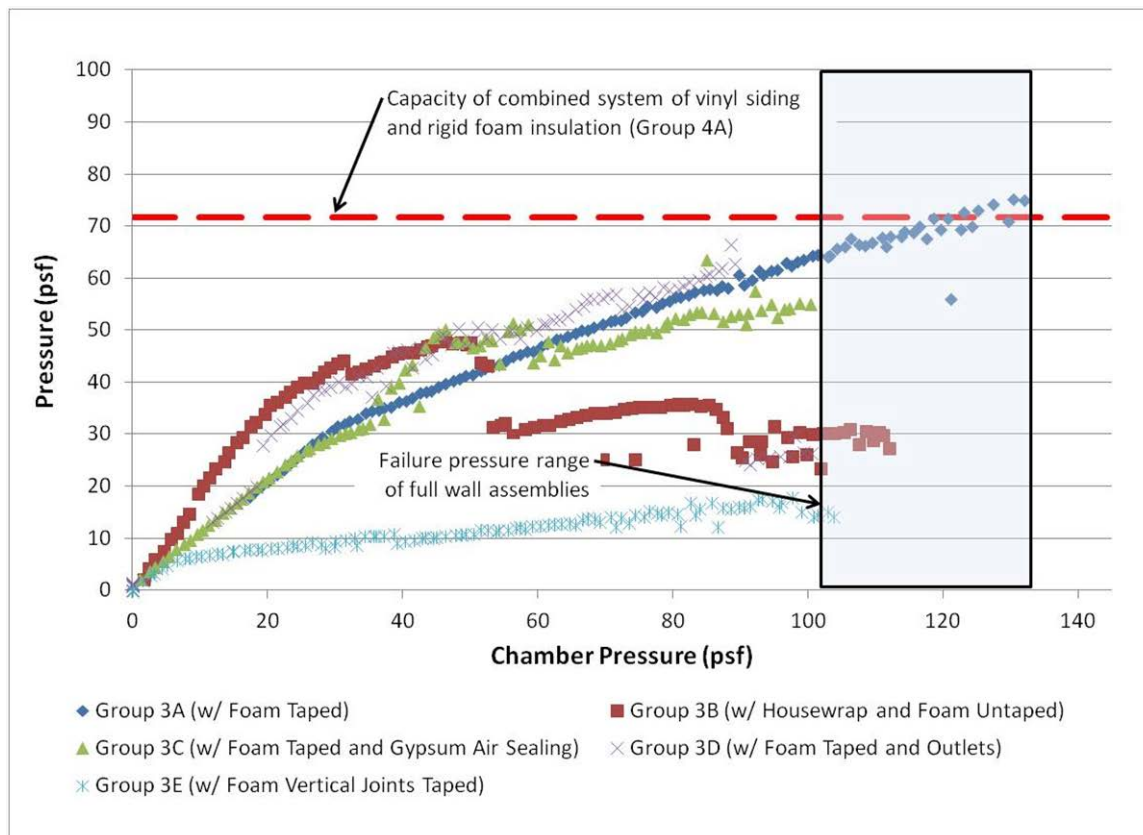
Figure 22. Calculated pressure on the combined system of rigid-foam insulation and vinyl siding versus pressures (Configuration 3)

For Group 3 specimens, Figure 22 shows the relationship between the total pressure gradient across the entire wall assembly (i.e., chamber pressure) and the pressure resisted only by the combined system of the rigid-foam sheathing, vinyl siding, and their associated fasteners. In addition, the horizontal dash line representing the capacity of the foam only (Group 1A) is included on the chart as a reference boundary. Of the five full-wall specimens of Group 3, only Configuration 3A approaches the capacity of Group 4A. This suggests that this is the only group in which the fasteners of the foam sheathing and siding system limit performance. None of the other wall systems experienced pressures approaching the capacity of the combined foam/siding system; failure in these walls, then, occurred in the framing. Because the capacities of Specimens 3B–3E were lower than the capacity for Specimen 3A, the research team concluded that the full-wall assemblies with foam sheathing are a relatively balanced system. Other factors, such as variability of lumber bending properties, have a greater impact on the overall system’s capacity than air sealing details. Configuration 3E again indicates that for systems with only vertical joints taped, the exterior assembly is resisting less than 20% of the total pressure with the majority of the load resisted by the interior gypsum.
