Applications of Fault Detection in Vibrating Structures

1. REPORT DATE (DD-MM-YYYY)		2. REPORT TYPE			3. DATES COVERED (From - To)	
01-10-2012		Technical Memorandum				
4. TITLE AND SUBTITLE Applications of Fault Detection in Vibrating Structures				5a. CONTRACT NUMBER		
				5b. GRANT NUMBER		
				5c. PROGRAM ELEMENT NUMBER

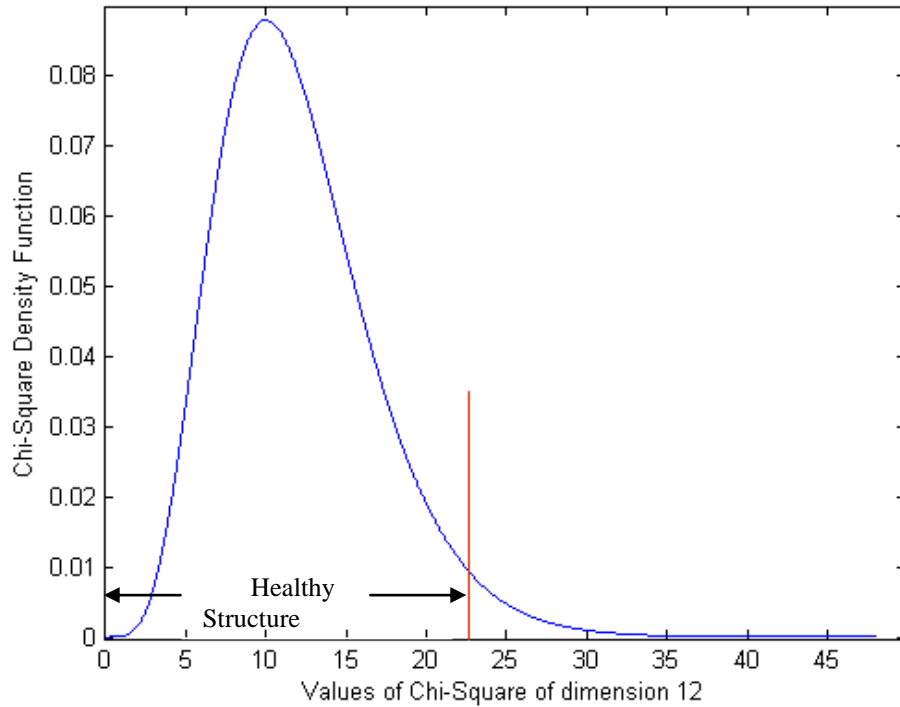
Figure 2: Illustration of Chi-Square distribution with decision threshold

The test variable Q forms a chi-square distribution with degree of freedom equal to the number of estimated system parameters [1], and may be used for structural fault detection. If the value falls to the left of a chosen cut off value as shown by the red line in Figure (2), the system is declared good, however, if Q falls to the right, a fault is declared. As with the non-parametric method, fault detection is based on the probability of false alarm.

In accordance to theory, the Q values should be spread around the number of parameters in the system identification model, which for this case was thirty. As shown in Figure 2 fault detection may be achieved by setting a threshold and declaring all values less than that threshold to be without fault. From Table 10 Section A, we see that the values are for the most part smaller than those given in Section B. This shows that the aircraft vibration response has changed slightly between the flight numbers with Section B indicating a slightly larger miss compare than that of Section A. This larger miss compare might indicate that the fault has been detected. However, Section C also contains slightly larger numbers than Section A. Since the flights of Section C were performed comparing the cut tube to the same cut tube, one would expect a more favorable comparison; that is, the numbers were expected to be closer to those of Section A.

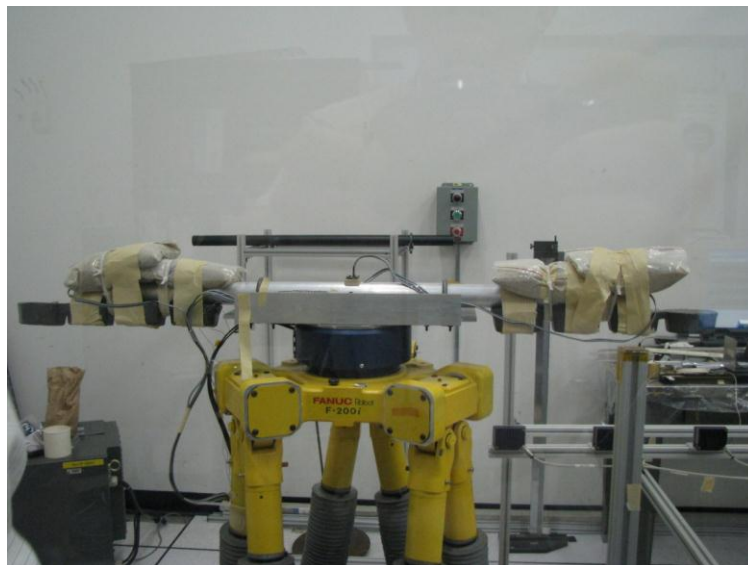
Figure 9: Aluminum tube used for crack detection

In addition to the vibrating panel of Figure 7, a cut aluminum tube which serves onboard the EDGE aircraft was tested as shown in Figure 9. The EDGE aircraft, a Subscale Aerial Vehicle, SAV, served as the final experimental platform for structural fault detection. The aluminum tube shown in Figure 9 is the main structural support for the wings of the Edge aircraft shown in Figure 10. In Figure 9 the tube under test is the shiny aluminum tube with the masses taped to both ends and an accelerometer centrally located. The tube was mounted on the shaker and test masses added to the tube as shown to simulate aerodynamic loading. Band-limited noise was used to drive the shaker and an accelerometer located towards the tube end was used as the output sensor. Data were taken for both the no cut case and a 3 mm cut case.

The tube shown in Figure 9 was used as a test platform in preparation for aircraft structural fault detection based on flight data. Only the parametric test was performed here. A comparison of several of the uncut and cut cases resulted in Figure 13. In Figure 13 the solid blue curve represents the theoretical distribution obtained while comparing the uncut cases. The green asterisks result from a comparison of uncut tube data and the light blue asterisks result when comparing the cut cases to one another. As expected, there was a positive comparison when equation (5) was applied to like cases. However, when cross comparing the system parameters of the cut with the uncut case as shown with the red asterisks, a clear indication of fault occurred in all experimental test cases.
