Impact Testing of Aluminum 2024 and Titanium 6Al-4V for Material Model Development

*J. Michael Pereira, Duane M. Revilock, Bradley A. Lerch and Charles R. Ruggeri
Glenn Research Center, Cleveland, Ohio*

National Aeronautics and
Space Administration

Glenn Research Center
Cleveland, Ohio 44135

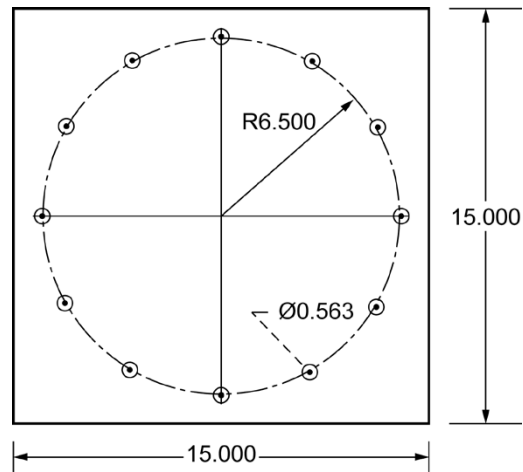
Figure 1.—Small Panel Test Specimen (dimensions in inches).

The test specimens were cut in squares, 15 in. on a side, with through holes for mounting bolts as shown in Figure 1. The through holes were 9/16 in. diameter on a 13 in. diameter bolt-hole circle. They were held in massive steel fixtures with a circular aperture shown in Figure 2(a) and (b). The two parts of the fixture were 1.5 in. thick steel.

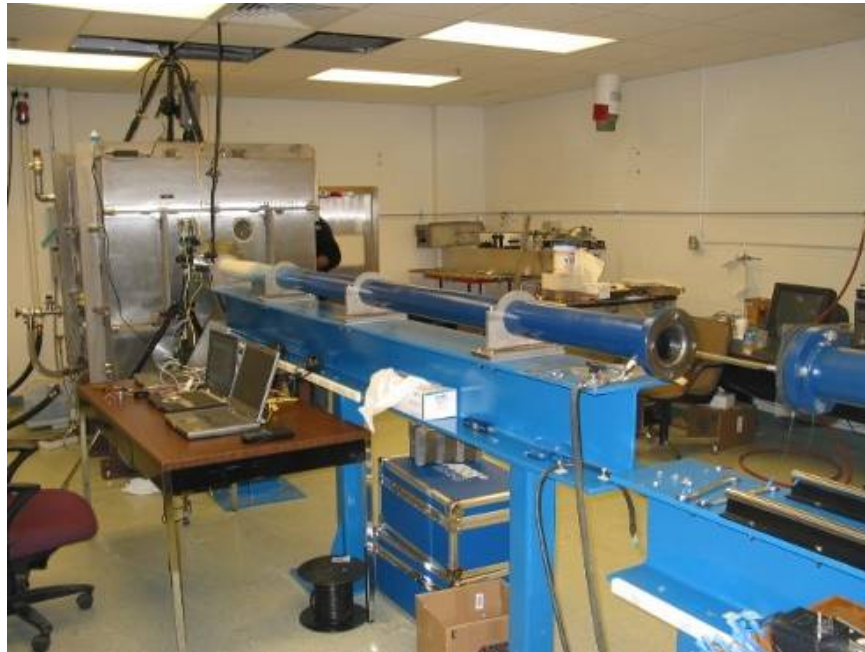
Figure 4.—Large Vacuum Gas Gun (shown with 3 in. diameter gun barrel).

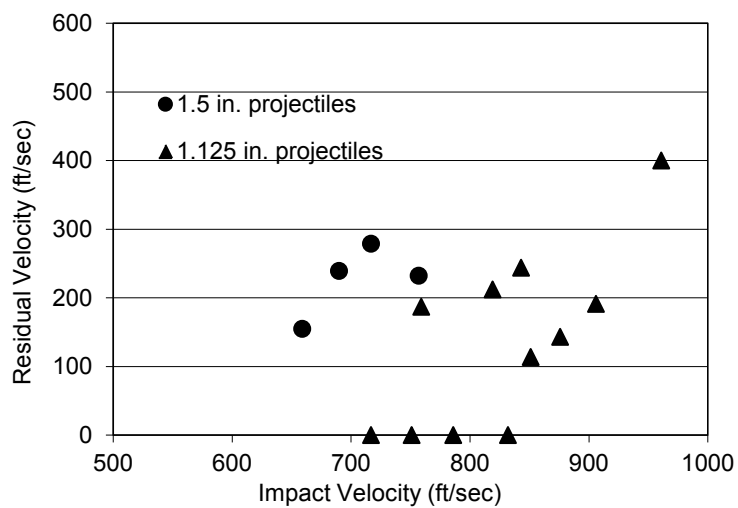
Figure 17.—Exit velocity vs. impact velocity for 0.5 in. thick Al-2024 plate.

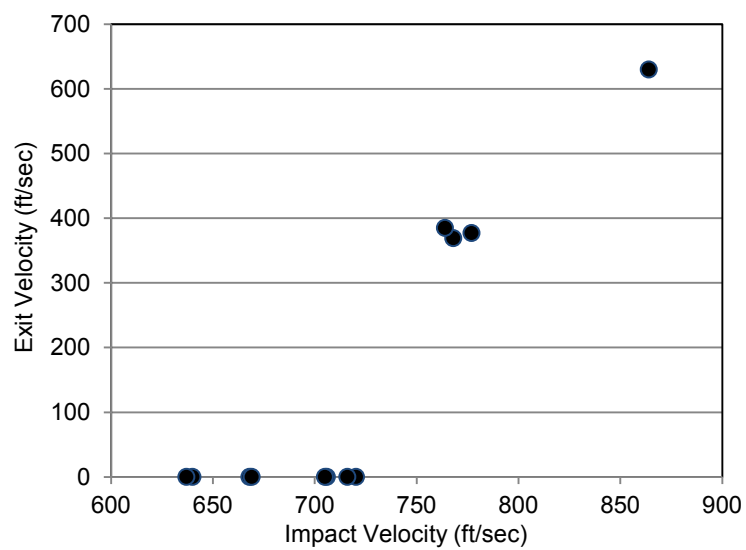
Figure 18.—Exit velocity vs. impact velocity for 0.09 in. thick Ti-6Al-4V sheet.

The residual velocity of the projectile is plotted against the impact velocity in Figure 18 to Figure 21 for the Ti-6Al-4V tests. Note that there is no residual velocity plot for the 0.14 in. thick Ti-6Al-4V impacted with the hardened steel projectile due to the fact that only one projectile penetrated this limited set of tests. The residual velocity was low, but could not be accurately measured. For all the Ti-6Al-4V tests there was a well-defined transition between tests where penetration occurred and those where there was no penetration as well as a generally regular increase in residual velocity as the impact velocity increased.

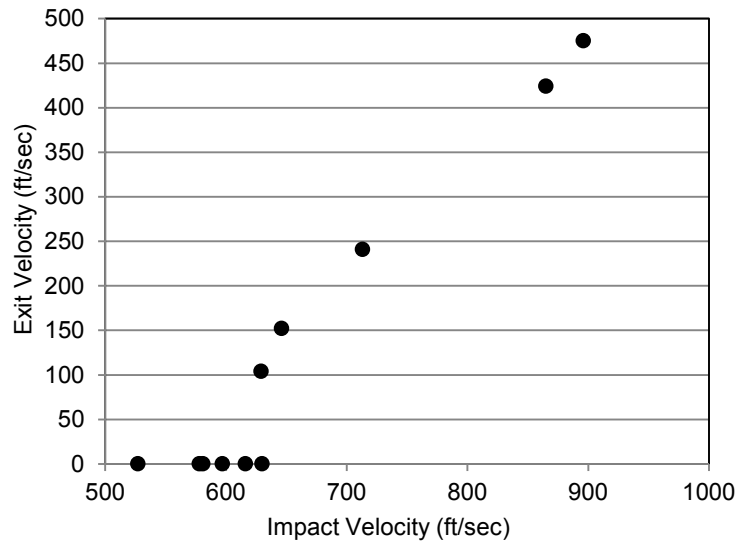
Figure 21.—Exit velocity vs. impact velocity for 0.5 in. thick Ti-6Al-4V plate.

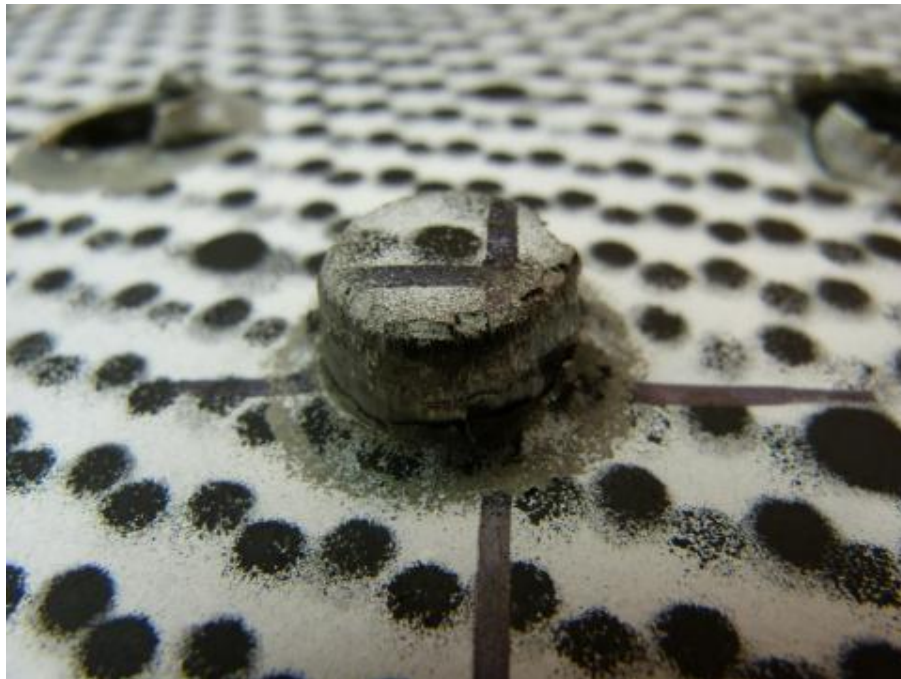
Figure 22.—Example of plug formed in 0.5 in. Ti-6Al-4V plate.

For the 0.5 in. Ti-6Al-4V plates, the damage was highly localized and there was a velocity range over which a plug developed but was not ejected (Figure 22). This occurred in the impact velocity range of 578 to 597 ft/sec. Above this there was a velocity range in which a plug was ejected but the projectile was contained. At velocities above 630 ft/sec both the plug and projectile penetrated the panel. For the tests in which a plug formed but was not ejected, measurements were made of the plug displacement (Table 6(e)). This measurement is the height of the plug face above the back surface of the plate.

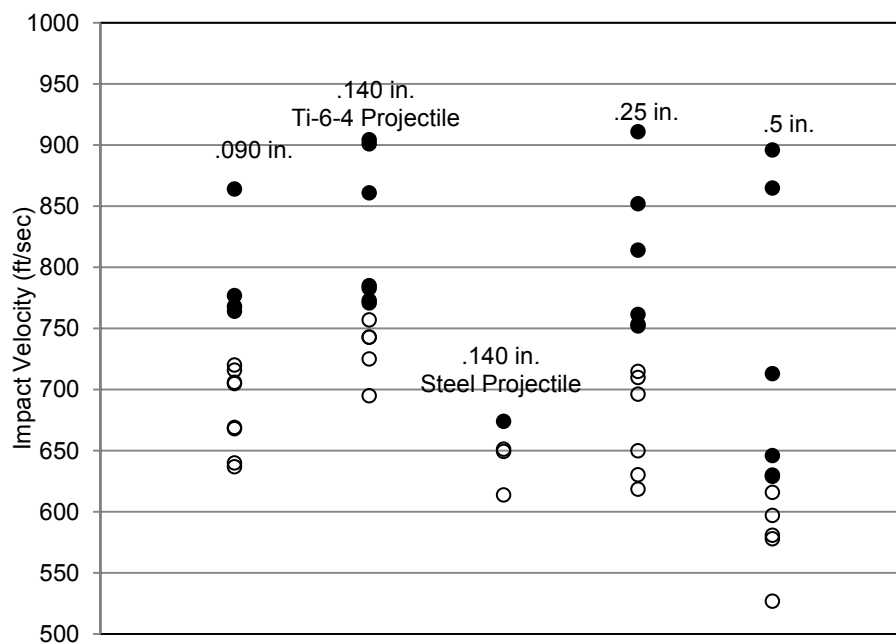
Figure 24.—Penetration results for Ti-6Al-4V. (Dark circles indicate tests in which penetration occurred. Open circles indicate tests where there was no penetration.)

The penetration results for the two materials are presented in Figure 23 and Figure 24 which show the impact velocity for each test and whether or not penetration occurred. Based on the results shown in Figure 15 to Figure 21 and Figure 23 and Figure 24 the approximate projectile penetration velocity results are shown in Table 7.

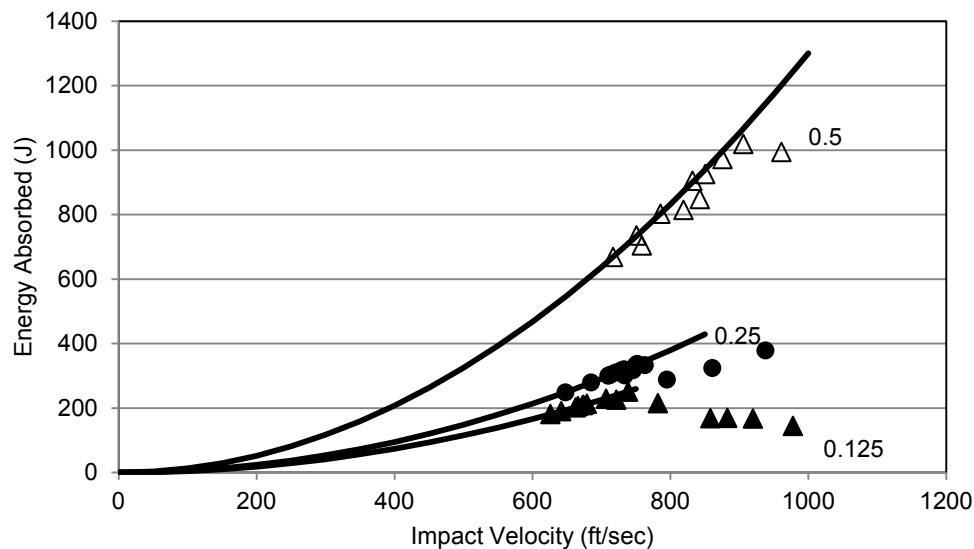
Figure 25.—Kinetic energy lost by projectile in Al-2024 impact tests.

A useful metric for impact model validation is the amount of kinetic energy absorbed by a panel when impacted. Figure 25 shows the kinetic energy absorbed by the Al2024 test panels. This is defined simply as the difference in projectile kinetic energy before and after impact and does not take into account the kinetic energy of the plug if one was ejected. In many cases it was not possible to accurately measure the plug kinetic energy, but in general it was less than 5% of the total energy absorbed. The curved reference lines represent the kinetic energy of the projectile as a function of impact velocity. For cases where all of the kinetic energy was absorbed (no penetration), the data points lie on the curves. For higher velocities where the projectile has residual kinetic energy, the points fall below the curves. Figure 26 to Figure 28 show the same information for the Ti-6Al-4V plates. The data is plotted on separate graphs for clarity. In general, for speeds just above the penetration velocity the amount of energy absorbed is slightly less than that at just below the penetration velocity. However, as speeds increase, there is no general trend. The data shows that for thicker panels (0.25 in. and above) the amount of energy absorbed increases as the speed increases beyond the penetration velocity. For thinner panels (0.14 in. and lower) the energy absorbed tends to decrease with increasing impact velocity. This may be indicative of a role that friction may play in the impact process. Another explanation may be related to the different failure modes in thicker specimens and related strain rate hardening effects. At this point there is not enough data to support a general conclusion.

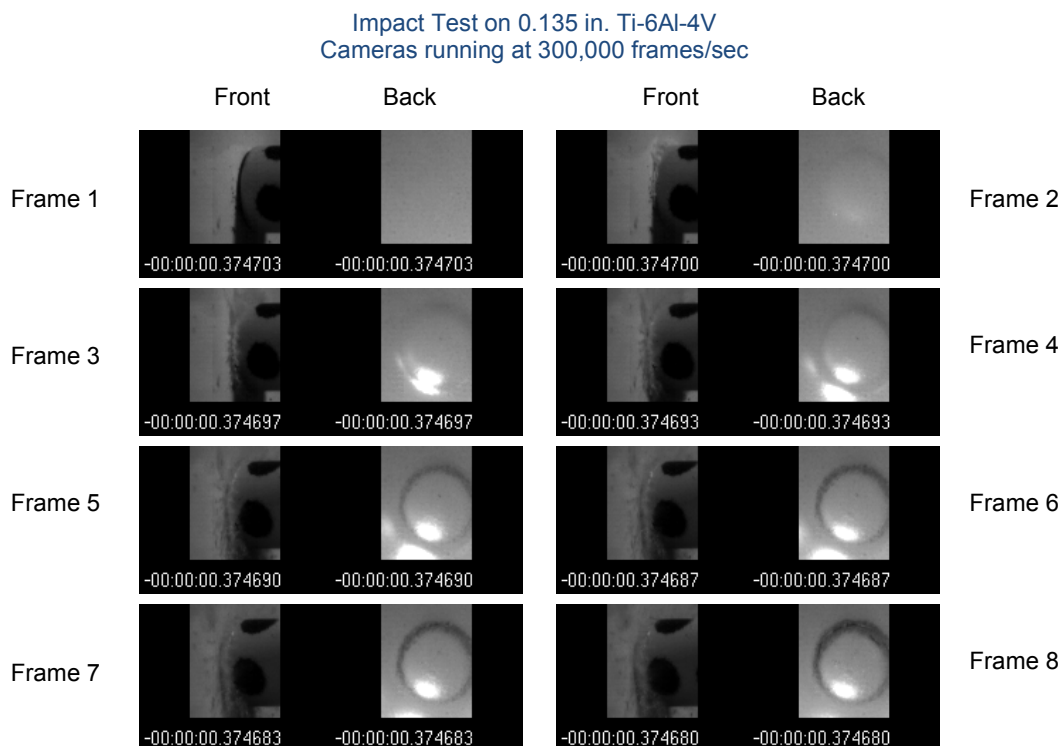
Figure 30.—Sequential frames from front and back cameras viewing an impact on a 0.135 in. thick Ti-6Al-4V specimen.

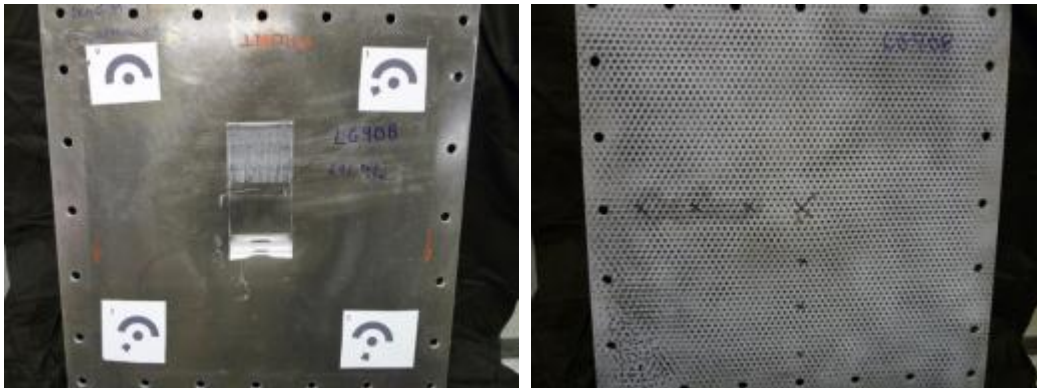
Figure 32.—Large Al-2024 Test Panel, front and back, side test LG908.

Four impact tests on each of the large Al-2024 and Ti-6Al-4V panels described in Section 2.2, using the NGFBB blade fragment simulating projectile. Results of these tests are shown in Table 8 and Table 9. Photos from the impact tests are shown in Figure 32 to Figure 39. It can be seen from the test photographs that failure initiation and the majority of the damage occurs when the heavier root section of the blade impacts the panel. This is consistent with what occurs in an actual jet engine fan blade out incident.

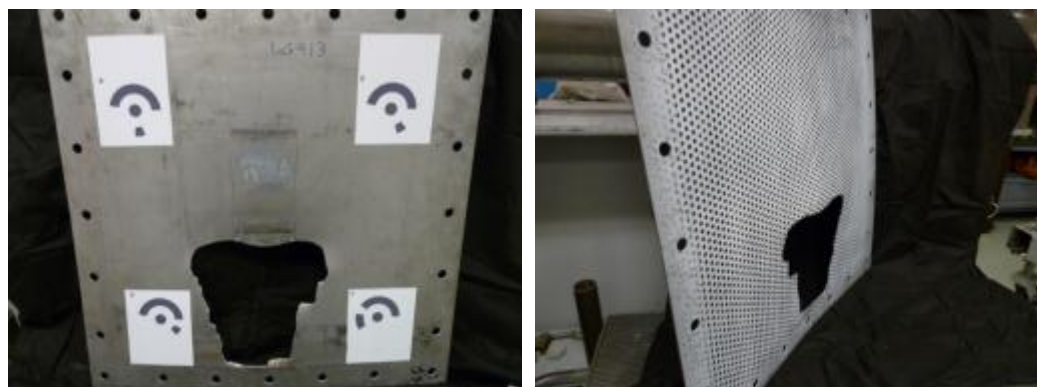
Figure 37.—Large Ti-6Al-4V Test Panel, front and back side, test LG913.
