Passenger Train Grade Crossing Impact Tests: Test Procedures, Instrumentation and Data

1. AGENCY USE ONLY (Leave blank)		2. REPORT DATE October 2003		3. REPORT TYPE AND DATES COVERED Test Report — June 4 and 7, 2002
4. TITLE AND SUBTITLE Passenger Train Grade Crossing Impact Tests: Test Procedures, Instrumentation, and Data			5. FUNDING NUMBERS DTFR53-93-C-00001 Task Order No. 125 Modification No. 05

9. SPONSORING/MONITORING AGENCY NAME(S) AND ADDRESS(ES) U.S. Department of Transportation Federal Railroad Administration Office of Research and Development 1120 Vermont Avenue, NW Washington, DC 20590			10. SPONSORING/MONITORING AGENCY REPORT NUMBER FRA/ORD – 03/18

13. ABSTRACT Two full-scale impact tests performed June 4 and June 7, 2002, involved single Budd Company Pioneer-type cab car impacts into a heavy steel coil on a frangible support. For the first test on June 4, a cab car was fitted with a 1990's design front end, and for the second test on June 7, with a state-of-the-art front end. For the 1990's design front end, there was a large amount of damage to the corner post, which pulled out of the anti-telescoping plate at the top and sheared away from the buffer beam at the

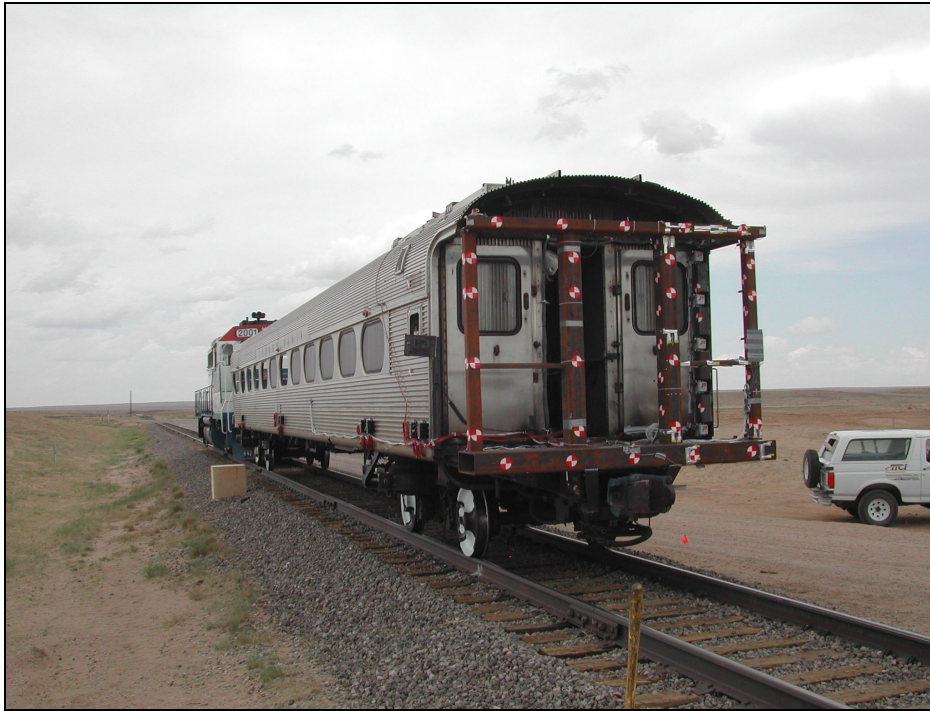
Figure 1. 1990's Cab Car Before Impact

Neither the pneumatic secondary suspension nor the air brakes worked on either vehicle. The 1990's test car is shown in Figure 1 and the SOA test car is shown in Figure 2.

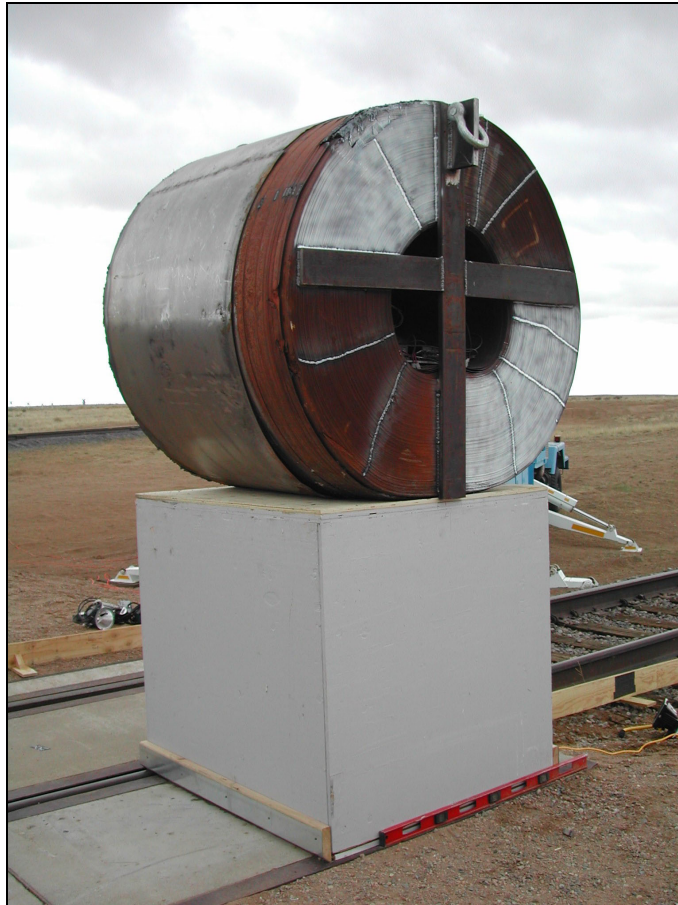
Figure 3. Steel Coil on Frangible Support

The steel coil on its frangible support is shown in Figure 3.

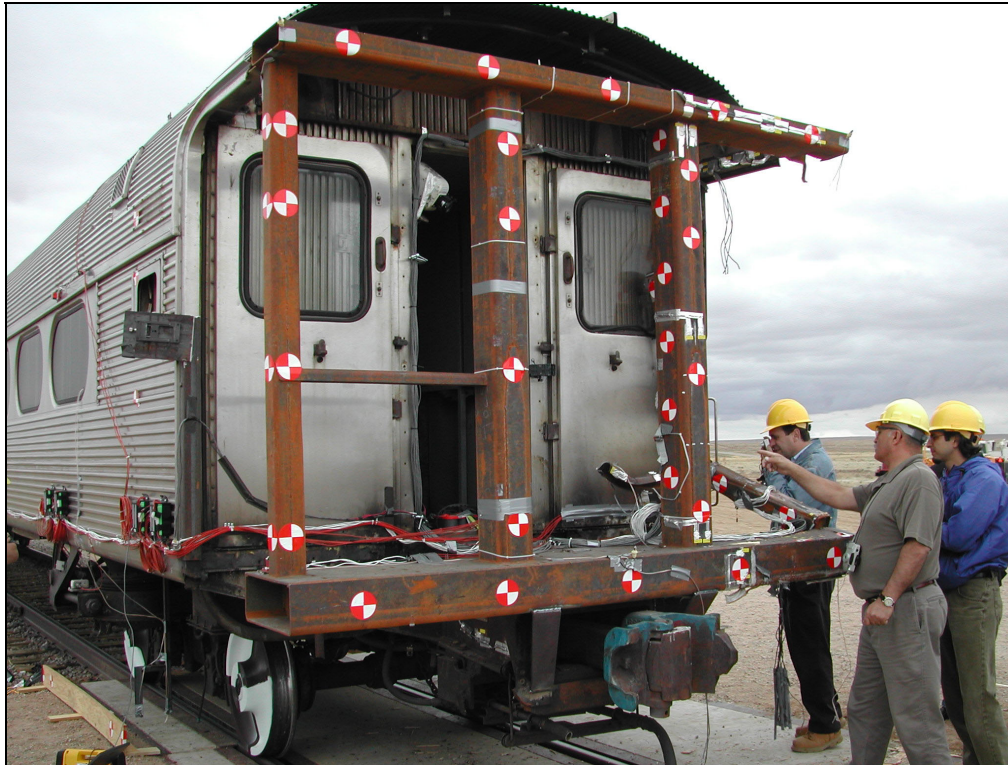
Figure 8. 1990's Design Cab Car After Impact With Steel Coil

Figure 8 shows the 1990's design cab car after impact with the steel coil.

There was a large amount of damage to the corner post, which pulled out of the anti-telescoping plate at the top and sheared away from the buffer beam at the bottom. The corner post buckled, and ended up at a point 14 inches off the floor level with the top of the post 56 inches off the floor, leaning back against the back of the doorpost.

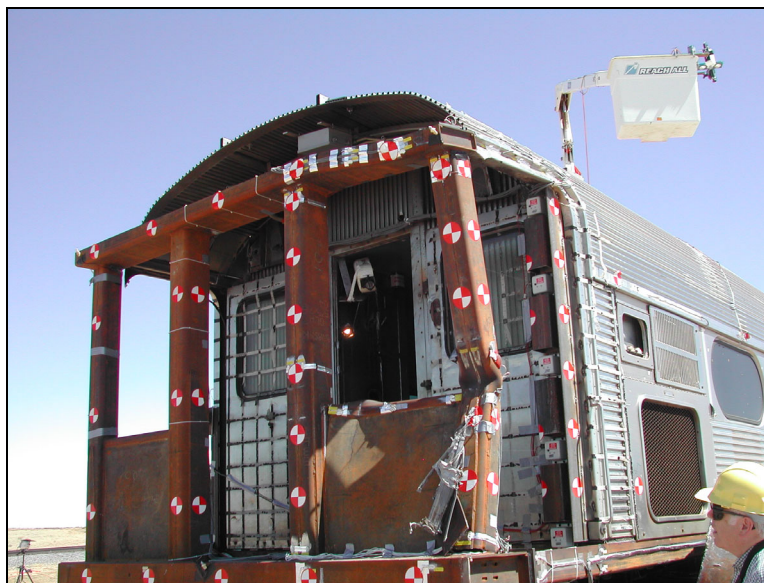
Figure 10. SOA Design Cab Car After Impact With Steel Coil

Figure 10 shows the SOA design cab car after impact with the steel coil.

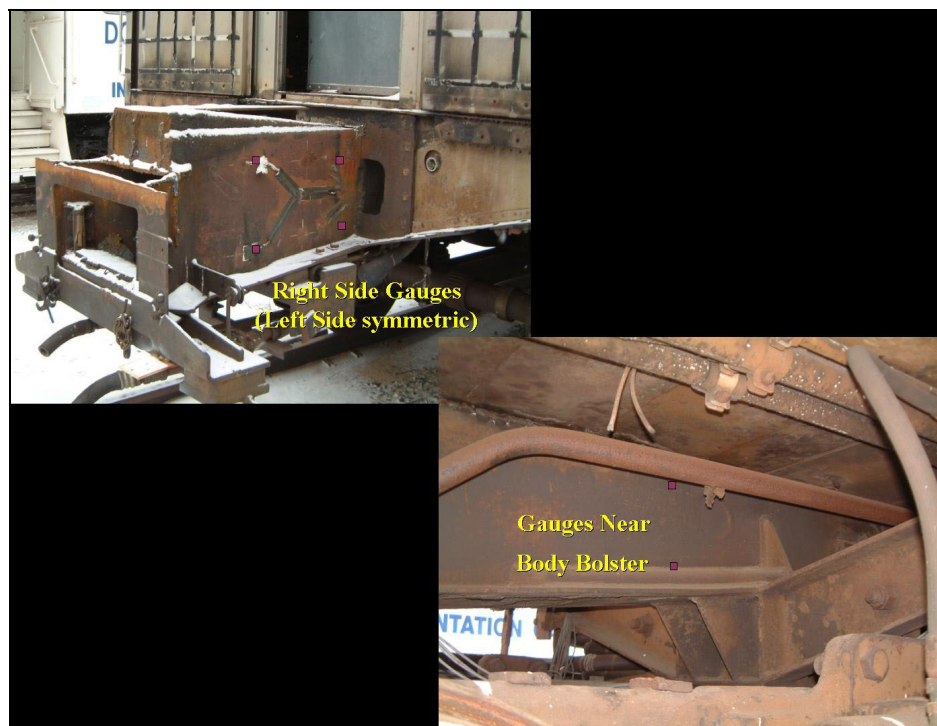
Figure 3. Placement of Strain Gauges on Draft Sill
