BUILDING MATERIALS and STRUCTURES

REPORT BMS22

Structural Properties of "Dun-Ti-Stone" Wall Construction Sponsored by the W. E. Dunn Manufacturing Company

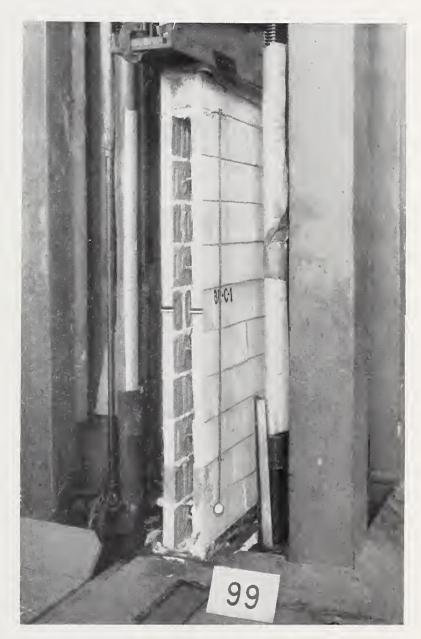
FIGURE 3.—Wall specimen BE-C1 under compressive load.

The compressive loads were applied to both the facing and the backing, 2.81 in. (one-third the thickness at the top of the units) from the inside face. The shortenings and sets shown in figure 4 for a height of 8 ft were computed from the values obtained from the compressometer readings. The gage length of the compressometers was 6 ft $5\frac{1}{2}$ in. The lateral deflections shown in figure 5 are the averages of the deflection of the facing and the backing, measured independently. The facing deflected the same amount as the backing within 0.01 in., the estimated error of measurement.

Each of the specimens failed by crushing of units in the backing in two courses either at midheight or near the upper end, cracking of the backing vertically through about four courses, and rupture of the bond between the units and the mortar at one or two bed joints in the facing at the height at which the units in the backing crushed.

Wall specimen BE-C1 under compressive load is shown in figure 3. The results for wall specimens BE-C1, C2, and C3 are shown in table 6 and in figures 4 and 5.

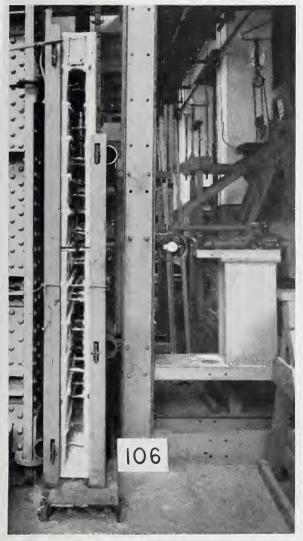
FIGURE 6.—Wall specimen BE-T1 under transverse load.

Each of the specimens failed by rupture of the bond between the mortar and the units at a bed joint at or between the loading rollers. The cracks usually appeared first in the face opposite the load and then in the loaded face.

Wall specimen BE-T1 under transverse load is shown in figure 6. The results are shown in table 6 and in figure 7 for wall specimens

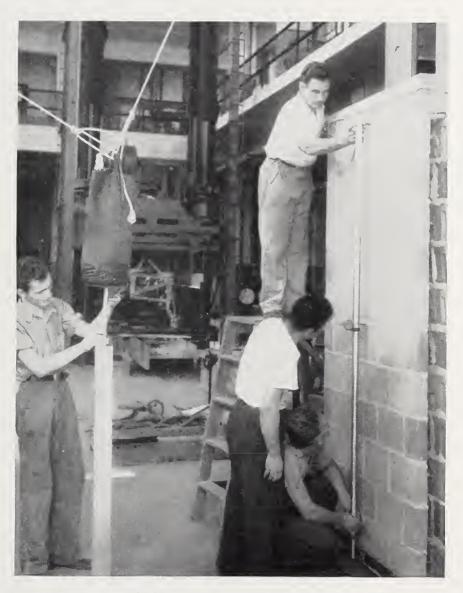
FIGURE 12.—Wall specimen BE-I1 during the impact test.

At the drops given in table 6 the faces of each specimen failed by rupture of the bond between the units and the mortar at bed joints near

midspan. At the maximum drops, each specimen failed by opening of these joints.

Wall specimen BE-I1 during the impact test is shown in figure 12. The results are shown in table 6 and in figure 13 for wall specimens BE-I1, I2, and I3, loaded on the inside face, and in figure 14 for wall specimens BE-I4, I5, and I6, loaded on the outside face.
