REPORT BMS48

Structural Properties of
"Precision-Built" Frame Wall
and Partition Constructions

Sponsored by
the Homasote Co.

ISSUED MAY 13, 1940

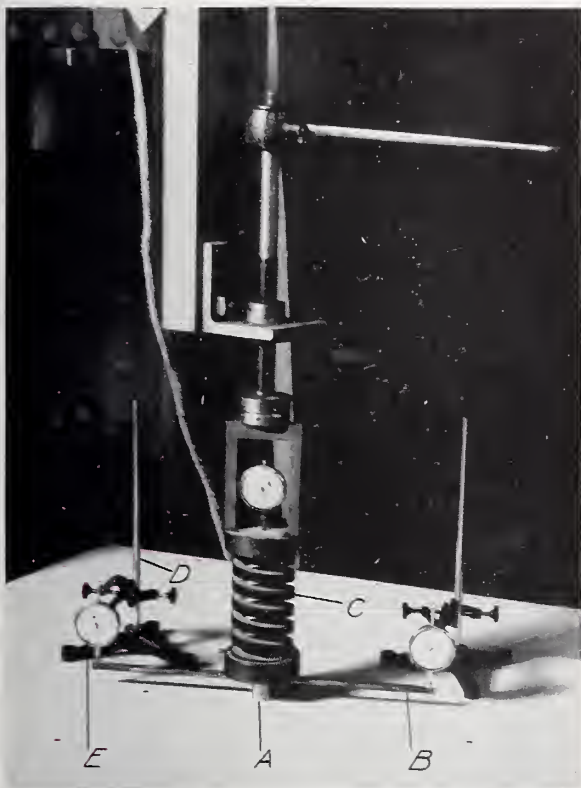
FIGURE 1.—Apparatus for concentrated load test.

A, steel loading disk; B, crossbar; C, dynamometer; D, stand; E, dial micrometer.

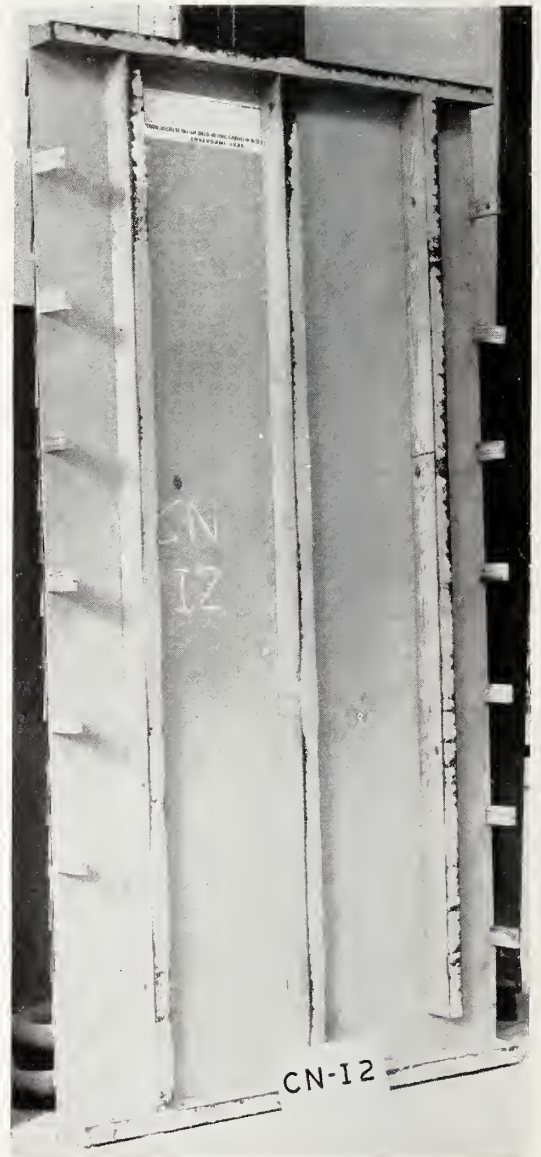
FIGURE 3.—Wall CN.
Typical specimen.

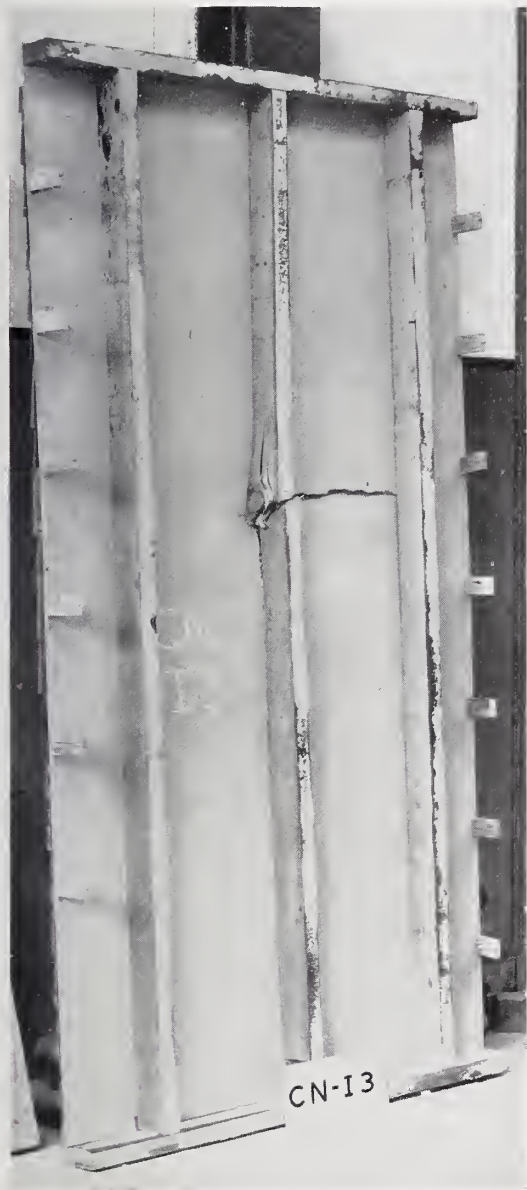
FIGURE 4.—Wall CN.

Two extremes in quality of framing are shown. The center stud is about the lowest and the two outer studs are the highest grade.

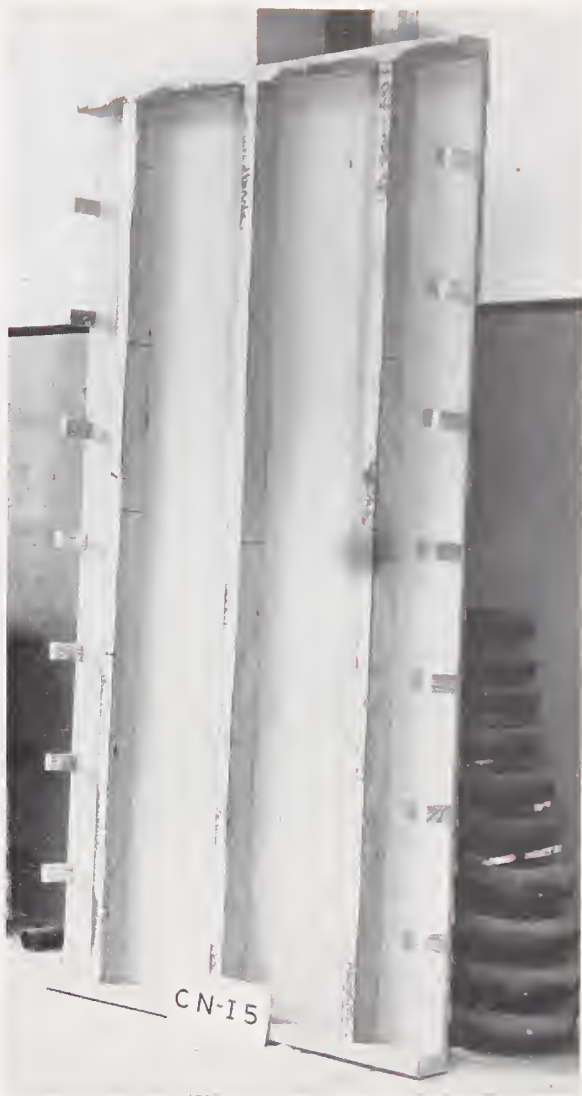
FIGURE 5.—Wall CN.

Typical specimen.

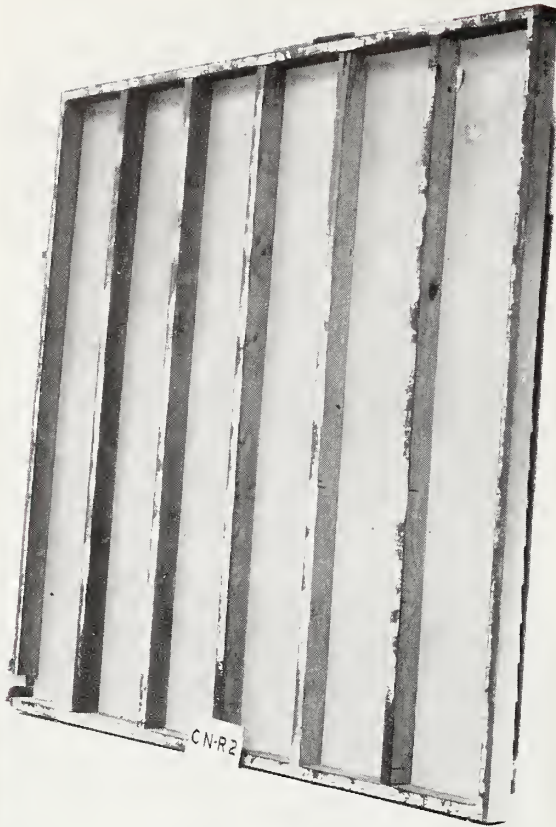
FIGURE 6.—Wall CN.
Typical specimen.

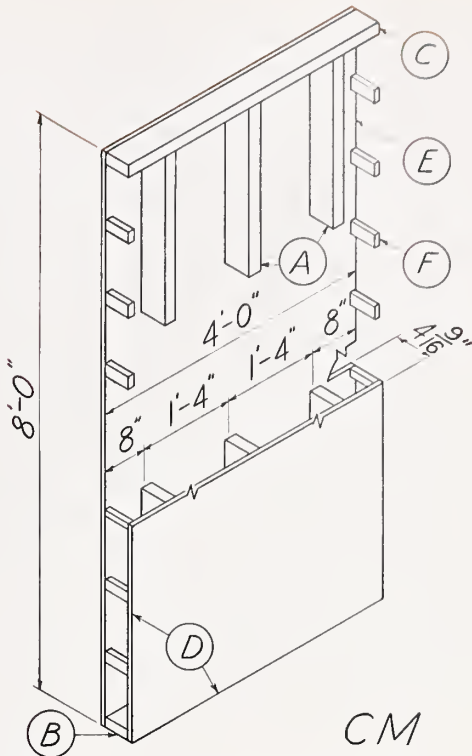
FIGURE 7.—Four-foot wall specimen CM

A, studs; B, floor plate; C, top plate; D, outside face (nailed); E, inside face (glued); F, spacer.

The 4-ft wall specimens, shown in figure 7, were 8 ft 0 in. high, 4 ft 0 in. wide, and 4¹/₁₆ in. thick. Each was a wood frame to which the faces were fastened. The frame consisted of three studs, A, fastened to a floor plate, B, and a top plate, C. Both the outside face, D, and the inside face, E, consisted of a single sheet of fiberboard. The overhanging edges of the faces were supported by spacers, F.

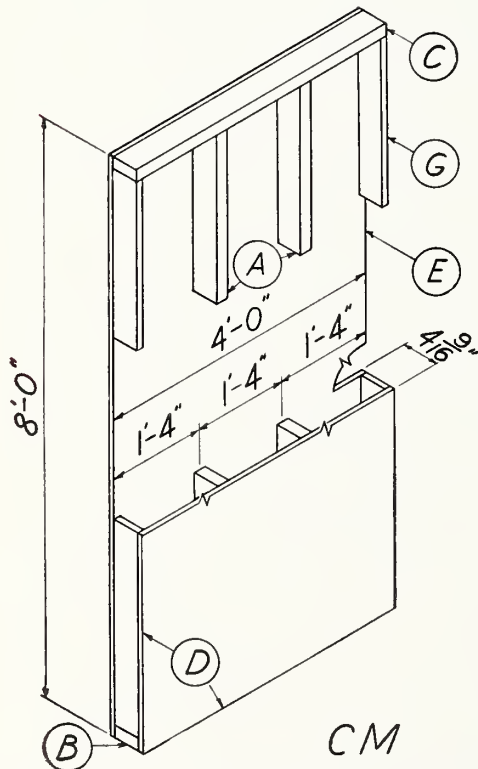
FIGURE 8.—Four-foot wall specimen *CM*, with half-sized studs.

A, full-sized studs; *B*, floor plate; *C*, top plate; *D*, outside face; *E*, inside face; *G*, half-sized stud.

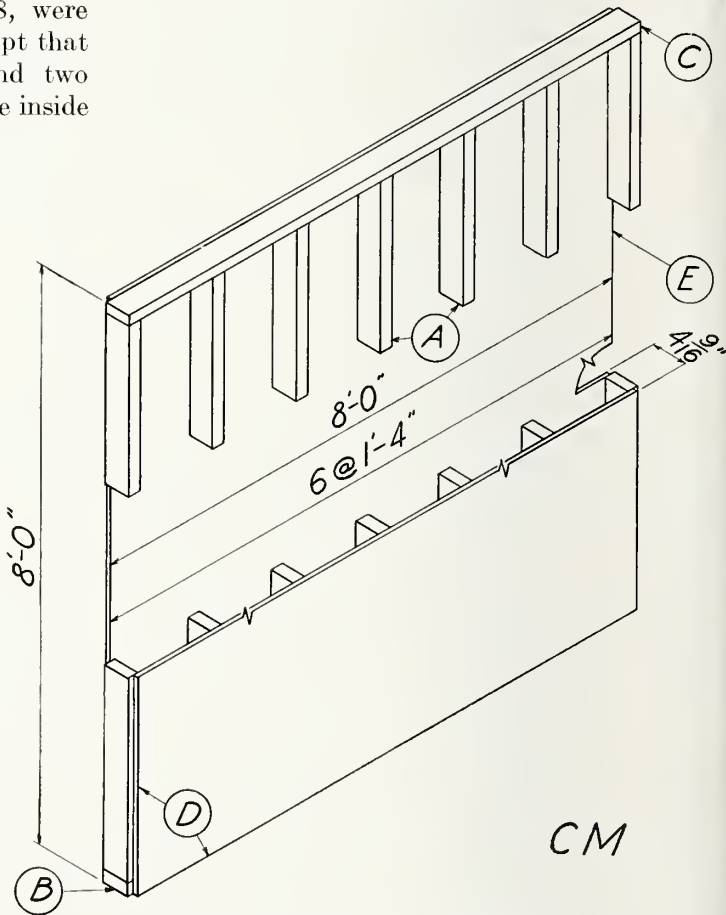
FIGURE 9.—Eight-foot wall specimen *CM*

A, full-sized studs; *B*, floor plate; *C*, top plate; *D*, outside face; *E*, inside face.

The 8-ft wall specimens, shown in figure 9, were 8 ft 0 in. high, 8 ft 0 in. face width, and $4\frac{9}{16}$ in. thick. The specimens were similar to the

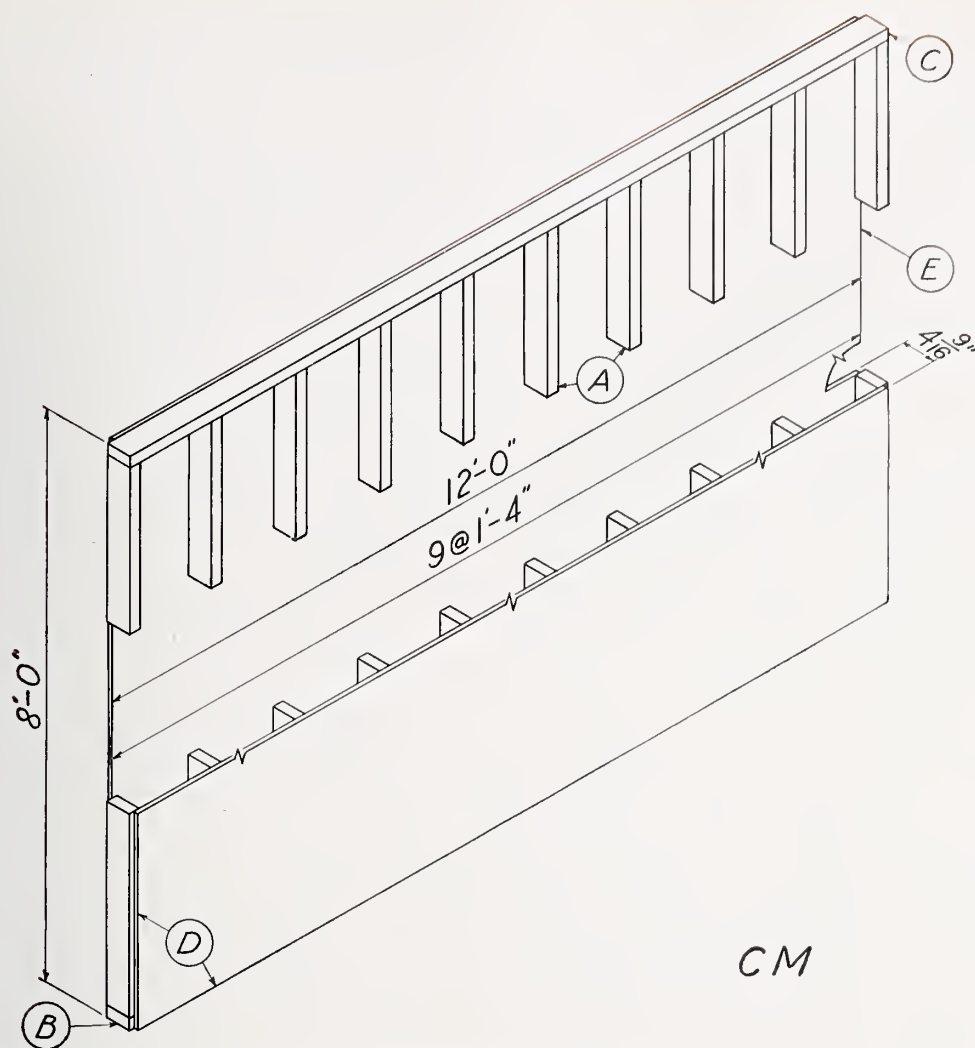
FIGURE 10.—*Twelve-foot wall specimen CM.*

A, full-sized studs; *B*, floor plate; *C*, top plate; *D*, outside face; *E*, inside face.

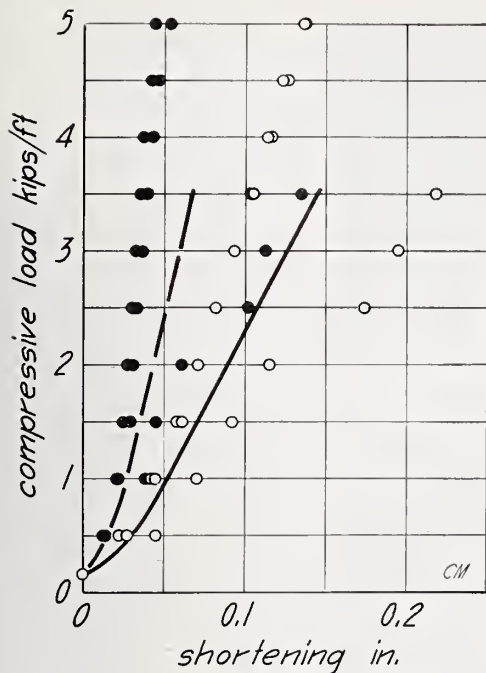
FIGURE 11.—Compressive load on wall CM.

Load-shortening (open circles) and load-set (solid circles) results for specimens CM-C1, C2, and C3. The load was applied 1.21 in. (one-third the thickness of the frame) from the inside surface of the studs. The loads are in kips per foot of actual width of specimen.

Under the maximum load the top plate on each of the specimens crushed locally at the inside edges of the studs, but none of the studs ruptured. The fiberboard on the inside face above midheight separated from the studs and from the top plate under a load of 2 kips/ft on specimen C3 and under the maximum load on specimens C1 and C2.

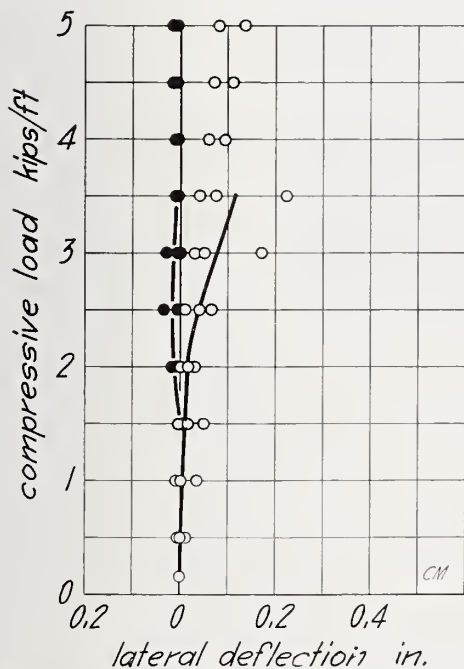
FIGURE 12.—Compressive load on wall CM.

Load-lateral deflection (open circles) and load-lateral set (solid circles) results for specimens CM-C1, C2, and C3. The load was applied 1.21 in. (one-third the thickness of the frame) from the inside surface of the studs. The loads are in kips per foot of actual width of specimen. The deflections and sets are for a gage length of 7 ft 10 in., the gage length of the deflectometers.

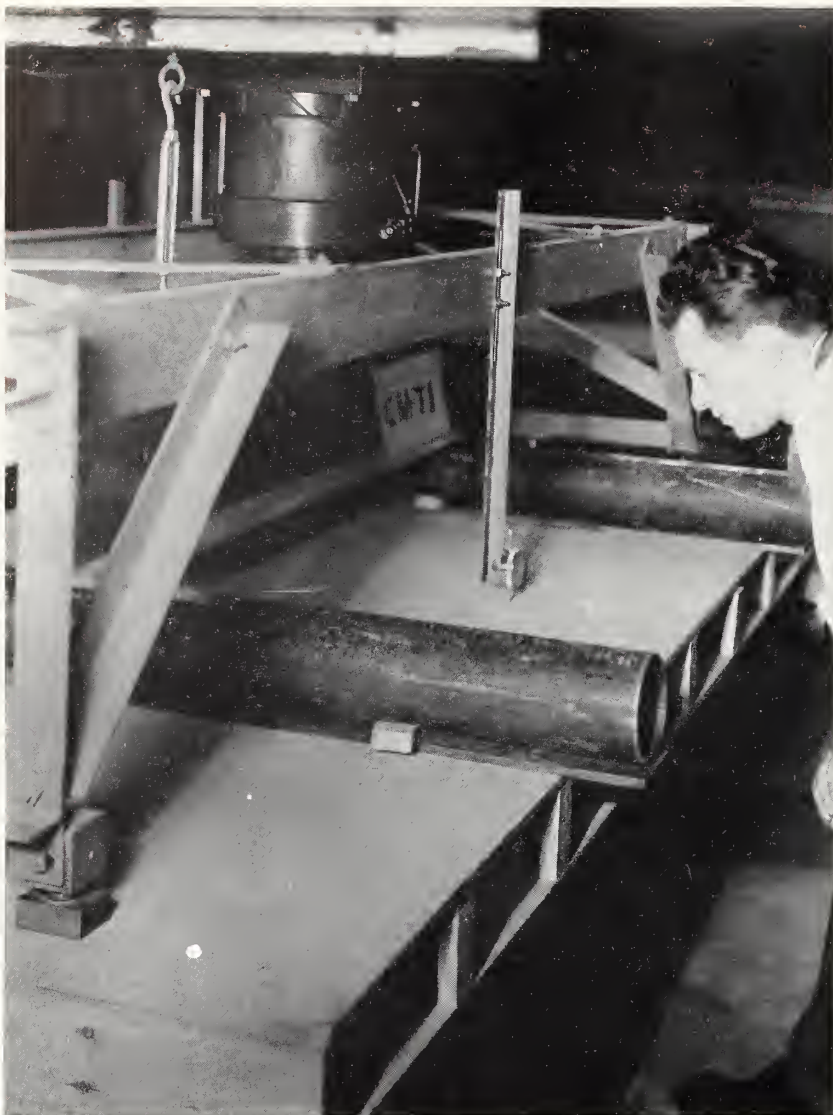
FIGURE 13.—Wall specimen *CM-T1* under transverse load.

Under a load of 100 lb/ft² one outer stud of specimen T1 partially ruptured at a knot near midspan. In specimen T2 under a load of 200 lb/ft² one outer stud partially ruptured at a knot under a loading roller.

Under the maximum loads on specimens T1 and T2 the fiberboard on the outside (unloaded) face was ruptured transversely by the force exerted by the partially ruptured stud; and this stud and the center stud ruptured completely.

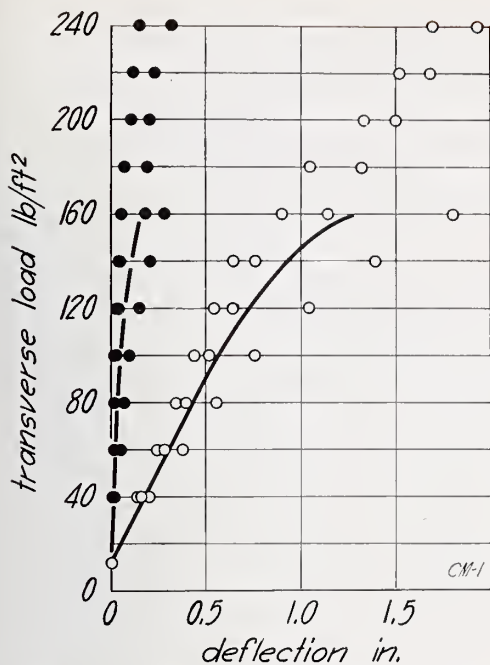
FIGURE 14.—Transverse load on wall CM, load applied to inside face.

Load-deflection (open circles) and load-set (solid circles) results for specimens CM-T1, T2, and T3 on the span 7 ft 6 in.

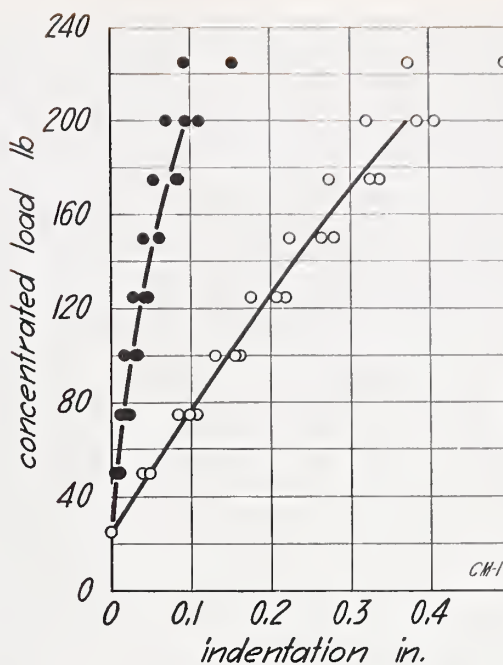
FIGURE 16.—Concentrated load on wall CM, load applied to inside face.

Load-indentation (open circles) and load-set (solid circles) results for specimens CM-P1, P2, and P3.

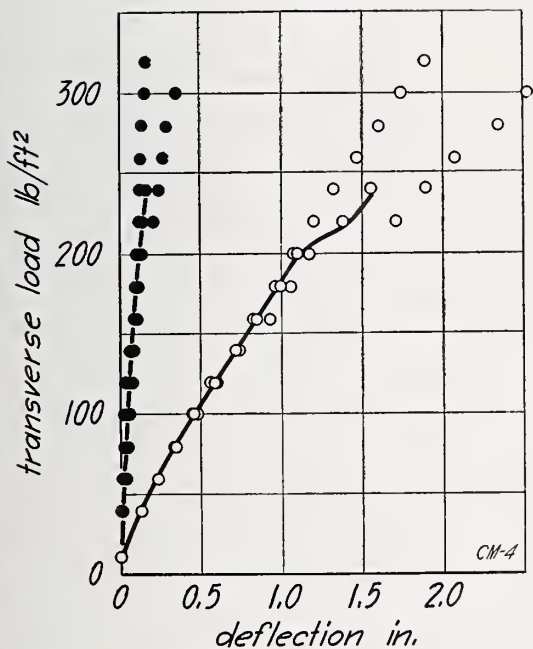
FIGURE 15.—Transverse load on wall CM, load applied to outside face.

Load-deflection (open circles) and load-set (solid circles) results for specimens CM-T4, T5, and T6 on the span 7 ft 6 in.

In specimen T4 the fiberboard on the inside (unloaded) face separated from the studs under a load of 220 lb/ft²; the same effect occurred in specimen T5 under a load of 300 lb/ft², and in specimen T6 under a load of 180 lb/ft². Under loads of 220, 430, and 200 lb/ft² on these specimens, respectively, one outer stud split along the grain near midspan. Under the maximum loads the split outer stud of each specimen ruptured, followed by rupture of the center stud. The fiberboard on the inside (unloaded) face of specimen T4 was ruptured transversely by the force exerted by the ruptured studs, but the inside faces of specimens T5 and T6 were undamaged.

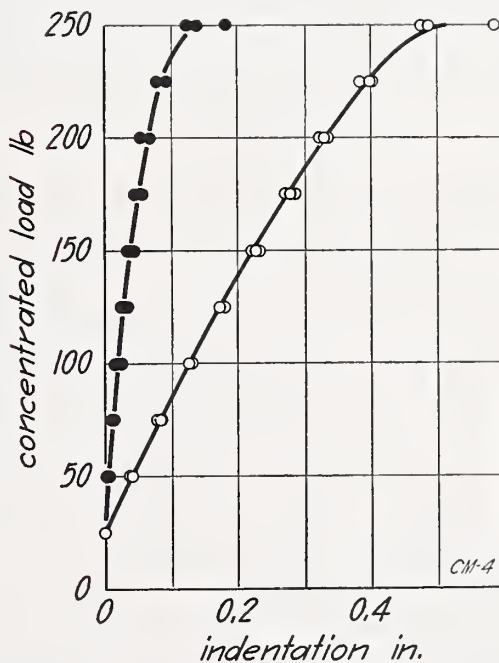
FIGURE 17.—Concentrated load on wall CM, load applied to outside face.

Load-indentation (open circles) and load-set (solid circles) results for specimens CM-P4, P5, and P6.

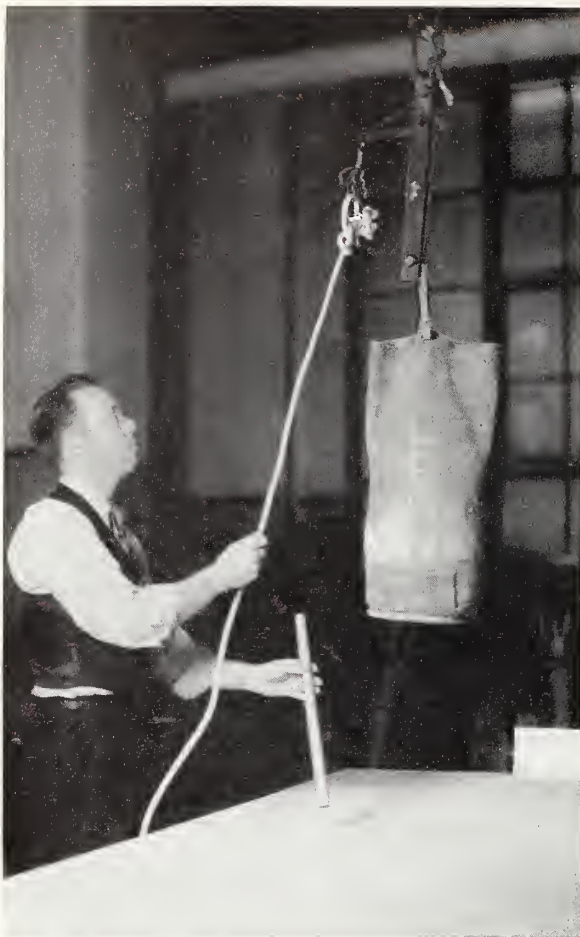
FIGURE 18.—Wall specimen CM-14a during the impact test.

The impact loads were applied to the center of the outside (nailed) face of specimens CM-14a, 15a, and 16a, the sandbag striking the fiberboard between the full-sized studs.

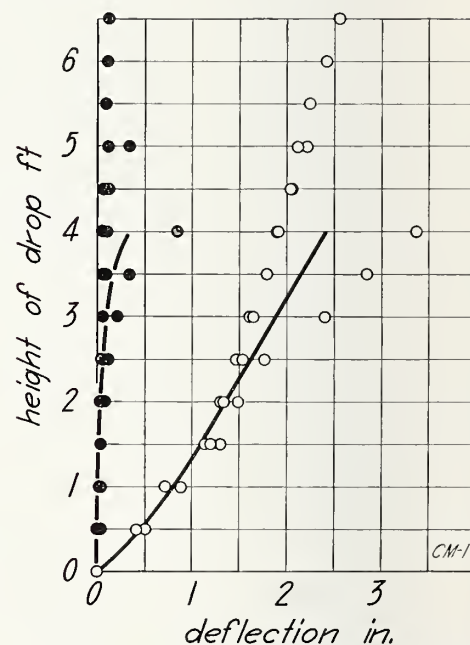
FIGURE 19.—Impact load on wall CM, load applied to inside face.

Height of drop-deflection (open circles) and height of drop-set (solid circles) results for specimens CM-11, 12, and 13. The sandbag struck the center of the specimen directly over a stud.

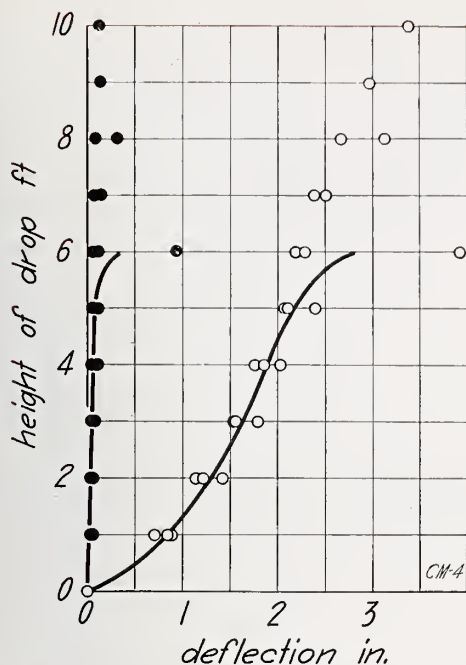
FIGURE 20.—Impact load on wall CM, load applied to outside face.

Height of drop-deflection (open circles) and height of drop-set (solid circles) results for specimens CM-14, 15, and 16. The sandbag struck the center of the specimen directly over a stud.

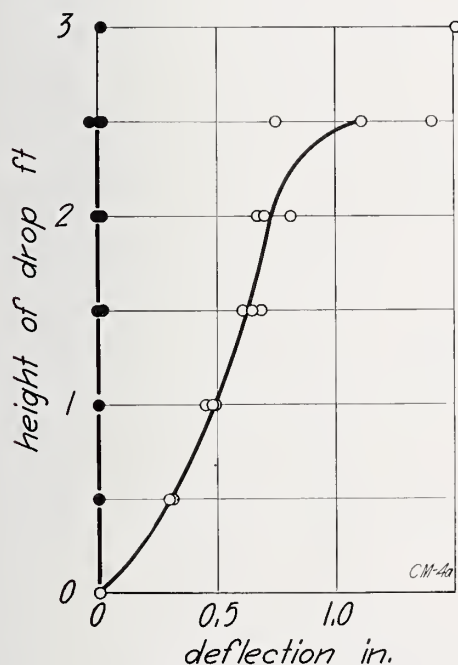
FIGURE 21.—Impact load on wall specimens CM-14a, 15a, and 16a.

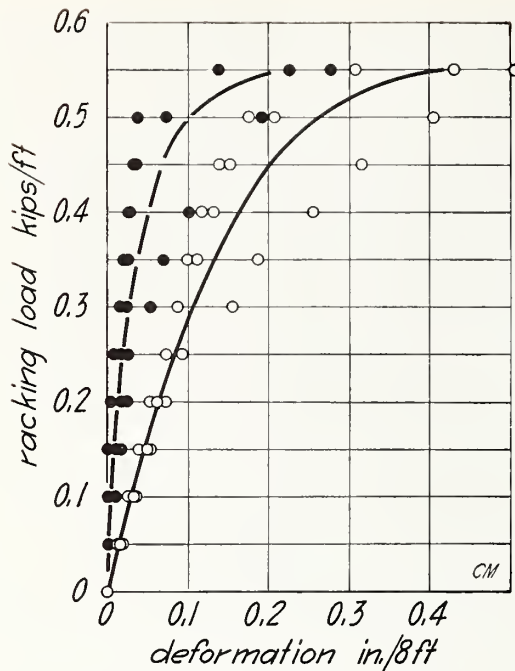
FIGURE 22.—Racking load on wall CM.

Load-deformation (open circles) and load-set (solid circles) results for specimens CM-R1, R2, and R3. The loads are in kips per foot of face width of specimen (8 ft 0 in.).

Under the maximum loads the fiberboard on the inside face of each specimen separated from the glued surface of the frame, and the frame was displaced relative to the inside face. The nails passing through the inside face into the top plate and into the stud at the unloaded edge tore through the edges of the fiberboard. The nails passing through the outside face into the

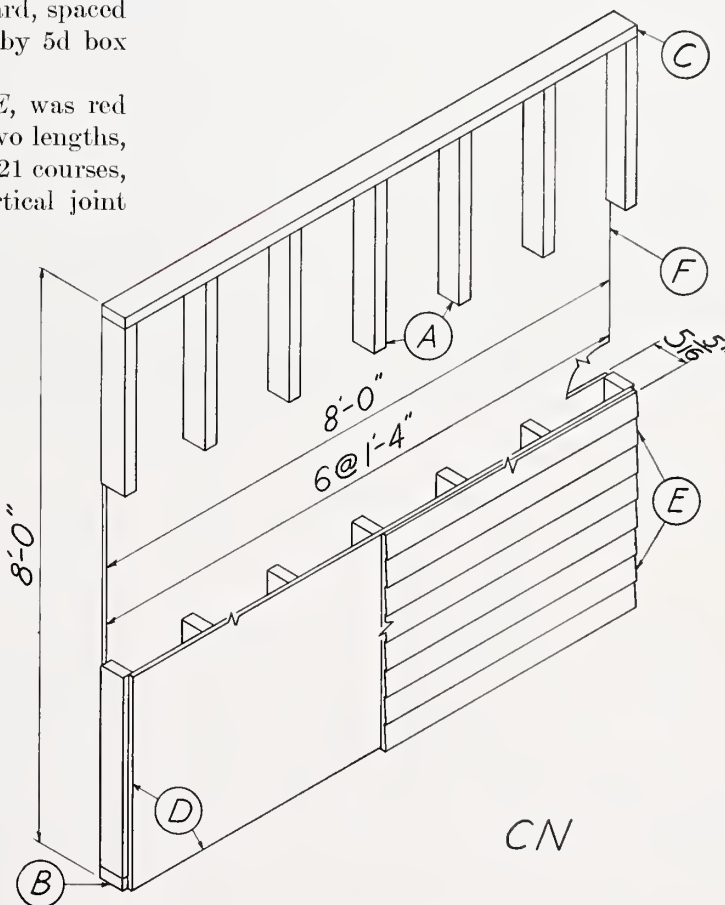
FIGURE 25.—Eight-foot wall specimen CN.

A, studs; *B*, floor plate; *C*, top plate; *D*, sheathing; *E*, bevel siding; *F*, inside face.

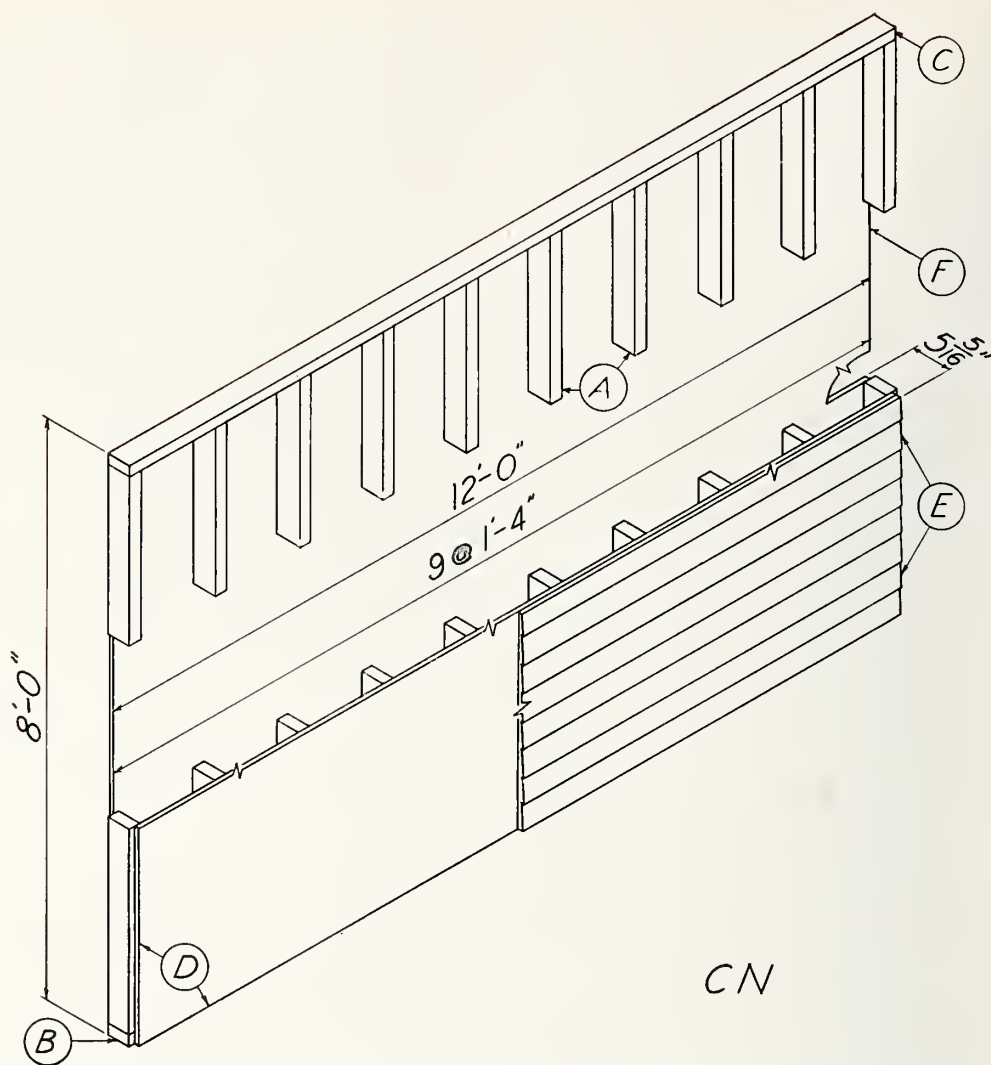
FIGURE 26.—Twelve-foot wall specimen CN.

A, studs; B, floor plate; C, top plate; D, sheathing; E, bevel siding; F, inside face.

To determine the relation between racking properties and width of specimen three additional racking specimens, CN-R1a, R2a, and R3a, were submitted. These specimens, shown in figure 26, were 8 ft 0 in. high, 12 ft 0 in. face width, and $5\frac{5}{16}$ in. thick, and were similar to the 4-ft specimens, except that there were ten studs, spaced 1 ft 4 in. on centers, and no spacers. A stud at each edge extended one-half its thickness beyond the faces. The width overall was 12 ft $1\frac{5}{8}$ in.

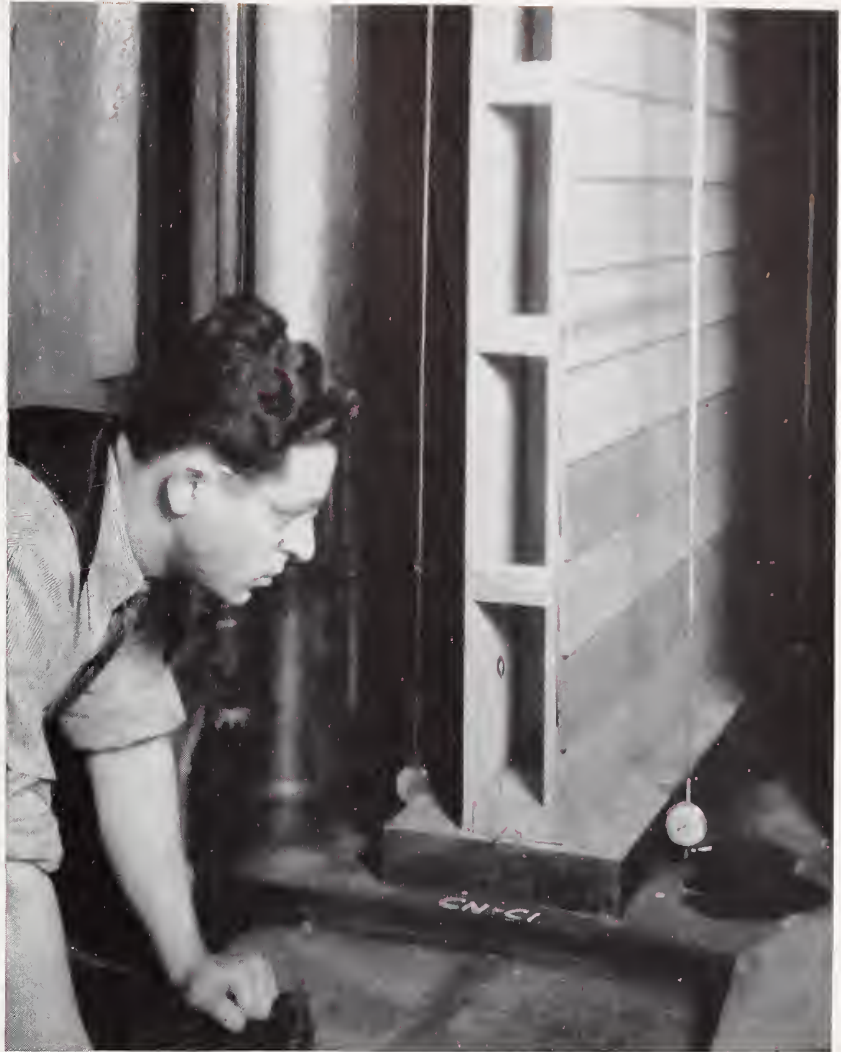
FIGURE 27.—Wall specimen
CN-C1 under compressive
load.

Wall specimen *CN-C1* under compressive load is shown in figure 27. The results for wall specimens *CN-C1*, *C2*, and *C3* are given in table 6 and in figures 28 and 29.

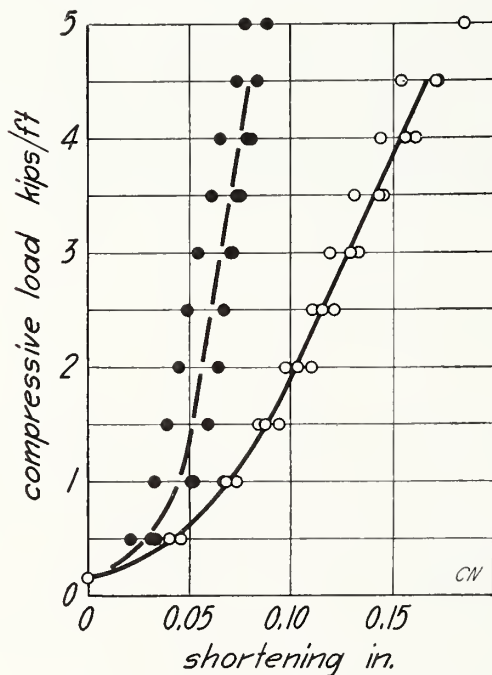
FIGURE 28.—Compressive load on wall *CN*.

Load-shortening (open circles) and load-set (solid circles) results for specimens *CN-C1*, *C2*, and *C3*. The load was applied 1.21 in. (one-third the thickness of the frame) from the inside surface of the studs. The loads are in kips per foot of actual width of specimen.

The fiberboard on the inside face of specimen *C1* began to separate from the top plate under a load of 3.0 kips/ft; on specimen *C2*, under a load of 5.0 kips/ft; and on specimen *C3*, under the maximum load. At the maximum load the top plate of each specimen crushed locally at

the inside edges of the studs. This was accompanied by separation of the fiberboard on the inside face from the upper half of the studs. The outer studs of specimen *C3* split at the top, but none of the studs ruptured.

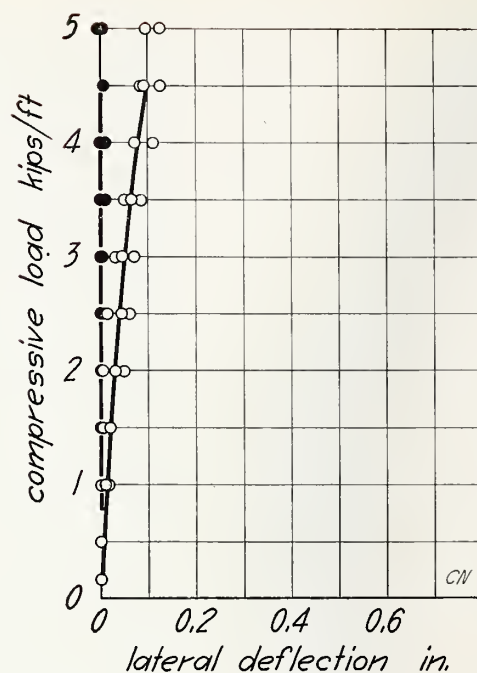
FIGURE 29.—Compressive load on wall *CN*.

Load-lateral deflection (open circles) and load-lateral set (solid circles) results for specimens *CN-C1*, *C2*, and *C3*. The load was applied 1.21 in. (one-third the thickness of the frame) from the inside surface of the studs. The loads are in kips per foot of actual width of specimen. The deflections and sets are for a gage length of 7 ft 10 in., the gage length of the deflectometers.

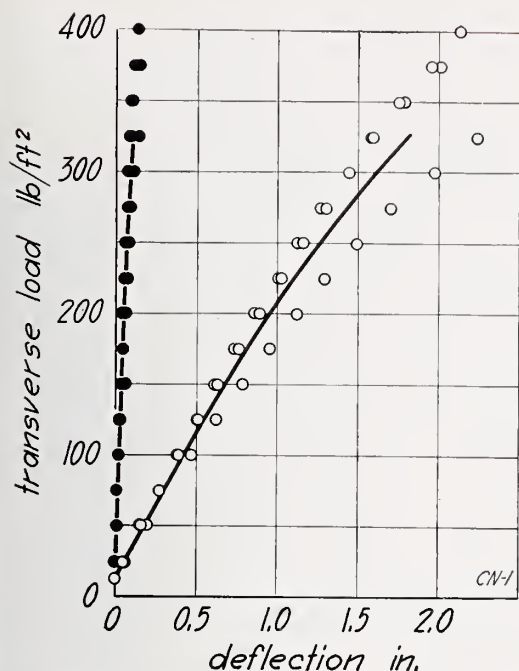
FIGURE 30.—Transverse load on wall CN, load applied to inside face.

Load-deflection (open circles) and load-set (solid circles) results for specimens CN-T1, T2, and T3 on the span 7 ft 6 in.

Under a load of 350 lb/ft² on specimen *T1*, one outer stud partially ruptured. The center stud and one outer stud of specimen *T2* began to rupture at a load of 400 lb/ft², and one outer stud of *T3* began to rupture under a load of 275 lb/ft². Under the maximum loads, the center stud and one outer stud of each specimen ruptured near midspan. The sheathings of specimens *T1* and *T2* was undamaged,

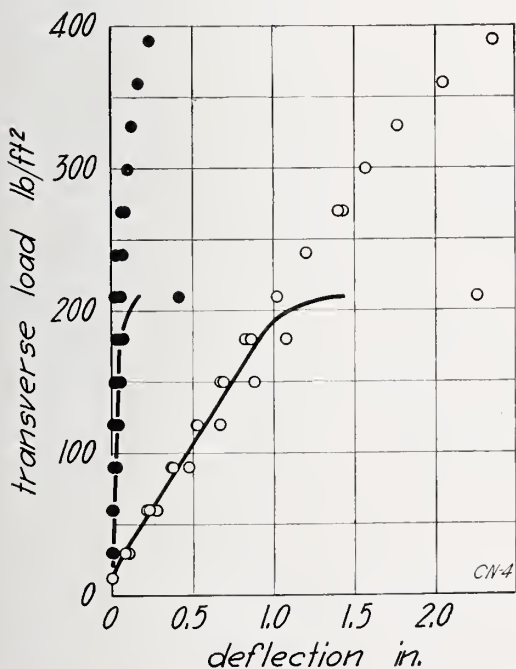
FIGURE 31.—Transverse load on wall CN, load applied to outside face.

Under a load of 390 lb/ft² on specimen T4, the fiberboard on the inside face began to separate from the studs near midspan; in specimen T5 separation began under a load of 180 lb/ft², and in T6 under a load of 263 lb/ft². One outer stud of each specimen ruptured partially under loads of 390, 208, and 263 lb/ft², respectively. Under the maximum load on each specimen, the partially ruptured outer stud and the center stud ruptured completely. The fiberboard on the inside face of specimens T4 and T6 was undamaged, but that on specimen T5 was ruptured transversely.

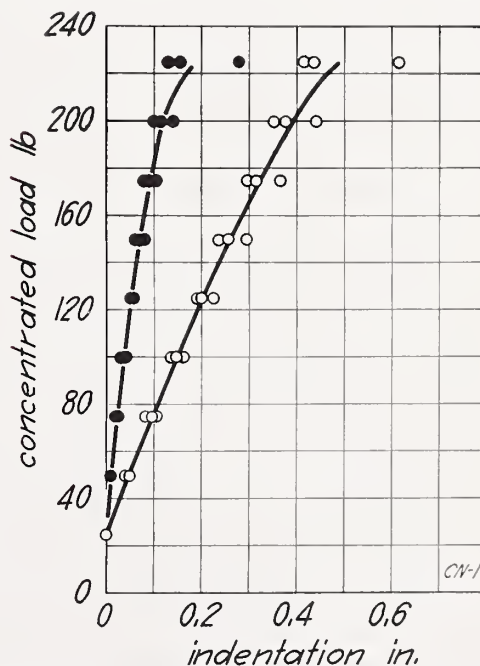
FIGURE 32.—Concentrated load on wall CN, load applied to inside face.

Load-indentation (open circles) and load-set (solid circles) results for specimens CN-P1, P2, and P3.

The concentrated load was applied to the inside face of specimens CN-P1, P2, and P3

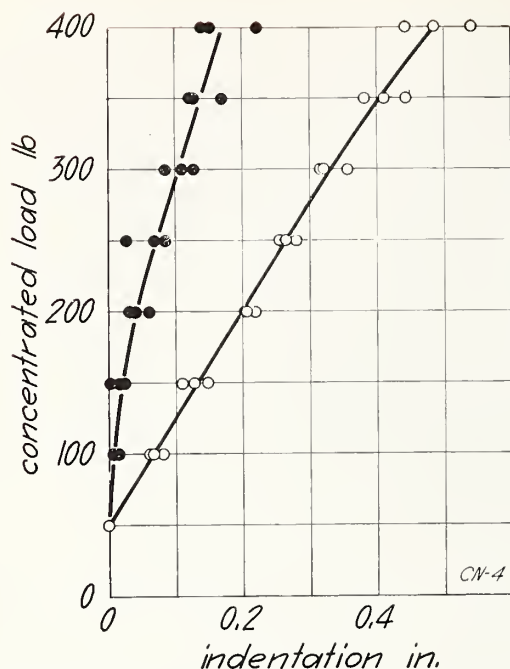
FIGURE 33.—Concentrated load on wall CN, load applied to outside face.

Load-indentation (open circles) and load-set (solid circles) results for specimens CN- P_4 , P_5 , and P_6 .

The results of the concentrated-load tests are shown in table 6 and in figure 32 for wall specimens CN-P1, P2, and P3, loaded on the inside face, and in figure 33 for wall specimens CN-P4, P5, and P6, loaded on the outside (bevel siding) face.

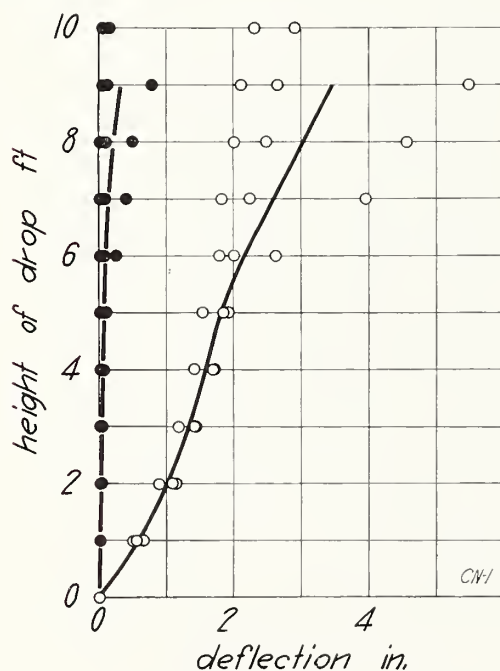
FIGURE 34.—Impact load on wall CN, load applied to inside face.

Height of drop-deflection (open circles) and height of drop-set (solid circles) results for specimens CN- I_1 , I_2 , and I_3 . The sandbag struck the center of the specimen directly over a stud.

The impact load was applied to the center of the inside faces of specimens CN- I_1 , I_2 , and I_3 , the sandbag striking the fiberboard directly

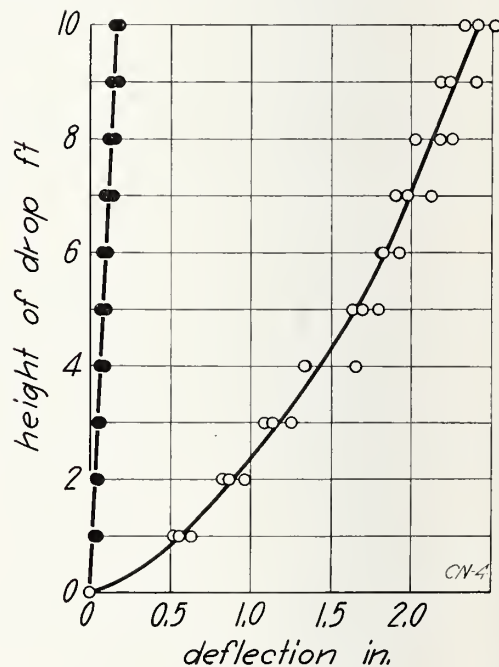
FIGURE 35.—Impact load on wall CN, load applied to outside face.

Height of drop-deflection (open circles) and height of drop-set (solid circles) results for specimens CN- I_4 , I_5 , and I_6 . The sandbag struck the center of the specimen directly over a stud.

Results of the impact tests are shown in table 6 and in figure 34 for wall specimens CN- I_1 , I_2 , and I_3 , loaded on the inside face, and in figure 35 for wall specimens CN- I_4 , I_5 , and I_6 , loaded on the outside face.

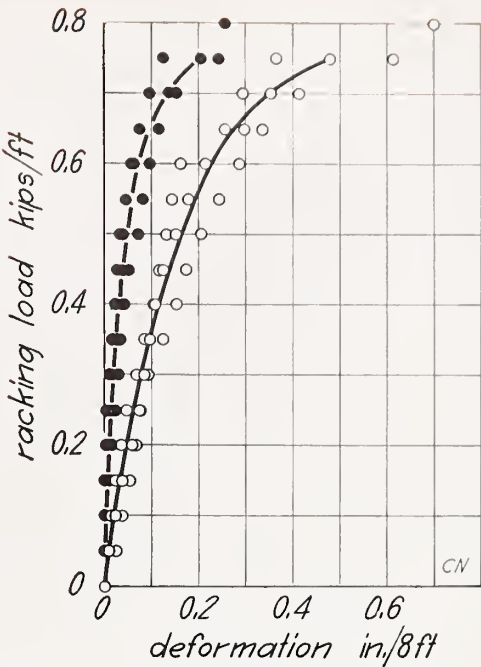
FIGURE 36.—Racking load on wall CN.

Load-deformation (open circles) and load-set (solid circles) results for specimens CN-R1, R2, and R3. The loads are in kips per foot of face width of specimen (8 ft 0 in.).

The results of the racking-load tests are shown in table 6 and in figure 36 for the 8-ft wall specimens CN-R1, R2, and R3, and in figure 37 for the 12-ft wall specimens CN-R1a, R2a, and R3a.

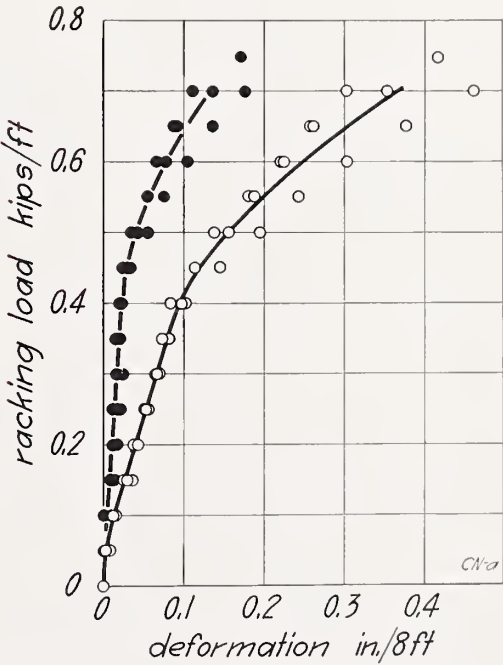
FIGURE 37.—Racking load on wall specimens CN-R1a, R2a, and R3a.

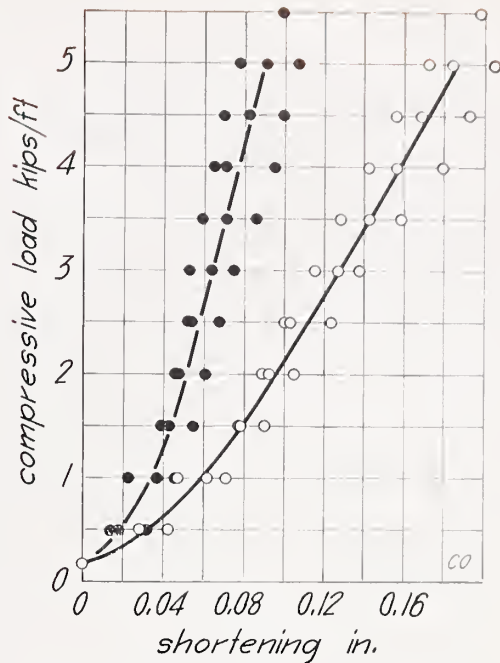
FIGURE 38.—Compressive load on partition *CO*.

Load-shortening (open circles) and load-set (solid circles) results for specimens *CO-C1*, *C2*, and *C3*. The load was applied 1.21 in. (one-third the thickness of the frame) from one surface of the studs. The loads are in kips per foot of actual width of specimen.

Under the maximum load the fiberboard on the "inside" face of each specimen separated from the upper half of the studs, and the top

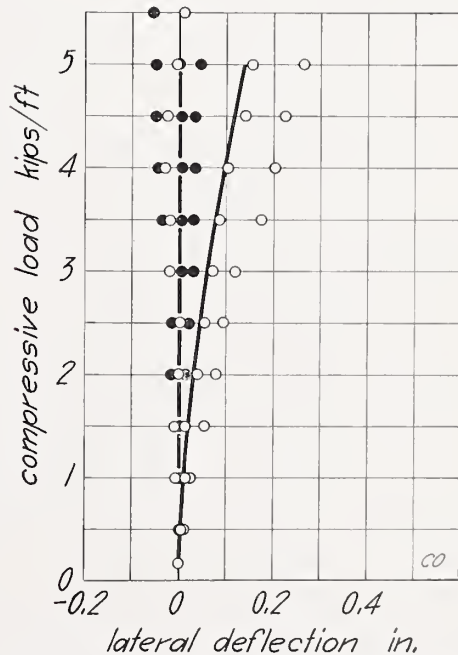
FIGURE 39.—Compressive load on partition *CO*.

Load-lateral deflection (open circles) and load-lateral set (solid circles) results for specimens *CO-C1*, *C2*, and *C3*. The load was applied 1.21 in. (one-third the thickness of the frame) from one surface of the studs. The loads are in kips per foot of actual width of specimen. The deflections and sets are for a gage length of 7 ft 10 in., the gage length of the deflectometers.

The results of compressive-load tests for partition specimens *CO-C1*, *C2*, and *C3* are shown in table 6 and in figures 38 and 39.

Deflections toward the "outside" face (positive deflection) were plotted to the right of the vertical axis in figure 39. The face farthest from the load line was taken as the "outside" face. Deflections toward the "inside" face (negative deflection) were plotted to the left of the vertical axis.

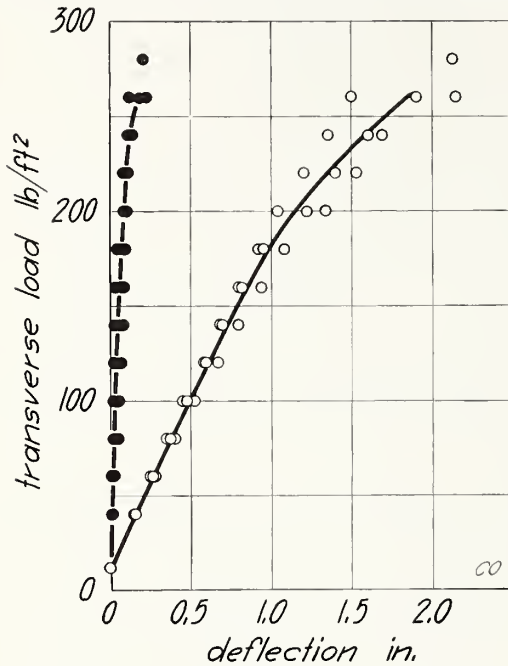
FIGURE 40.—Transverse load on partition *CO*.

Load-deflection (open circles) and load-set (solid circles) results for specimens *CO-T1*, *T2*, and *T3* on the span 7 ft 6 in.

Transverse-load test results for partition specimens *CO-T1*, *T2*, and *T3* are given in table 6 and in figure 40.

The speed of the movable head of the testing machine under no load was adjusted to 0.14 in./min.

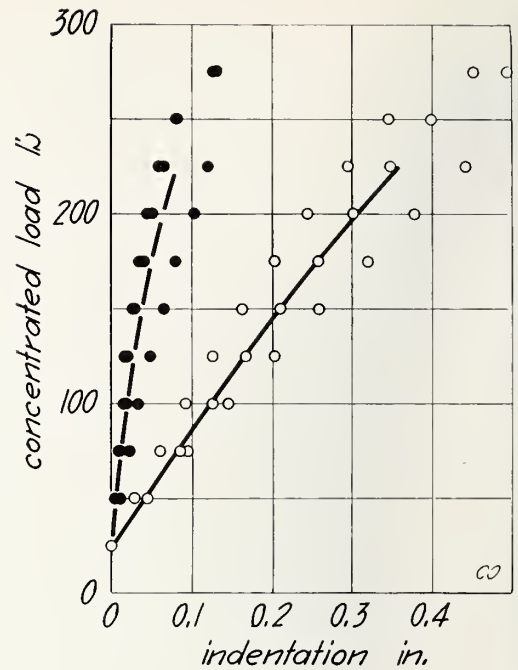
FIGURE 41.—Concentrated load on partition *CO*.

Load-indentation (open circles) and load-set (solid circles) results for specimens *CO-P1*, *P2*, and *P3*.

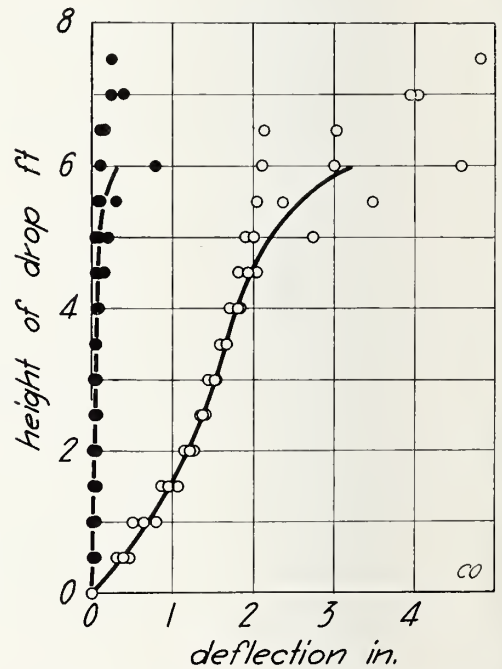
FIGURE 42.—Impact load on partition *CO*.

Height of drop-deflection (open circles) and height of drop-set (solid circles) results for specimens *CO-T1*, *T2*, and *T3*. The sandbag struck the center of the specimen directly over a stud.

Impact-test results are shown in table 6 and in figure 42 for partition specimens *CO-I1*, *I2*, and *I3*, and in figure 43 for partition specimens *CO-I1a*, *I2a*, and *I3a*.

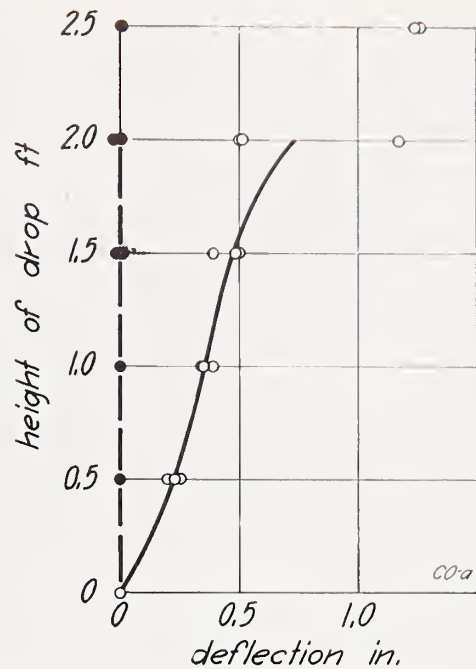
FIGURE 43.—Impact load on partition specimens *CO-I1a*, *I2a*, and *I3a*.

Height of drop-deflection (open circles) and height of drop-set (solid circles) results. The sandbag struck the center of the specimen midway between studs.

The impact loads were applied to the center of one face of specimens *CO-I1a*, *I2a*, and *I3a*, the sandbag striking the fiberboard between the full-sized studs.

To prevent misleading results from local effects on the loaded face of this type of specimen, the deflections and sets were measured with two deflectometers and two set gages, not one, as described in BMS2. The deflectometers were placed in contact with the unloaded face of the specimen at midheight, one at each inner stud, and the set gages rested on the loaded face, one over each of these studs.

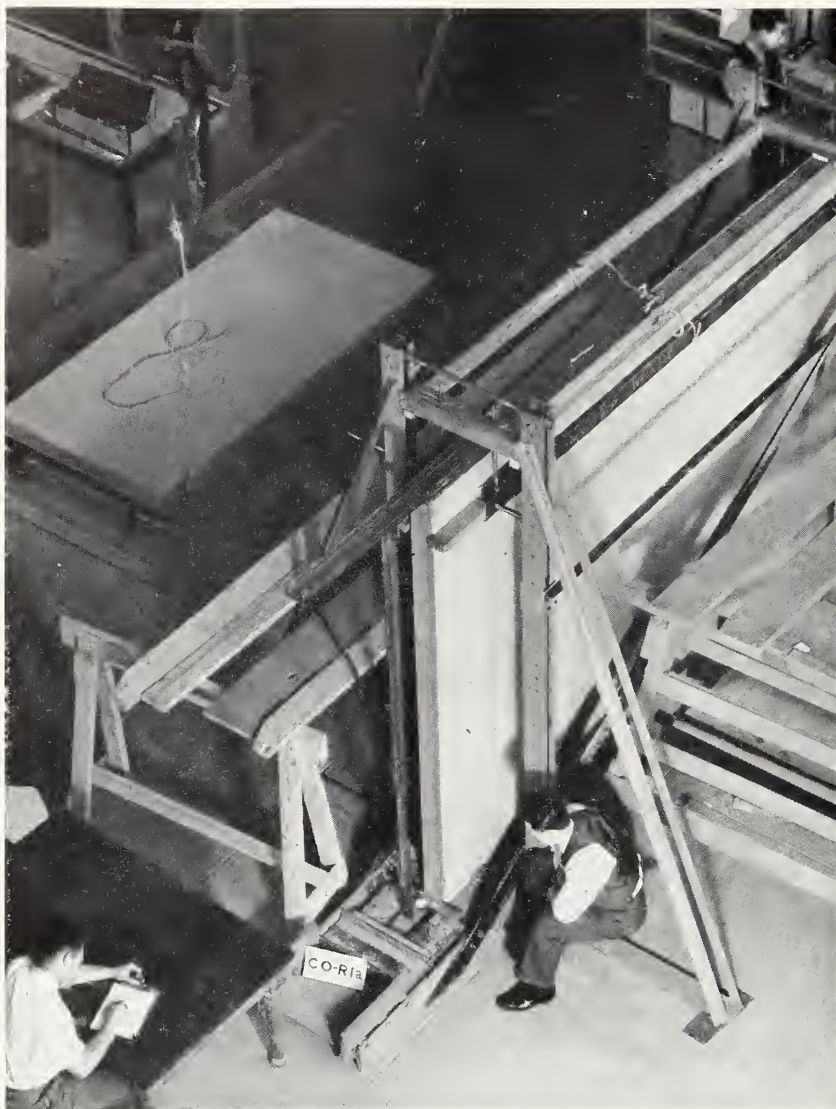
FIGURE 44.—*Partition specimen CO-R1a under racking load.*

Partition specimen *CO-R1a* under racking load is shown in figure 44. The results are shown in table 6 and in figure 45 for the 8-ft partition specimens *CO-R1*, *R2*, and *R3*, and in figure 46 for the 12-ft partition specimens *CO-R1a*, *R2a*, and *R3a*.

The glued joints between the fiberboard and the frame appeared to fail consecutively, beginning at the edge to which the racking load was applied.
