REPORT BMS48

Structural Properties of
"Precision-Built" Frame Wall
and Partition Constructions

Sponsored by
the Homasote Co.

ISSUED MAY 13, 1940

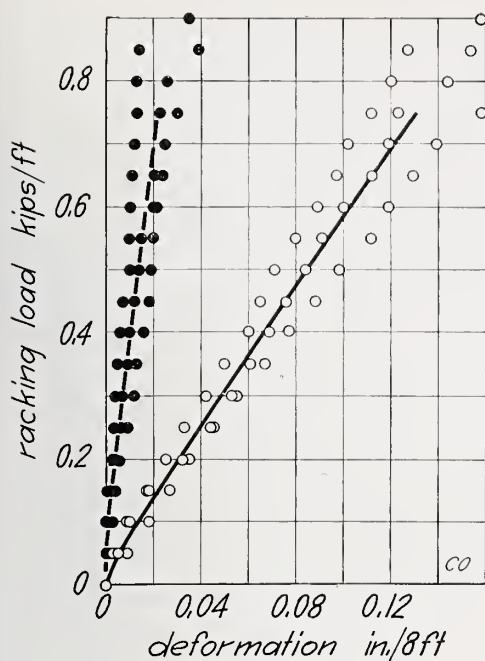
FIGURE 45.—Racking load on partition C'O.

Load-deformation (open circles) and load-set (solid circles) results for specimens C'O-R1, R2, and R3. The loads are in kips per foot of face width of specimen (8 ft 0 in.).

Partition specimen *CO-R1a* under racking load is shown in figure 44. The results are shown in table 6 and in figure 45 for the 8-ft partition specimens *CO-R1*, *R2*, and *R3*, and in figure 46 for the 12-ft partition specimens *CO-R1a*, *R2a*, and *R3a*.

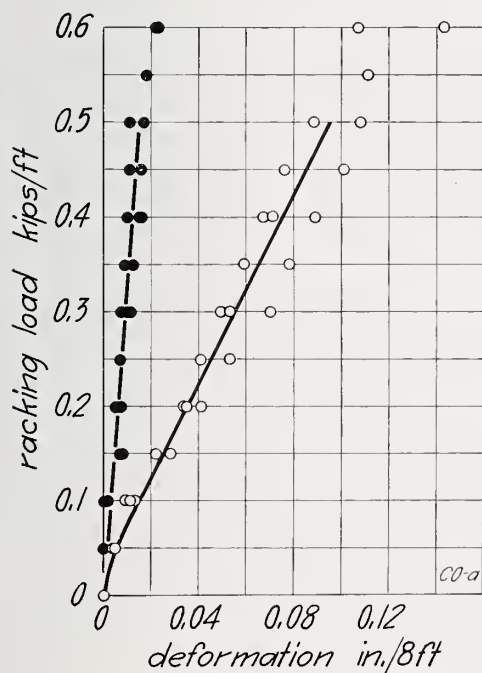
FIGURE 46.—Racking load on partition specimens C'O-R1a, R2a, and R3a.

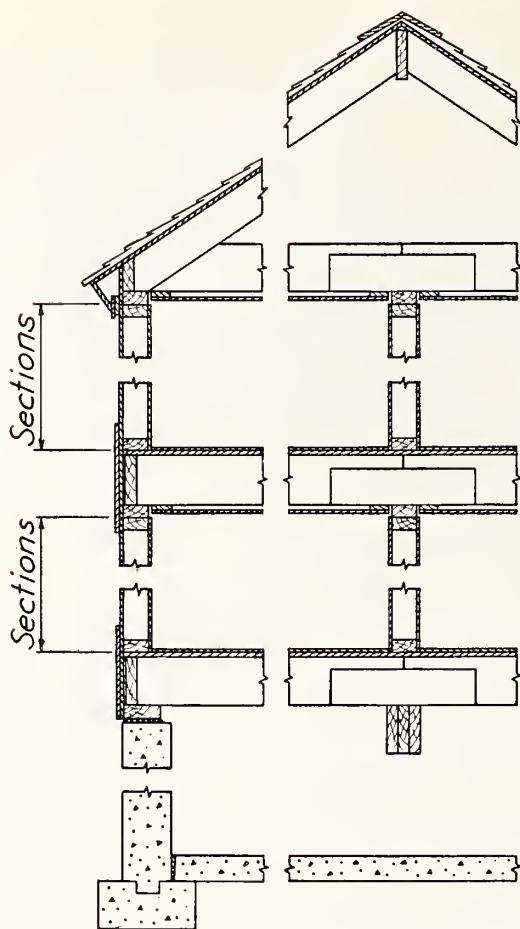
FIGURE 47.—Section of typical "Precision-Built" house.

The superstructure is erected in accordance with the conventional platform, or western, system of house framing on a masonry foundation, with or without a basement. Wood sills, 2 by 6 in., fastened to the foundation by $\frac{3}{8}$ -in. anchor bolts, support the first-story floor joists. Sills are joined with half laps, leveled by means of slate shims, and grouted. The joists are 2 by 8 in., spaced 1 ft 4 in. on centers, and are toenailed to the sill. Starting joists, joists under parallel partitions, and headers and trimmers for openings are doubled. Continuous headers are nailed to the outside ends of the joists. For splines over girders the joists are either lapped and nailed or butt jointed and splined with 1-in. material. The subflooring consists of 1-in. boards tongue-and-grooved, laid at an angle of 45°.

Wall and partition sections are made in standard heights of 7 ft 2 in., 7 ft 6 in., 7 ft 10 in., and 8 ft 2 in.; and in widths up to 21 ft. The widths usually correspond to the sides of a room. The sections weigh approximately 4 lb/ft² and usually can be handled by four men. When in position, the sections rest on the subfloor of either the first or the second story and are fastened to the floor and to each other by 16d nails. A continuous wood plate, 2 by 4 in., is nailed over the tops of the sections, serving to align the sections and to form an additional tie. Corners
