CULTURAL LANDSCAPE REPORT FOR SLATER MILL HISTORIC SITE

BLACKSTONE RIVER VALLEY NATIONAL HISTORICAL PARK

PAWTUCKET, RHODE ISLAND

Olmsted Center for Landscape Preservation
National Park Service, Boston, Massachusetts, 2021

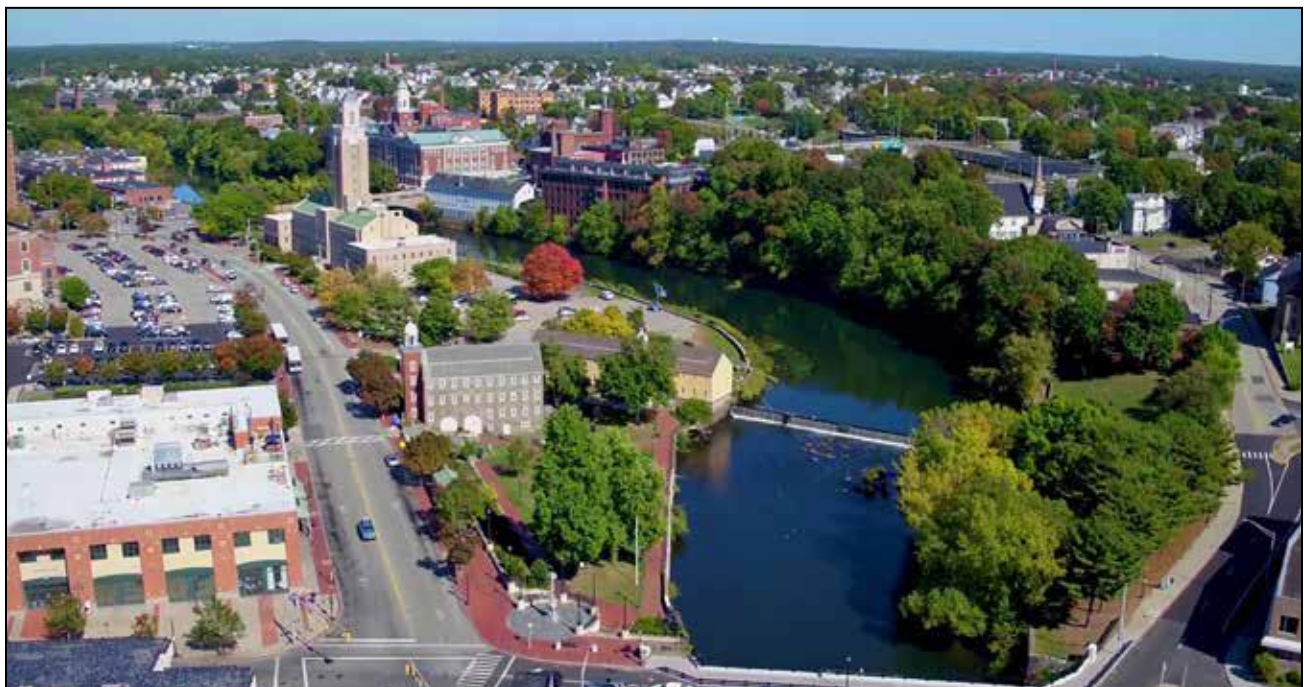
Figure 0.3. Oblique aerial view looking northeast at Slater Mill Historic Site and the Blackstone River. The Old Slater Mill (light yellow building) and the upper dam are at image center. (Old Slater Mill Association [hereafter OSMA] Archives)

Located on the banks of the lower Blackstone River in Pawtucket, Rhode Island, Slater Mill Historic Site is a component of the Blackstone River Valley National Historical Park, a park unit established in December 2014 (Figures 0.1, 0.2). The park preserves, protects, and interprets the nationally significant resources that exemplified the industrial heritage of the Blackstone River Valley. The 4.23-acre property includes two historic mills and a cottage, a partially reconstructed raceway and tailrace, old stone and concrete river walls, remnant foundations, and a footbridge. These features are set amongst tree-shaded lawns and paved walkways that provide views of the river and Pawtucket Falls (Figure 0.3).

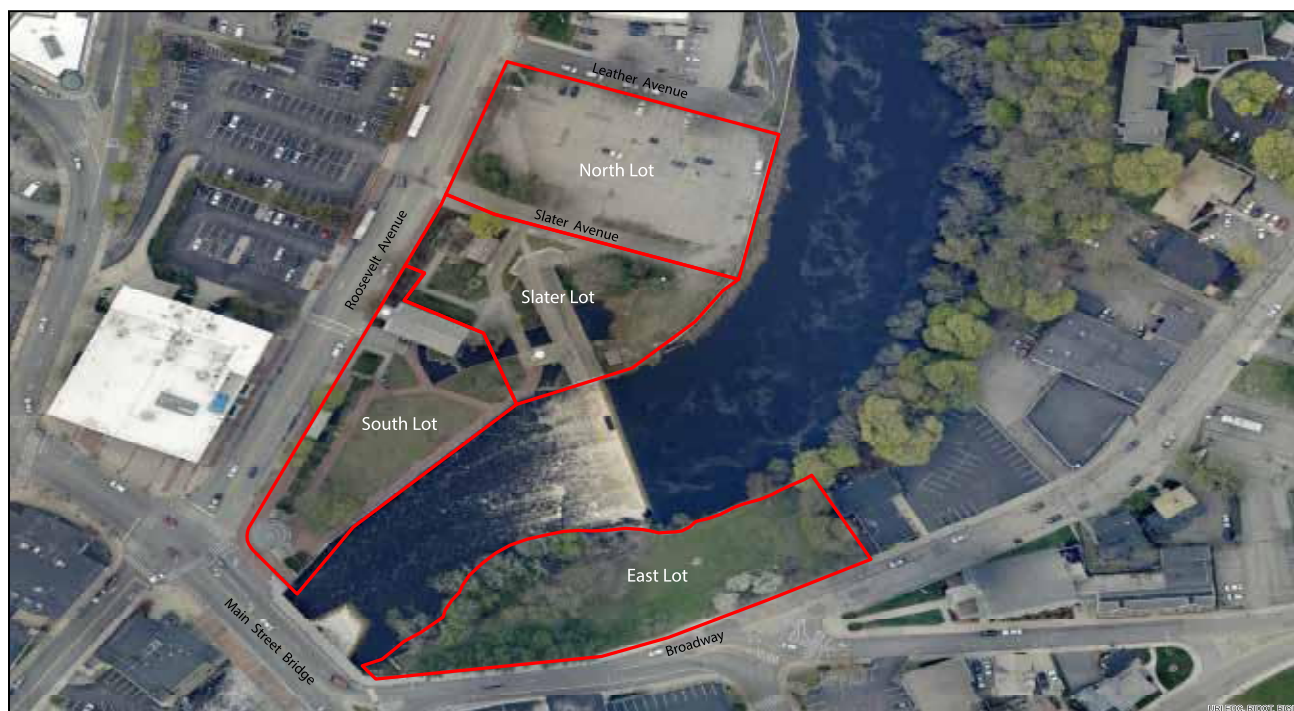
Figure 0.4. Aerial map showing the four city lots that comprise Slater Mill Historic Site, and the names ascribed to them for this report. (Olmsted Center for Landscape Preservation [hereafter OCLP] 2020; City of Pawtucket GIS, "parcels.shp")

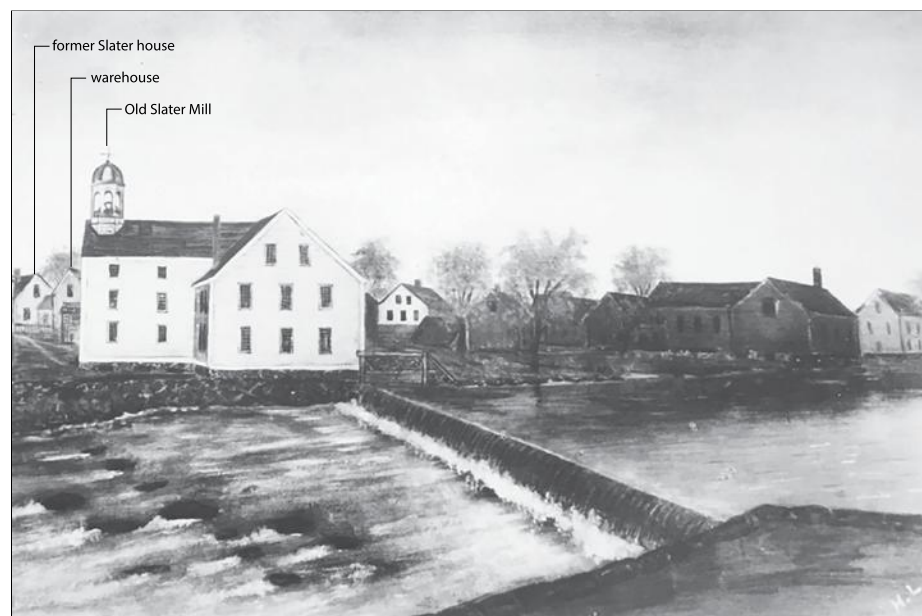
Figure 1.11. Painting of the south side of Old Slater Mill from the east bank, c.1840. (H.L. Spencer, “Painting of South Elevation of Slater Mill,” c.1840. OSMA Archives, from HSR 2018: 39)

Two drawings from c.1840 show for the first time close up views of the mill, calling it “Old Slater Mill” and depicting the building with its stairtower topped with a cupola (Figures 1.11, 1.12). One of the drawings also indicated a wooden wing-wall at the north end of the upper dam, presumably intended to protect the mill’s foundation from the scouring forces of the river as it tumbled over the upper dam.

The c.1840 drawings provide glimpses of areas within the Slater Lot as viewed from the east bank of the river and the Main Street Bridge (see Figures 1.11, 1.12). The river view indicates buildings just north of the mill that are possibly a 1.5-story storage building and the 2-story former residence of Samuel Slater, and two unidentified 1-story buildings to the east in the former bleach yard north of the Great Flume. The bridge view shows the 1.5-story dye house west of the mill. According to the drawings, there were stone walls lining both sides of the river, a tree on the peninsula, and relatively tall trees and shrubs around the mill's stone tailrace arch. The c.1840 and c.1850 drawings provide additional context, indicating scattered grasses and a tree at the northwest corner of the mill and a path leading to the stairtower (see Figures 1.13, 1.14). One of these drawings also depicts a wood fence at the dye house west of the mill that may have marked the property line that ran between the two buildings.

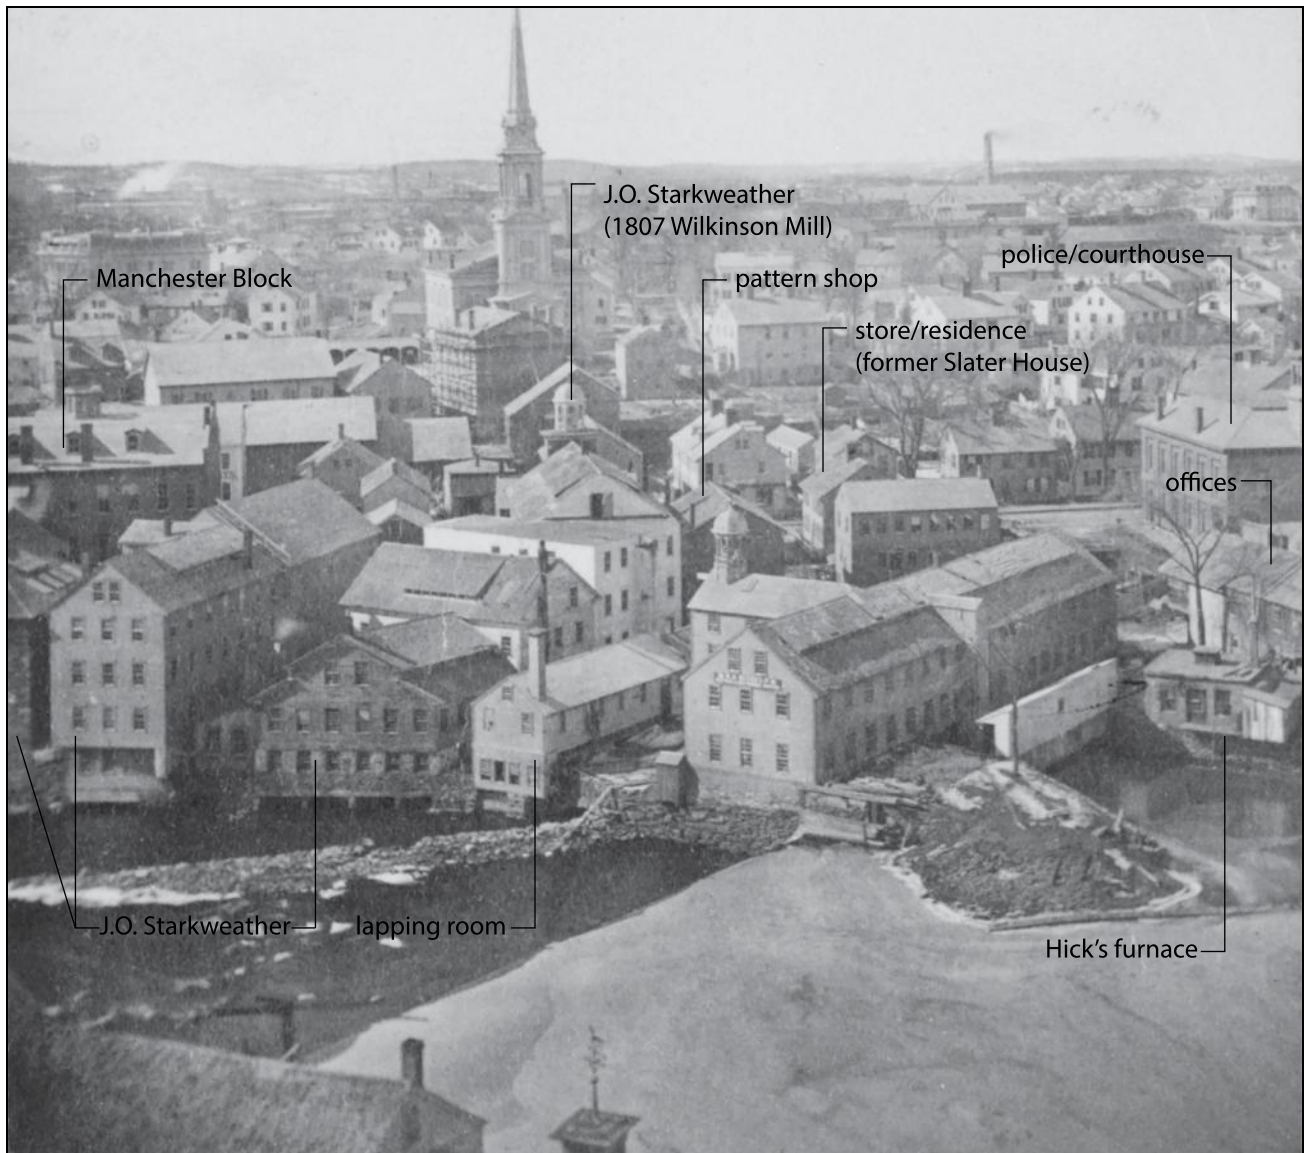
Figure 1.25. View looking north at the south and west sides of Old Slater Mill, c.1871, which features larger windows on the first floor. (OSMA Archives, from HSR 2018: 46)

of the stairtower were replaced with double windows (Figure 1.25). Two of the c.1869 photographs also show a newly built gatehouse on top of the previous gangway during this period on the east side of the mill. The structure straddled the Great Flume to protect the gates and machinery.¹⁵³

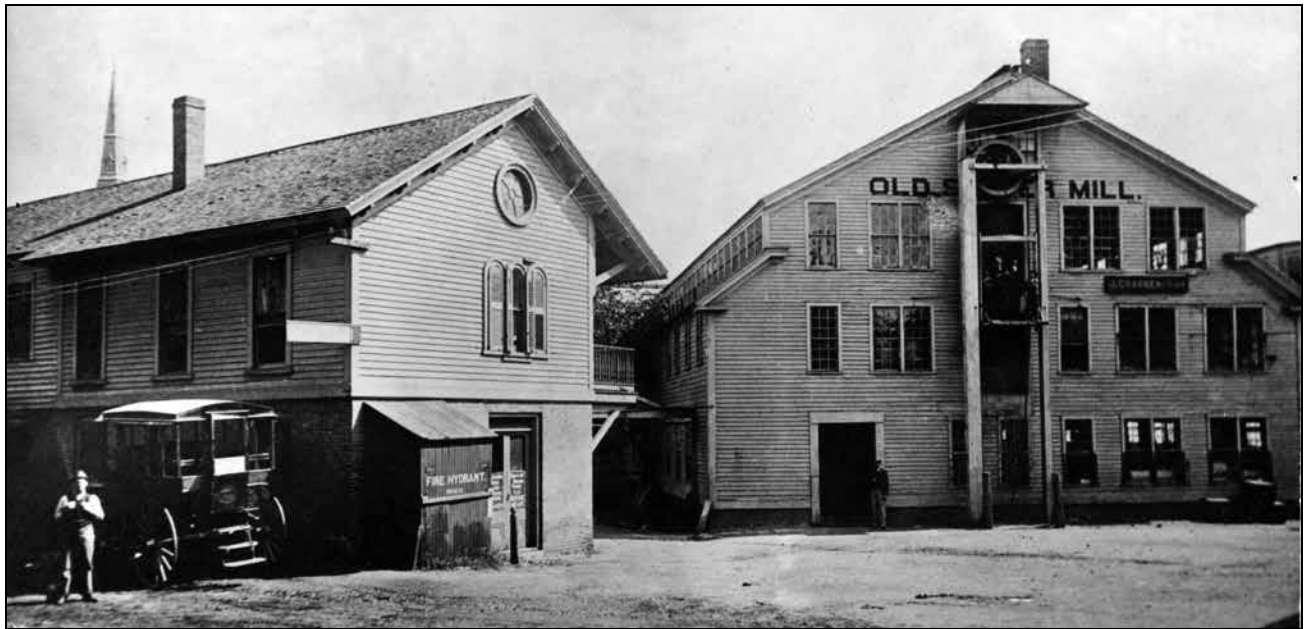
Figure 1.29. View looking south at the north and east sides of Old Slater Mill, c.1886. This is the first view showing the second and third story west addition and the rope pulley elevator, and the former Joseph Smith building to the east. Note the fence that once bordered Slater Avenue is gone. (OSMA Archives, from HAER RI-1, 1991)

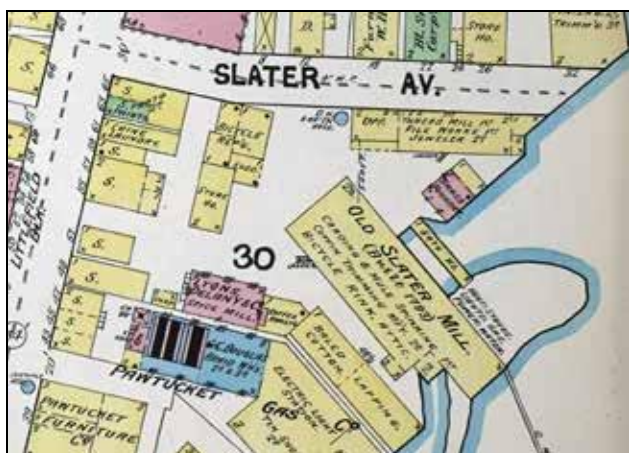
Figure 1.40a. Map of Slater Lot, dated 1890. (Sanborn Map Company, *Sanborn Fire Insurance Map from Pawtucket, Providence County, Rhode Island, Sheet 15, 1890*. (Washington DC: Library of Congress Prints and Photographs Division, from HSR 2018: D-56)

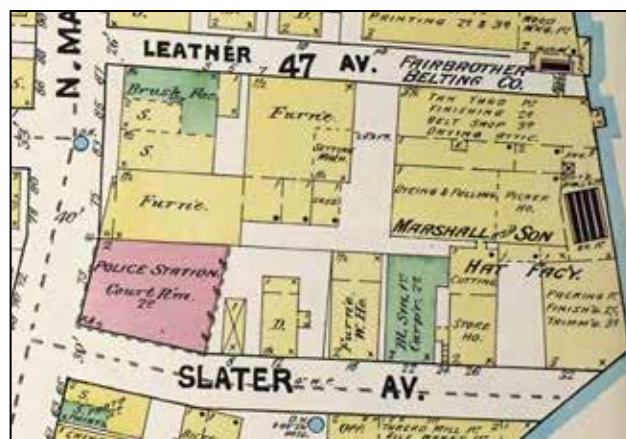
Figure 1.41a. Map of North Lot, dated 1890. (Sanborn Map Company, *Sanborn Fire Insurance Map from Pawtucket, Providence County, Rhode Island, Sheet 15, 1890*. (Washington DC: Library of Congress Prints and Photographs Division, from HSR 2018: D-56)

Aside from the brick 2-story police and courtroom building, several major changes occurred in the North Lot during this period (Figures 1.41a-b-c). The storage building and tenement just to the east was eventually removed. The series of 1- to 1.5-story buildings in the northwest corner transitioned from small individual stores and factories to furniture and stove businesses. On the east half along the river, the connected 1- to 3.5-story buildings were associated with the H.L. Fairbrother & Company tannery/belting, Bucklin & Trescott belting company, and Marshall & Son hat factory. One of these buildings at the southeast corner was removed by 1895, and by 1902 all of the tannery/belting/factory buildings as well as the carpenter and blacksmith shop were razed, leaving the east half of the lot empty.

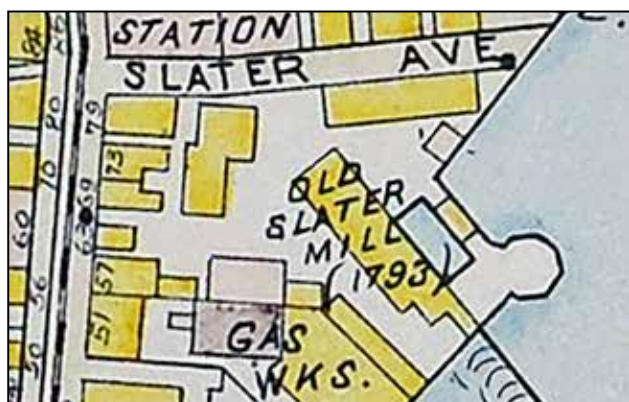
Figure 1.40b. Map of Slater Lot, dated 1895. (Everts & Richards, *City of Pawtucket, Plate 3, 1"=300 feet*. New Topographical Atlas of Surveys, Providence County. Pawtucket, Rhode Island, 1895. Pawtucket Public Library, from HSR 2018: D-59)

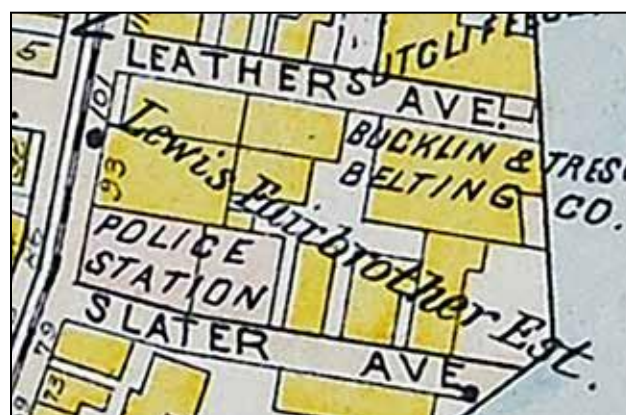
Figure 1.41b. Map of North Lot, dated 1895. (Everts & Richards, *City of Pawtucket, Plate 3, 1"=300 feet*. New Topographical Atlas of Surveys, Providence County. Pawtucket, Rhode Island, 1895. Pawtucket Public Library, from HSR 2018: D-59)

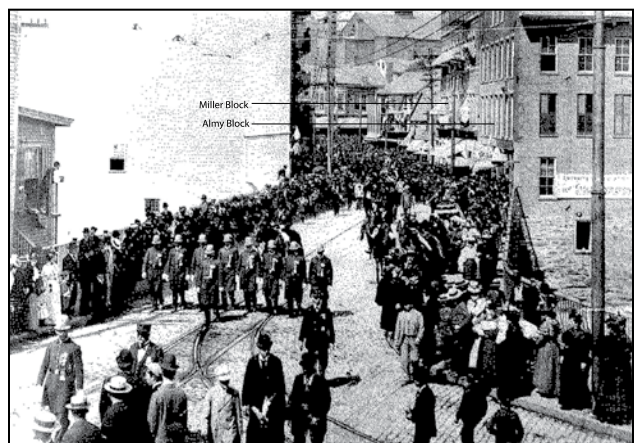
Figure 1.44. View looking northwest at the Main Street Bridge, c.1891. At this time the Almy Block addition cantilevered over the river has not been built. (Johnson et.al. 1995: 30)

tall chimney continued to dominate this space (Figure 1.43). Unlike the 1880 atlas, the two Sanborn maps from this period show an open portion of the Great Flume next to the buildings. In the west part of the lot facing North Main Street, a variety of businesses continued to operate in the brick 3-story Manchester and Miller Blocks, and in two other 3-story buildings, including the Pawtucket Furniture Company. In the south part of the lot, the library was replaced by offices, but stores and a lodge room filled the brick 3- to 4-story Spencer, Miller, and Almy buildings. By 1895 the Almy Block became the Smith Block, and by 1902 an addition that cantilevered over the river was built on the east side this building (Figures 1.44, 1.45).

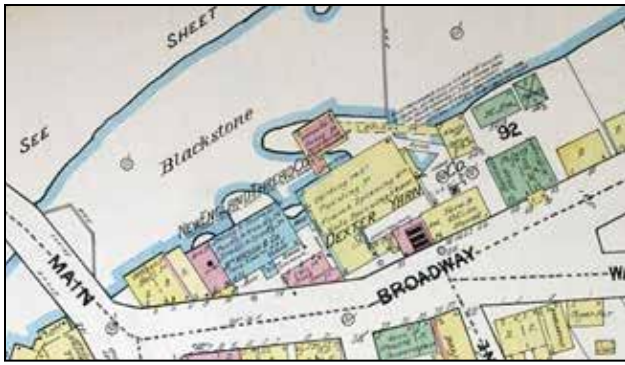
Figure 1.46a. Map of East Lot, dated 1890. (Sanborn Map Company, *Sanborn Fire Insurance Map from Pawtucket, Providence County, Rhode Island, Sheet 15, 1890*. (Washington DC: Library of Congress Prints and Photographs Division, from HSR 2018: D-56)

The East Lot continued to be packed with buildings and structures (Figures 1.46a-b-c). At the east end of the upper dam, the area was dominated by the complex of 2- to 5-story buildings operated by the Dexter Yarn Company, as well as the 2-story building on the spit of land and a footbridge that during this period connected to a 3-story building at the raceway inlet. The spit and the 2-story building are visible in an early c.1890s photograph, which also shows some of the stone walls that armored the spit (Figure 1.47). The raceway passed under a gatehouse (not shown on previous maps) and the main building. Heading downstream from the dam, the raceway still connected to the brick and stone buildings occupied during this period by William Mason & Company and the New England Thread Company, although the 1895 map suggests they were also operated by Dexter. The brick and

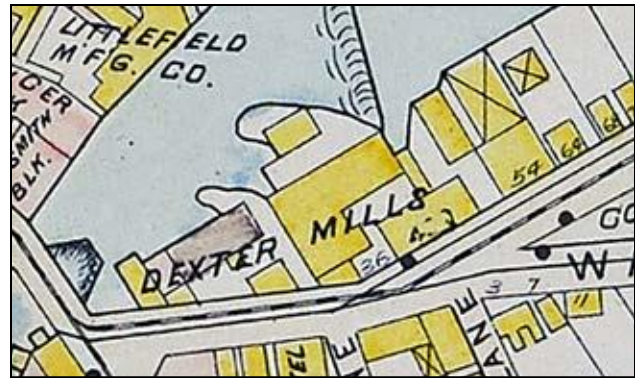
Figure 1.46b. Map of East Lot, dated 1895. (Everts & Richards, *City of Pawtucket, Plate 3, 1"=300 feet. New Topographical Atlas of Surveys, Providence County. Pawtucket, Rhode Island, 1895*. Pawtucket Public Library, from HSR 2018: D-59)

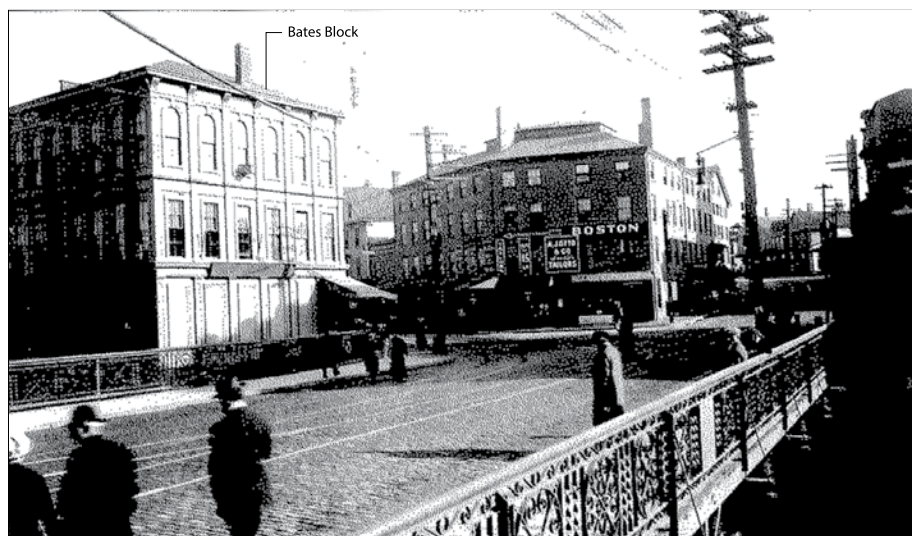
Figure 1.49. View looking east from the west end of the widened Main Street Bridge, 1914. Note the double streetcar track and the decorative iron fence. (Johnson et.al 1995: 30)

During this period the Main Street Bridge was widened northward by 1905, which made possible the installation of a second streetcar line across the bridge. Elevated walks lined both sides of the bridge, and decorative wrought iron railings replaced the earlier simple railings. The bridge expansion brought the northeast edge of the structure much closer to the Bates Block building (Figures 1.48, 1.49).

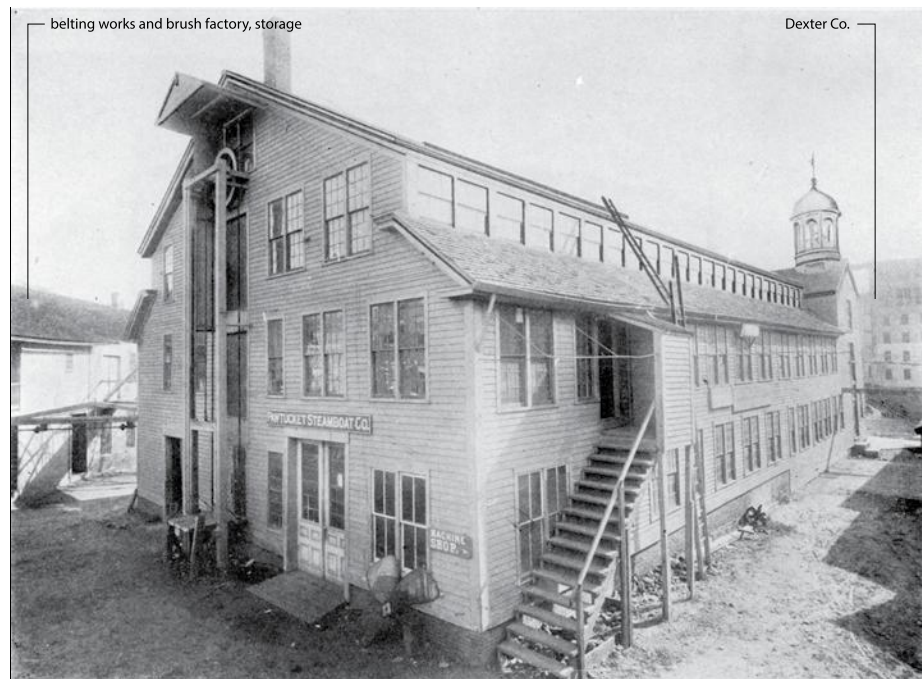
Figure 1.51. View looking northwest at the south side of Old Slater Mill, c.1907. Note the missing window on the second floor of the stairtower, which was earlier modified into a door for access to the second floor addition that was removed by 1900. (Spaulding House Research Library, from HAER RI-1, 1991)

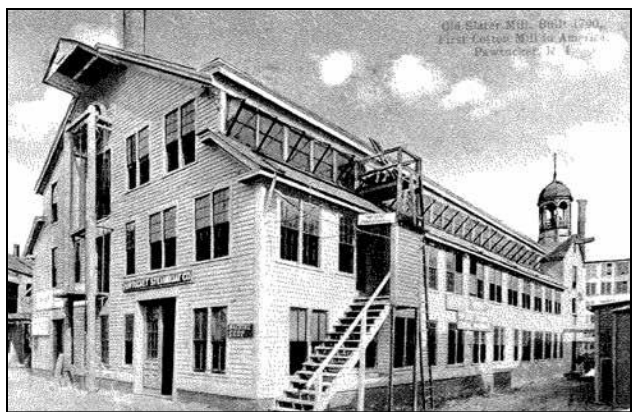
Figure 1.52. View looking east at the north and west sides of Old Slater Mill, c.1913. Note the new clerestory roof and tilt windows. (OSMA Archives, from HSR 2018: 69)

A series of fires in April and May 1912 caused substantial damage to Old Slater Mill and prompted several changes to the structure. The May fire was especially bad, damaging the second and third floors and flooding the first floor. Many of the tenants in the mill were uninsured and sustained major or total losses, and did not return. Spencer nonetheless made repairs, and opted to replace the damaged gable roof north of the stairtower with a flat clerestory roof and tilt windows, except for the gable at the far north end that was retained for continued use of the elevator (Figures 1.52, 1.53, 1.54).¹⁷⁴

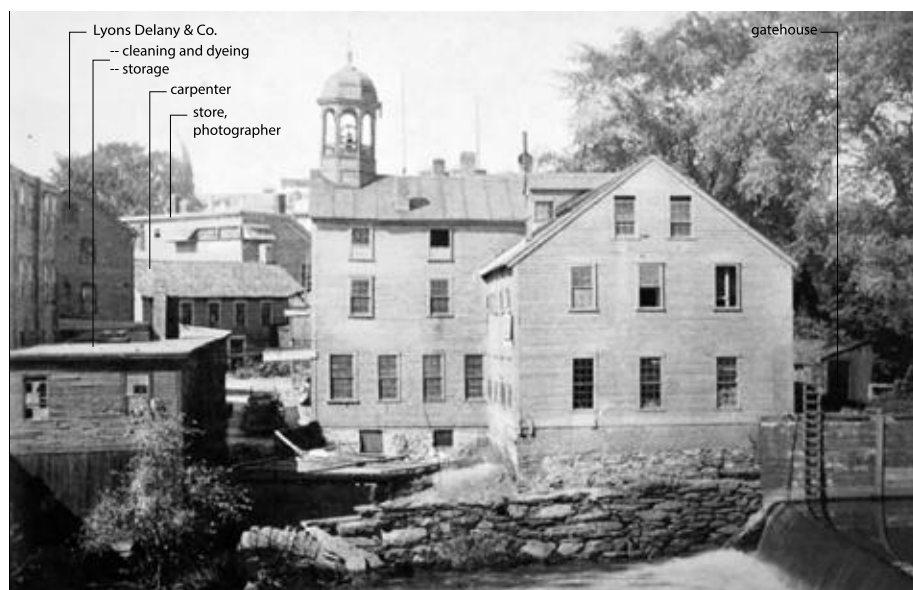
Figure 1.53. View looking northwest at the south side of Old Slater Mill, c.1912, after the roof north of the stairtower was replaced with a flat roof. Note the missing window on the second floor of the stairtower has been replaced, and the gable window on the south slope of the mill. The cleaning dyeing room has a flat roof at this time. (OSMA Archives, from HSR 2018: D-70)

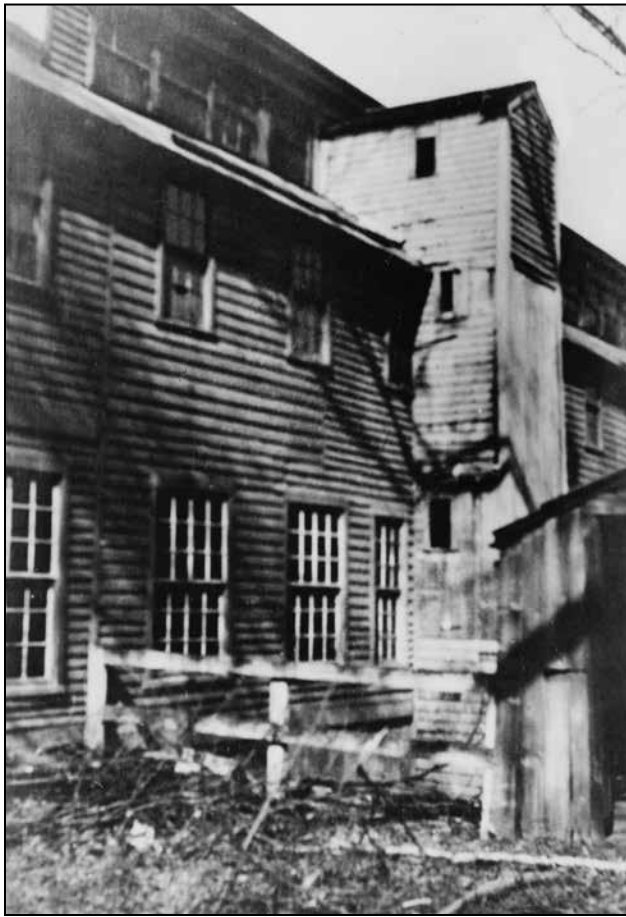
Figure 1.59. View looking west at the east side of Old Slater Mill, 1924. Note the split rail fence along the edge of the Great Flume, between the mill and the gatehouse. (OSMA Archives, from HAER RI-1, 1991)

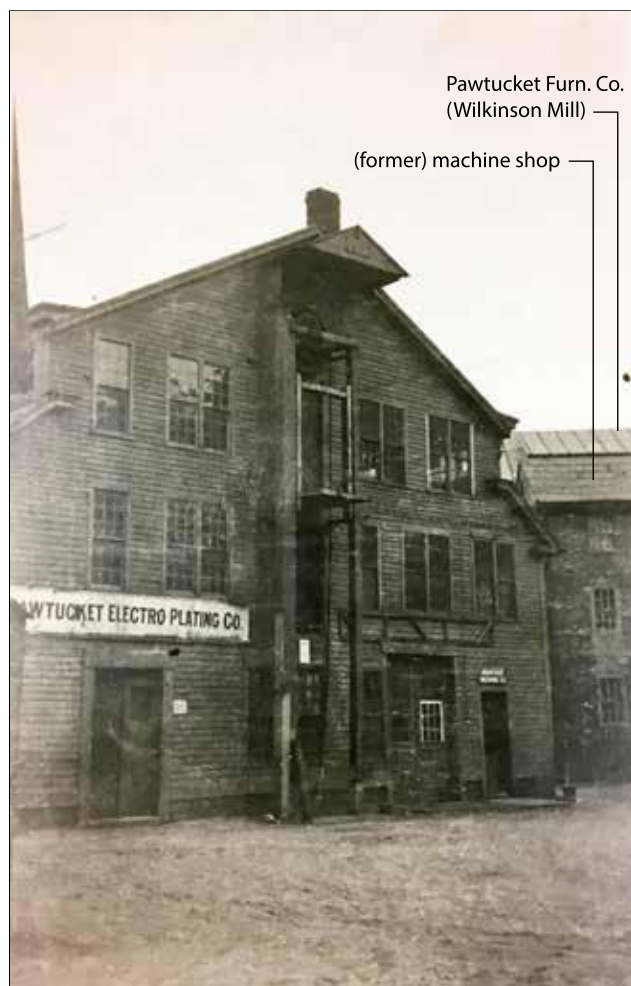
Figure 1.67. View looking southwest at the north side of Old Slater Mill, 1924-1925. (OSMA Archives, from HSR 2018: 73)

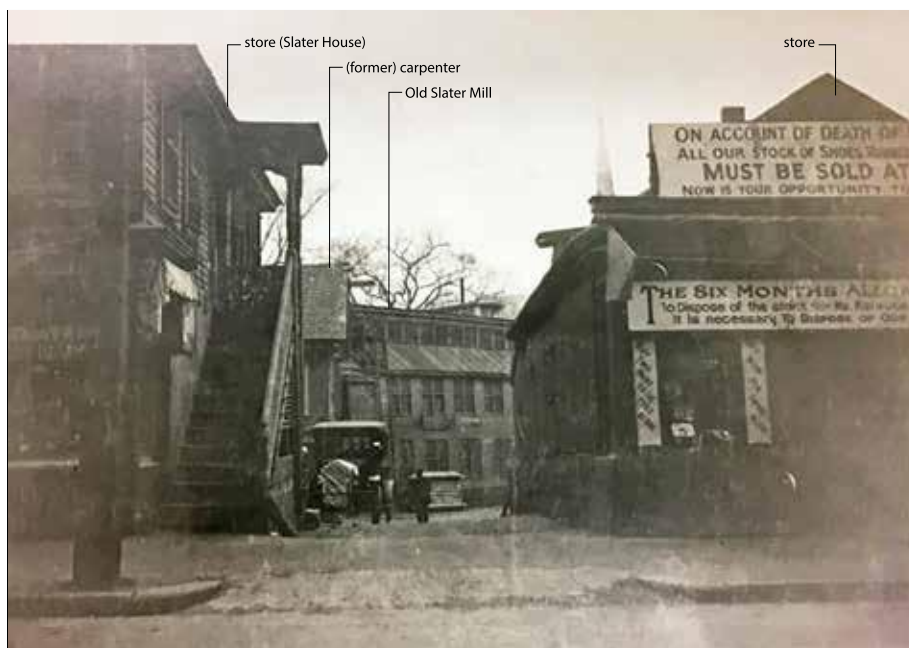
Figure 1.70. View looking southeast at the alley named Spice Mill Way and the buildings facing North Main Street, 1924-1925. The former Slater House is at image left. (OSMA Archives, from HSR 2018: D-76)

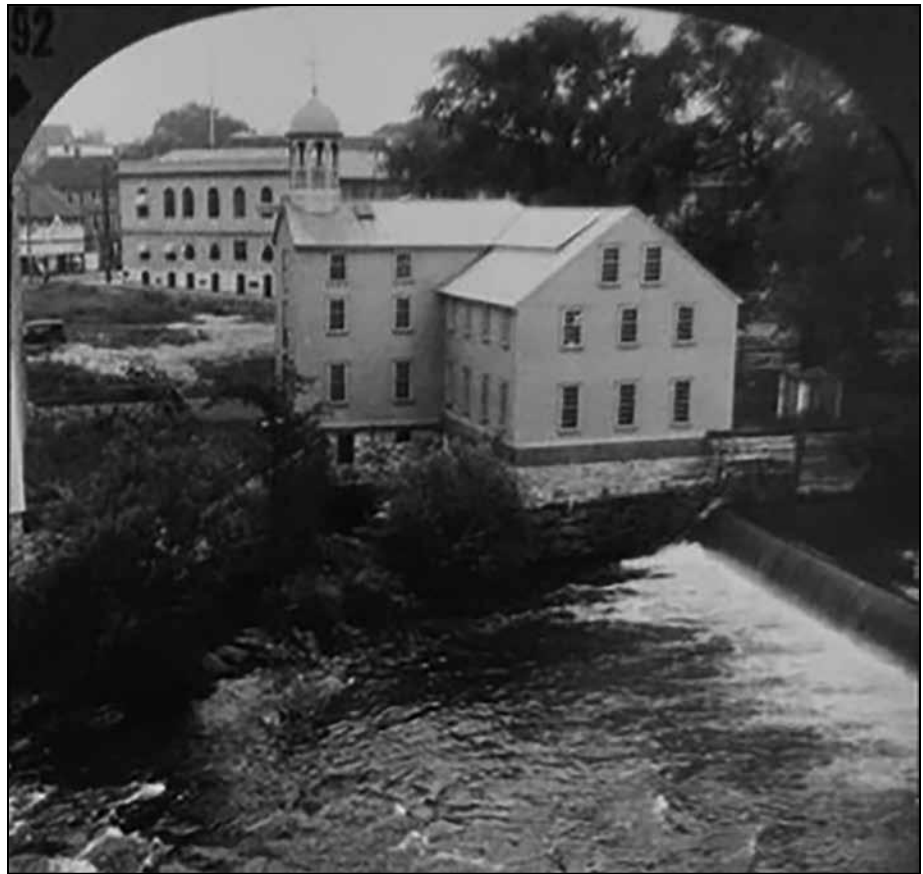
Figure 1.72. View looking northwest at the cleared land at the Slater Lot, c.1925. Note the sloping topography of the lot from North Main Street to the Old Slater Mill. (OSMA Archives, from HSR 2018: D-86)

The last tenants in Old Slater Mill – Pawtucket Electro-Plating and Moncrief Machine Company – left in early 1924. With donations in hand from prominent manufacturers and other private citizens, restoration of Old Slater Mill began in June 1924, with the dual goals of recreating the 1830s appearance of the mill and the improving the surrounding landscape. By October 1924 Henry Dexter reported, “we have all buildings removed from the premises excepting the old Slater Mill.”¹⁹³ A photograph from the following year showed the cleared lot and the landform that gradually sloped down from North Main Street to the mill (Figure 1.72).

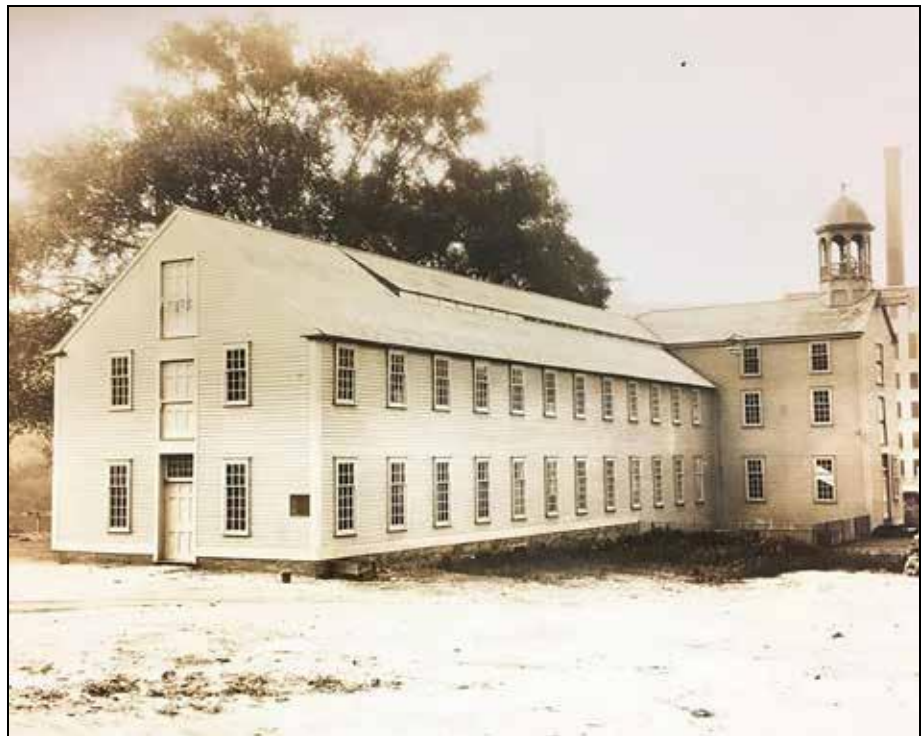
Figure 1.73. View looking east at the north and west sides of Old Slater Mill, c.1925, after the building's restoration but before landscaping was completed. (OSMA Archives, from HSR 2018: D-86)

By late 1925 the restoration of Old Slater Mill was complete (Figure 1.73, 1.74). Returning the mill to its early nineteenth-century appearance required removing all post-1830s additions to the building (except for the brick foundation), removing the flat roof over the center and north portion of the mill, and replacing the fenestration. The sides of the mill and cupola were rebuilt “according to authenticated sketches” and mill’s exterior was repainted its original yellow color.¹⁹⁴ The restored building’s dimensions were 140 feet 6 inches by 29 feet six inches, while the stairtower measured 18 feet 5 inches by 21 feet 2 inches, approximately the size of

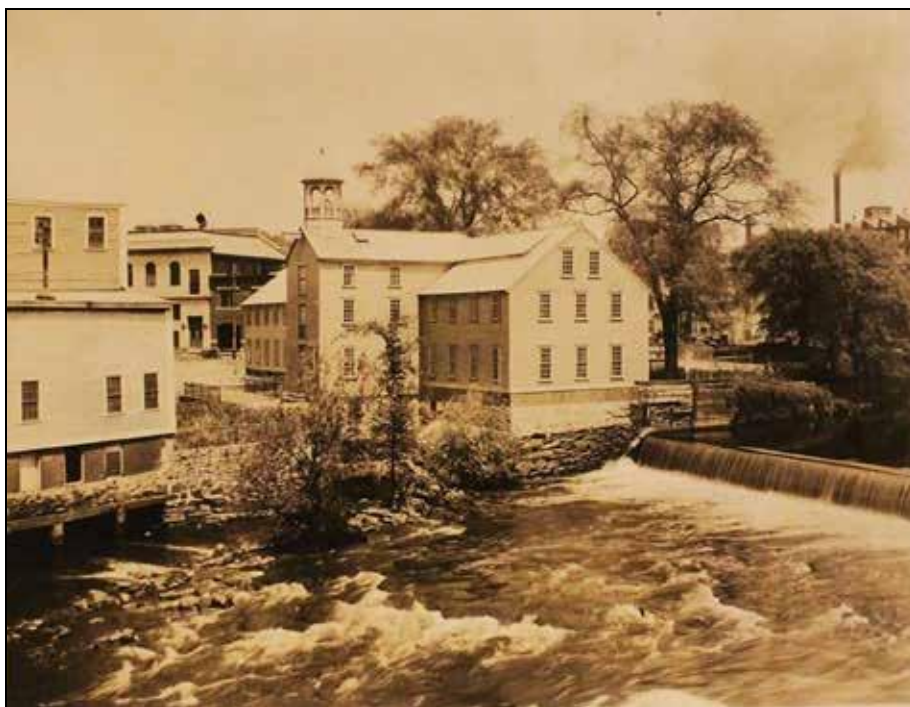
Figure 1.74. View looking north at the south and west sides of Old Slater Mill, c.1925, after the building's restoration but before landscaping was completed. Note the wood footbridge and iron fence crossing the Great Flume on the west side of the mill, and mature trees on the east side. (OSMA Archives, from HSR 2018: D-86)

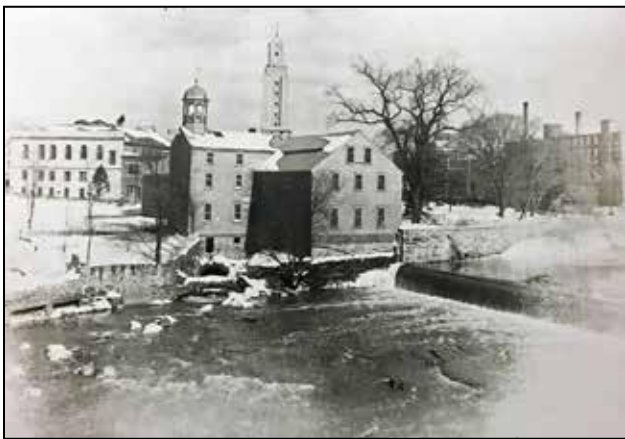
Figure 1.75. View looking north at the Slater Lot, c.1940. Young trees are visible in the lawn southwest of the mill, existing trees east of the mill and in the North Lot, and along Slater Avenue. Note that the buildings that once stood along the river in the South Lot (image left) are gone. (OSMA Archives, from HSR 2018: D-88)

east half of the lot was used for parking. Historic photographs show mature volunteer trees along the river wall (see Figures 1.75, 1.76).

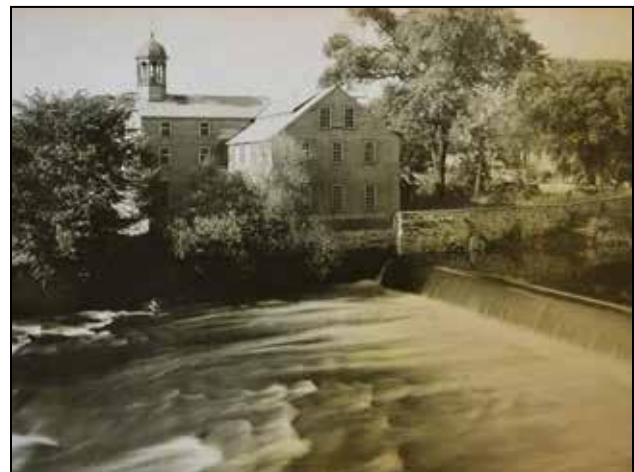
Figure 1.76. View looking north at the south and west side of Old Slater Mill, c.1940. This summer view shows the vegetation in full leaf. Note the trees in the North Lot along the riverbank. (OSMA Archives, from HSR 2018: D-88)

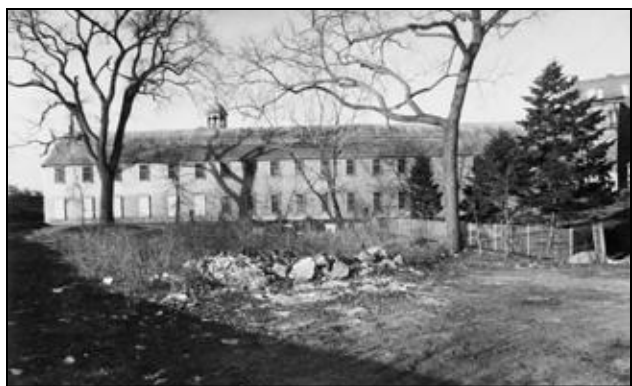
Figure 1.77. View looking west at the Slater Lot, 1949, showing the filled in portion of the Great Flume, new fencing atop the north wall of the flume, and existing and new vegetation. (OSMA Archives, from HSR 2018: D-91)

meet the bottom of the flume at the site of the former gatehouse (Figure 1.77). The new river wall and fill work effectively obscured the peninsula that had separated the flume from the river since Samuel Slater's time. Around this time a 50-foot long underground penstock was installed near the former gatehouse to draw river water into the remaining open segments of the flume.

Despite the decision to clear the Slater Lot, the OSMA had retained several existing vegetation features as shown in photographs from the 1940s. This included three mature trees on the east side of the mill and the shrubs and groundcovers draped over the stone river wall (see Figure 1.77). Several trees and shrubs that had reestablished around the stone tailrace arch and on the curved jetty were also kept.

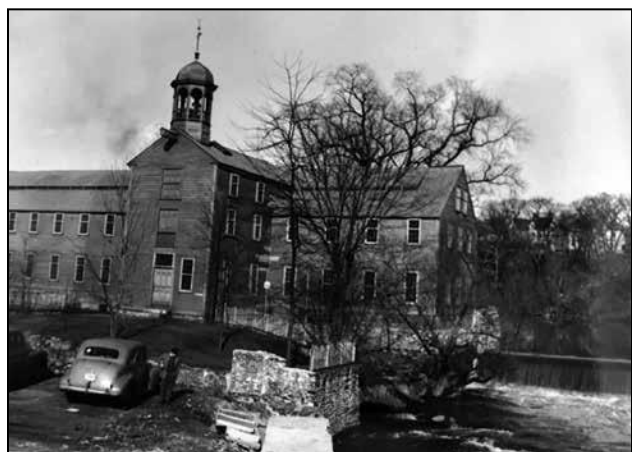
Figure 1.78. View looking northeast at the Slater Lot, c.1949, and fencing atop the tailrace wall and river wall. Note the young trees and lawns in front of the steeple. By this time, only foundation walls of former buildings in the South Lot remained, which marked the boundary of the Slater Lot. However, pilings and walls of one of the buildings along the river were removed, leaving a gap in the river wall. (OSMA Archives, from HSR 2018: D-93)

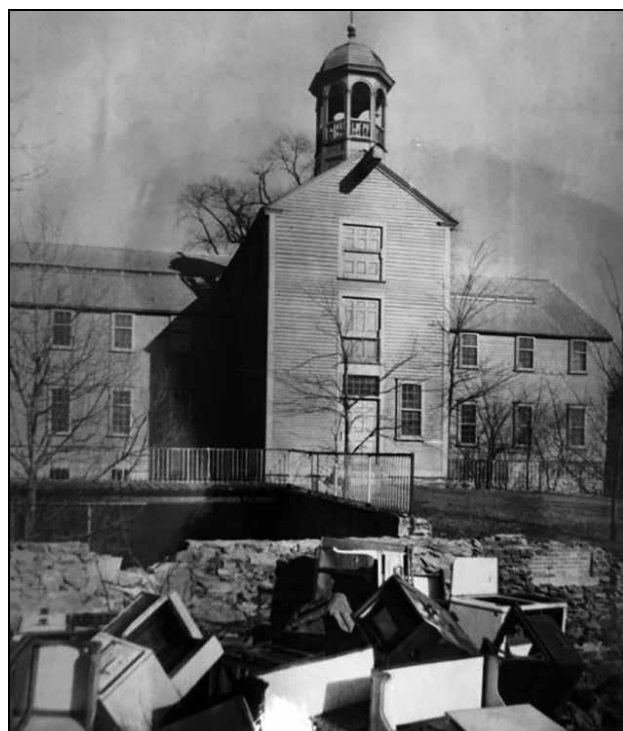
Figure 1.79. View looking east at the Slater Lot, c.1949, and the fencing around the Great Flume. Note the young trees and lawns in front of the steeple. The Great Flume terminated at the west boundary of the Slater Lot, which at the time of this photograph was defined by foundation walls of former buildings in the South Lot. (OSMA Archives, from HSR 2018: D-93)

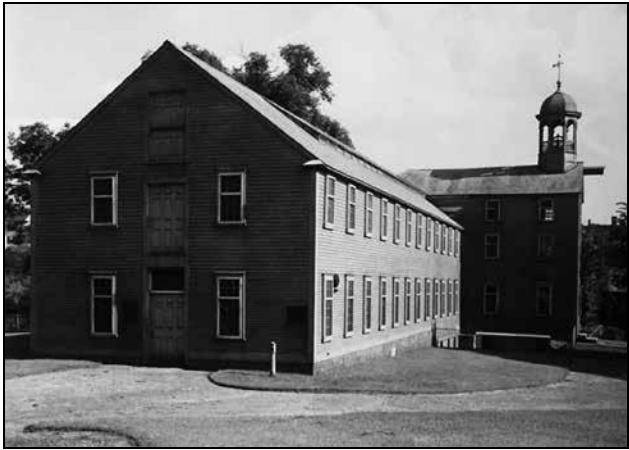
Figure 1.80. View looking southeast, c.1949, at the lawns on the north and west sides of Old Slater Mill. The path shown in this photograph served as the primary pedestrian route through the Slater Lot. (OSMA Archives, from HSR 2018: D-92)

Although no planting plan has been located, between 1925 and 1940 the OSMA also installed lawns throughout most of the Slater Lot (Figure 1.80). They also planted several deciduous and evergreen trees and shrubs within the lawns, including deciduous trees in the lawn southeast of the stairtower (at the former site of the pre-1823 dye house) and a grouping of new spruce trees and a hedge along Slater Avenue (at the former site of the 1856 weaving shop), and a hedge along Roosevelt Avenue (former sites of the Slater House and other businesses) (Figure 1.81, see also Figures 1.78, 1.79).

Circulation through the Slater Lot was by a single gently curving pea gravel path, tracking from Slater Avenue, through the former work yard on the north side of the mill, along the west side of the mill and across the footbridge spanning the Great Flume, and to the river (see Figure 1.80). No dedicated paths accessed the areas around the Great Flume or the former peninsula, which had not been landscaped and were apparently allowed to become overgrown.

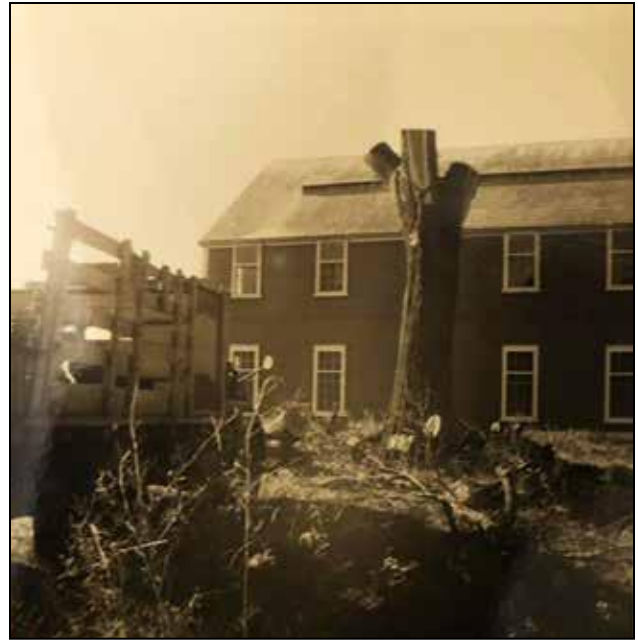
Figure 1.83. View looking southwest at the removal of the large tree on the former peninsula, 1954. (OSMA Archives, from HSR 2018: D-109)

In May 1952 Daniel Tower was hired as museum curator by OSMA's new director, Donald Shepard.²⁰⁴ One of the first projects completed by Tower and Shepard was cleaning up the overgrown vegetation in the area east of in the Great Flume and on the former peninsula (Figure 1.82). This work was done to advance a long-deferred decision on how to heat the building. In early 1955 construction began in this area on a small 1-story boiler house on a concrete block foundation. The new building required the removal of one of the Slater Lot's oldest trees (Figures 1.83, 1.84).²⁰⁵

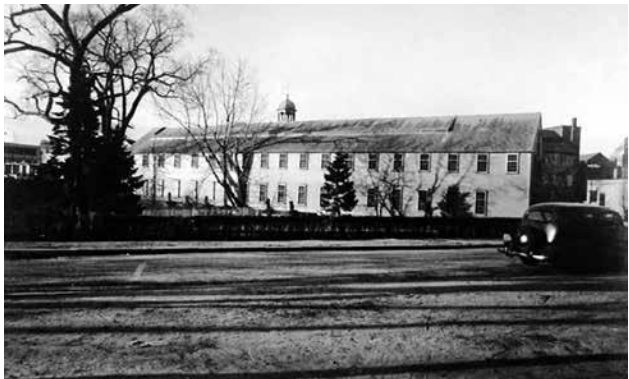
Figure 1.81. View looking southwest at the Slater Lot, 1949, at existing and new vegetation along Slater Avenue. (OSMA Archives, from HSR 2018: D-91)

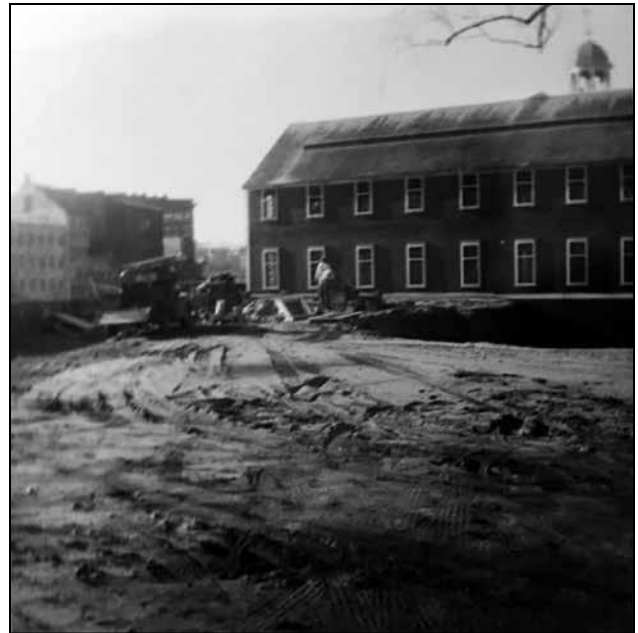
Figure 1.84. View looking southwest at construction of the boiler house on the former peninsula, 1954. (OSMA Archives, from HSR 2018: D-109)

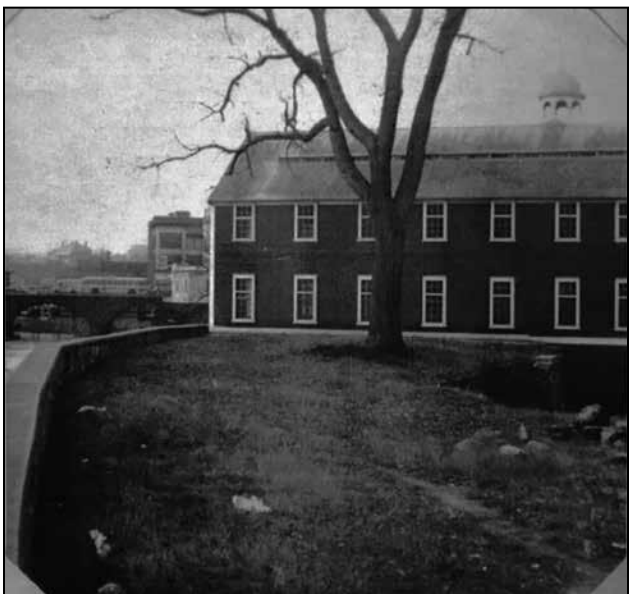
Figure 1.82. View looking southwest at the landscaped former peninsula area, 1954. (OSMA Archives, from HSR 2018: D-108)

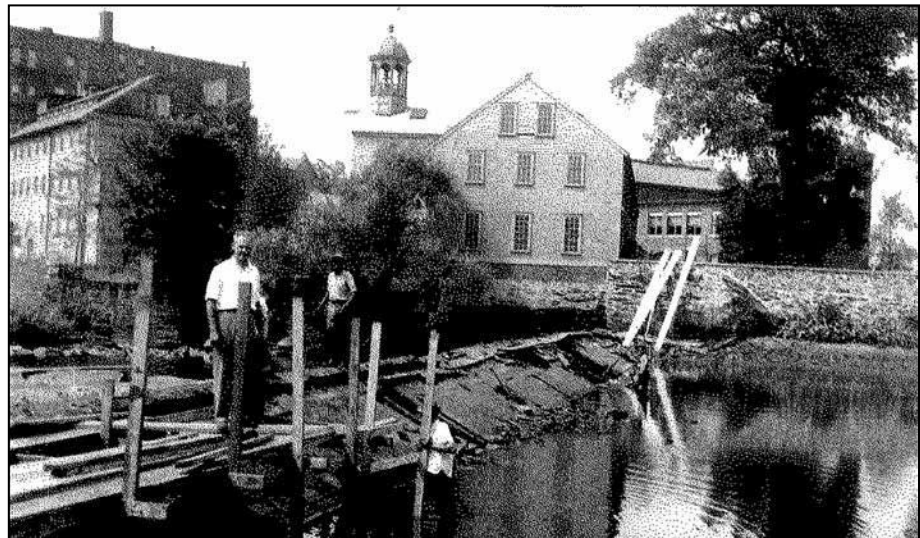
Figure 1.86. View looking northwest at upper dam repairs, 1944. The 1.5- and 3-story additions attached to the former Wilkinson Mill are gone, as is the chimney adjacent to the Wilkinson Mill. (Blackstone Valley Electric Company, from Leavitt 1997: 55)

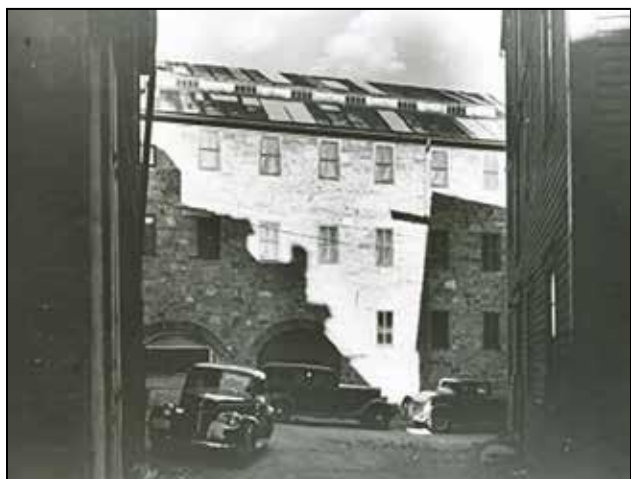
Figure 1.88. View looking northeast at the south side of the former Wilkinson Mill, toward the Wilkinson Place alley, early 1940s, when it housed a furniture store. This photograph was taken before the mill buildings at image right were razed. (Rhode Island State Digital Archives, Rhode Island Department of State, <https://sosri.access.preservica.com/home>)

Street, a single 2-story building continued to house unnamed stores on the first floor and a printing shop on the second. Just to the north were the two 1-story stores (formerly part of the Slater Lot). In the east part of the lot along the river, the complex of 3- to 4-story buildings and the 85-foot chimney were razed and the area became a parking lot (Figure 1.87). The foundations along the river were retained to serve as a river wall, but the section of the Great Flume that had provided power in this area was filled in. In the west part of the lot facing Roosevelt Avenue, various businesses continued to operate in the brick 3-story Manchester and Miller Blocks, and in two other 3-story buildings, including the Pawtucket Furniture Company who still maintained the second floor covered passageway across Wilkinson Place to connect to their operations in the stone mill (Figure 1.88). In the south part of the lot, stores, offices, and a lodge room still occupied

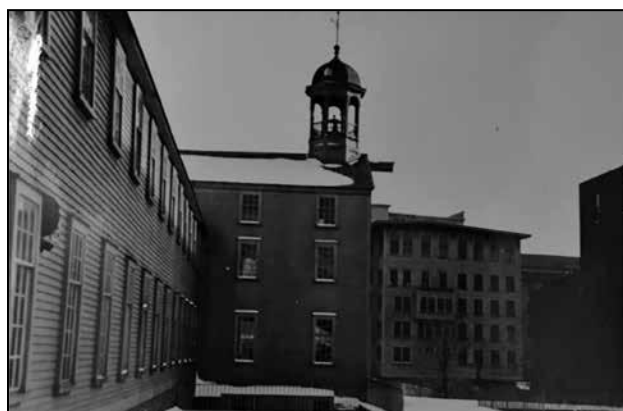
Figure 1.89. View looking south, 1925-1940, showing one of the Dexter Yarn Co. buildings on the East Lot. This photograph was taken after the mill was restored and before the factory buildings at image right (on the South Lot) were razed. (OSMA Archives, from HSR 2018: D-91)

There is little documentation of the East Lot for this period, except for a c.1925-1940 photograph of one of the Dexter Yarn Company buildings (Figure 1.89). Based on that evidence and later photographs, heading downstream from the dam and the Dexter Company, there were the 4- to 4.5-story brick and stone buildings, and the 3-story Bates Block next to the Main Street Bridge. Heading upstream from the dam and Dexter Company were the 2- and 3-story buildings once used by Dexter Company, that included the concrete block 3-story building.²⁰⁶

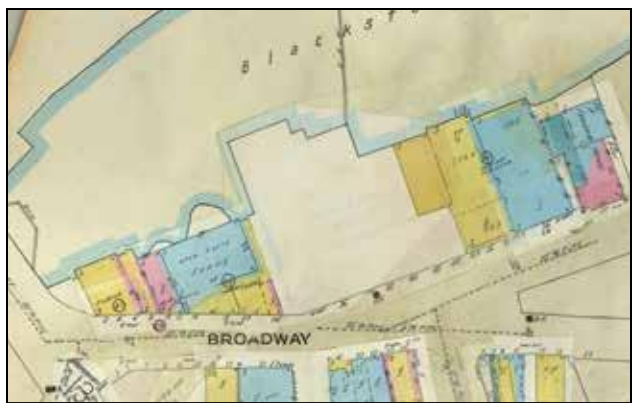
Figure 1.97. Map of the East Lot, dated 1962. (Sanborn Map Company, *Sanborn Fire Insurance Map from Pawtucket, Providence County, Rhode Island, Volume 1, Sheet 4, 1962*. Pawtucket Public Library, from HSR 2018: D-116)

In the East Lot, a 1955 historic aerial and a 1962 Sanborn map provide good comparisons for this period (Figure 1.97). The core of the Dexter Yarn Company complex and chimney were removed by 1955 and replaced with a parking lot (Figures 1.98, 1.99). Like the earlier removal of some of the buildings along the west riverbank, these removals also created a gap in the line of buildings along the east riverbank. Heading downstream from the dam and Dexter Company were the 4- to 4.5-story brick and stone buildings, and the 3-story Bates Block next to the Main Street Bridge. Heading upstream from the dam and Dexter Company were the 2- and 3-story buildings once used by Dexter Company, including the concrete block 3-story building.²¹⁵
