CULTURAL LANDSCAPE REPORT FOR SLATER MILL HISTORIC SITE

BLACKSTONE RIVER VALLEY NATIONAL HISTORICAL PARK

PAWTUCKET, RHODE ISLAND

Olmsted Center for Landscape Preservation
National Park Service, Boston, Massachusetts, 2021

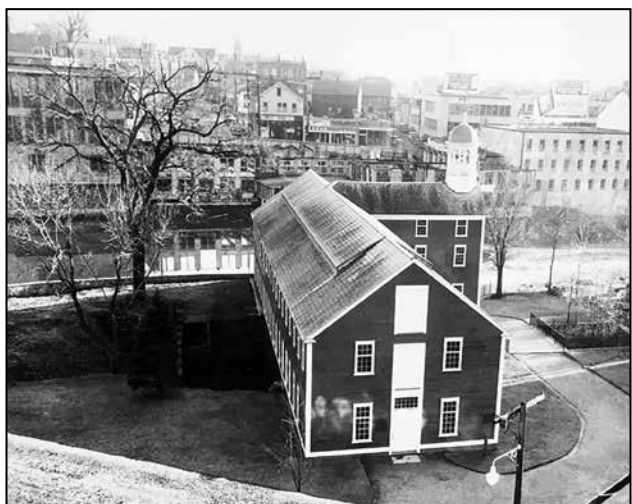
Figure 1.98. View looking south at the partially demolished Dexter Yarn Co., 1954, on the East Lot. (OSMA Archives, from HSR 2018: D-106)

In the East Lot, a 1955 historic aerial and a 1962 Sanborn map provide good comparisons for this period (Figure 1.97). The core of the Dexter Yarn Company complex and chimney were removed by 1955 and replaced with a parking lot (Figures 1.98, 1.99). Like the earlier removal of some of the buildings along the west riverbank, these removals also created a gap in the line of buildings along the east riverbank. Heading downstream from the dam and Dexter Company were the 4- to 4.5-story brick and stone buildings, and the 3-story Bates Block next to the Main Street Bridge. Heading upstream from the dam and Dexter Company were the 2- and 3-story buildings once used by Dexter Company, including the concrete block 3-story building.²¹⁵

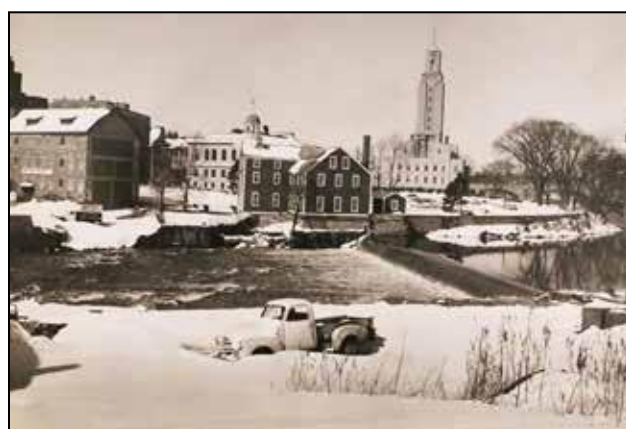
Figure 1.99. View looking north at the vacant site of the Dexter Yarn Co., 1958. (OSMA Archives, from HSR 2018: D-116)

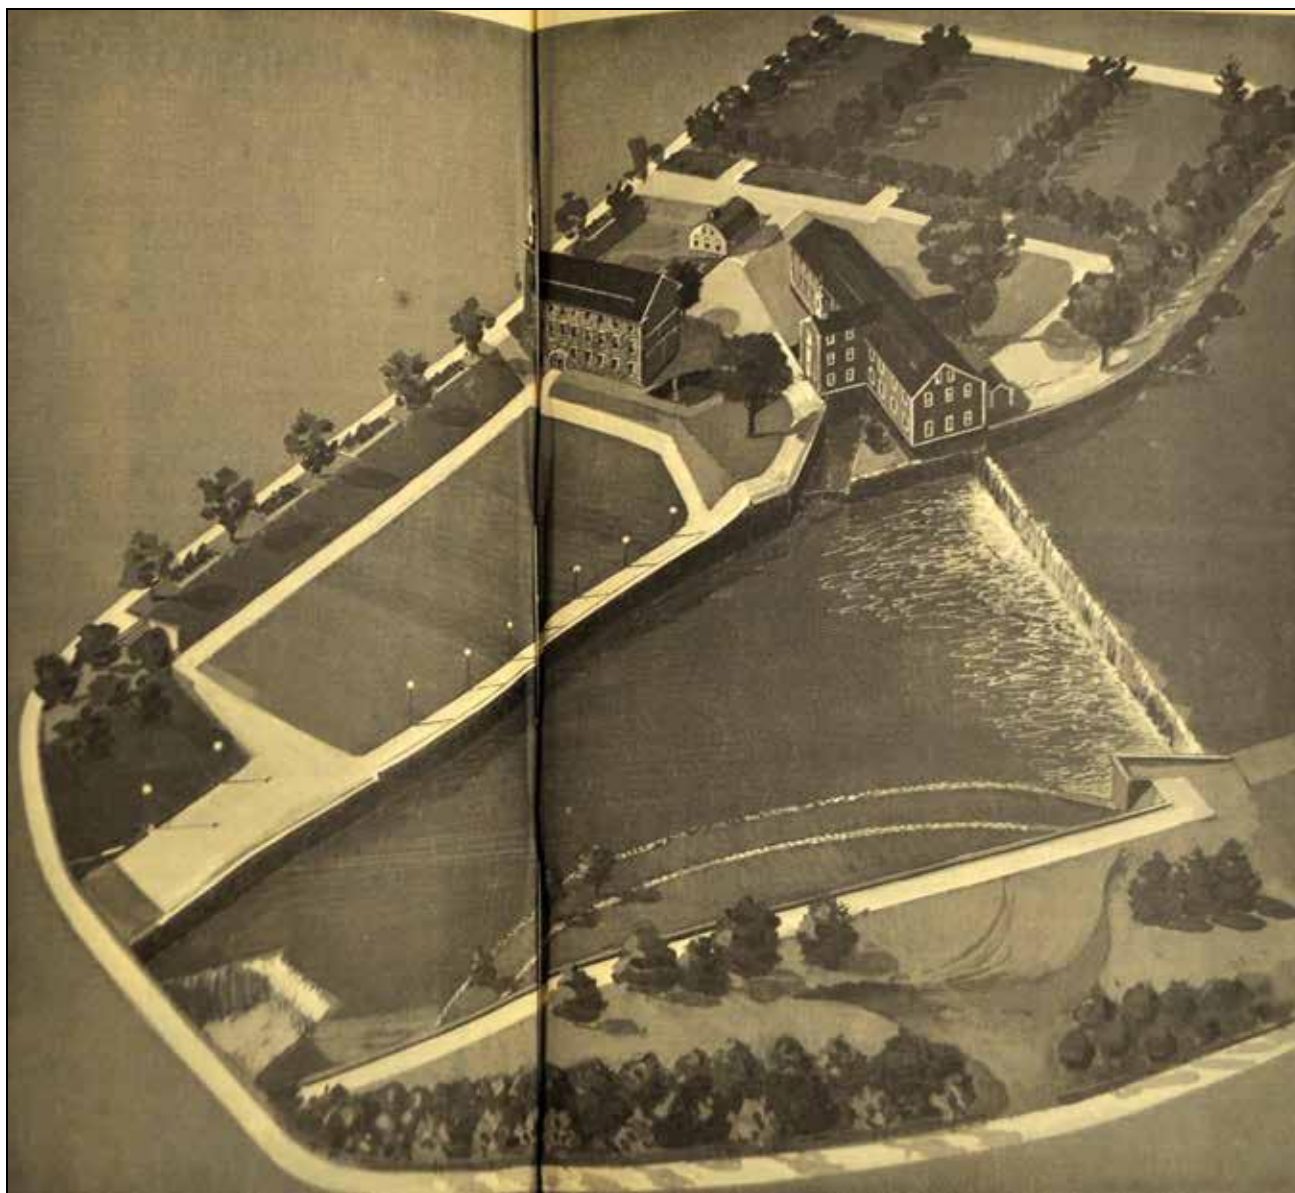
Figure 1.102. Proposed plan of Old Slater Mill and the Slater, North, South, and East Lots, late 1960s. (*The Flyer*, Vol. II, No. 7, July 1971: 6-7, from OCLP 2018, DSC-3851)

By mid-1967 plans for the Slater Urban Renewal Project were finalized, its goals impacting the size of the Slater Lot and completely changing the physical appearance of the North, South, and East Lots (Figure 1.102). In the plan, federal funds would be used to purchase and restore the Wilkinson Mill and move the Sylvanus Brown House to a new spot between the Wilkinson and Old Slater Mills, creating a core of three buildings. The North Lot would be used for parking, the South Lot would be transformed into a public park, and the East Lot would become open space to provide a views of the three buildings. Roosevelt Avenue and the North Main Street Bridge would also be widened.²¹⁹

The late 1960s plan featured parking throughout the entirety of the North Lot (see Figure 1.102). However, plans from 1970 proposed less parking, featuring a lighted parking area in the east half of the lot and separated by a low berm, and a higher landscaped berm on the west half (Figures 1.109, 1.110). Lines of Norway maple and Kwanzen cherry trees were proposed in the higher berm, likely to partially screen the parking lot from the core of the site. Trees that once had grown along the river wall were to be replaced with grass. By 1971, however, the entire lot was a paved parking lot. There were no center islands in the lot, but the perimeter was planted with lawns and a mix of white pine, red maple, and crabapples.

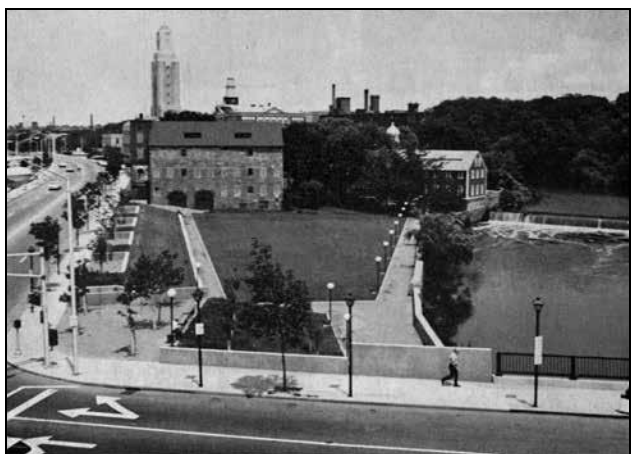
Figure 1.104. View looking northeast at Hodgson-Rotary Park, 1970. ("Hodgson Rotary Park," from www.flickr.com/photos/pawtucketlibrary/albums/72157705896995034)

The park featured a large, level, roughly triangular-shaped panel of grass bordered on the east by a pea gravel walk paralleling the river wall that connected to the existing pea gravel walk on the Slater Lot, and on the west by a pea gravel walk and seat-high retaining wall at the bottom of the fill slope (Figure 1.104). Stairs at either end of the west walk connected to concrete sidewalks along Roosevelt Avenue and North Main Street. A sloped driveway next to the Wilkinson Mill provided access from the street to the west walk, but the connecting walk from this point to the river, as shown in

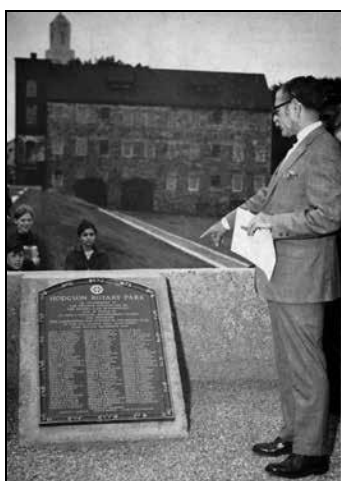
Figure 1.105. View looking northeast at the memorial tablet, 1970. ("Hodgson Rotary Park," from www.flickr.com/photos/pawtucketlibrary/albums/72157705896995034)

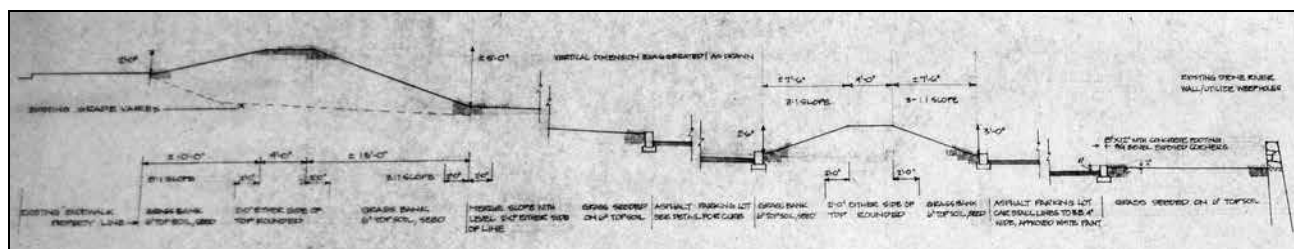
Figure 1.110. Cross-section of the North Lot, 1970. (Johnson & Hayes, Architects and Alexander E. Rattray, Landscape Architect, Parcel P-2: Parking Lot, Slater Mill Park, 1"=20 feet. Prepared for Old Slater Mill Association, 4 April 1969. OSMA Archives, from OCLP 2018, DSC-3948)

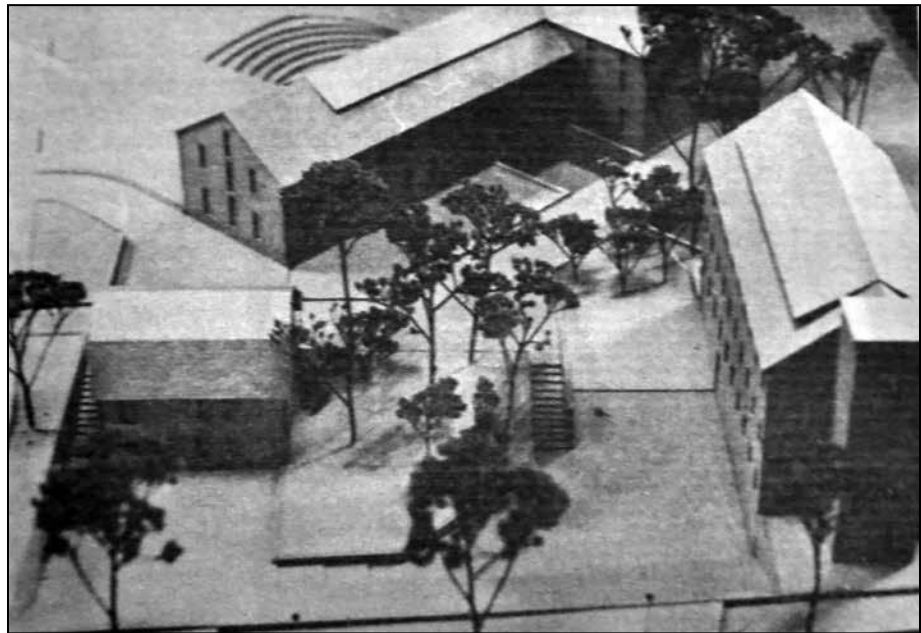
Figure 1.111. Photograph of a model of the Slater Lot property, c.1970. (*The Flyer*, May 1970: 3, from OCLP 2019, DSC-3837)

Wilkinson Mill, and Sylvanus Brown House (Figures 1.111, 1.112). Plans from 1971 indicate not all of the proposals in the model were implemented, but major changes were undertaken on the fill slopes that extended east from the widened Roosevelt Avenue. By lowering the grade of the slope between the Wilkinson Mill and Slater Avenue, it was possible to reveal all four stories of the mill and also create a space in which to recreate the basement kitchen garden that was known to exist at the Brown House (Figure 1.113).²²⁴

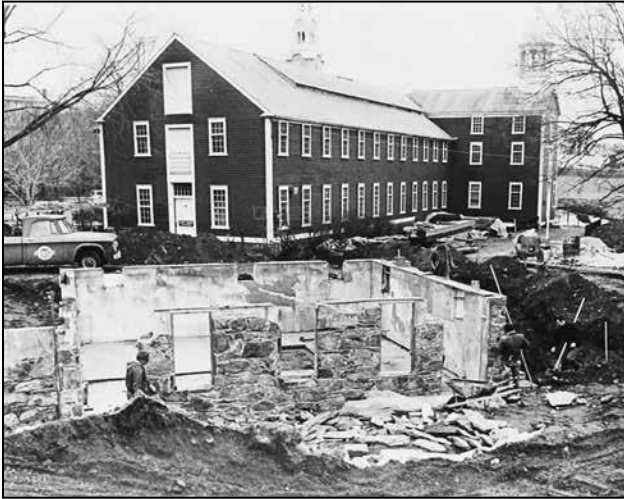
Figure 1.114. View looking southeast at the new foundation for the Sylvanus Brown House, 1972. (OSMA Archives, from HSR 2018: D-121)

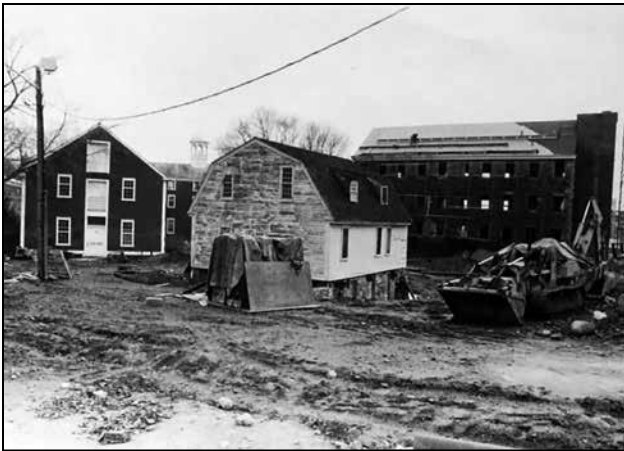
Figure 1.115. View looking south at the relocated Sylvanus Brown House, 1972. Restoration work is also underway in the Wilkinson Mill. (OSMA Archives, from HSR 2018: D-121)

In 1972 the OSMA moved the Sylvanus Brown House from the east end of Slater Avenue to its new location northwest of Old Slater Mill, in the location where the buildings that housed a carpenter shop and Henry Spencer’s bike shop used to be prior to 1925, and more recently, the flagpole in the 1950s. After the new concrete foundation and basement kitchen was built, the house was moved and the chimney was rebuilt. At the same time, OSMA began restoration work at the Wilkinson Mill, cleaning and repointing exterior stone walls and brick stairtower, installing new frames and windows, repairing the roof and monitor windows, and rebuilding the missing cupola (Figures 1.114, 1.115, 1.116).²²⁷

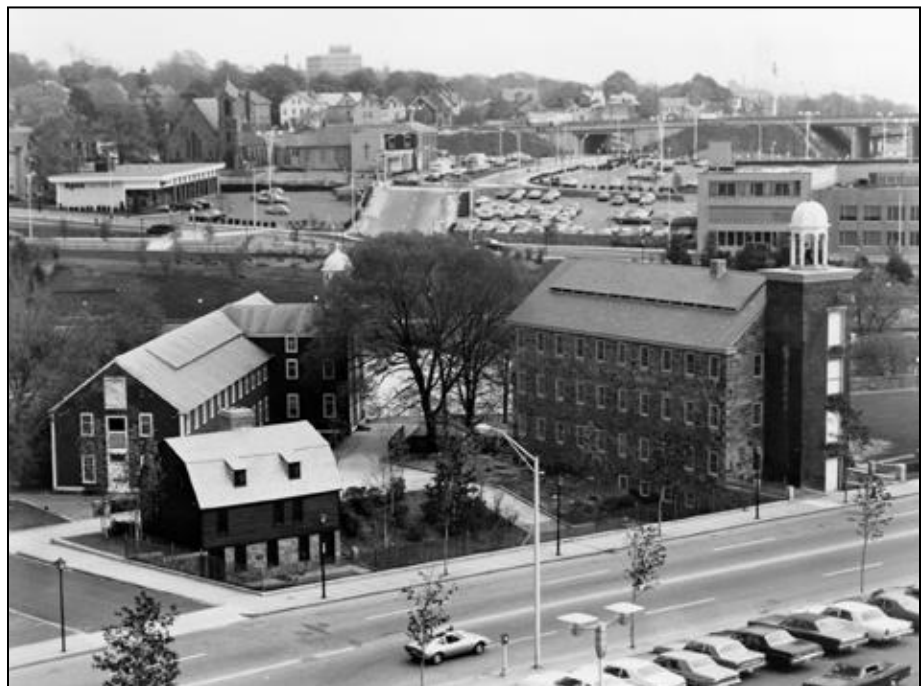
Figure 1.117. View looking southeast at the Slater Lot, 1973, soon after site work was completed. In the background are the bridges associated with Interstate 95. (NR 1975)

By 1973 OSMA had essentially completed building restorations and site work in the three-building core area (Figure 1.117). The OSMA modified and expanded the pedestrian circulation system, shifting the site’s main entrance to a new 20-foot wide pea gravel walkway extending from Slater Avenue to the front of the Brown House. To provide access to the Brown House, the elevation of this walkway segment was set around three feet higher than the entrance to Old Slater Mill, which required a set of steps from the walkway to the lower pea gravel patio on the north side of the mill and the existing pea gravel walk that extended to Slater Avenue. Just to the south of the Brown House the new walk, and another set of steps, ramped down to a large central patio area that connected to two other paths. One of the paths was a new walk between the Wilkinson Mill and the Brown House and terminating at the basement of the house. The other path utilized the existing pea gravel walk on the west side of the mill for access to the footbridge, stairtower, and the river, where it connected to the new pea gravel walk paralleling the river wall in Hodgson-Rotary Park. A historic photograph shows the lawn area at this junction was rebuilt as a series of pea gravel terraces around the existing mature trees. There was also a set of stone steps on the south side of the Brown House, but at this time there was no walkway connection to the Wilkinson Mill. All of the new walks were around 10 feet wide and bordered by curbs, except for a short section of the new walk in front of the Brown House that featured a retaining wall topped by a granite and pipe rail fencing to account for the 3-foot grade change (Figure 1.118). The same fencing was also installed on either side of the Wilkinson Mill stairtower. To keep visitors off of the steep slopes

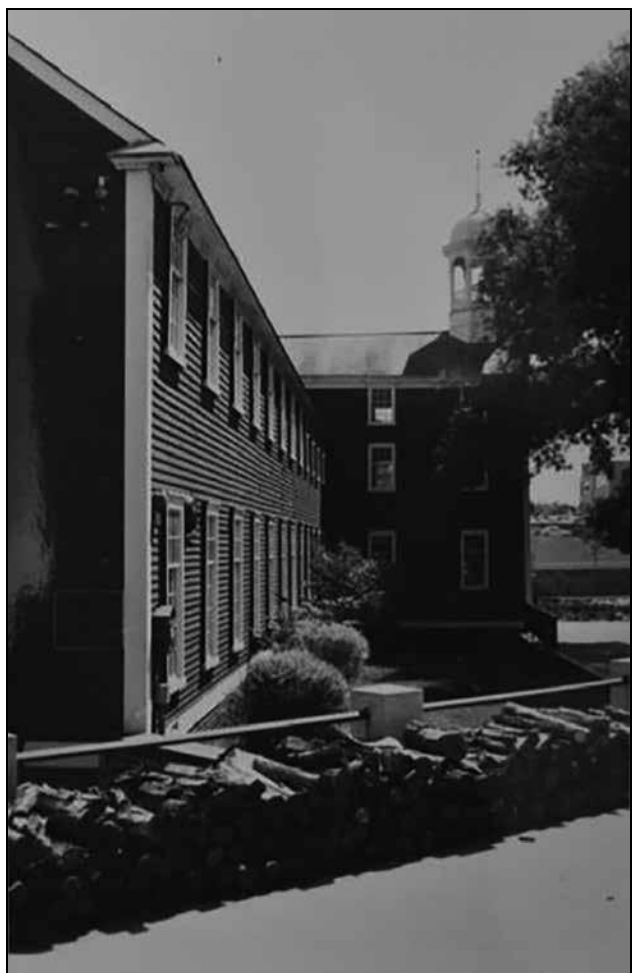
Figure 1.118. View looking southeast at the granite and pipe fence on the new walk between Old Slater Mill and the Brown House, 1973-1975. (OSMA Archives, from HSR 2018: D-121)

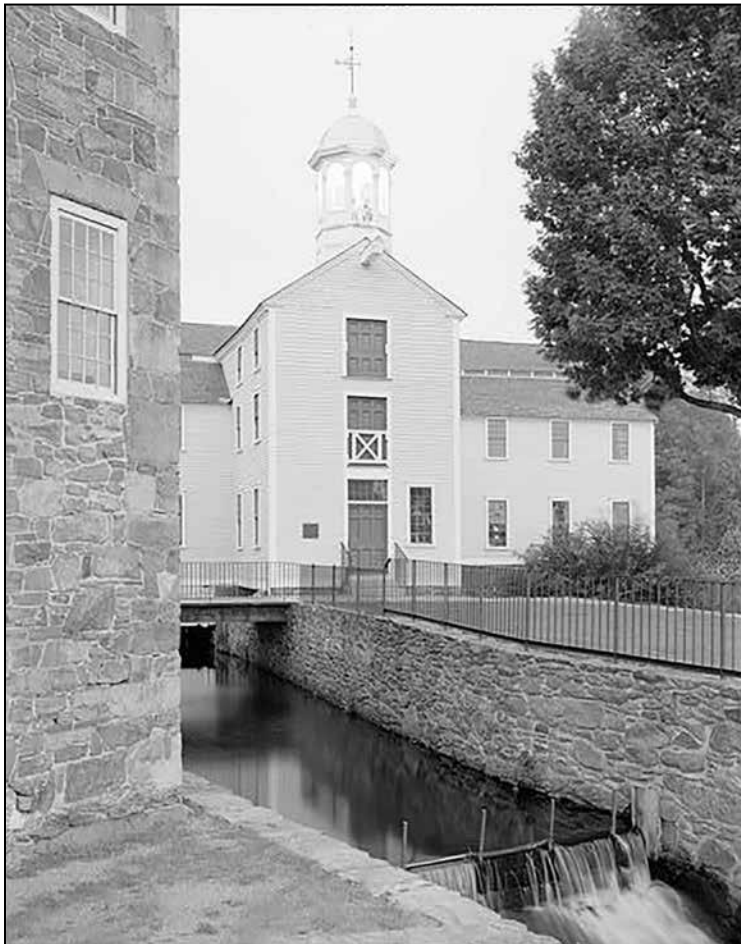
Figure 1.121. View looking east at the extension of the Great Flume and the small dam, 1991, around ten years after it was built. By this time the terraced patio west of the stairtower was replaced with grass, and trees that once grew along the wall of the Great Flume were gone. (Photograph by Joseph E.B. Elliott, HAER RI-1, 1991)

By 1980, the OSMA constructed and operated a new waterwheel in the Wilkinson Mill, which was informed by several excavations in the 1970s. In 1981 archeologists found evidence of the Great Flume under the mill, which made it possible to extend the raceway from the old Slater Lot property line into the mill, as well as around to its southeast corner via a small scupper dam. Below the dam, the raceway's water, and the tailrace water from the Wilkinson Mill, was channeled to an underground pipe that exited through an outlet in the river wall. Stone walls topped with iron fencing lined the raceway and tailrace. By 1982 river water flowing through the Great Flume once again powered the wheel in the Wilkinson Mill (Figure 1.121).²³⁰

Overall the site's landscape was characterized by broad, manicured lawns dotted with shade trees. In the core area, the patio terrace just west of the Old Slater Mill stairtower was replaced with grass, and several trees that once grew in and along the Great Flume were gone (see Figure 1.121). The mill's tailrace was partially obscured by a mass of volunteer trees and shrubs, and a row of shrubs marked the top of the fill slope in the Great Flume

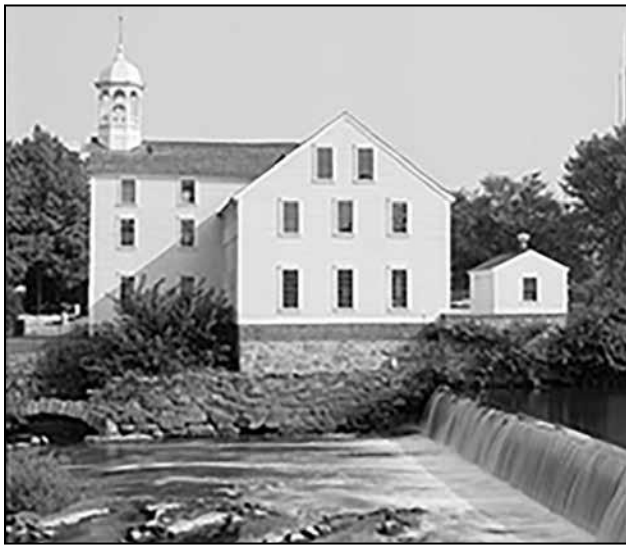
Figure 1.123. View looking northeast at the south side of Old Slater Mill, 1991, and the vegetation in the mill's tailrace. (Photograph by Joseph E.B. Elliott, HAER RI-1, 1991)

east of the mill. A large lilac thrived on the east side of the mill, along with several mature trees in the lawn, but only one of the lilacs remained along the west foundation (Figures 1.123, 1.124, 1.125, 1.126). Some of the shade trees and shrubs planted by OSMA around the Sylvanus Brown House also matured (Figure 1.127). A variety of deciduous and evergreen shade and ornamental trees were present along the perimeter of parking lot north of mill, but none had been planted within the lot (Figure 1.128).

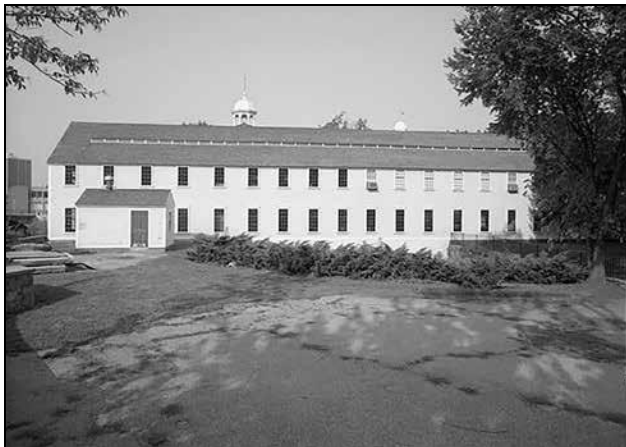
Figure 1.124. View looking southwest at the east side of Old Slater Mill, 1991, and the shrubs along the top of the fill slope in the Great Flume. (Photograph by Joseph E.B. Elliott, HAER RI-1, 1991)

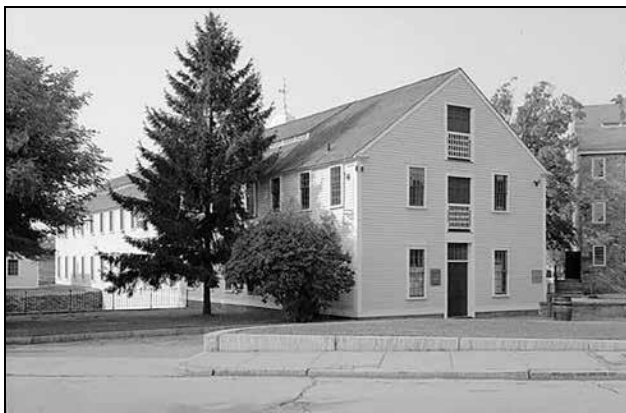
Figure 1.125. View looking south at the north and east sides of Old Slater Mill, 1991, and the lawns and mature trees and shrubs. (Photograph by Joseph E.B. Elliott, HAER RI-1, 1991)

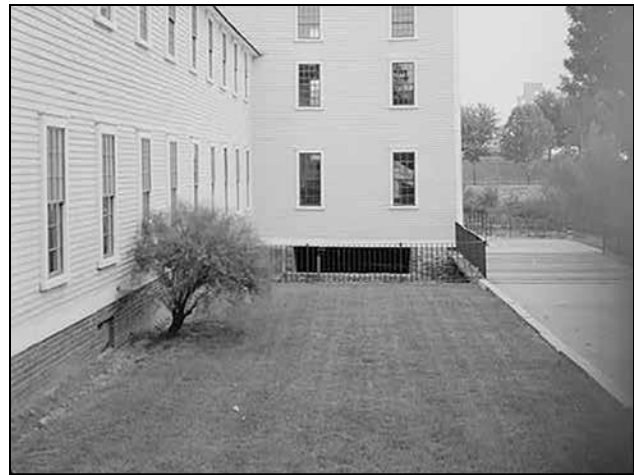
Figure 1.126. View looking southeast at the west side of Old Slater Mill, 1991, and the last remaining foundation shrub. (Photograph by Joseph E.B. Elliott, HAER RI-1, 1991)

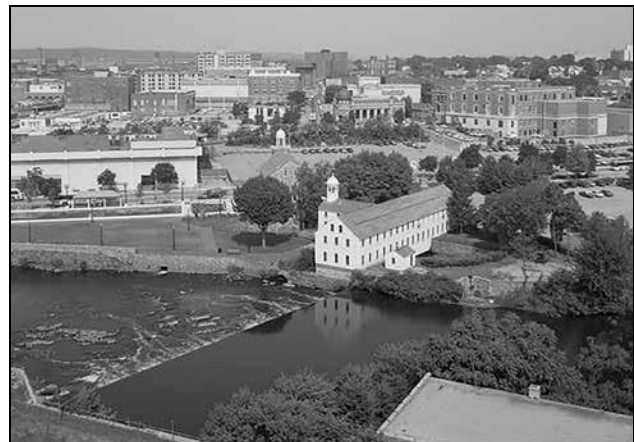
Figure 1.128. View looking west, 1991, at the trees along the perimeter of the parking lot north of the Old Slater Mill. Note the brick walks in Hodgson-Rotary Park. (Photograph by Joseph E.B. Elliott, HAER RI-1, 1991)

In addition to removing the patio terrace at the stairtower, the OSMA also added a walkway from the east end of the Wilkinson Mill to the central patio (see Figure 1.127). In Hodgson-Rotary Park south of Old Slater Mill, a new Y-shaped walk was built at the north end of the park to link the west walk and driveway to the east walk, and an accessible switchback ramp was constructed next to the driveway for a connection between Roosevelt Avenue and the west walk. The HAER photographs also indicate that all of the walks in the park were paved in red brick by 1991 (see Figure 1.128).

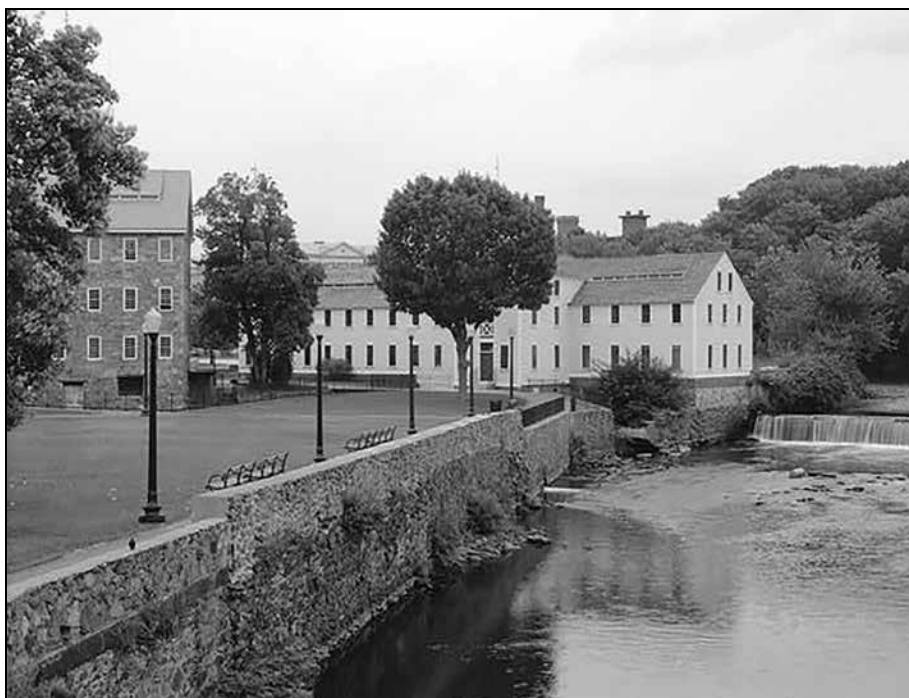
Figure 1.130. View looking northeast, 1991, at the relocated Cogswell Fountain at the corner of Roosevelt Avenue and Main Street. (Pawtucket Times, from Johnson et.al. 1995: 103)

Perhaps the most significant change at Hodgson-Rotary Park was the installation of the Cogswell Fountain at the southwest corner of the park (Figure 1.130). Replacing the park's original pea gravel patio, the monument was set within a circular gray granite patio at the same elevation as the sidewalks along Roosevelt Avenue and Main Street. This patio transitioned to a smaller rectangular-shaped patio paved in brick next to the Main Street Bridge. The north and east sides of the circular patio were supported by a concrete retaining wall, at the ends of which two staircases led to the walks and lawn areas below. The addition of the monument and the new patios eliminated a small area of trees installed adjacent to this area in 1970, and slightly lengthened the main lawn area southward to abut new brick walks at the base of the retaining wall. It also removed the retaining walls that surrounded the trees along Roosevelt Avenue. The project concluded with the installation of shrubs and additional ornamental lights posts, as well as four large floodlights next to the river pointed toward the Old Slater Mill and the upper and lower dams.²³¹

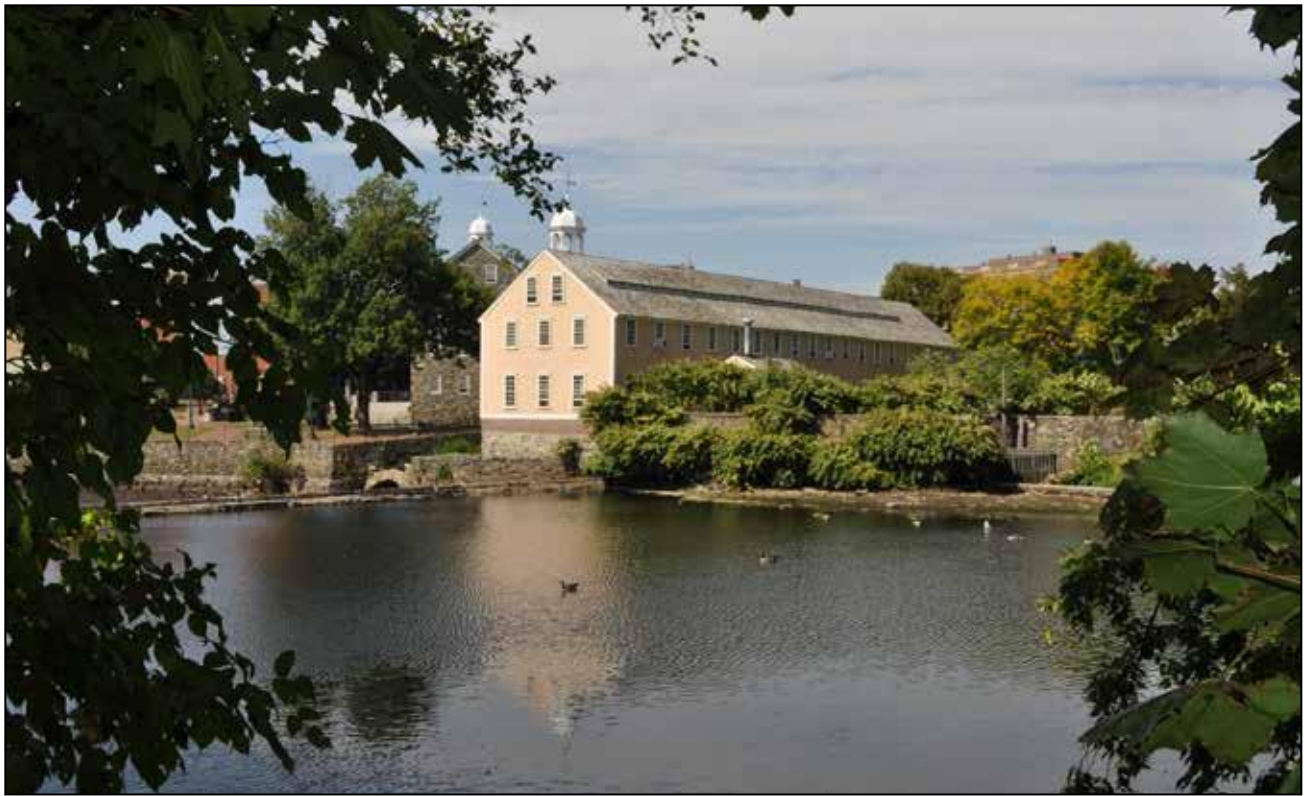
Figure 2.1. View looking west at the Slater Lot, 2019. The Old Slater Mill's stone foundation, stone retaining walls, and earthen banks define the river edge. (Olmsted Center for Landscape Preservation [hereafter OCLP] 2019, DSC-5478)

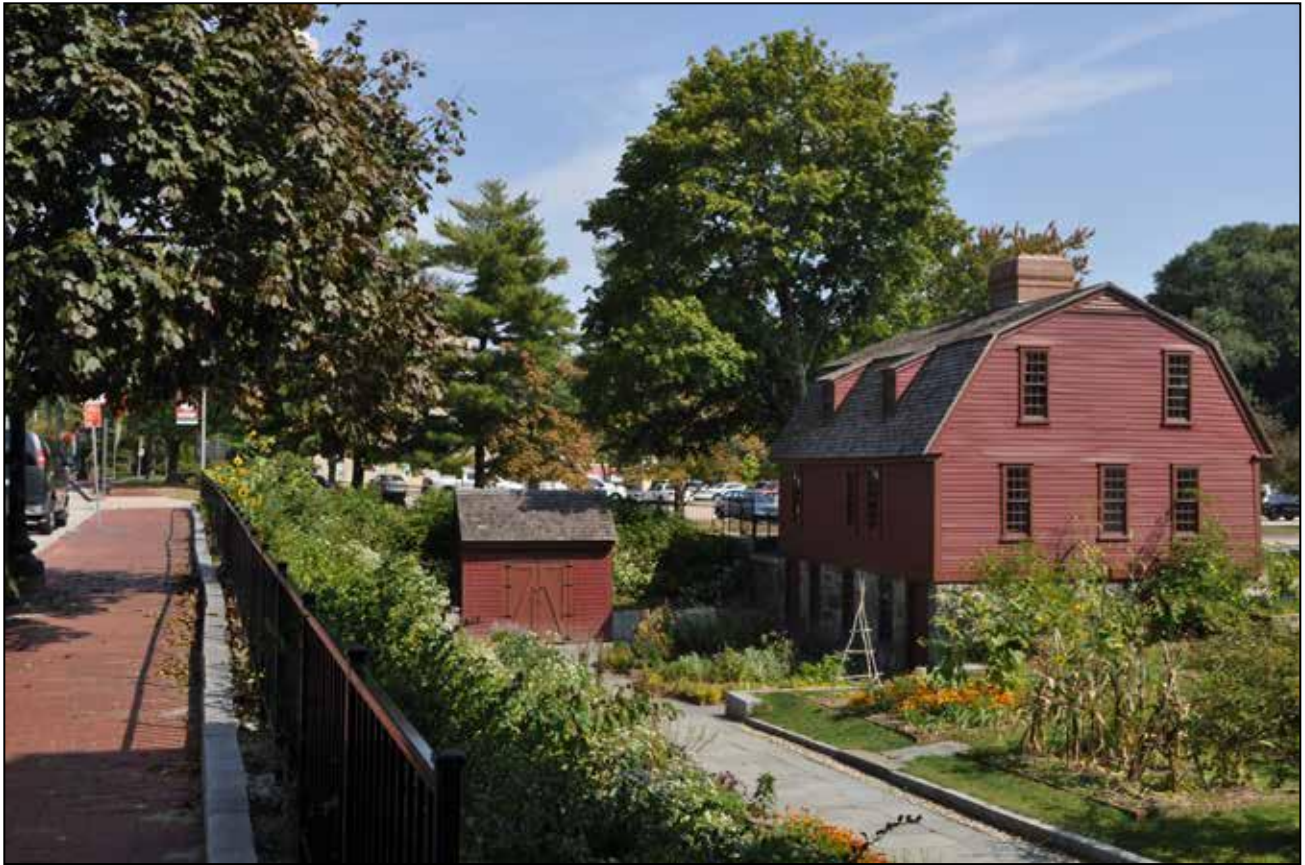
Figure 2.2. View looking northeast at the depressed landform in the western part of the Slater Lot, 2019. Pictured are the Sylvanus Brown House and the garden shed. The brick walk at image left was replaced with a concrete walk in late 2020. (OCLP 2019, DSC-5451)

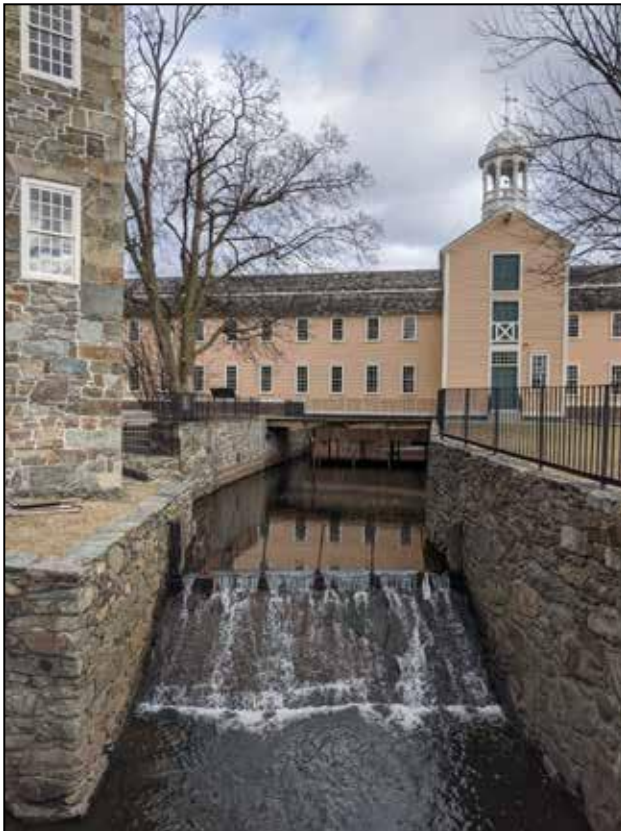
Figure 2.4. View looking north at the partially-filled Great Flume on the east side of Old Slater Mill. (OCLP 2021, IMG-20210111-142600)

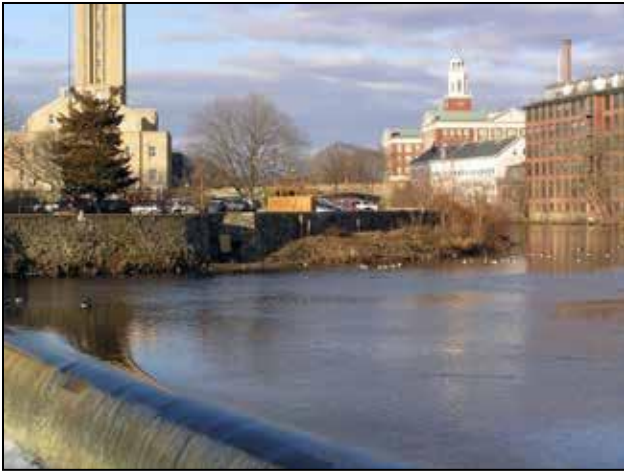
Figure 2.5. View looking north at the stone river wall and earthen bank that defines the river's edge in the North Lot. (OCLP 2021, P1010043)

The North Lot sits along the Blackstone River, which at this point in its course is characterized by flat water conditions created by the pool above the upper dam, located just downstream. The river edge is defined by a stone retaining wall fronted by an earthen bank covered in riparian vegetation, as well as weed trees such as *Ailanthus altissima* (Figure 2.5).

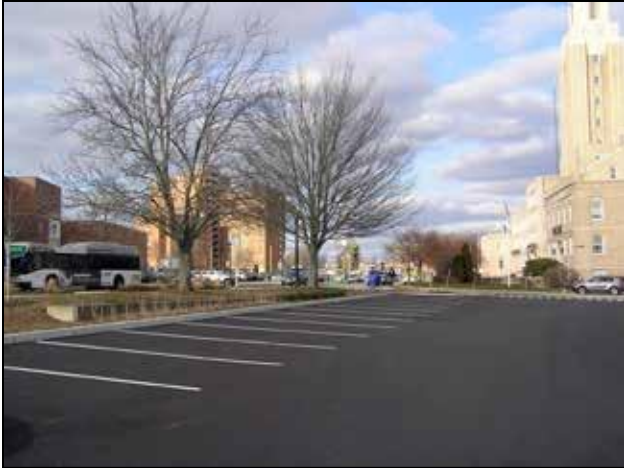
Figure 2.6. View looking north at a portion of the parking lot concrete retaining wall in the North Lot. The entrance to the lot is in the background at image right. (OCLP 2021, P1010001)

The overall landform of the North Lot generally slopes west to east, from an elevation around 38 feet at Roosevelt Avenue to around 32 feet at the land side of the river wall. On the west side of the lot, a portion of the landform is depressed around three feet for the parking lot (Figure 2.6). This condition was created in the early 1970s by cutting into the fill slopes associated with the widening of Roosevelt Avenue.

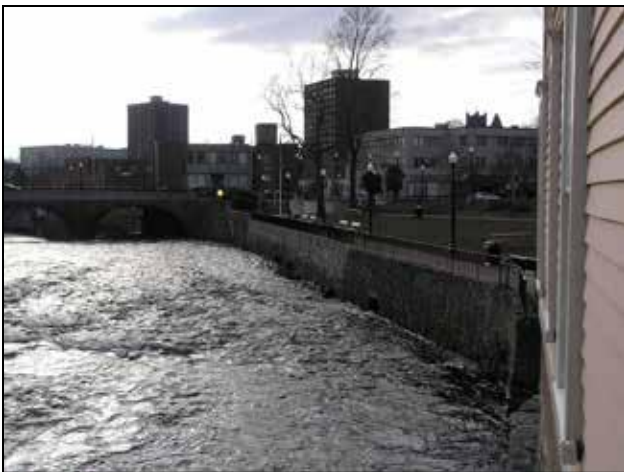
Figure 2.7. View looking southwest at the stone river wall / foundation walls that define the river's edge in the South Lot. (OCLP 2021, P1010011)

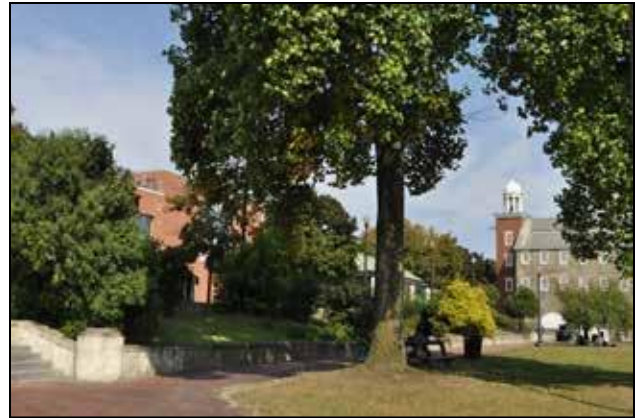
Figure 2.8. View looking north at the topography in the South Lot, known as Hodgson-Rotary Park. Concrete retaining walls account for the change in grade between the park and Roosevelt Avenue to the west. (OCLP 2019, DSC-5440)

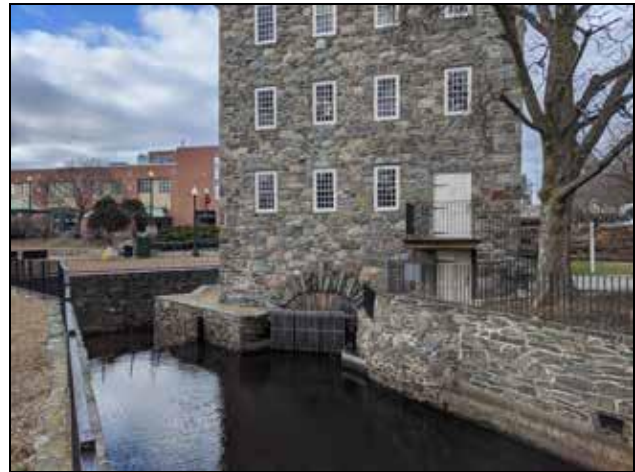
Figure 2.9. View looking northwest at part of the restored Great Flume as it enters the Wilkinson Mill. (OCLP 2020, IMG-20200105-120440)

The overall landform of the South Lot generally slopes northwest to southeast, from an elevation of around 32 feet along Roosevelt Avenue to between 22-27 feet at the land side of the river wall. Most of the lot features level topography except along the south and west edges, where the sloped topography is defined by sets of steps associated with the patio around the Cogswell Monument, a sloped planting bed set within two retaining walls, steps and an accessible pedestrian ramp, and a sloped vehicular driveway (Figure 2.8). The restored segment of the Great Flume that enters the South Lot is around 6-8 feet below the adjacent grade, but there are no longer any above-ground traces of the Swift Flume or Sargeant's Trench raceways that tracked through the South Lot (Figure 2.9).

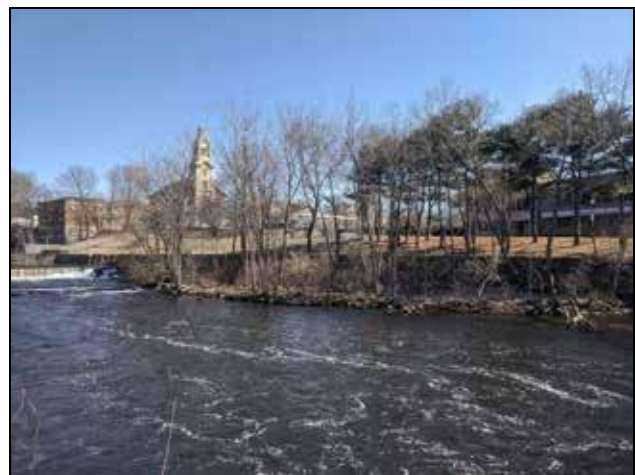
Figure 2.10. View looking east at the upper dam and the river's edge on the East Lot. (OCLP 2020, IMG-20200223-130935)

The East Lot borders the Blackstone River, which flows over the upper dam, dropping around six feet in elevation, and the lower dam at the top of Pawtucket Falls, dropping another 30 feet. Above the upper dam the water flows slowly, but quickens after flowing over the upper dam and then tumbling over the lower dam and through the falls (Figures 2.10, 2.11). The river edge is defined by a stone retaining

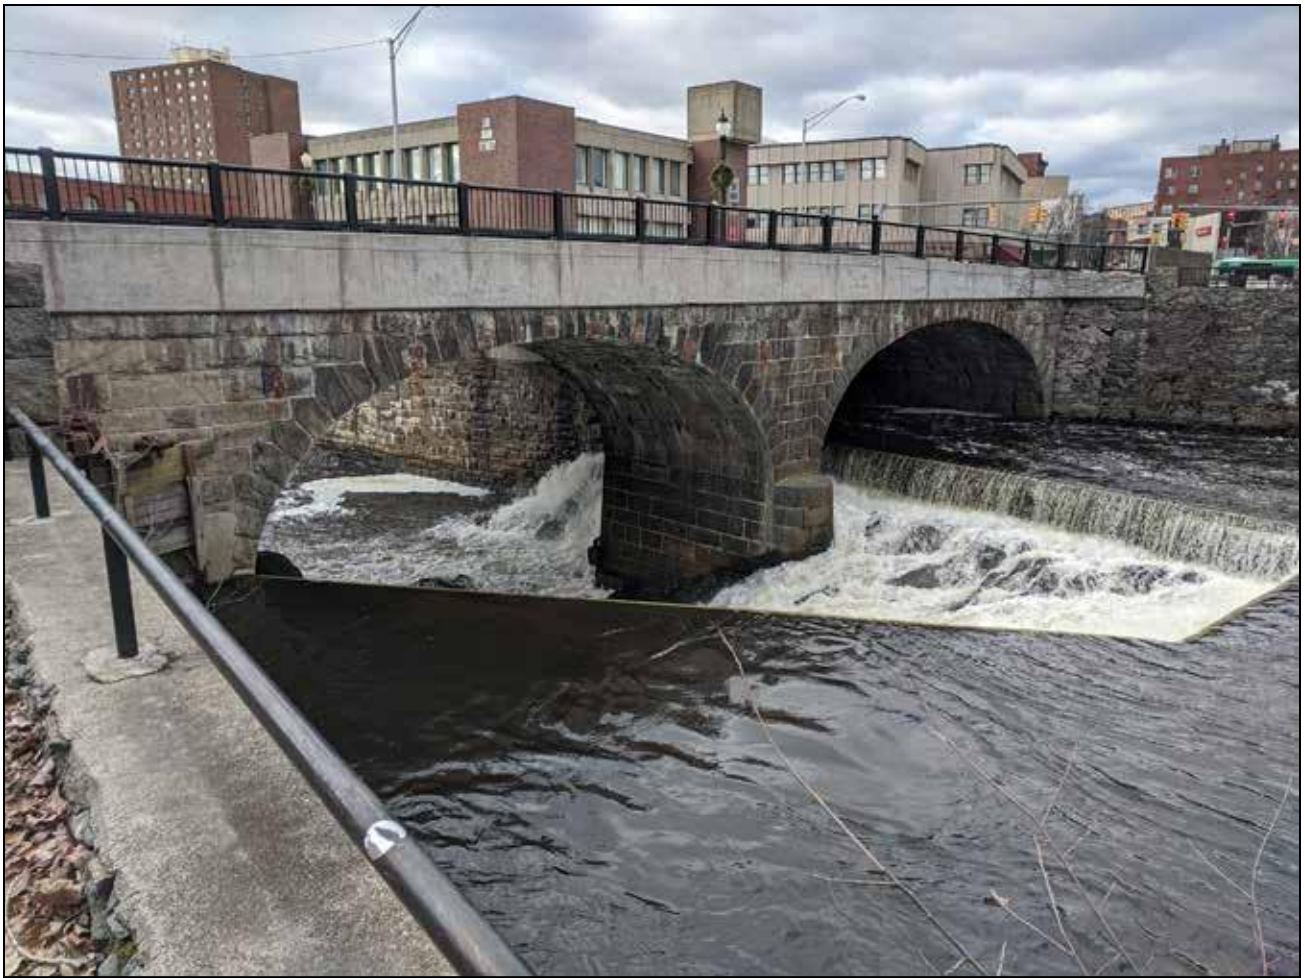
Figure 2.11. View looking west at the Main Street Bridge and the lower dam above Pawtucket Falls. (OCLP 2020, IMG-20200105-122315)

The Main Street Bridge was rehabilitated and widened in 1968, adding a second span on the downstream side of the stone arch bridge, thus preserving its upstream stone façade. The total length of the bridge is 124 feet with its longest span being 40 feet and a width of 63 feet (see Figure 2.11).

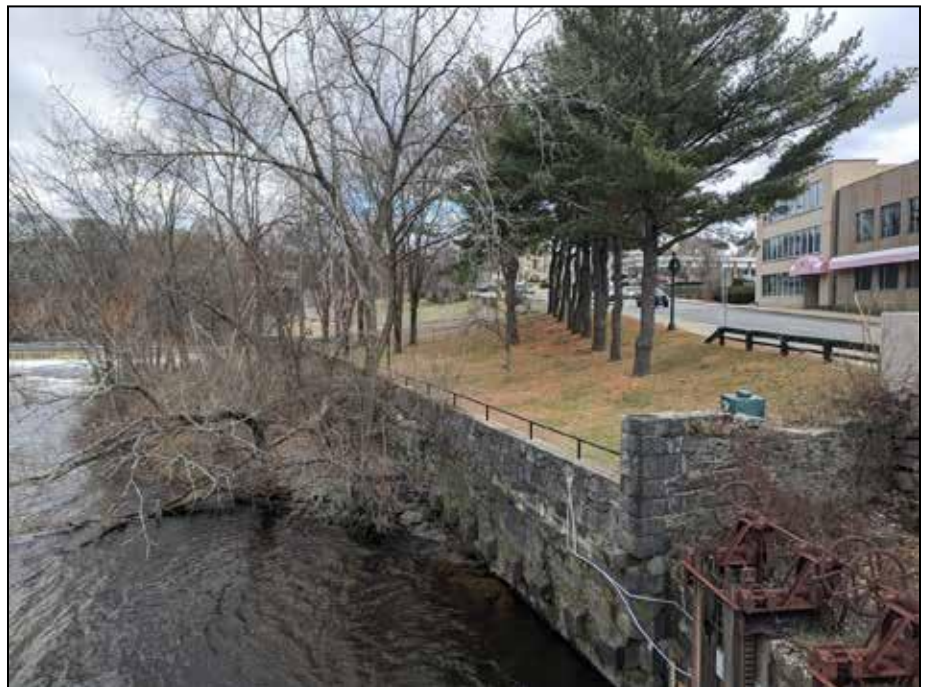
Figure 2.12. View looking east at the stone river wall and earthen bank on the East Lot, known as Slater Mill Park. (OCLP 2020, IMG-20200105-122156)

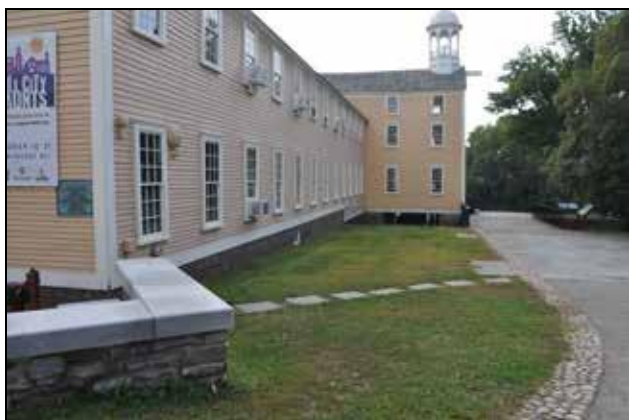
Figure 2.13. View looking southeast at the west side of Old Slater Mill. Note the retaining wall, steeping stone path, and two concrete pads that once supported benches. (OCLP 2019, DSC-5351)

Old Slater Mill was painted red in 1949 and then back to its original yellow color in 1975 (refer to the 2018 Historic Structures Report for a full description of projects at the mill) (Figure 2.13). The OSMA constructed a boiler house on the former peninsula on the east side of the mill in 1955. The wood-frame structure measures 15 by 12 feet and features a gable roof and yellow siding (Figure 2.14). In 1962 the OSMA relocated the 1758 Sylvanus Brown House to the site to save it from demolition, and moved it again 1972-1973 to its current location on a new foundation between the two extant mills. The 2-story house measures 30 by 20 feet and features a gambrel roof and red siding (Figure 2.15). In 2001, a small garden shed was built at the herb garden. It measures 13 by 8 feet and features a gable roof and red siding (see Figure 2.2).

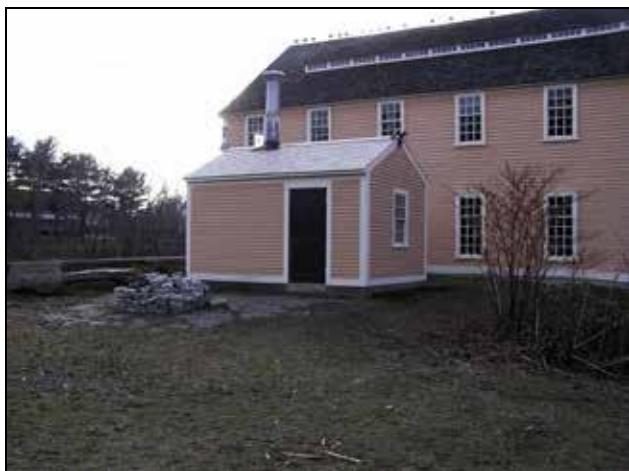
Figure 2.14. View looking south at the boiler house on the east side of the mill. (OCLP 2021, P1010012)

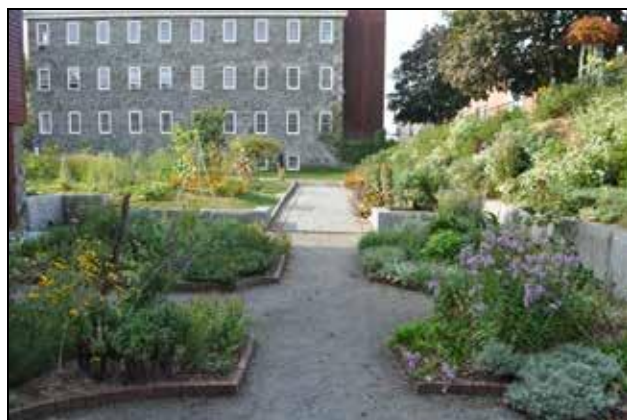
Figure 2.16. View looking south at the low granite retaining walls in the herb garden area. (OCLP 2019, DSC-5343)

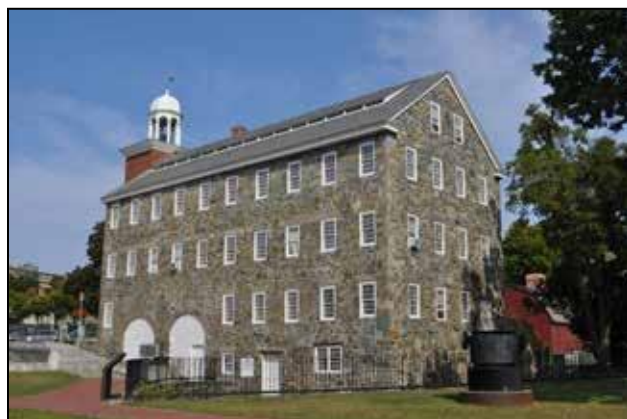
Figure 2.17. View looking north at the Wilkinson Mill. (OCLP 2019, DSC-5415)

The Wilkinson Mill's chimney and additions were removed in the 1930s and 1940s, and the building was restored in the early 1970s (Figure 2.17). As for the other South Lot buildings, around half were removed in the 1930s-1940s and the rest between 1967-1969. The stone foundations of factories that abutted the river were retained for use as a river wall (see Figure 2.7). A gap in the river wall was filled with new stone wall in 1970-1971, and a small segment of the river wall was lowered to meet the grade of the adjacent walk in 2014 (as part of a Federal Emergency Management Agency project). As part of the development of Hodgson-Rotary Park, concrete retaining walls and steps were built along the west edge of the lot to address the grade change between the park and Roosevelt Avenue (see Figure 2.8). Additional concrete retaining walls were built at the north end in

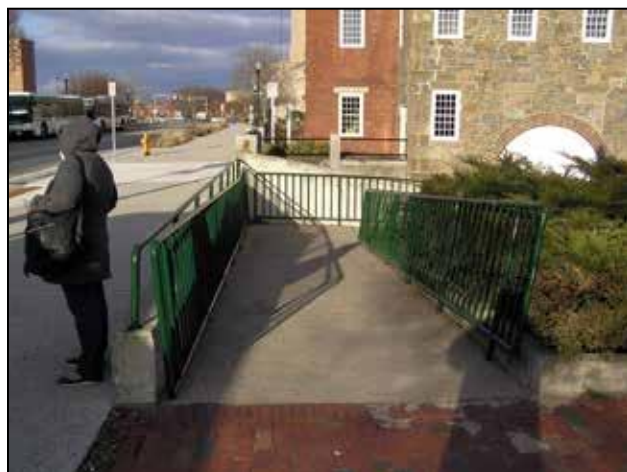
Figure 2.18. View looking northeast at the concrete retaining walls along the accessible ramp in Hodgson-Rotary Park. (OCLP 2021, P1010031)

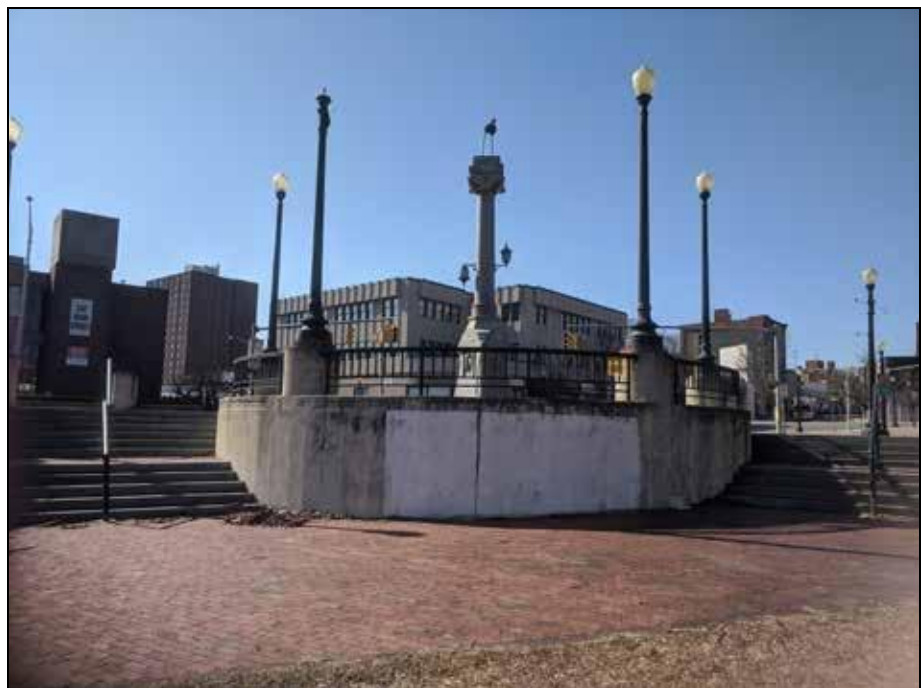
Figure 2.19. View looking west at the concrete retaining walls and steps at the Cogswell Monument. (OCLP 2020, IMG-20200223-130908)

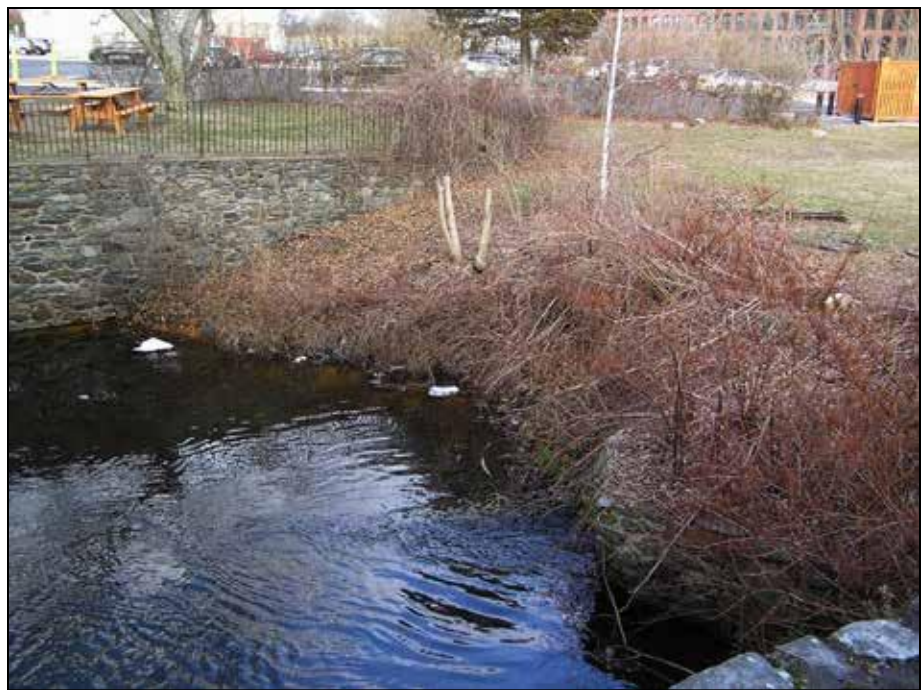
Figure 2.23. View looking northeast at the partially filled in Great Flume, and the stone headwall around the outlet of the penstock pipe (image mid-right). (OCLP 2021, P1010015)
