CULTURAL LANDSCAPE REPORT FOR SLATER MILL HISTORIC SITE

BLACKSTONE RIVER VALLEY NATIONAL HISTORICAL PARK

PAWTUCKET, RHODE ISLAND

Olmsted Center for Landscape Preservation
National Park Service, Boston, Massachusetts, 2021

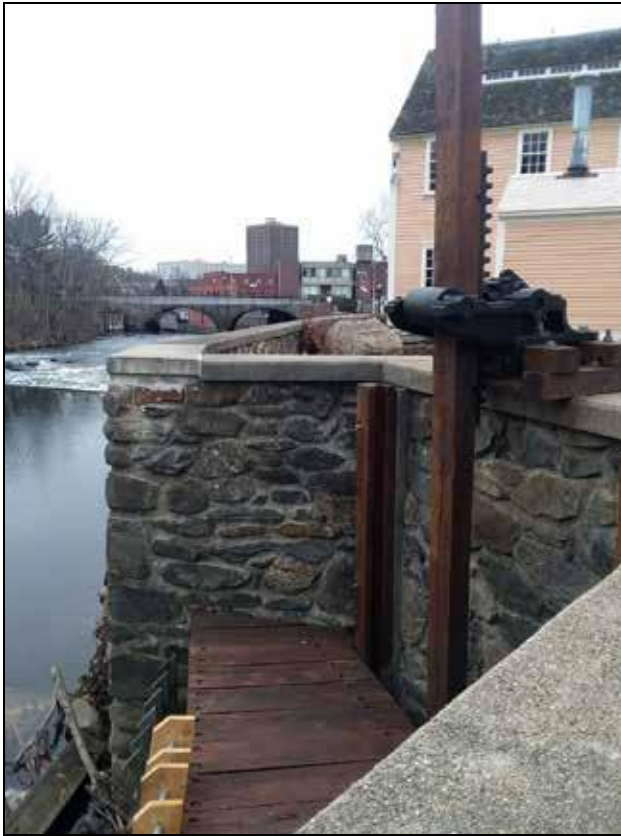
Figure 2.24. View of the trash rack and gate at the inlet of the penstock pipe. (OCLP 2021, IMG-20210111-140514)

By 1940, in conjunction with reconstruction of the stone river wall, much of the Great Flume east of Old Slater Mill was filled in with soil. The grade of the fill at the river wall matched the grade of the adjacent Slater Avenue, and then beginning at around 60 feet from the east side of the mill, the fill gradually sloped down to meet the original grade of the flume (Figure 2.23). At the same time, a penstock was installed from the river into the flume to control the amount of water into the still-exposed portion of the raceway. The pipe was replaced in the 1980s and in 2012-2013 the inlet was rebuilt by creating an insert in the river wall to accommodate the machinery and trash rack (Figure 2.24). The stone walls and stone arch on the tailrace have been recently restored (Figure 2.25).

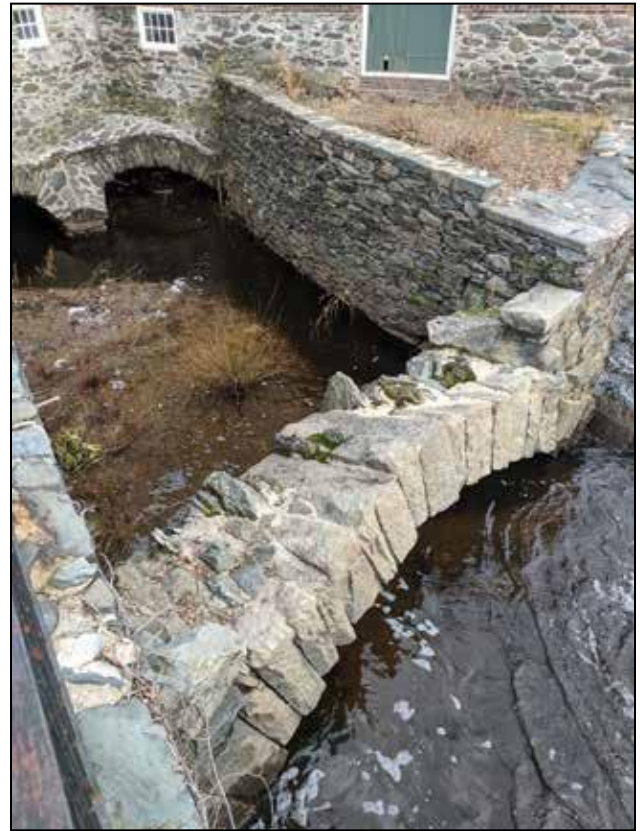
Figure 2.25. View of the tailrace stone walls and stone arch. (OCLP 2020, IMG-20200105-121104)

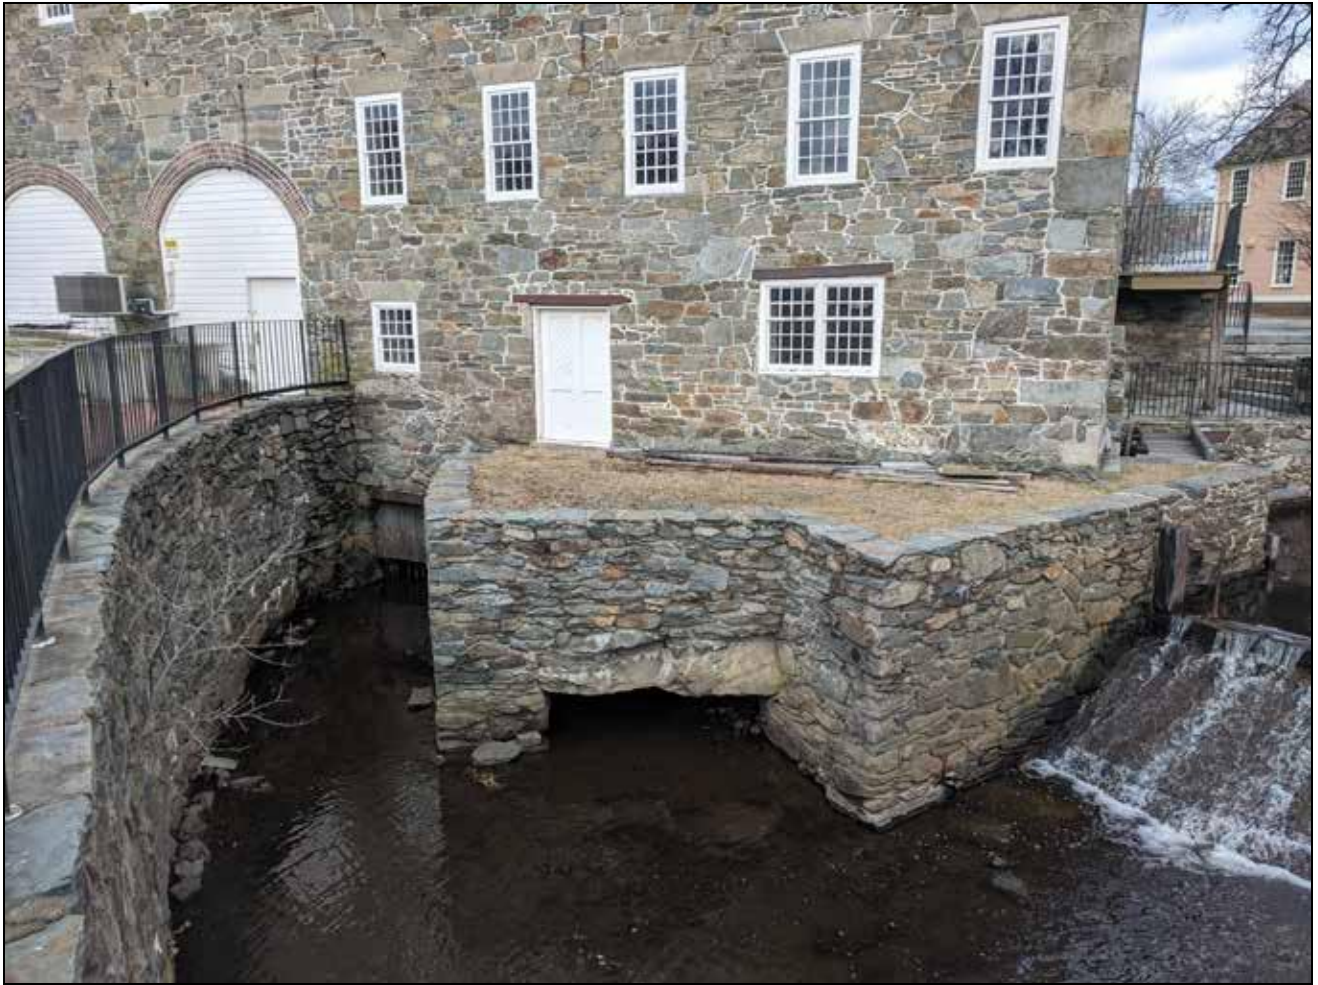
Figure 2.26. View looking northeast at the check dam on the Great Flume and the Wilkinson Mill tailrace. (OCLP 2020, IMG-20200105-120554)

Historic maps indicate short sections of the Great Flume, Swift Run, and Sargeant's Trench raceways in the South Lot after the historic period, but their uses and configurations are unclear. It appears portions of the raceways were altered after 1923, and most were filled in by 1949, which corresponds to the first phase of buildings removals, after which the vacant land was used for parking. In 1981 archeologists confirmed the location of the Great Flume from the Slater Lot/South Lot property line to the Wilkinson Mill, allowing for the reconstruction of the raceway and tailrace stone walls. This made it possible to have water in the Slater Lot portion of the Great Flume to flow into the new section, which via a check dam could be directed into the Wilkinson Mill or around it. Water exiting the raceway and Wilkinson tailrace was then directed into a new underground pipe that headed to the river (Figures 2.26, 2.27, see also Figure 2.9).

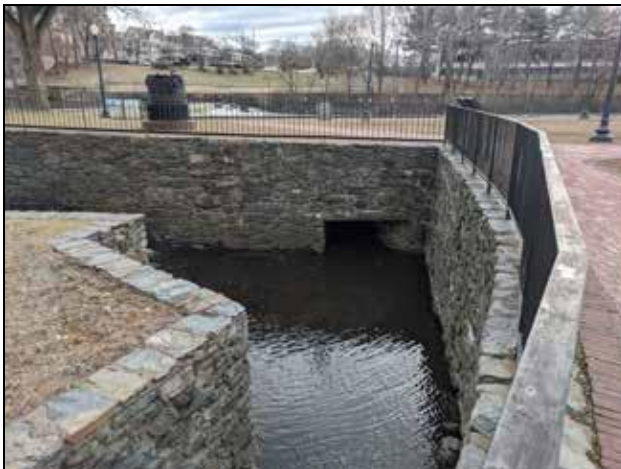
Figure 2.27. View looking southeast at the pipe inlet that carries water from the Great Flume and the Wilkinson Mill tailrace back to the river. (OCLP 2020, IMG-20200105-120816)

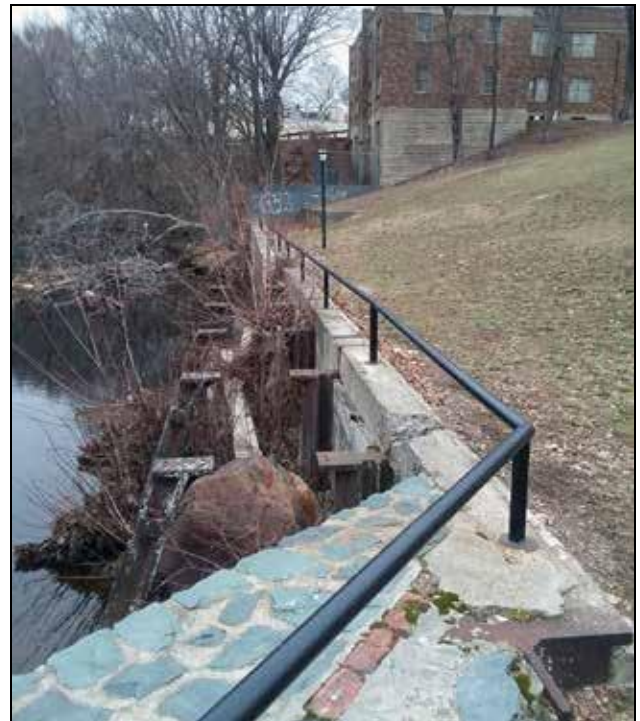
Figure 2.28. View looking northwest at the remnants of the raceway inlet on the East Lot. (OCLP 2021, IMG-20210111-144655)

Documentation of the raceway on the East Lot is minimal, but it appears that it was removed or filled in by 1955, likely around the same time that the first group of buildings had been razed. Old machinery associated with the raceway inlet is still visible, but its installation date requires additional research (Figure 2.28).

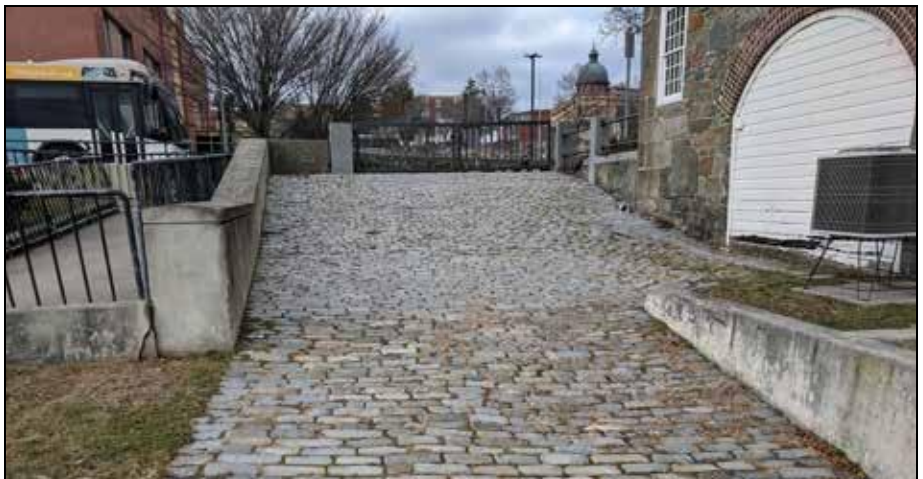
Figure 2.38. View looking northwest at the driveway connecting the park to Roosevelt Avenue. (OCLP 2020, IMG-20200105-120804)

The parking lot in the South Lot was replaced in 1971 with Hodgson-Rotary Park. Circulation in the park was through a series of pea gravel paths laid out parallel the river and Roosevelt Avenue. The path along the river connected to the Main Street Bridge to the south and the path system in the Slater Lot to the north, which allowed visitors to easily move from one area of the site to another. At this time a short driveway was built on the south side of Wilkinson Mill to provide service access from Roosevelt Avenue down into the park. This driveway generally followed the route of the Wilkinson Place alley. By 1991 an accessible ramp was built next to the driveway and a granite block patio was constructed around the new Cogswell Monument. At this point all of the pea gravel surfaces in the park were replaced with brick pavers (Figures 2.36, 2.37, 2.38, see also Figure 2.8).

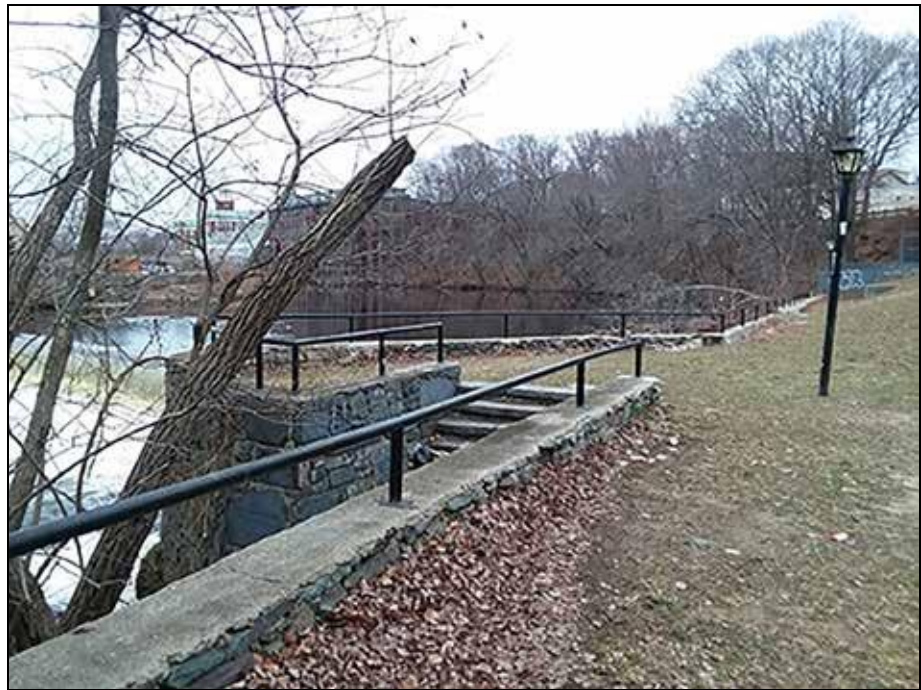
Figure 2.39. View looking northeast at the overlook and steps in the East Lot. (OCLP 2021, IMG-20210111-144804)

Of all lots that comprise Slater Mill Historic Site, the East Lot likely had the least number of workyards and alleyways due to the tightly-packed arrangement of buildings and the steep topography. Rather, circulation was likely by way of footbridges and boardwalks, some of which appear in historic Sanborn maps. The lot's first buildings were removed by 1955, after which these areas became an informal parking lot until the lot's last buildings were razed in 1969. At that time the parking was removed and entire lot was planted with lawns and trees as part of the new Slater Mill Park. In 1970-1971 part of the stone river wall at the east end of the upper dam was removed for a walled overlook area and staircase that accessed the riverbank below. The overlook and stairs remain as the only constructed circulation feature in the East Lot. Scouring from river water flow is evident at the bottom of the overlook walls (Figure 2.39).

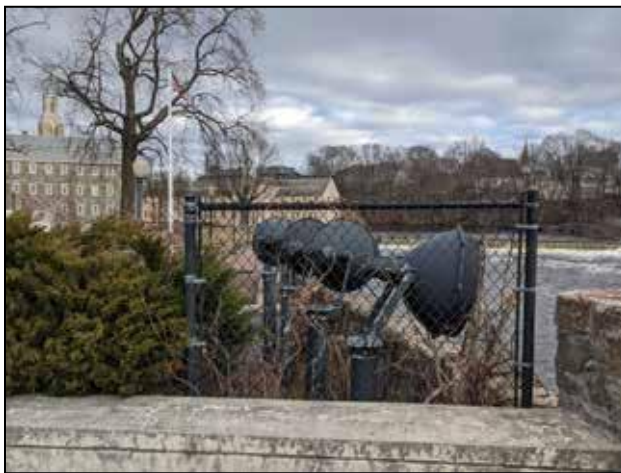
Figure 2.51. View looking north at the river floodlights. (OCLP 2020, IMG-20200105-121825)

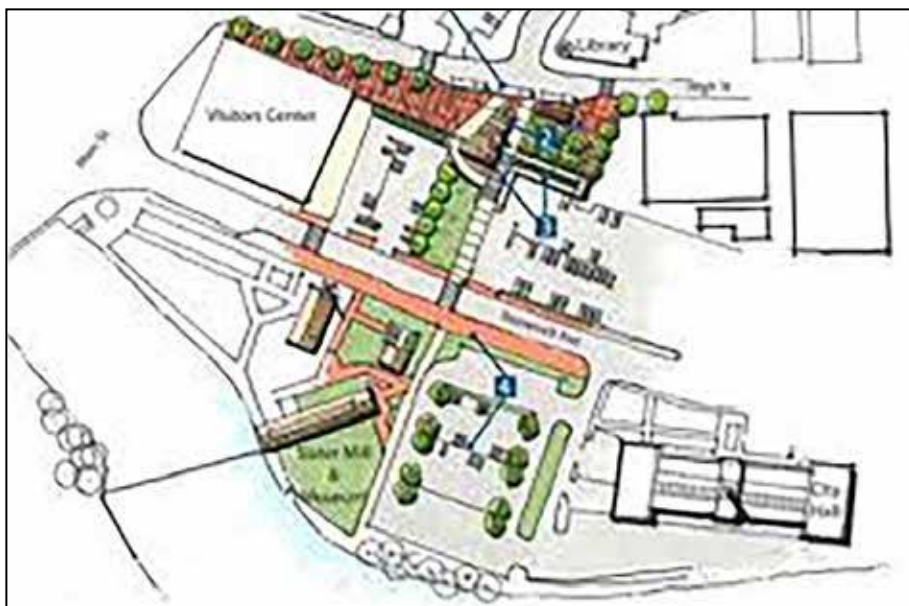
Figure 3.3. Proposed long-term improvements at and around the west side of Slater Mill Historic Site. (Vanasse, Hangen & Brustlin, Inc., "Long Term Improvements," *River Corridor Development Plan (Draft)*, September 2013: 47. <https://www.vhb.com/Pages/Experience/Projects/Planning>)

- Create a Downtown "Hub" of Activities. Short term improvements would include moving the Roosevelt Avenue bus operations to High Street to create a less congested and safer connection between the Visitors Center and Old Slater Mill; and implement parking improvements and the off street bikeway at Old Slater Mill (Figure 3.2). Long term improvements included creating a grand civic space and view to link High Street to Old Slater Mill, Wilkinson Mill, and the river; reconfiguring the parking area in the North Lot and installing new paths and plantings; and planting trees along the entire west riverbank (Figure 3.3).

- Plant grasses in the raceway and replant the missing tree on the peninsula (see Figures 1.23, 1.74, 1.75, 1.82). This should replace the proposed plantings of new trees along the stone river wall as shown in the 2013 *River Corridor Management Plan* (see Figure 3.3).

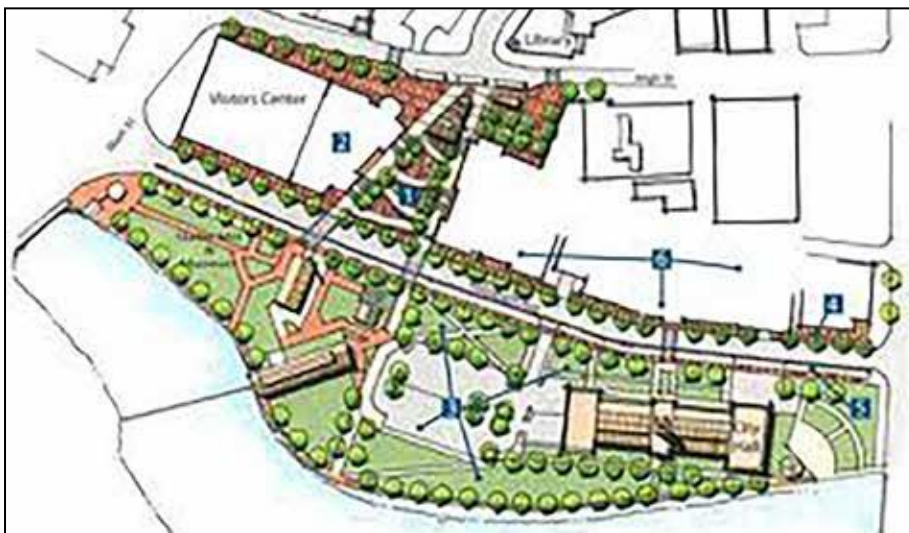
Figure 3.4. Proposed improvements at and around the east side of Slater Mill Historic Site. Vanasse, Hangen & Brustlin, Inc., "Blackstone River/Slater Mill Park," *River Corridor Development Plan (Draft)*, September 2013: 49. (<https://www.vhb.com/Pages/Experience/Projects/Planning>)

- Enhance the Riverfront at Slater Mill. Key improvements included selective trimming and clearing of existing vegetation, adding additional landscaping along new accessible pathways, adding fish ladder viewing areas at the upper and lower dams with educational signage, and enhancing the existing overlook. The overlooks would be designed with materials and architectural details that reflect the style of Old Slater Mill (Figure 3.4).

tions were removed and the area was transformed into Slater Mill Park, leaving behind only the historic river wall and a few remnant foundations. There is currently no accessible circulation feature that leads to the existing overlook (Figure 3.19). Volunteer riparian vegetation in the lower area blocks views from the lawns above the wall toward Old Slater Mill (Figures 3.20, 3.21, 3.22). The 2013 *River Corridor Management Plan* recommended a new walkway along the riverfront, enhancement of the existing overlook and a new overlook at the proposed fish ladder, and installation of new plantings and management of existing plants (see Figure 3.4).

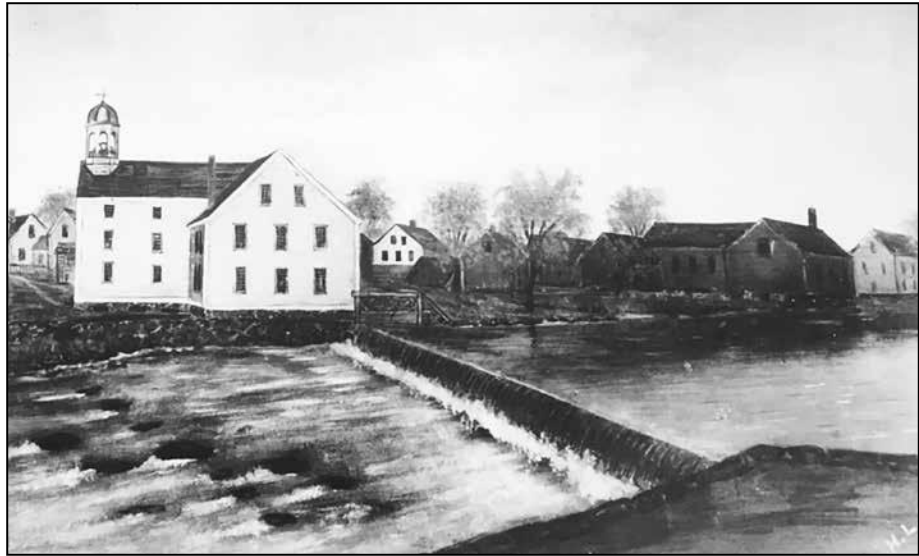
Figure 3.6. Painting of the south side of Old Slater Mill from the east bank, c.1840, and one of the first sketches of the Great Flume and peninsula. (H.L. Spencer, "Painting of South Elevation of Slater Mill," c.1840. Old Slater Mill Association [hereafter OSMA] Archives, from LeeAnne Brooks and Lauren Laham, *Slater Mill, Historic Structure Report* [hereafter HSR], *Blackstone River Valley National Historical Park, Pawtucket, Rhode Island*, Lowell, MA: National Park Service, Northeast Region, Historic Structure, Research, and Documentation Branch, Historic Architecture, Conservation, and Engineering Center, 2018: 39)

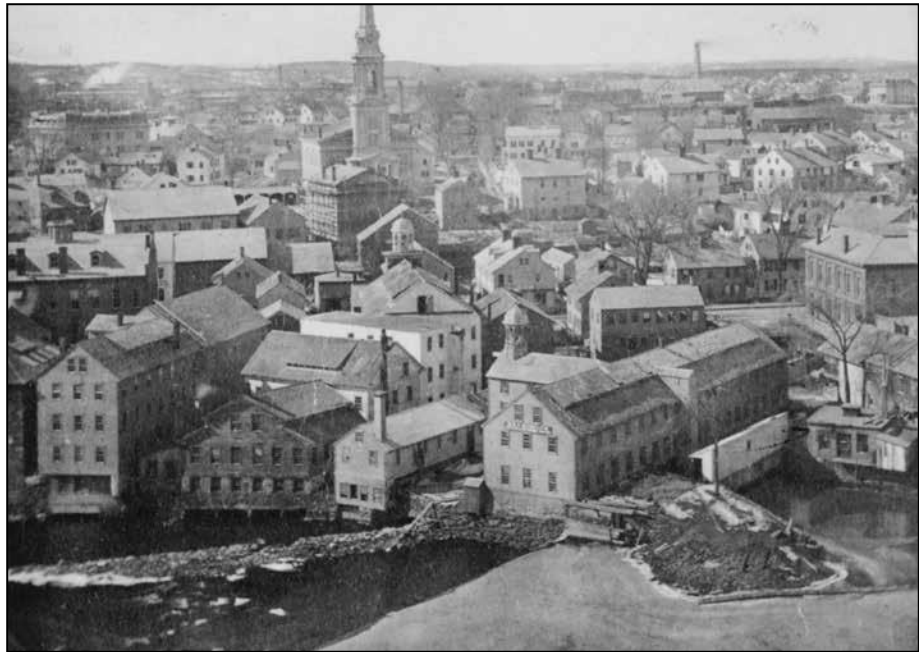
Figure 3.7. Oblique aerial view looking west, ca. 1869, at the Great Flume, peninsula, and the gatehouse. (OSMA Archives, from Emma J.H. Dyson and Louis P. Hutchins, *Historic American Engineering Record* [hereafter HAER], *Addendum to Old Slater Mill*, HAER No. RI-1, Washington, DC: Library of Congress Prints and Photographs Division, August 1991)

Figure 3.7). The first reference to a gatehouse is a plat map from 1872 (see Figures 1.20, 1.21). Subsequent maps and photographs also depict the gatehouse (see Figures 1.30a-b, 1.35, 1.40a-b-c, 1.51, 1.53, 1.55a-b, 1.56, 1.57). The last photograph and plan showing the gatehouse dates to 1924-1925 (see Figures 1.59, 1.66).

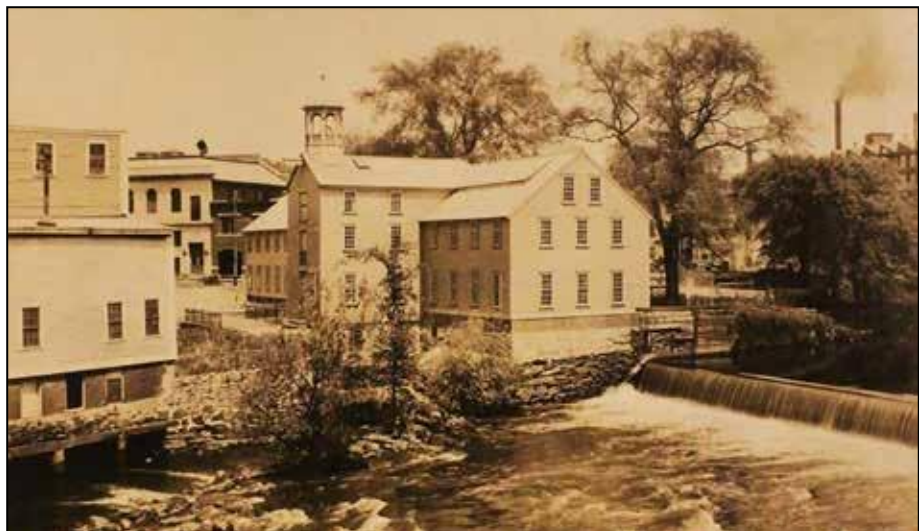
Figure 3.8. One of the last photographs of the Great Flume and peninsula. (OSMA Archives, from HSR 2018: D-86)

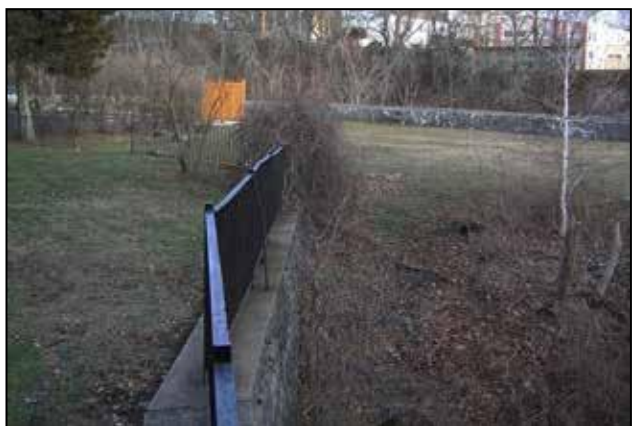
Figure 3.9. View looking northeast at the railing on top of the Great Flume stone wall. At image left is the lawn and picnic area, at image right is the filled-in Great Flume. (Olmsted Center for Landscape Preservation [hereafter OCLP] 2021, P1010025)

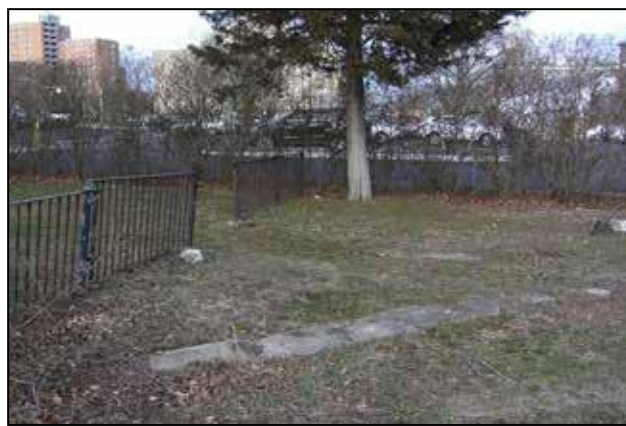
Figure 3.12. View looking north from the filled in raceway, at what may be the top of the raceway wall and/or former building foundation. (OCLP 2021, P1010019)

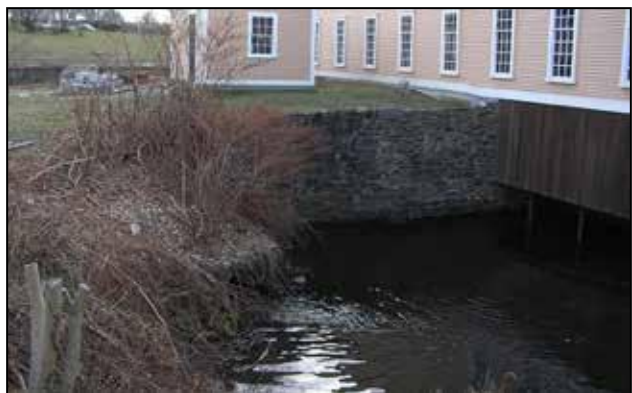
Figure 3.10. View looking southeast at woody vegetation in the Great Flume, the outlet of the penstock pipe, and the boiler house on top of the former island peninsula. (OCLP 2021, P1010020)

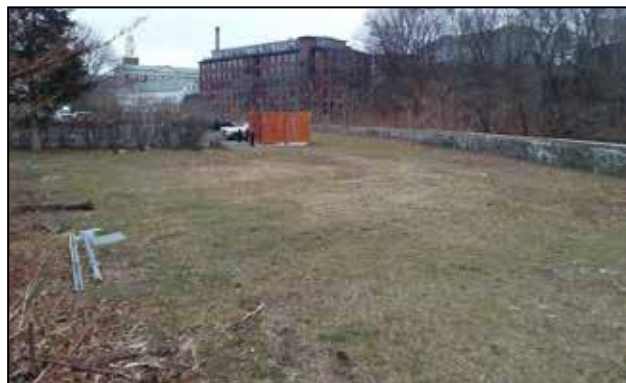
Figure 3.13. View looking east at the filled in Great Flume, with the stone river wall at image right. The North Lot parking area is in the distance. (OCLP 2021, 20210111_142532)

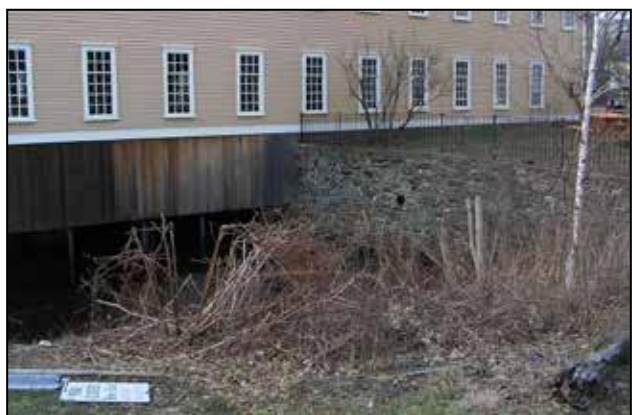
Figure 3.11. View looking west at woody vegetation in the Great Flume. (OCLP 2021, P1010017)

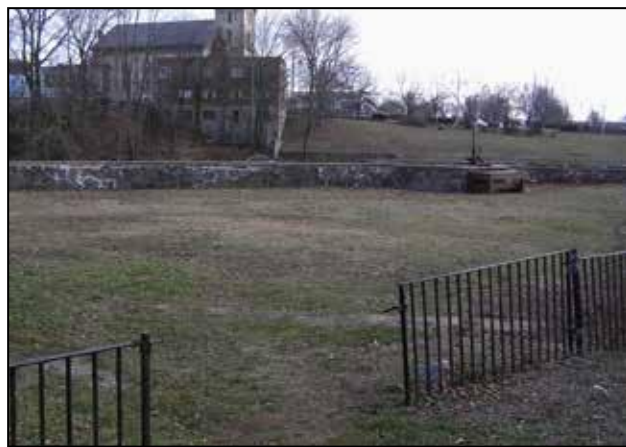
Figure 3.14. View looking south at the filled in raceway and the stone river wall. (OCLP 2021, P1010021)

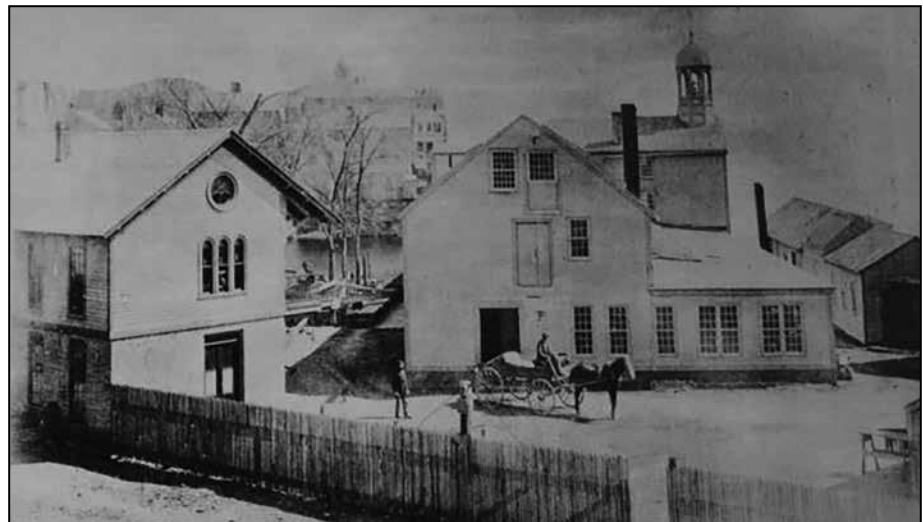
Figure 3.16. View looking southeast at the north side of Old Slater Mill, c.1869. This is the first photograph of the gangway on the east side of the mill. (HSR 2018: 48)

The gangway historically spanned the Great Flume on the east side of Old Slater Mill, supporting the mechanisms required to control the flow of water in the raceway as well as a trash rack to intercept debris before flowing into the mill. The first documentary evidence that suggests the presence of a gangway is an 1823 map, although some type of earlier structure would have been needed at this location when the raceway and mill were constructed in 1793 (see Figure 3.5). The first plan to show the gangway in detail dates to 1856 (Figure 3.15). The first photograph of the gangway dates to c.1869, but another photograph from around the same time is the first to show a gatehouse structure on top of it, which was presumably built to protect the machinery from the weather (Figure 3.16, see also

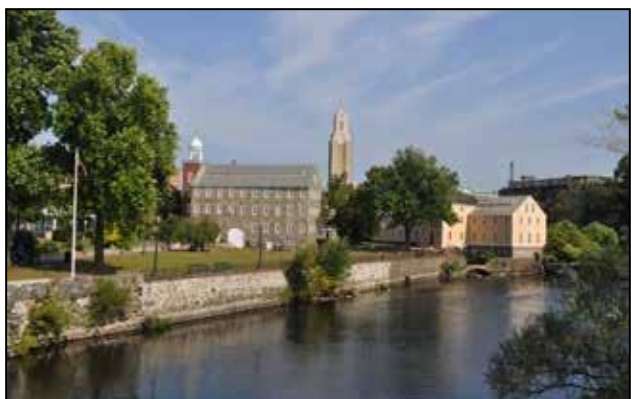
Figure 3.17. View looking north at vegetation growing in the river wall/foundation walls in the South Lot and North Lot, 2019. The park removed this vegetation in 2020. (OCLP 2019, DSC-5432)

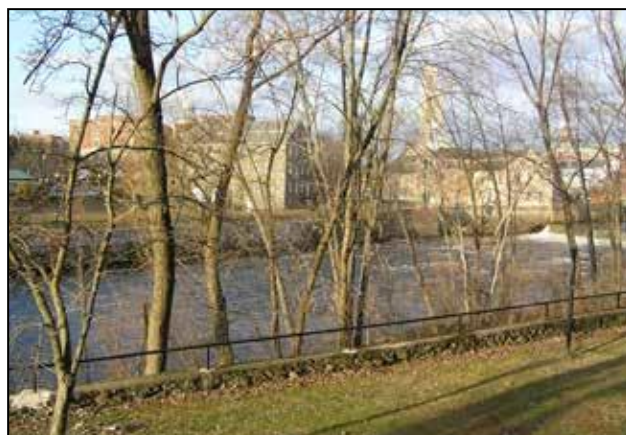
Figure 3.20. View looking north at volunteer vegetation growing in the lower area of the East Lot. (OCLP 2021, P1010045)

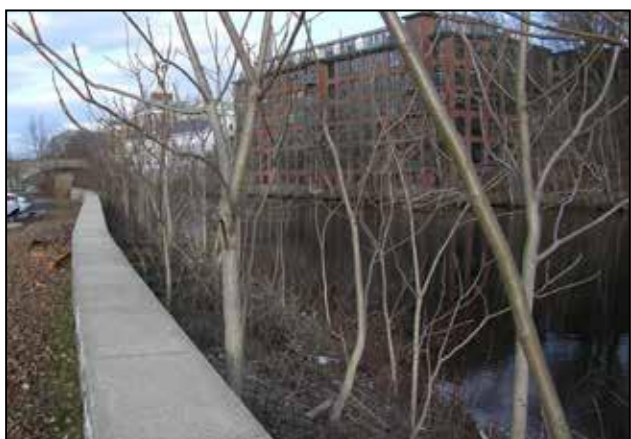
Figure 3.18. View looking north at invasive trees close to the stone retaining wall in the North Lot. (OCLP 2021, P1010007)

Stone was the most common building material used for most foundations and walls in the Blackstone Valley, and was later supplemented with concrete and brick in the nineteenth century. Examples of historic stone and brick construction are extant at Old Slater Mill and Wilkinson Mill, as are stone and concrete walls along the riverbanks that served as both building foundations and protection from the river. Masonry materials deteriorate over time, allowing the growth of woody vegetation between the stones and bricks or in cracks in the concrete. Such vegetation can threaten the integrity of the structure by displacing stones and mortar, forming and widening cracks, and creating openings for moisture to freeze and thaw. Historic photographs reveal several time periods where trees and shrubs were growing along and over the river wall in the North Lot, next to the stone and brick foundation of Old Slater Mill, and in the river walls/foundation walls in the South Lot. These conditions were present until late 2020 when the park removed the vegetation (Figure 3.17). However, invasive woody plants are still growing next to the historic stone wall in the North Lot (Figure 3.18).

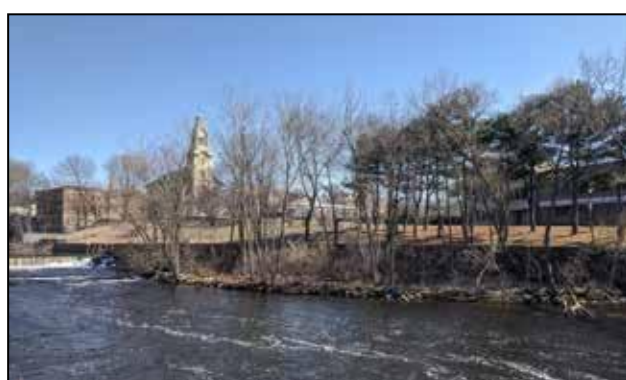
Figure 3.21. View looking northeast at vegetation growing in the lower area of the East Lot. (OCLP 2020, IMG-20200223-130935)

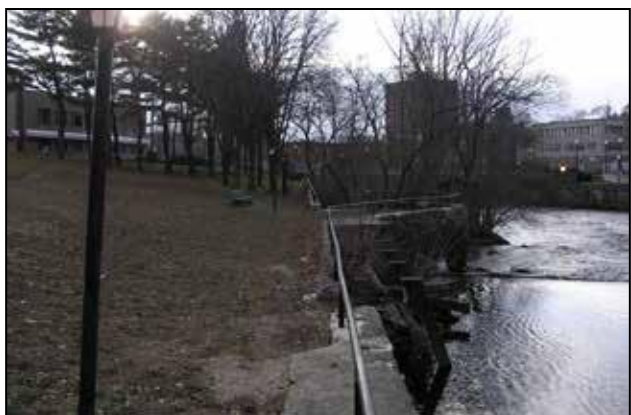
Figure 3.19. View looking southwest at the river wall and the overlook at the upper dam. (OCLP 2021, P1010038)

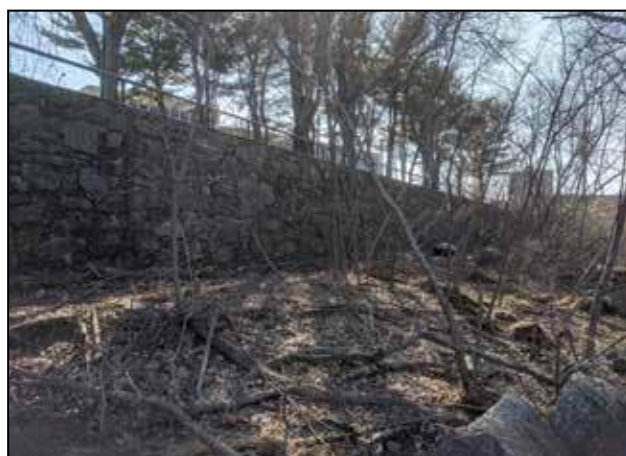
Figure 3.22. View looking northwest at remnant stones and volunteer vegetation in the lower area of the East Lot. (OCLP 2020, IMG-20200223-133021)

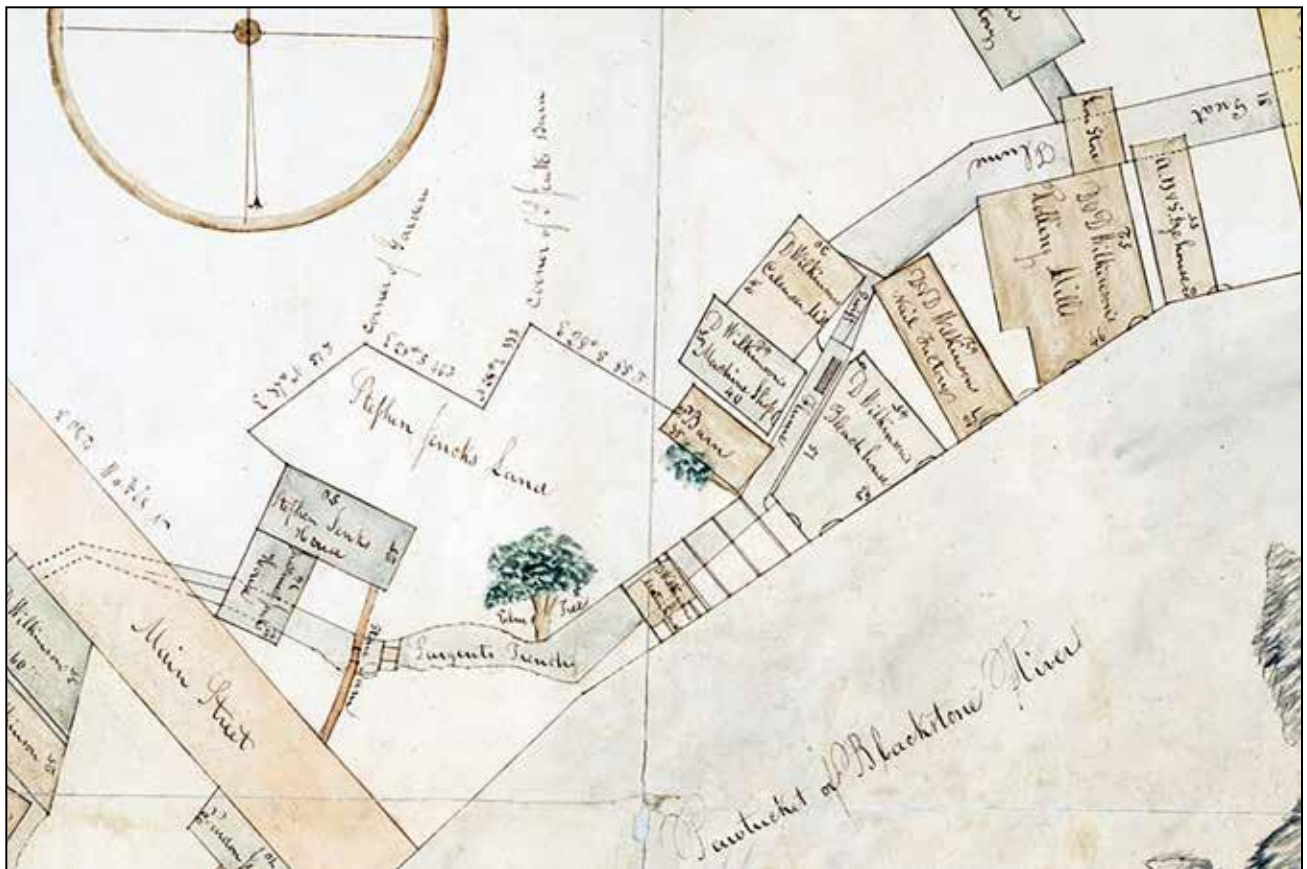
Figure 3.23. Detail of map from c. 1823 showing the course of the Great Flume, Swift Run, and Sargeant's Run raceways through the South Lot, now Hodgson-Rotary Park. (Thomas Mann, *Plat of Blackstone River and Sargent's Trench in Pawtucket, June 13, 1823*. OSMA Archives, from HSR 2018: D-25)

- Conduct archeological investigations to determine the locations and conditions of the raceways in the park. Consider replanting the tree shown in 1823 map (see Figure 3.23) if there is sufficient information.
- Based on the archeological findings, workshop ideas that show the courses of the raceways across the existing surfaces of lawns and walks, through the use of hardscape and plant materials.
- Alternatively, transform the sloped planting bed on the west side of the park into an interactive water feature that gestures to the historic presence of the raceways. This bed is currently defined by concrete retaining walls with a mix of shrubs, grasses, and the Hodgson-Rotary tablet (Figures 3.29, 3.30).
- Plant new trees along the brick walk that parallels the stone river wall/foundation, as shown in the 2013 *River Corridor Management Plan* (see Figure 3.3)

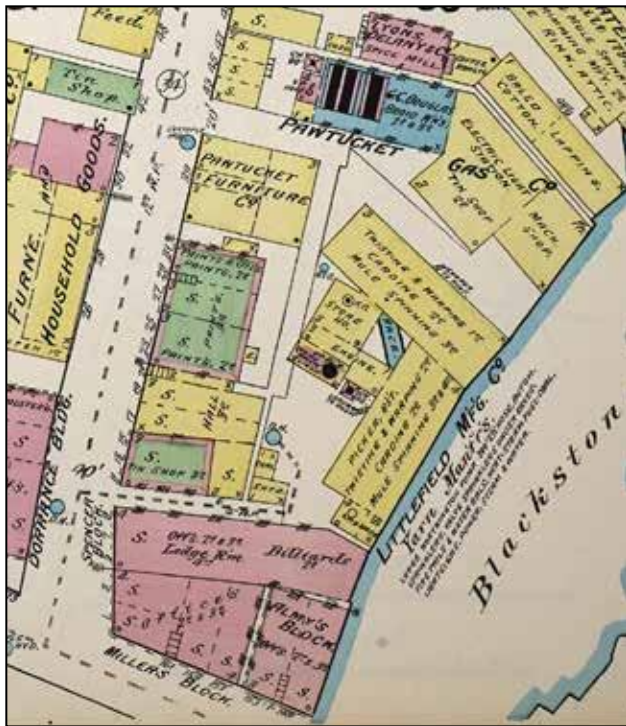
Figure 3.25. Map of South Lot, dated 1890, revealing a short segment of Swift Run. (Sanborn Map Company, *Sanborn Fire Insurance Map from Pawtucket, Providence County, Rhode Island*, Sheet 15, 1890. Washington DC: Library of Congress Prints and Photographs Division, from HSR 2018: D-56)

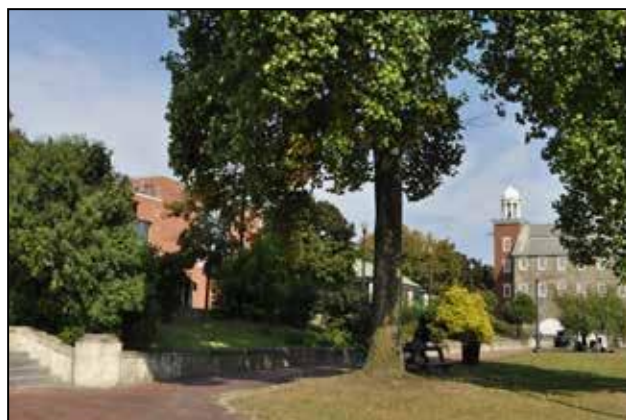
Figure 3.29. View looking north at the lower wall of the sloped planting bed on the west side of Hodgson-Rotary Park. (OCLP 2019, DSC-5440)

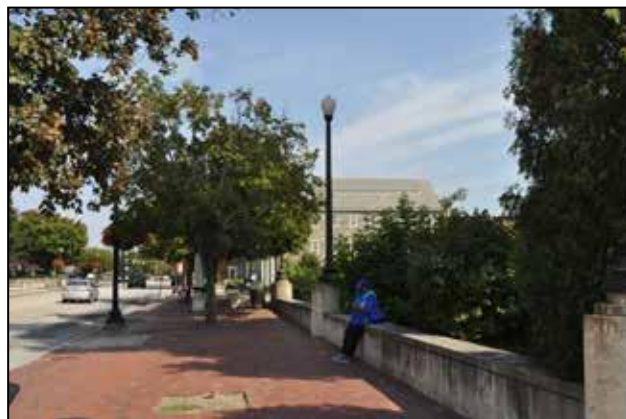
Figure 3.30. View looking northeast at the upper wall of the raised planting bed that defines Hodgson-Rotary Park. (OCLP 2019, DSC-5444)
