# Wind Turbine Gearbox Condition Monitoring Round Robin Study – Vibration Analysis

S. Sheng, Editor  
*National Renewable Energy Laboratory*

**Technical Report**  
NREL/TP-5000-54530  
July 2012

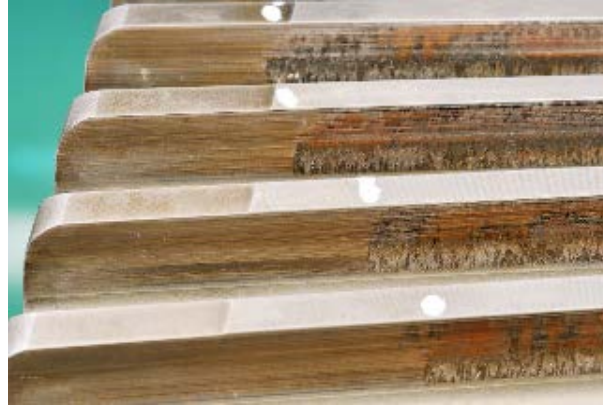
After the dynamometer retest, the gearbox was sent to a rebuild shop, where it was disassembled and a detailed failure analysis [4] was conducted. A complete list of actual damage found through the failure analysis is given in Table 2.5. For example, the high speed stage gear damage in Figure 2.9 shows clear scuffing marks.

**Figure 2.9. Test gearbox high speed stage gear damage. NREL/PIX #19599.**
