NATIONAL BUREAU OF STANDARDS REPORT

NBS REPORT 6475

QUARTERLY REPORT ON EVALUATION OF REFRACTORY QUALITIES OF CONCRETES FOR JET AIRCRAFT WARM UP, POWER CHECK, MAINTENANCE APRONS, AND RUNWAYS

W. L. Pendergast, E. C. Tuma, Bruce Foster Refractories Section Mineral Products Division

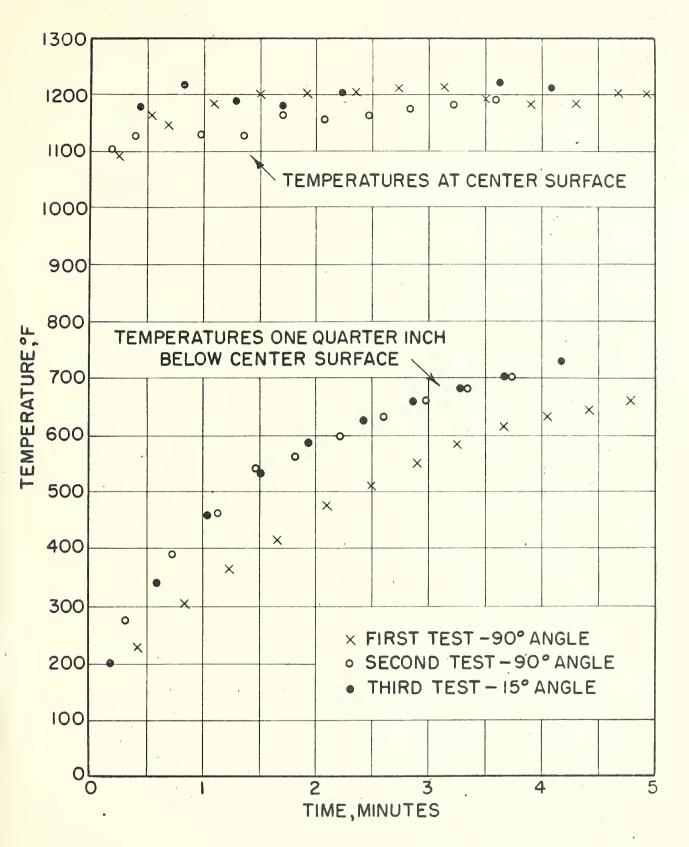
FIG. I-TIME-TEMPERATURE CURVES AT CENTER SURFACE AND ONE QUARTER INCH BELOW CENTER SURFACE OF TEST PANEL DURING THREE JET IMPINGEMENT TESTS.

Repeated jet impingement tests on successive days on panel P-BF-5-3 affected the temperature gradient in the top 1/4 inch. The curves shown in Figure I give the results of temperature measurements on and within the same panel during three successive jet impingement tests.

The difference between surface temperatures and those one quarter inch below the surface at the end of each time interval was greater during the first test than during subsequent tests. We attribute this to the presence of more moisture in the concrete available for cooling by evaporation during the first test.

The studies that were made of the effect of reducing the angle of impingement of the jet stream from 90 to 15° did not materially alter the temperature pattern. Temperature data at other positions and depths during the three tests gave similar results.
