NISTIR 7902

Fatigue Flaw NDE Reference Standard Development Phase I— Feasibility Study

Mark D. Richards
J. David McColskey
Timothy S. Weeks

November 2012

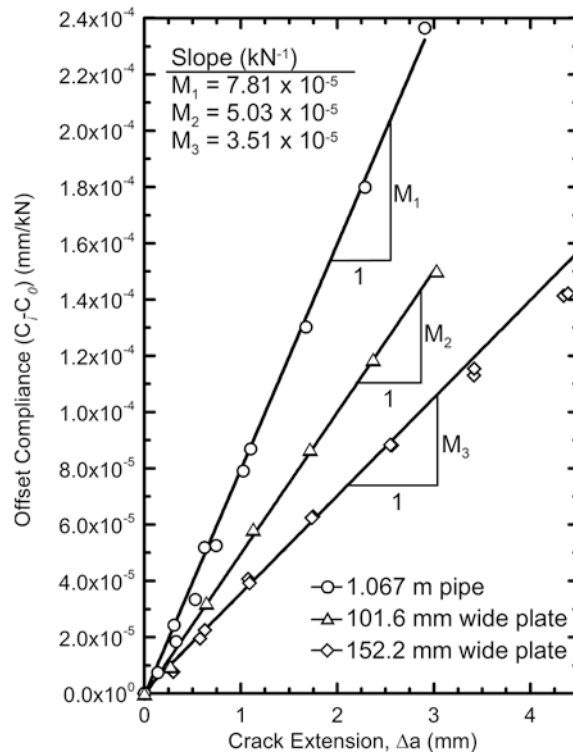
Figure 7 – Offset compliance versus crack extension measured optically from exposed fracture surfaces for the 1.067 m. diameter pipe (1.9 mm x 48.3 mm starter notch) and the 101.6 mm and 152.2 mm wide flat plates (1.4 mm x 23.2 mm starter notch).

From Figure 7, the characteristic slope values relating the change in compliance with an extension of the fatigue crack are listed for the 1.067 m diameter pipe specimens having 1.9 mm x 48.3 mm notches and for the 101.6 mm and 152.2 mm wide flat plate specimens having 1.4 mm x 23.2 mm notches. The linear regression analysis of the slope of the offset compliance versus crack extension data for the 6 in wide plate data in Figure 7 was limited to a crack extension of approximately 3 mm, as the data began to deviate from linearity beyond this limit. The linear relationship between compliance change and crack extension allows for the use of a simple equation to predict the instantaneous crack length a_i in a component based upon the instantaneous compliance C_i and the initial crack length a_0 and the initial compliance, C_0 [7]:

The data in Figure 8 demonstrate an excellent correlation between the predicted and measured crack lengths from Equation 2. The data maintain a 1:1 relationship, demonstrated by the solid line in Figure 8, and the dashed lines represent deviation limits of ± 0.1 mm from the 1:1 ratio. The data for the 1.4 mm × 23.2 mm starter notch in the 152.2 mm wide plate show a deviation from the linear response in Figure 8 at crack lengths greater than 5.5 mm, this corroborates with the deviation in the response of the compliance change with crack extensions greater than 3 mm in Figure 7.

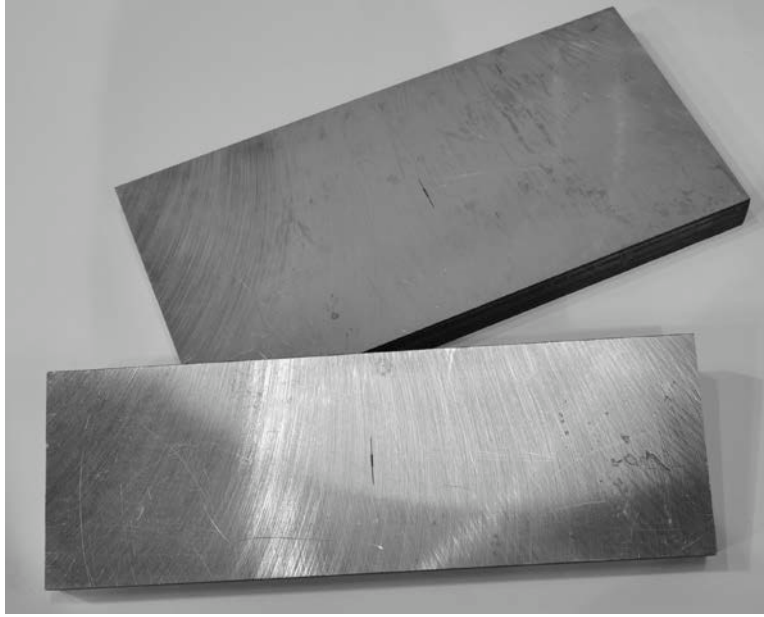
Figure 9 – Flat-plate reference standard development specimens in the EDM notched condition.

Two flat plate specimens, one 101.6 mm wide and one 152.2 mm wide, and labeled NDE SD 4-003 and NDE SD 6-002 respectively, which had EDM starter notches as shown in Figure 9, were fatigue-cracked with a target crack length of 4.4 mm. The final predicted crack length of the 102.6 mm wide plate was 4.38 mm, which was achieved at 72,000 cycles. The final predicted crack length of the 152.2 mm wide plate was 4.40 mm upon initial cracking at 61,000 cycles. However, after further evaluation of the compliance change versus crack extension data in Figure 6 for the 152.2 mm wide plates, the data at crack extensions beyond 3 mm were excluded. The result was an increase in the characteristic slope used in Equation 2. The adjusted predicted crack length for the 152.2 mm wide plate was 4.25 mm.

After each of the industrial collaborators had analyzed the reference plates shown in Figure 9, the specimens were prepared for exposure of the surfaces of the fatigue crack. The sides of the specimens were saw-cut to within 25 mm of the fatigue crack edges at the surface to reduce the cross-sectional area of the specimen. The specimens were then submerged into liquid nitrogen and allowed to cool to approximately 77 K. Once thermal equilibrium was achieved, the specimens were loaded in four-point bending until catastrophic failure. The two sides of the fracture were then immersed in ethanol and allowed to warm to ambient temperature. The fractured pieces were then dried and optical fractography of the fatigue crack fracture surfaces was performed. Figure 10a shows the fatigue fracture surface of the 4 in. NDE SD specimen, and Figure 10b shows a closeup of the fatigue crack region. Figure 11a shows the fatigue fracture surface of the 6 in. NDE SD specimen, and Figure 11b shows a closeup of the fatigue crack region.
