Boiling Experiment Facility (BXF): Post Flight Assessment Anomaly Investigation Report

ZIN Technologies, Incorporated, Middleburg Heights, Ohio

Prepared under Contract NNC09BA02B

National Aeronautics and
Space Administration

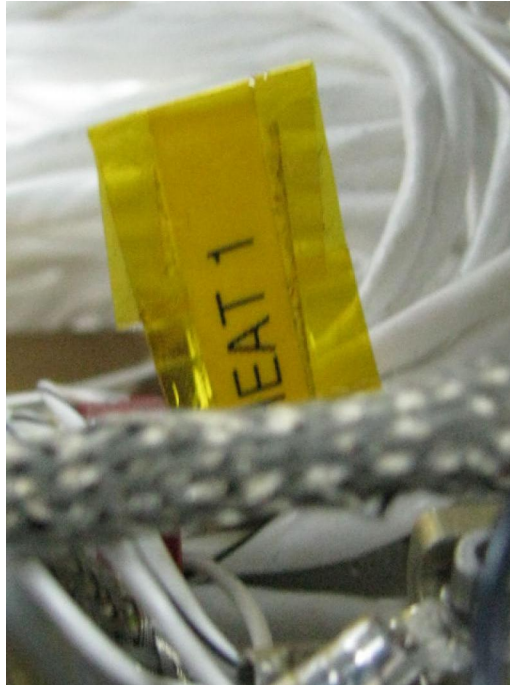
Figure D.1.—Heater 1 power cable.

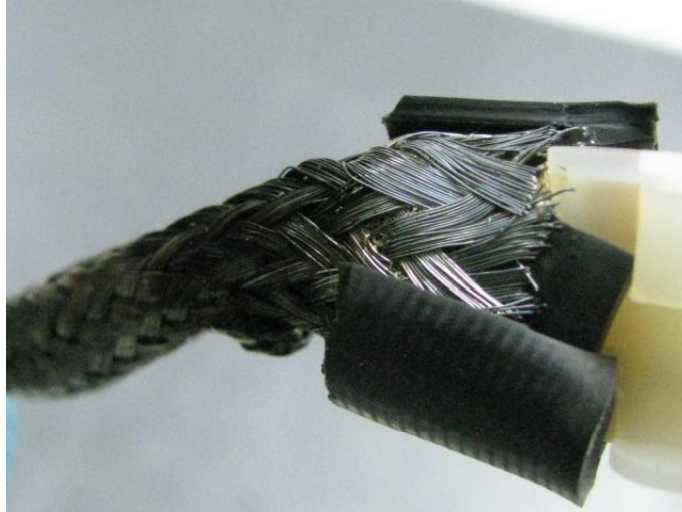
Figure D.5.—Heater 1 Molex connector, strain relief sliced open, note discoloration on wire braid.

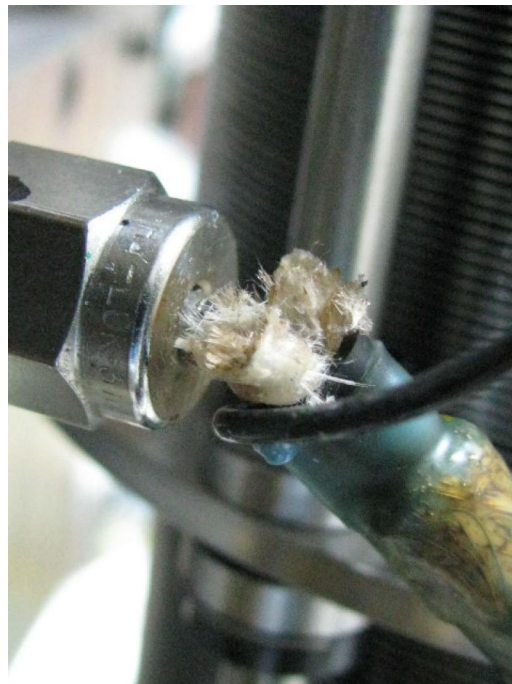
Figure D.6.—Heater 1 feedthrough into TC.

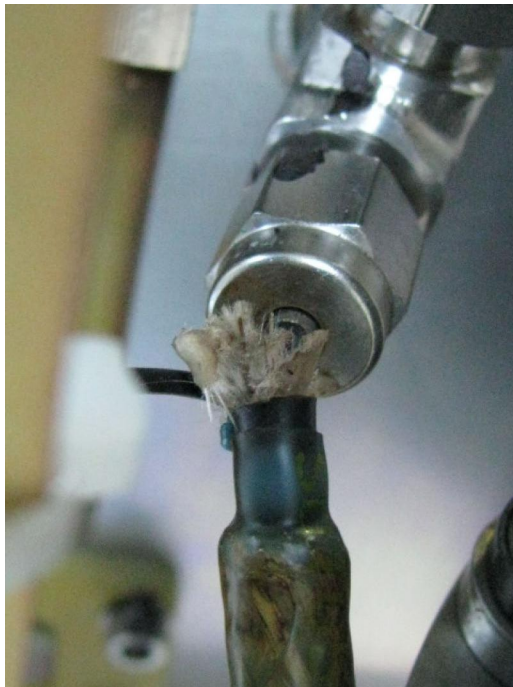
Figure D.7.—Heater 1 feedthrough into TC.
Note melted shrink wrap.

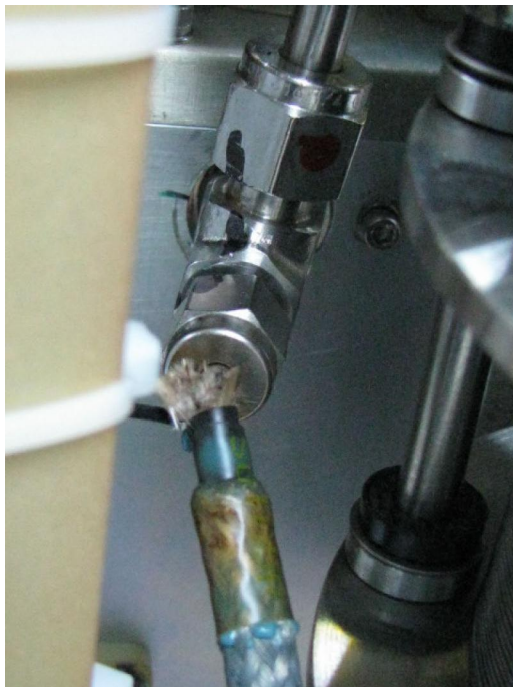
Figure D.8.—Heater 1 feedthrough into TC.

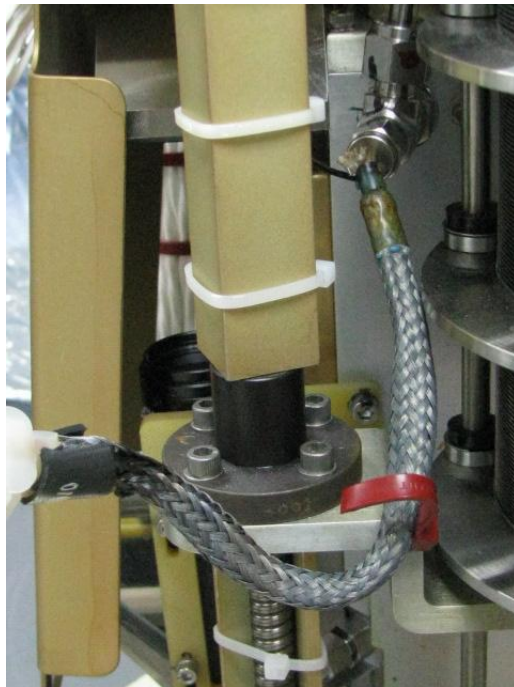
Figure D.9.—Heater 1 power cable, note discoloration on wire braid by Molex connector and melted ty-rap.

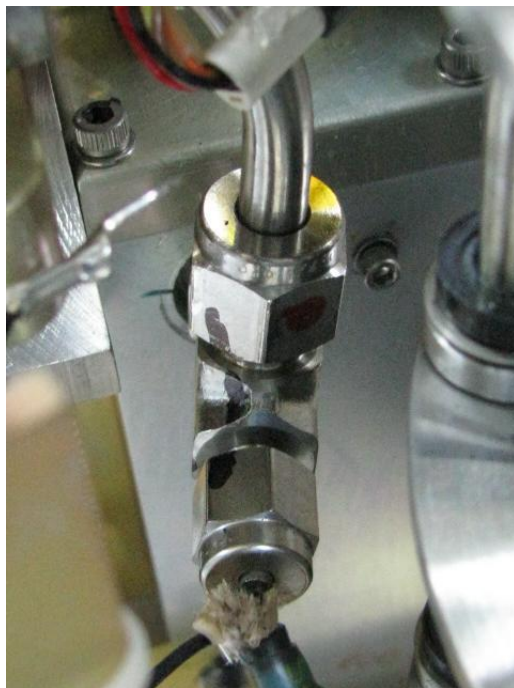
Figure D.10.—Heater 1 Feedthrough into TC.

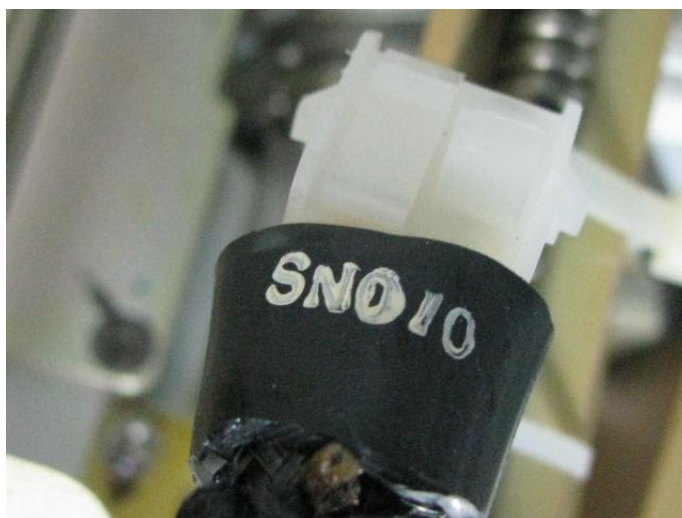
Figure D.12.—Heater 1 Molex connector, note discoloration on wire braid.

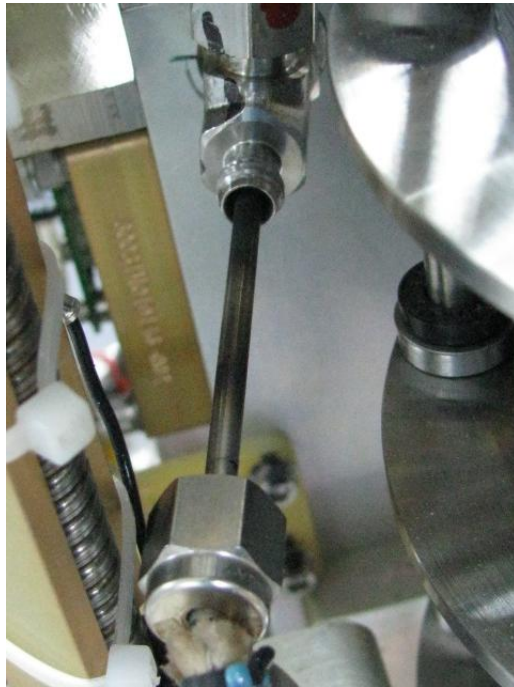
Cartridge Heater S/N 010 (Bulk Fluid Heater 1) could not be extracted from its port fitting on the Test Chamber. So, the entire fitting was removed from the chamber and left in place on the heater. Heater 1 showed extreme damage at two locations along the sheath. Melting of the Incoloy 800 is evident in both locations. The brownish magnesium oxide (MgO) insulating material and greenish remains of the nickel chromium (NiCr) wiring inside are also visible. Melting points of the various materials are listed below.

Figure D.13.—Heater 1 extracted from tee to maximum possible extent.

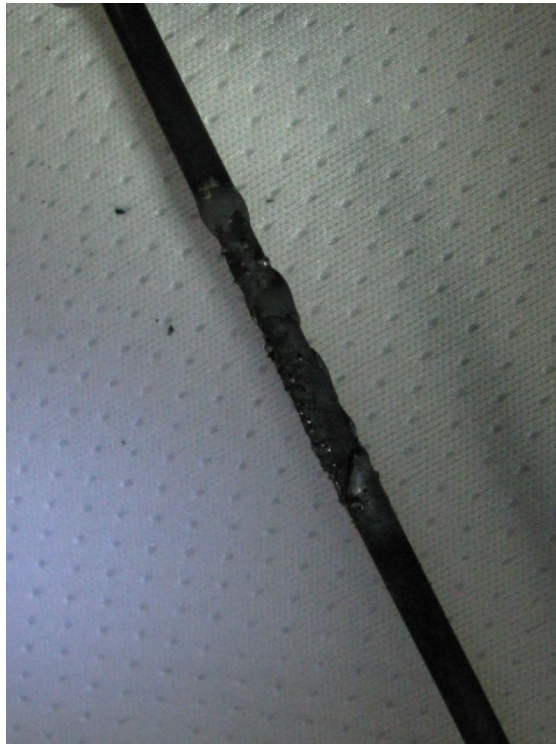
Figure D.16.—Close-up of Heater 1 melted surface.

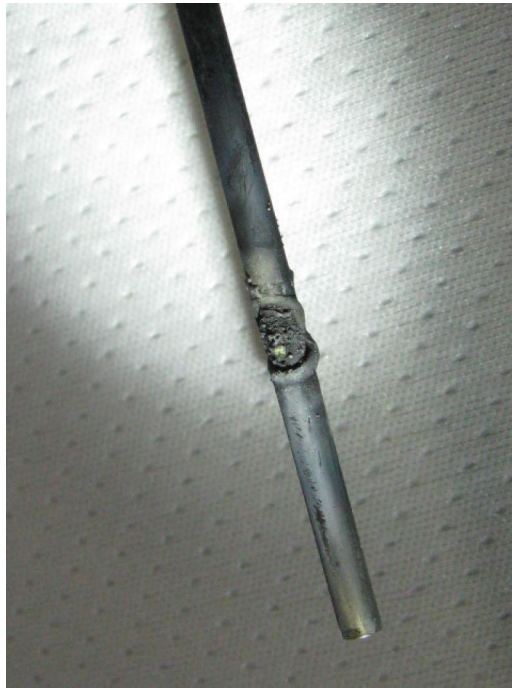
Figure D.17.—Close-up of Heater 1 melted surface near tip of heater.

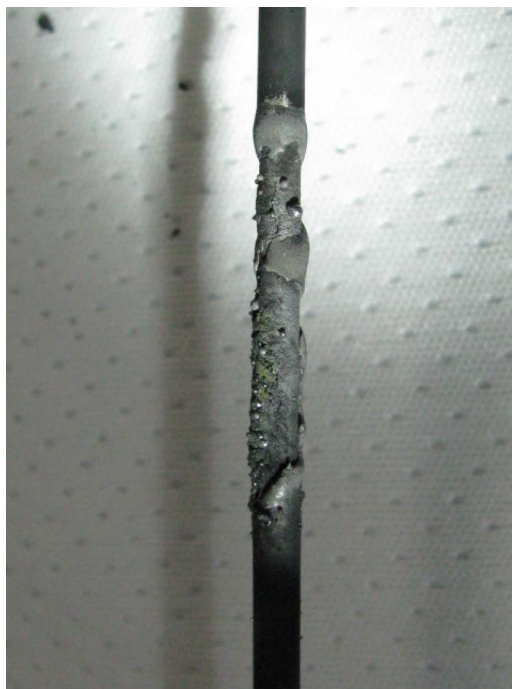
Figure D.18.—Close-up of Heater 1 melted surface.

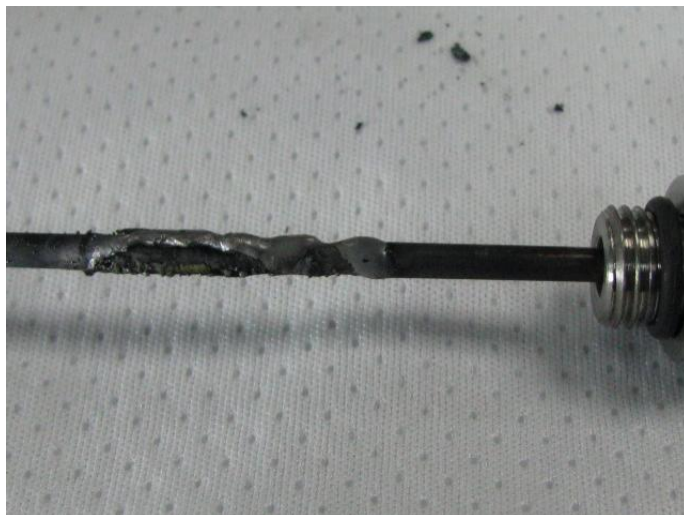
Figure D.24.—Close-up of Heater 1 melted surface.

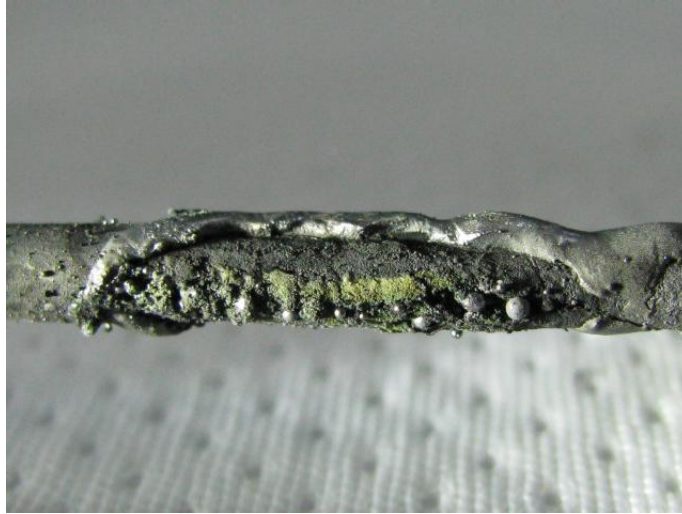
Figure D.25.—Close-up of Heater 1 melted surface.

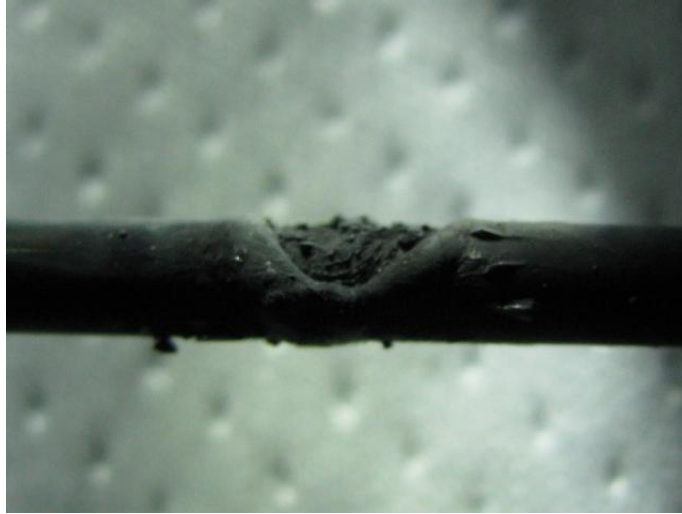
Figure D.28.—Close-up of melted surface near Heater 1 tip.

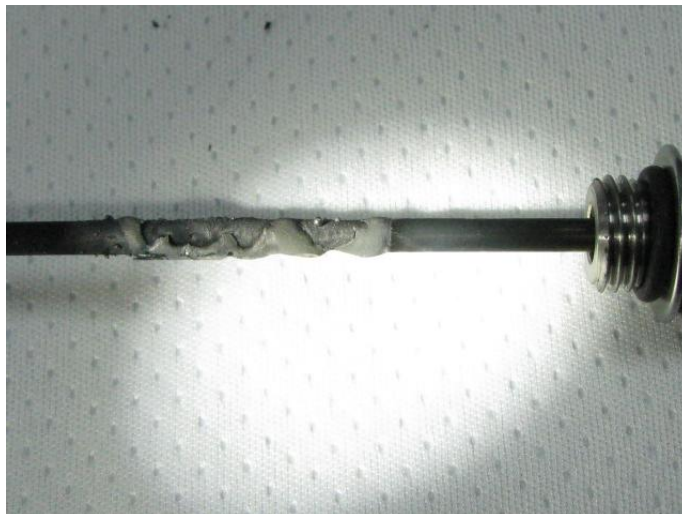
It can be concluded from the investigation results that Cartridge Heater S/N 010 (Bulk Fluid Heater 1) overheated. The heater temperature had to have reached at least 1400 °C in order to melt the Incoloy 800 and NiCr materials of the heater. The heat that was generated probably transferred via thermal conduction down the cartridge heater wiring causing the burn and melt damage observed near the connector. The

Figure D.29.—Heater 1 melted surface.

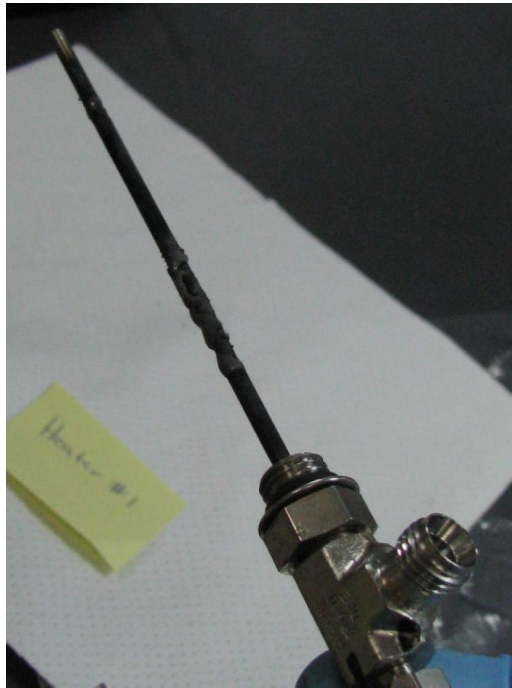
One or more of the factors above contributed to a scenario in which nucleation boiling of the fluid may have been induced around the heaters. In the case of Heater 1, this nucleation boiling may have progressed to film boiling, causing the heater to become completely enveloped in vapor. The vapor, in turn, would have acted as a thermal insulator and significantly reduced heat transfer from the heater to the fluid. This would have caused the heater to enter into a “runaway” condition in which the heater temperature increases extremely rapidly. The Bulk Fluid temperature sensors throughout the Test Chamber would not have detected this local temperature rise at the heater.

Figure D.31.—Fluid immersed portion of Heater 1: Note two melted areas of Heater 1

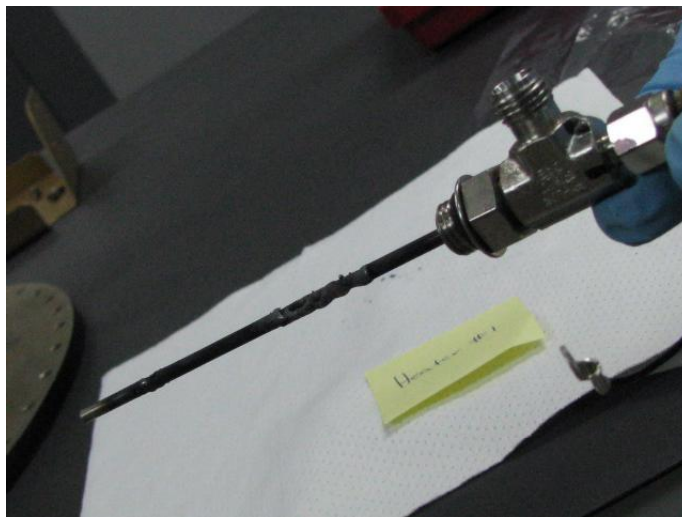
Figure D.32.—Fluid immersed portion of Heater 1: Note two melted areas of Heater 1.

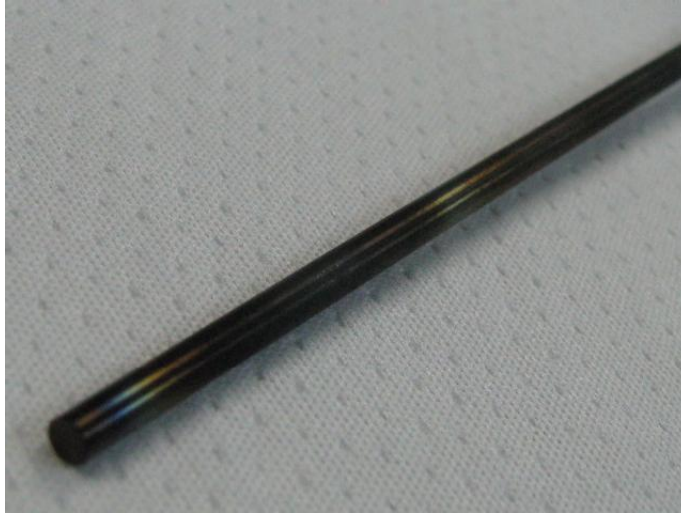
Figure D.66.—Heater 2 fluid immersed portion: Note bluing and blackening.

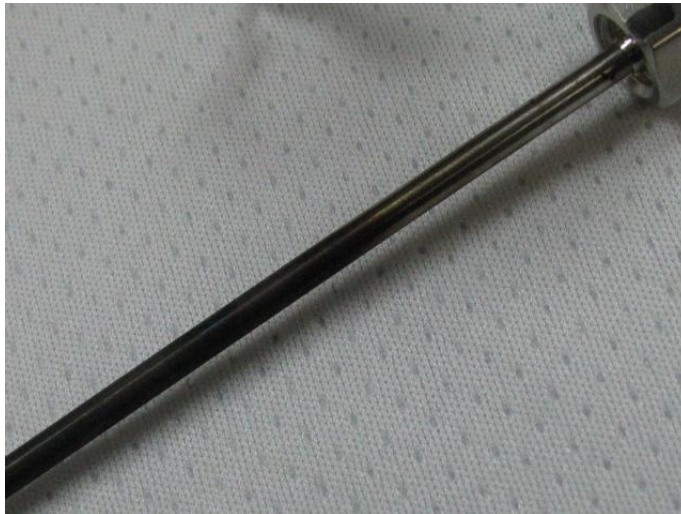
Figure D.67.—Heater 2 fluid immersed portion: Note blackening.

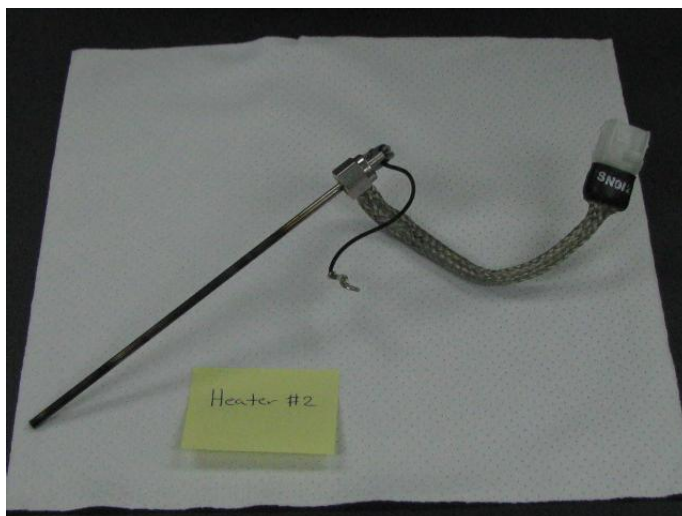
Figure D.69.—Heater 2 assembly: Note bluing and blackening on fluid immersed portion.

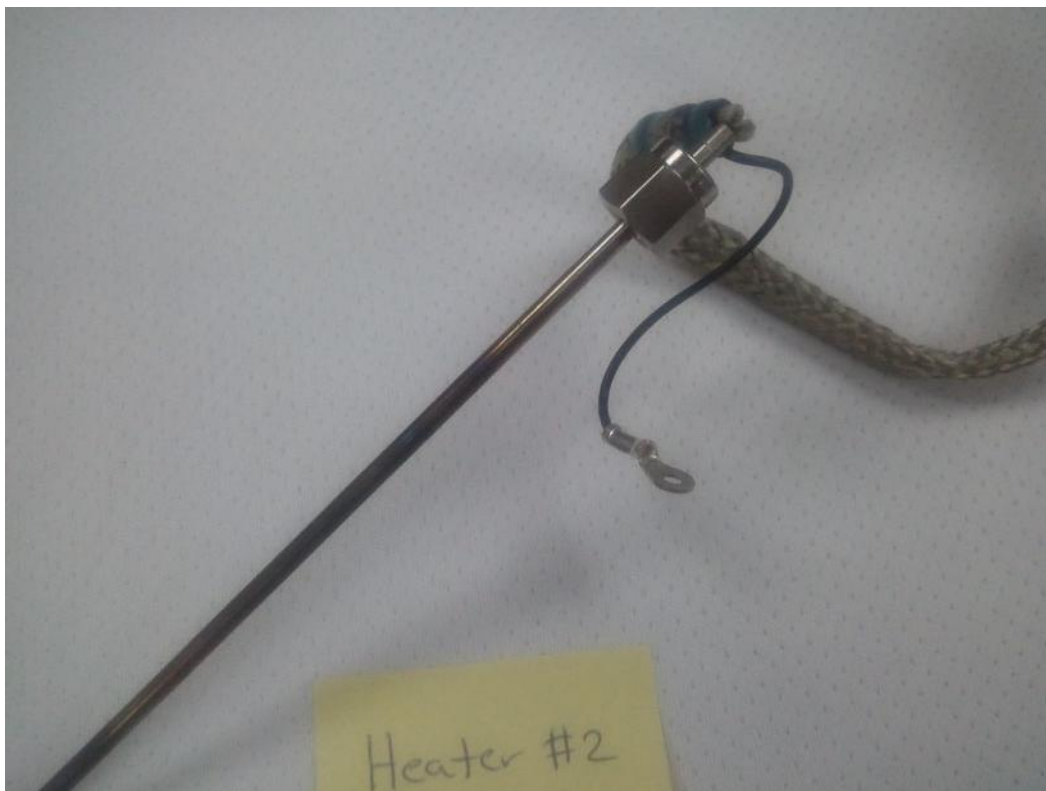
Figure D.71.—Heater 2 assembly: Note bluing and blackening on fluid immersed portion.

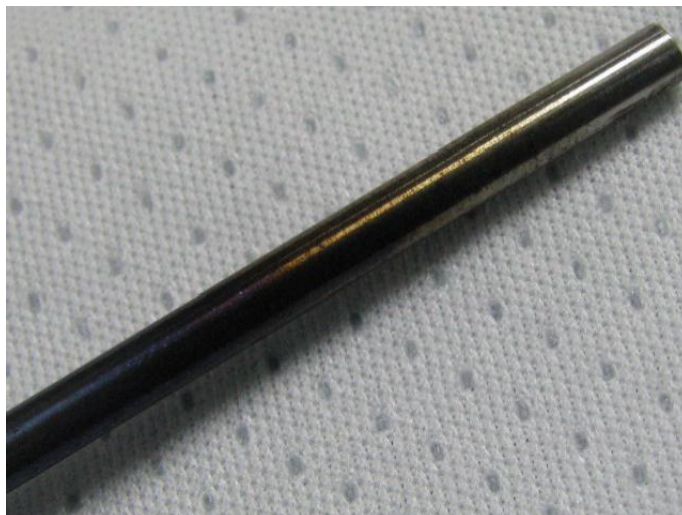
Figure D.85.—Heater 3 fluid immersed portion: Note bluing and blackening.

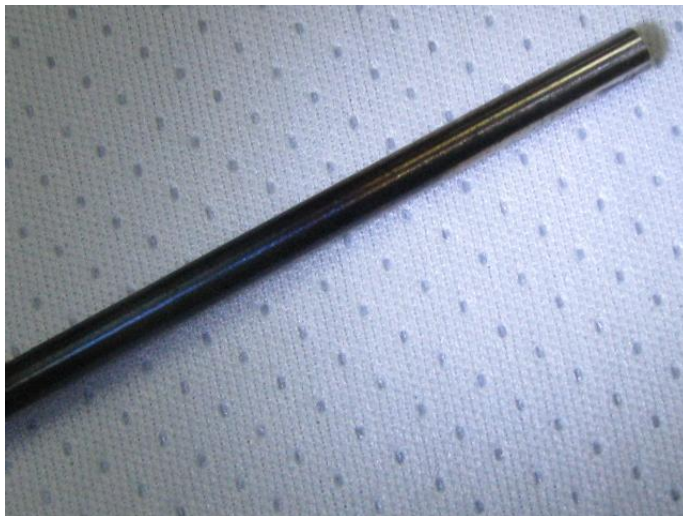
Figure D.87.—Heater 3 fluid immersed portion: Note bluing and blackening.

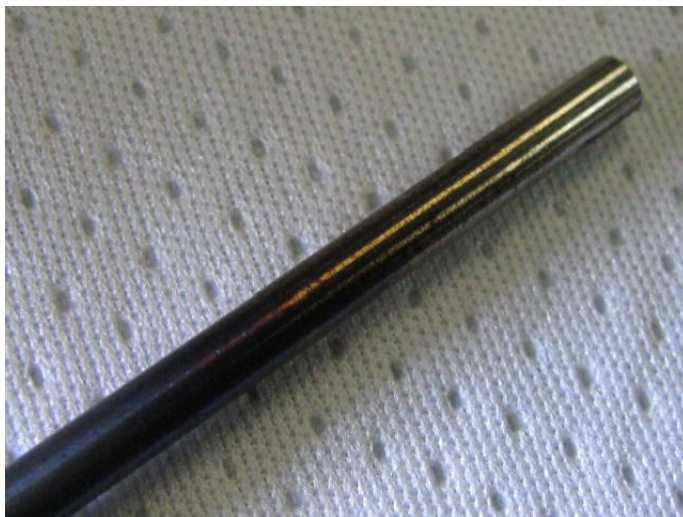
Figure D.88.—Heater 3 fluid immersed portion: Note bluing and blackening.

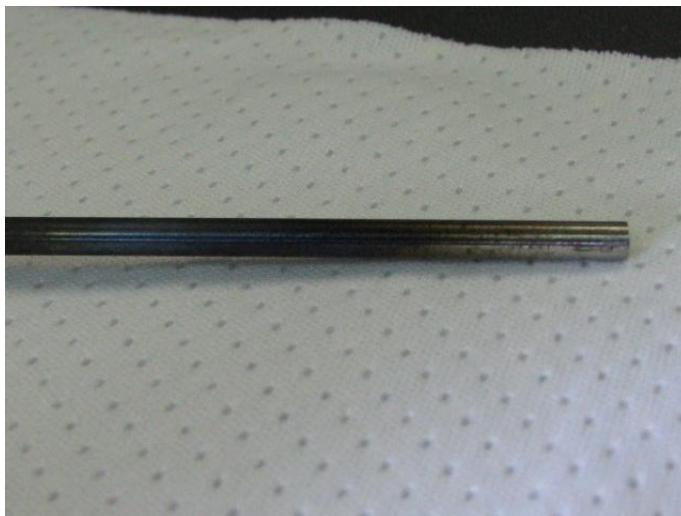
Figure D.89.—Heater 3 fluid immersed portion: Note bluing and blackening.

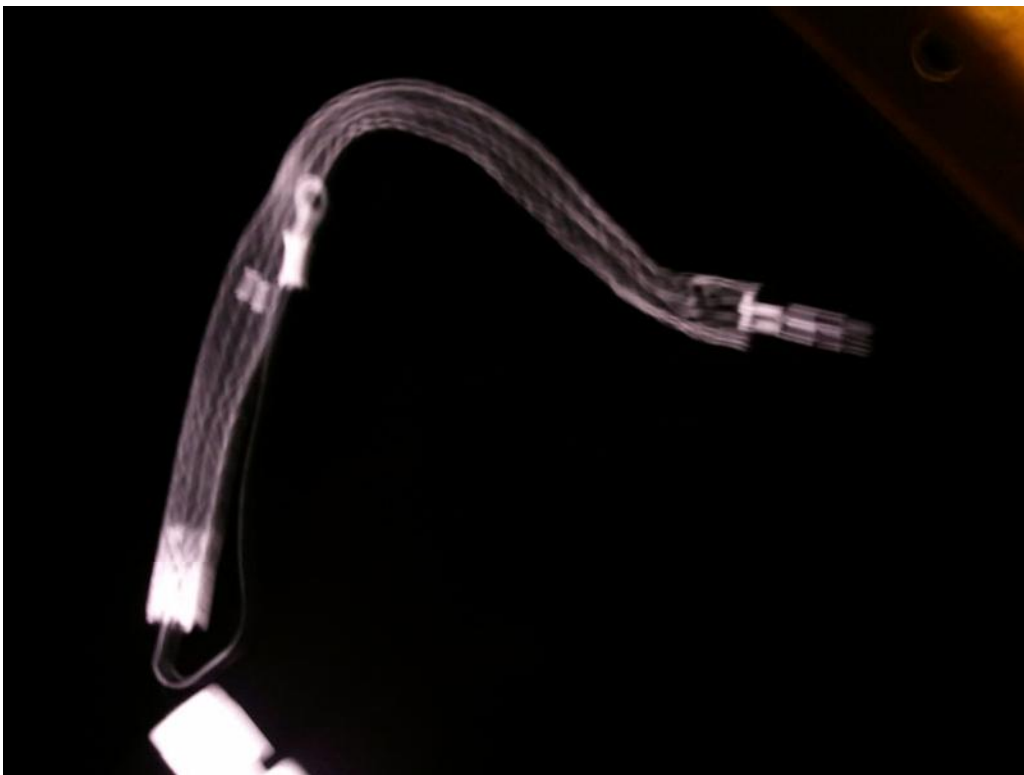
Difficulties were encountered during the dissection of Heater 1. The wiring shield braid could not be pulled back from the connector, because the shield was fused with the internal insulation sleeving. Cutting open the shield braid proved to be a slow process, as it was found that the shield had been hardened. After the shield was cut open, it was observed that the internal insulation sleeving was carbonized near the connector. The sleeving crumbled apart easily as the dissection proceeded. The insulation of the internal wiring appeared blackened overall, but whitened over the crimped area. The wire insulation near the connector was melted away leaving bare exposed wire. When the insulation sleeving was finally removed from around the connector, it was observed that the connector was melted and completely encasing the internal contacts. The contacts could not be extracted. During the dissection, the wiring separated from the heater sheath on its own without the need for cutting it, and the heater sheath became bent at one of the damaged portions of the sheath. The heater resistance was unstable and varied greatly as the assembly was handled. A stable value of 7.08Ω was finally measured during the Post-Dissection Resistance Check. Shorts of $\approx 8 \Omega$ each were found between the heater sheath and both power and return lines. The wiring that separated from the heater sheath failed continuity testing.

Figure E.31.—Wiring harness for Bulk Fluid Heater 1.

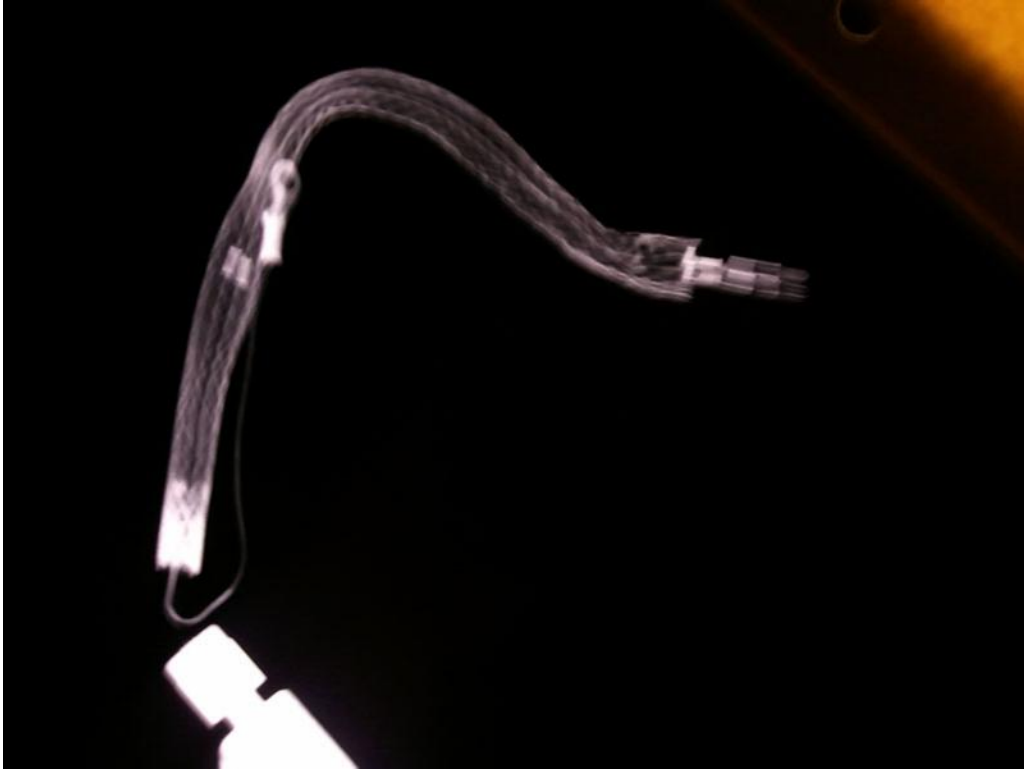
Figure E.32.—Wiring harness for Bulk Fluid Heater 1.

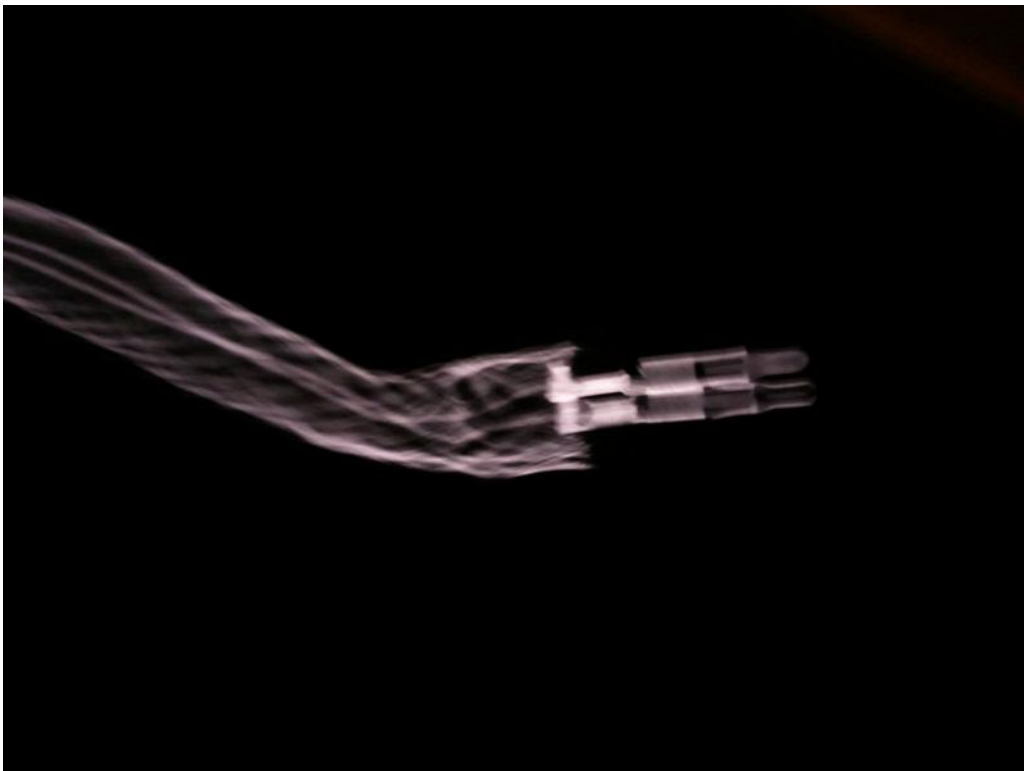
Figure E.33.—Wiring harness for Bulk Fluid Heater 1.

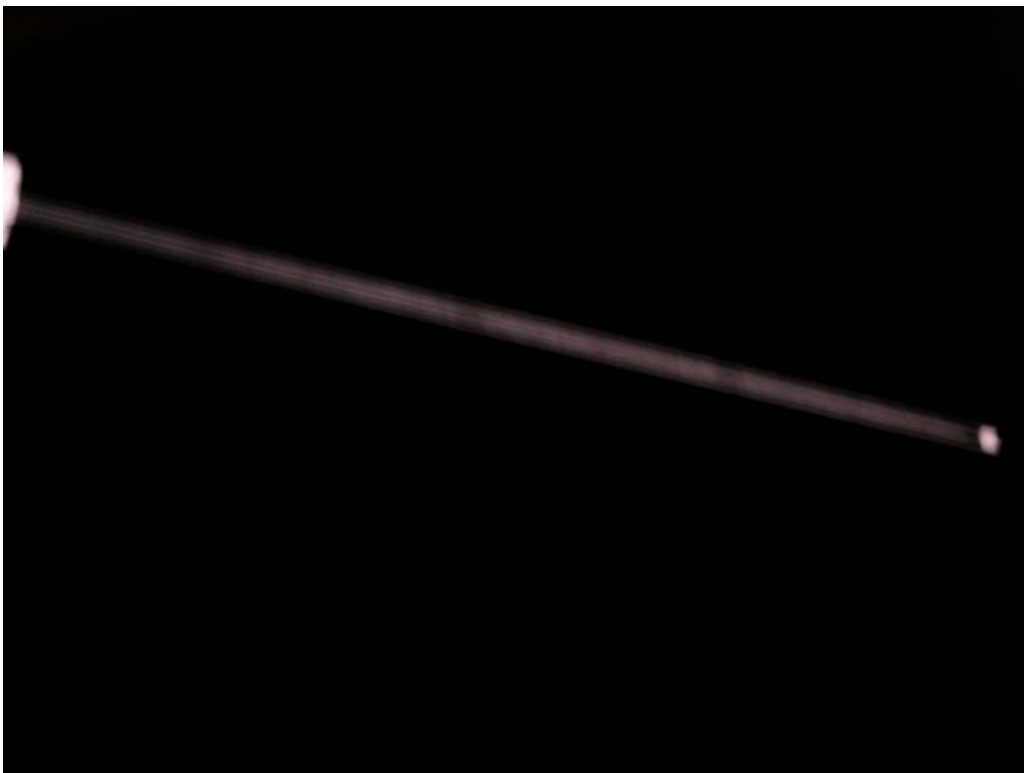
Figure E.73.—Heating element for Bulk Fluid Heater 3. Note irregularities.

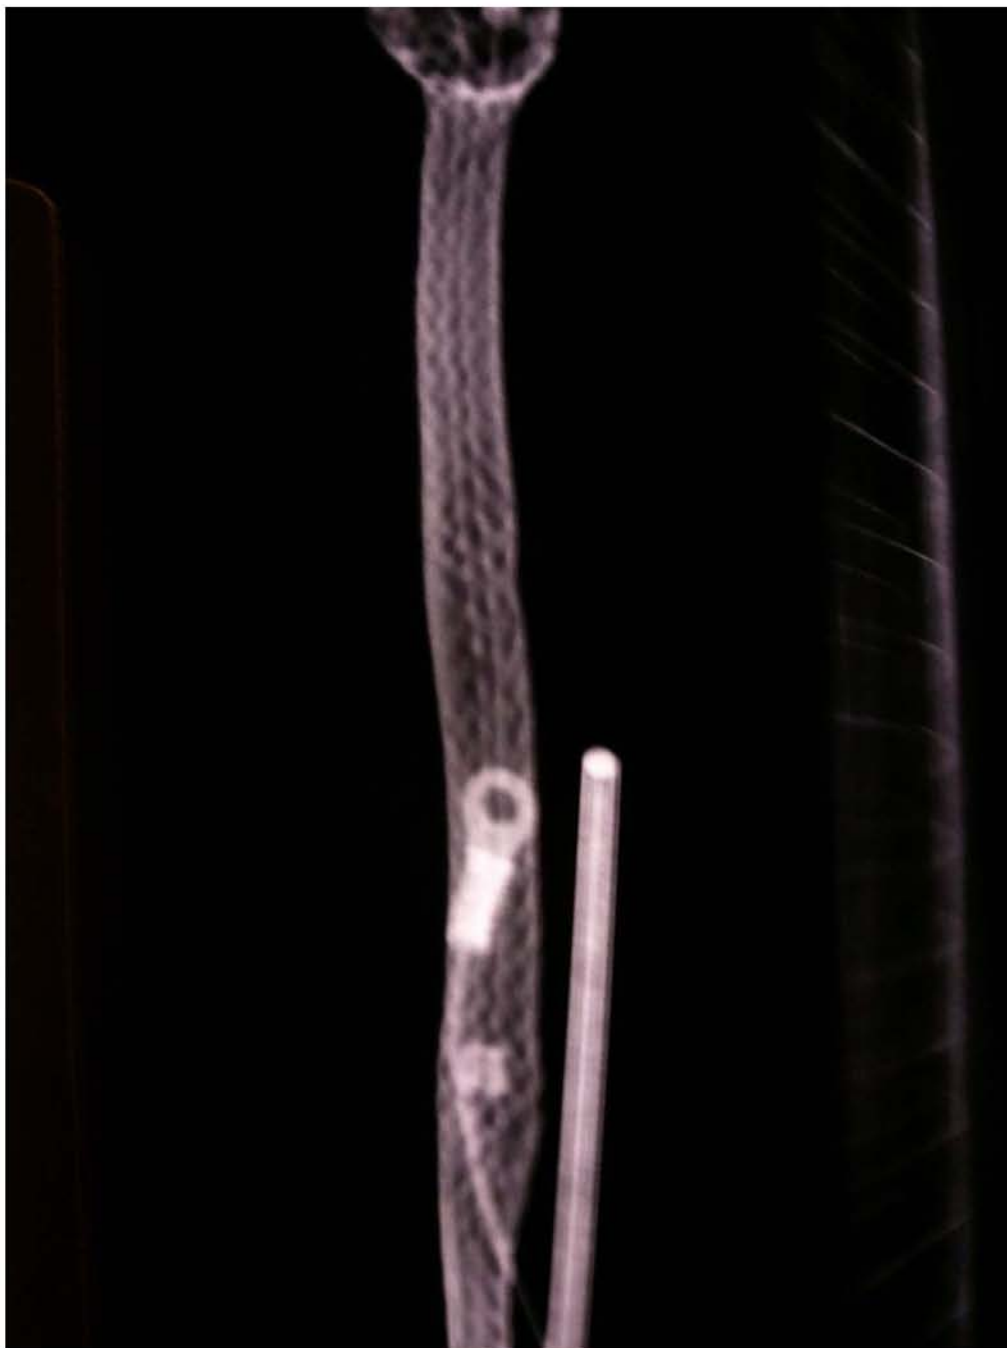
Figure E.95.—Grounding connection for Bulk Fluid Heater 3.
